**STAFF REPORT: FEBURARY 17, 2021 MEETING**

**APPLICATION NUMBER: 21-7091**

**ADDRESS: 19365 WARRINGTON**

**SCOPE OF WORK: REPLACE STEEL CASEMENT WINDOWS AS PROPOSED**

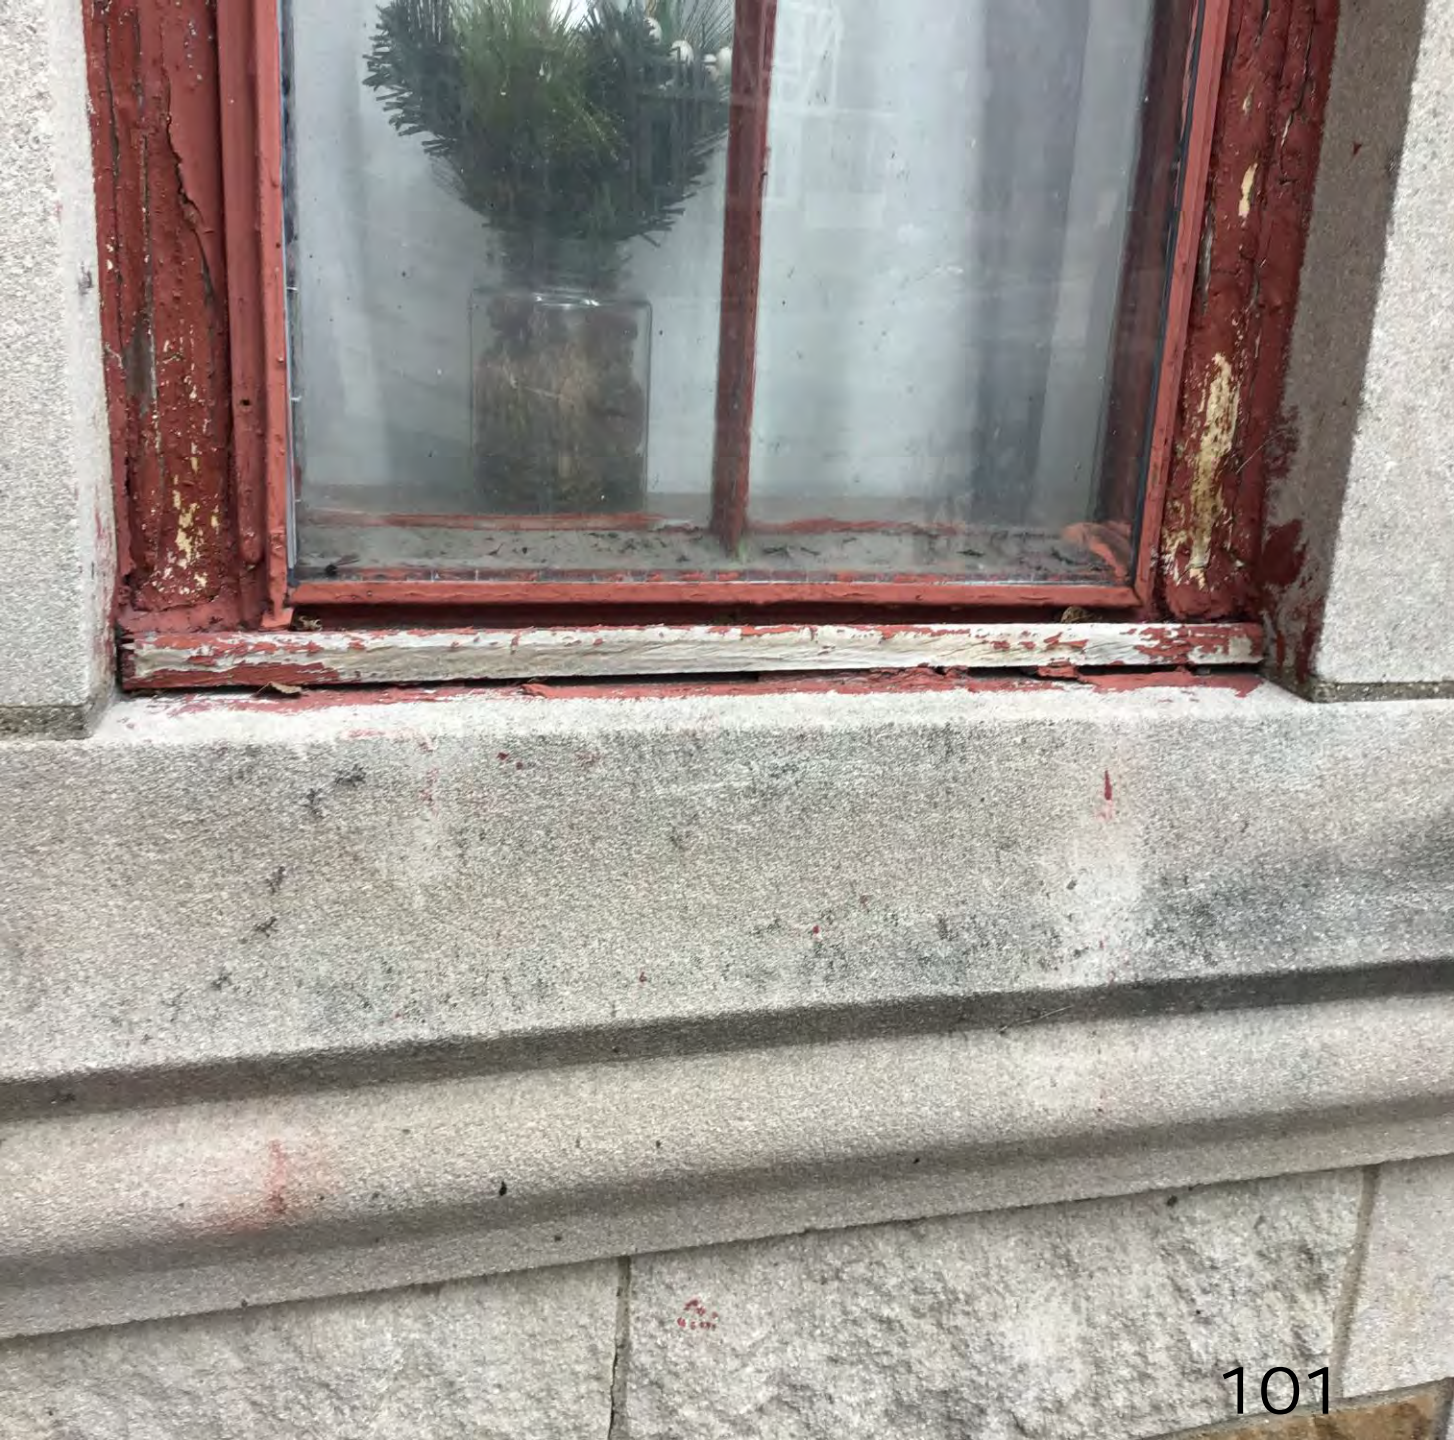
101

- Double casement
- Window is in Living room
- Window is hard to close if opened
- Exterior of window showing signs of rotting around frame
- Missing screen

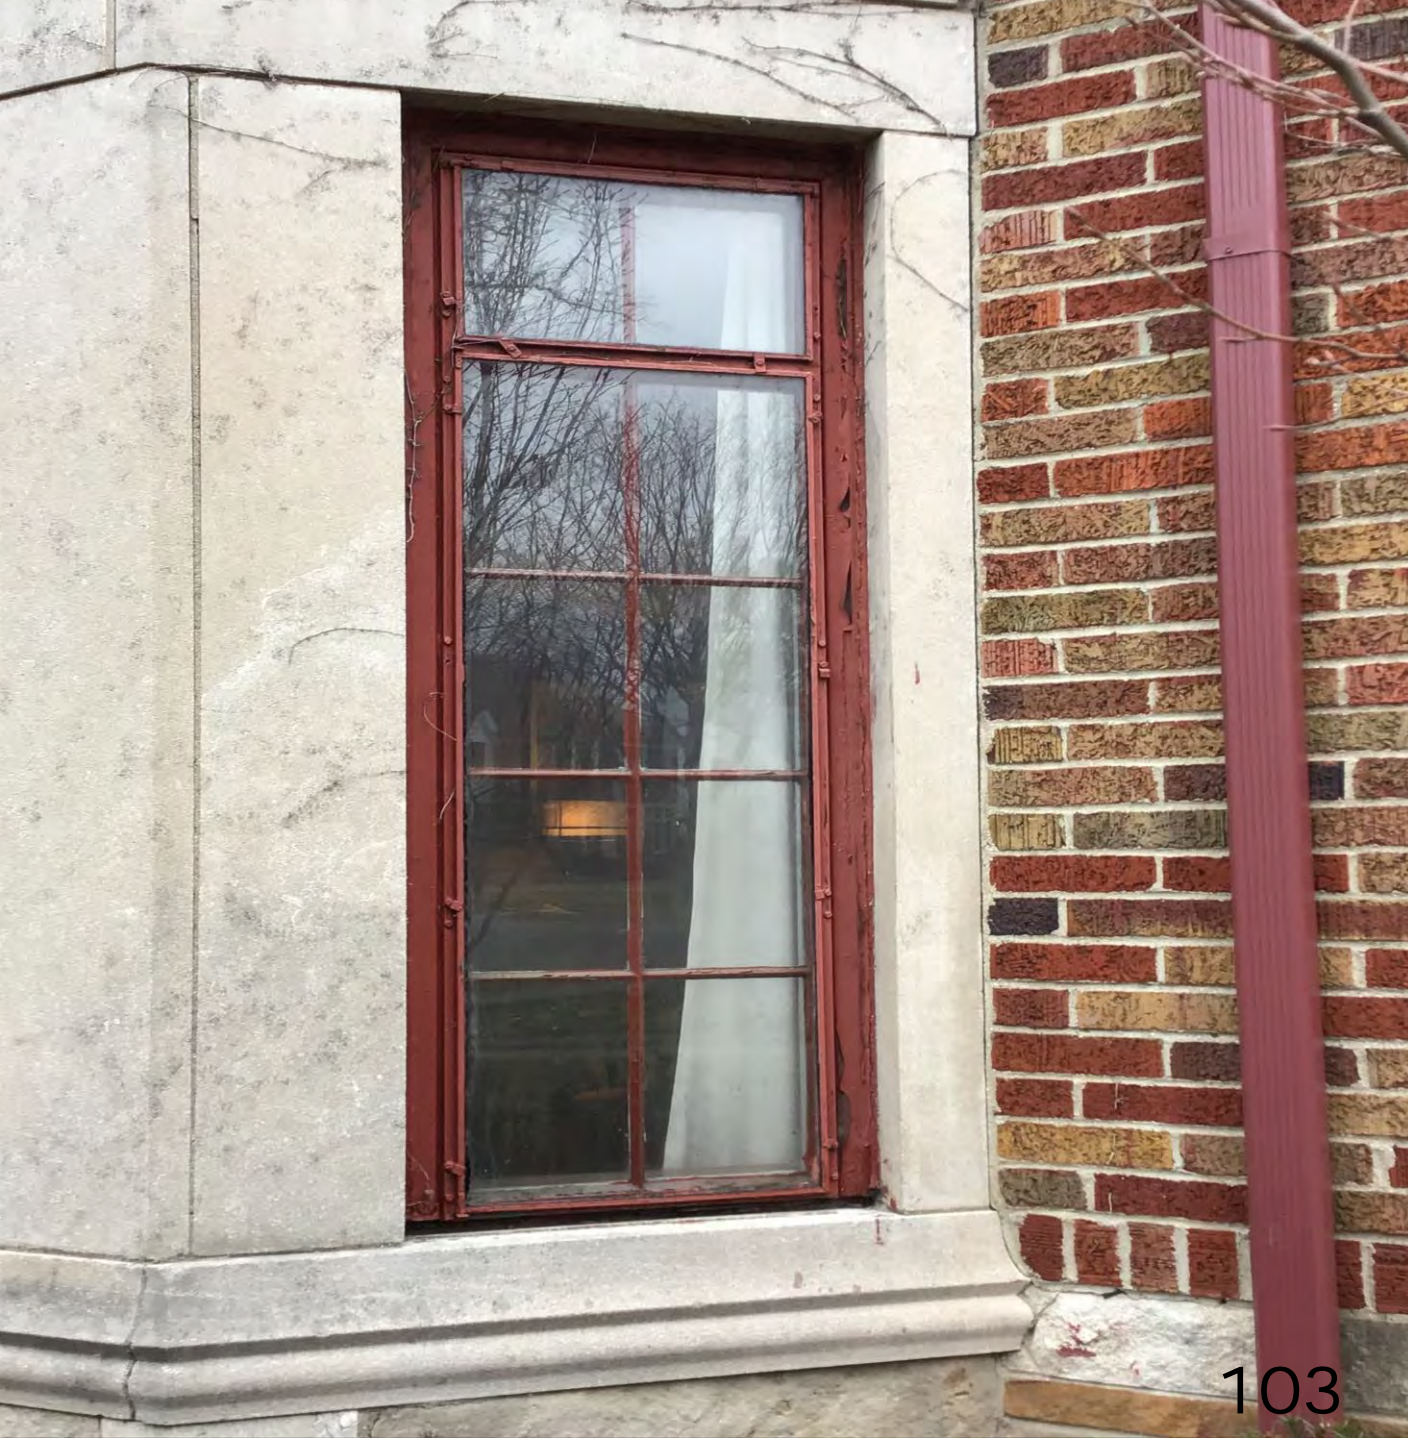
103

- Fixed window – Steel casement
- Window is in Living room
- Window is hard to close if opened
- Exterior of window showing signs of rotting around frame – bottom exterior sill missing

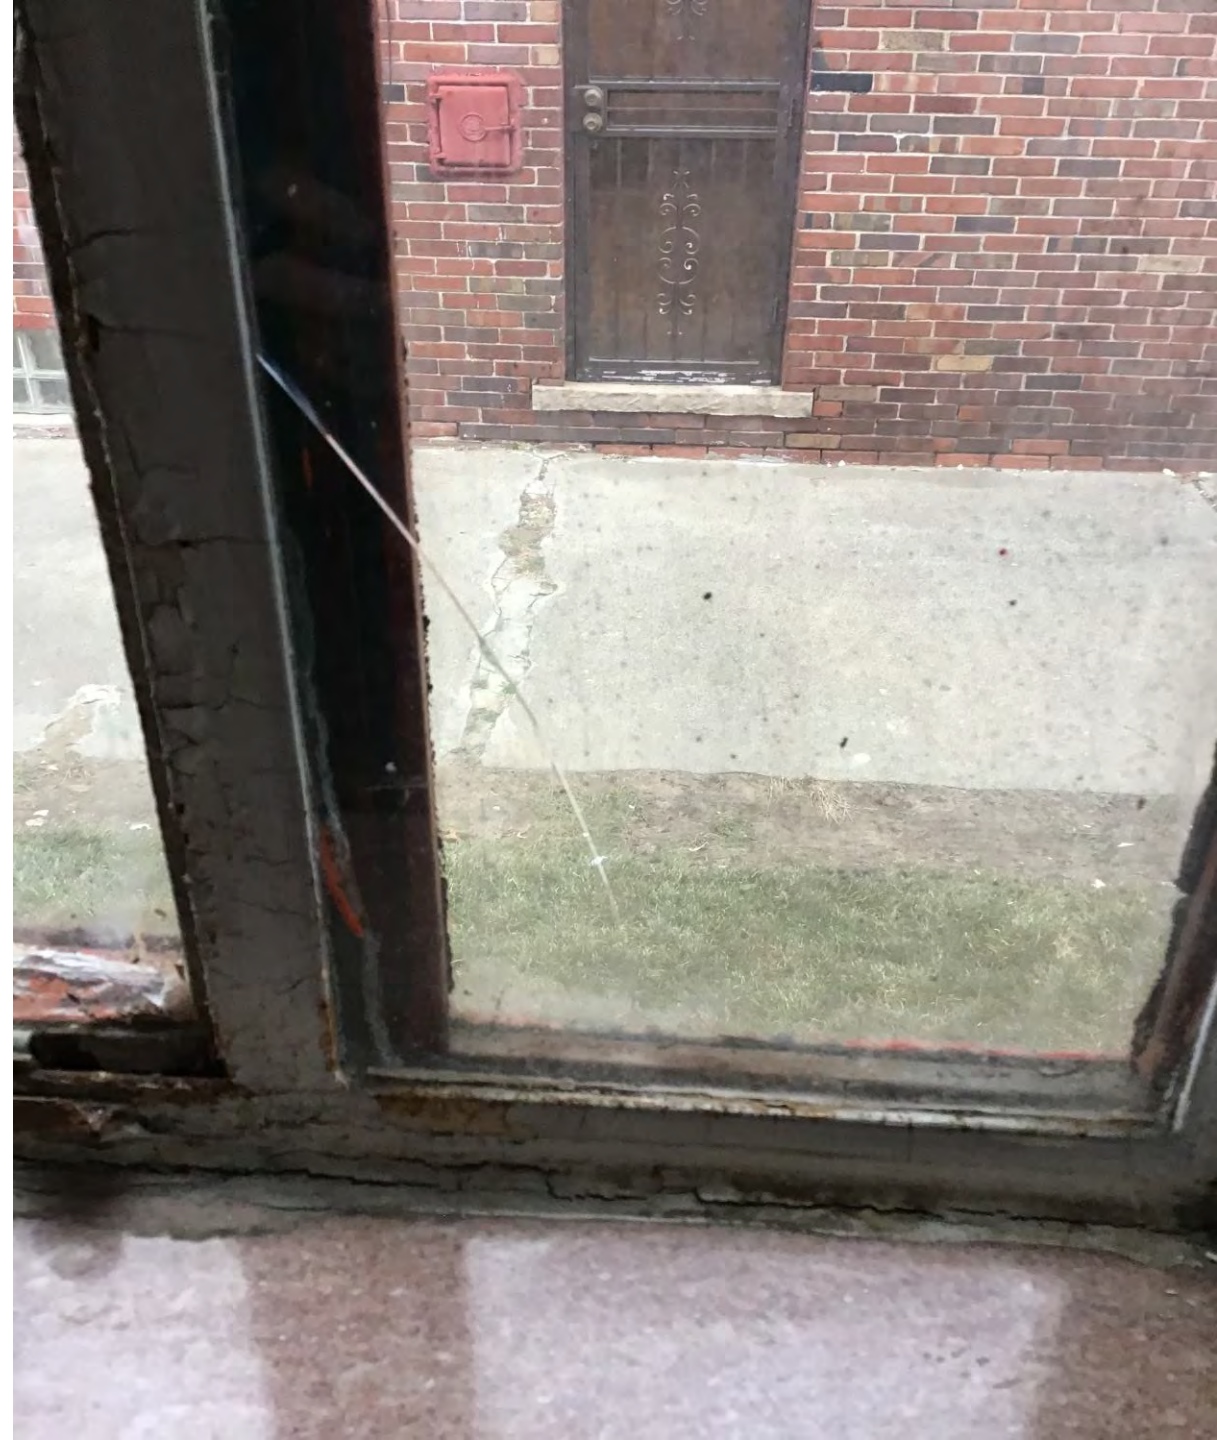
105

- Single Casement window
- Window is in Living room
- Window doesn't open
- Windowpane cracked
- Missing screen

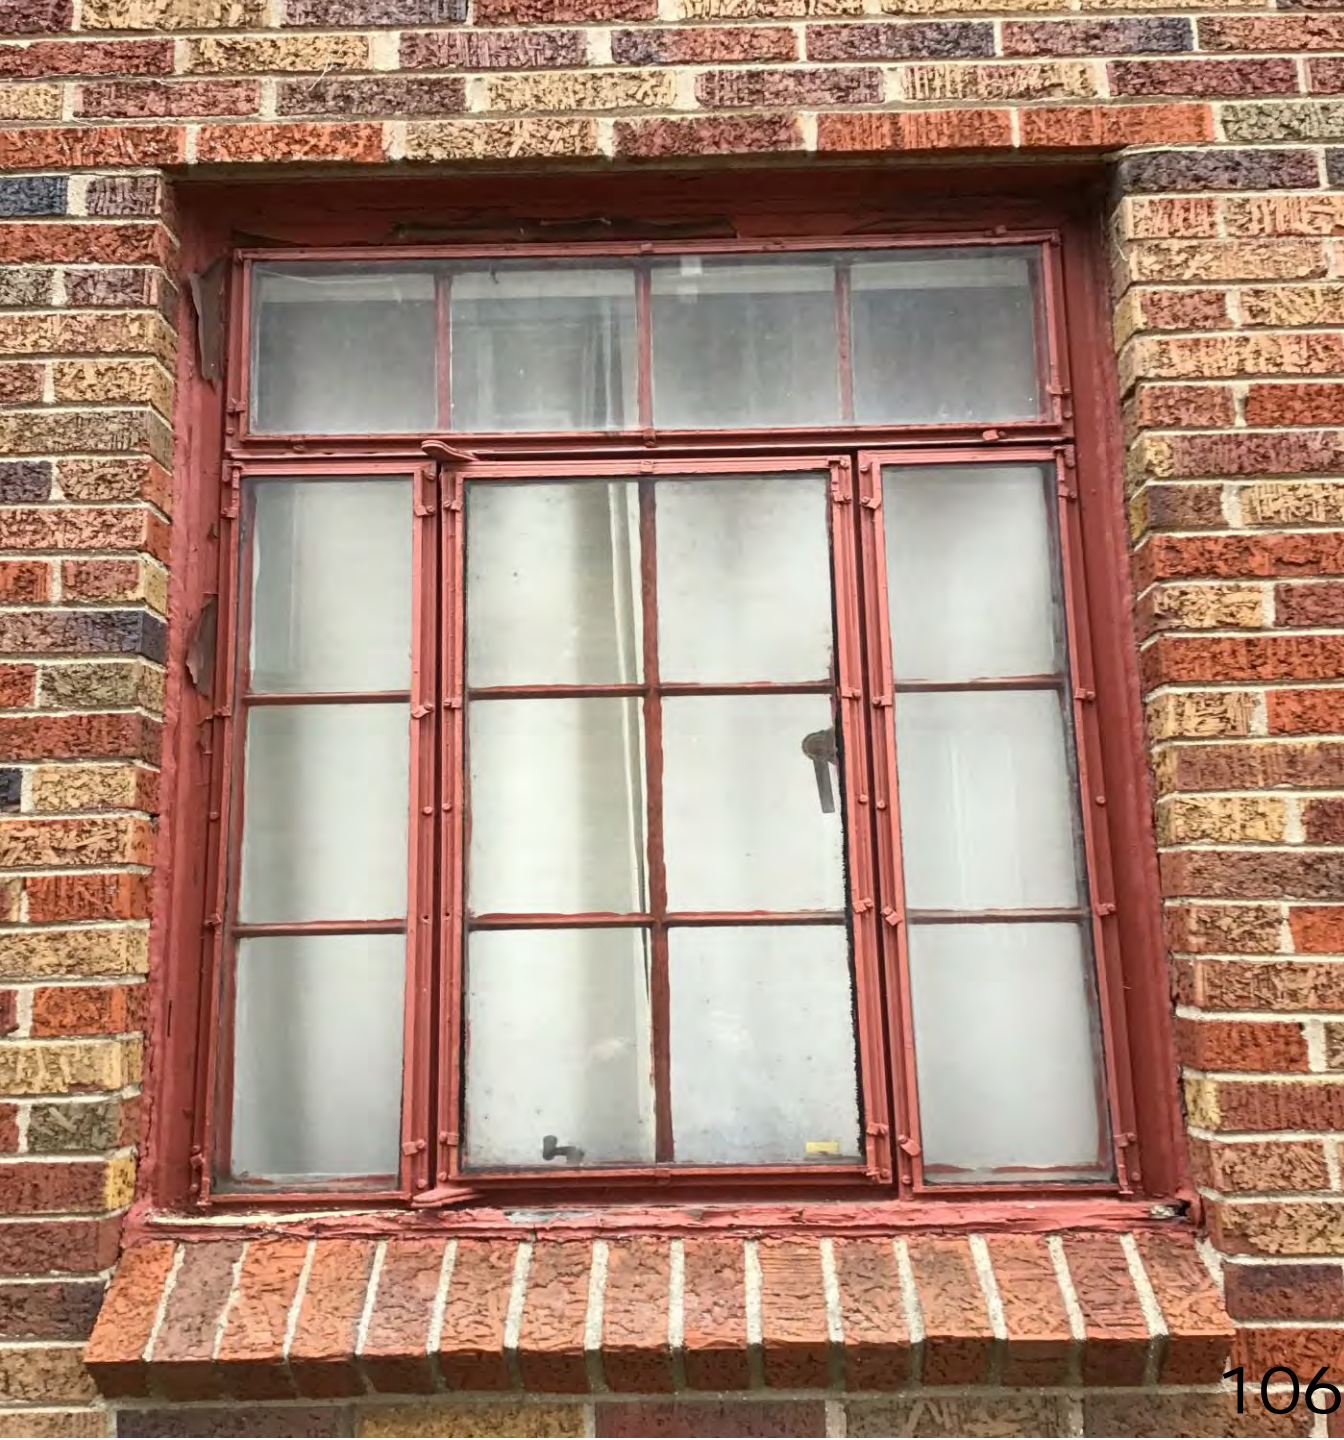
106

- Single Casement Window
- Window is in Dining room
- Window is hard to close if opened
- Exterior of window is rotting
- Screen missing

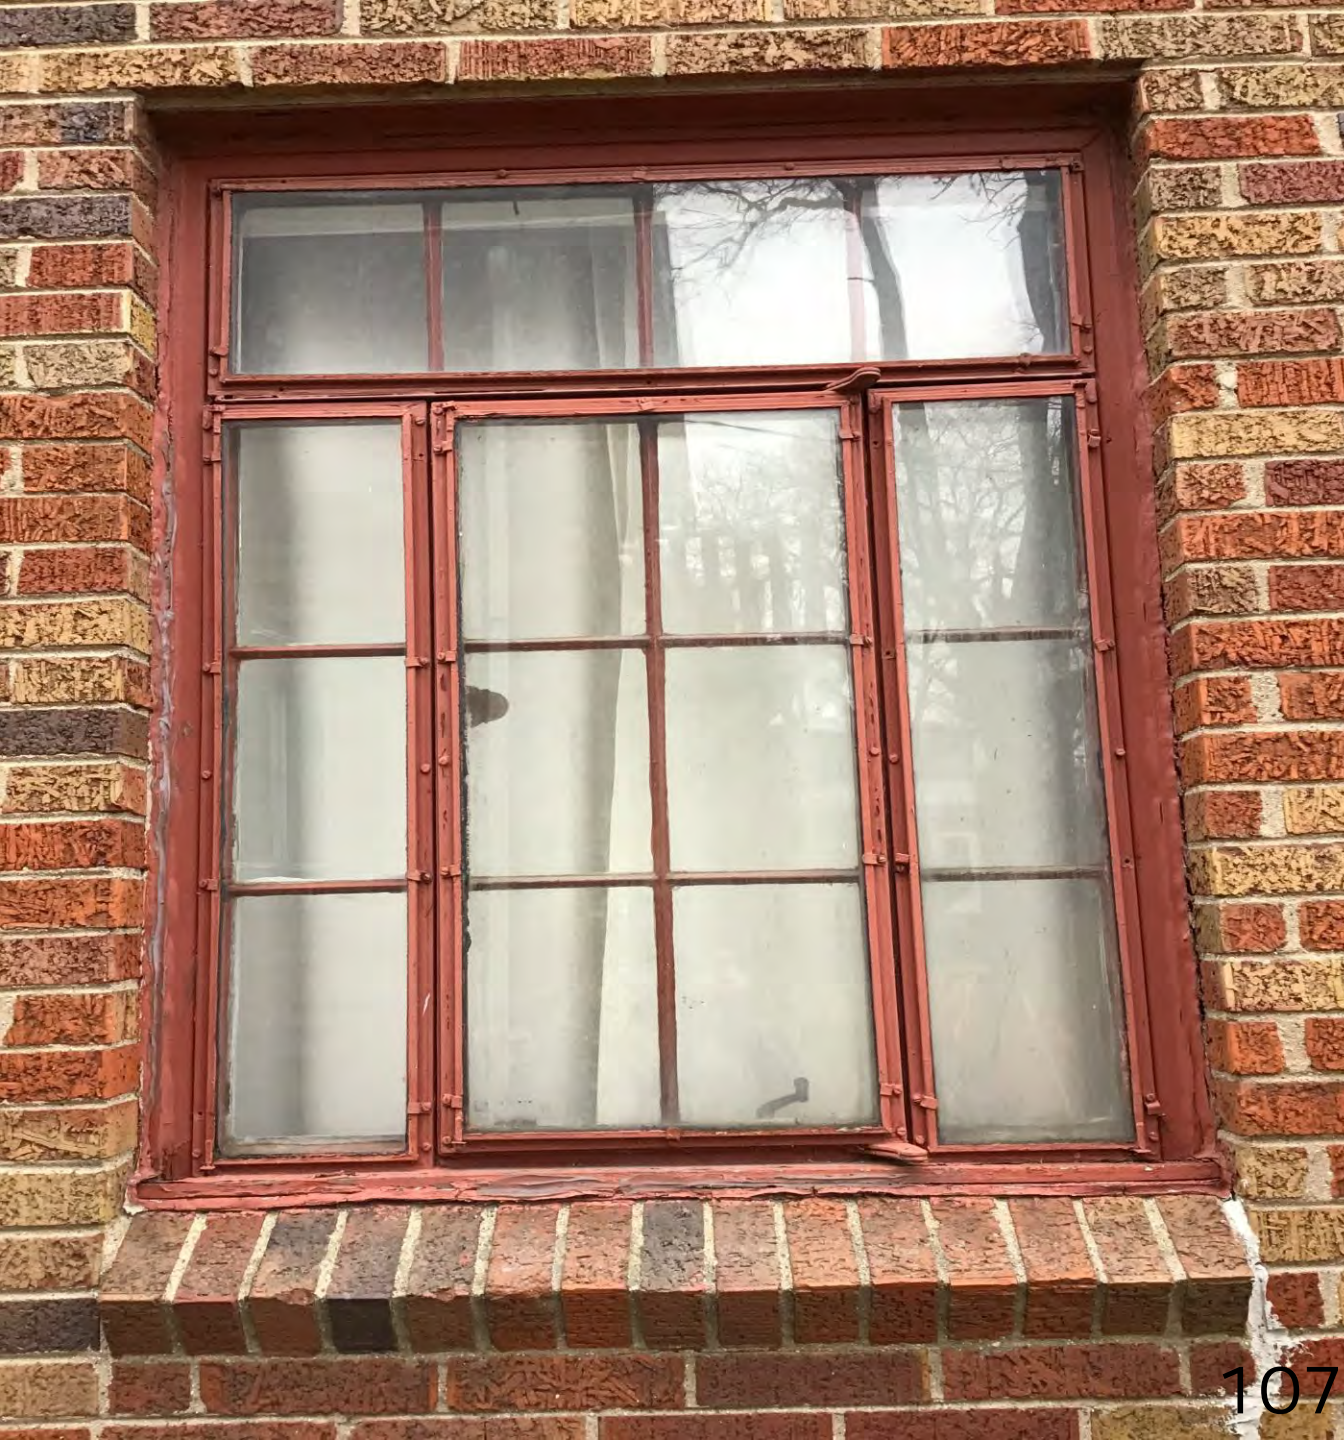
107

- Single Casement Window
- Window is in Dining room
- Window is hard to close if opened
- Windowpane cracked
- Screen missing

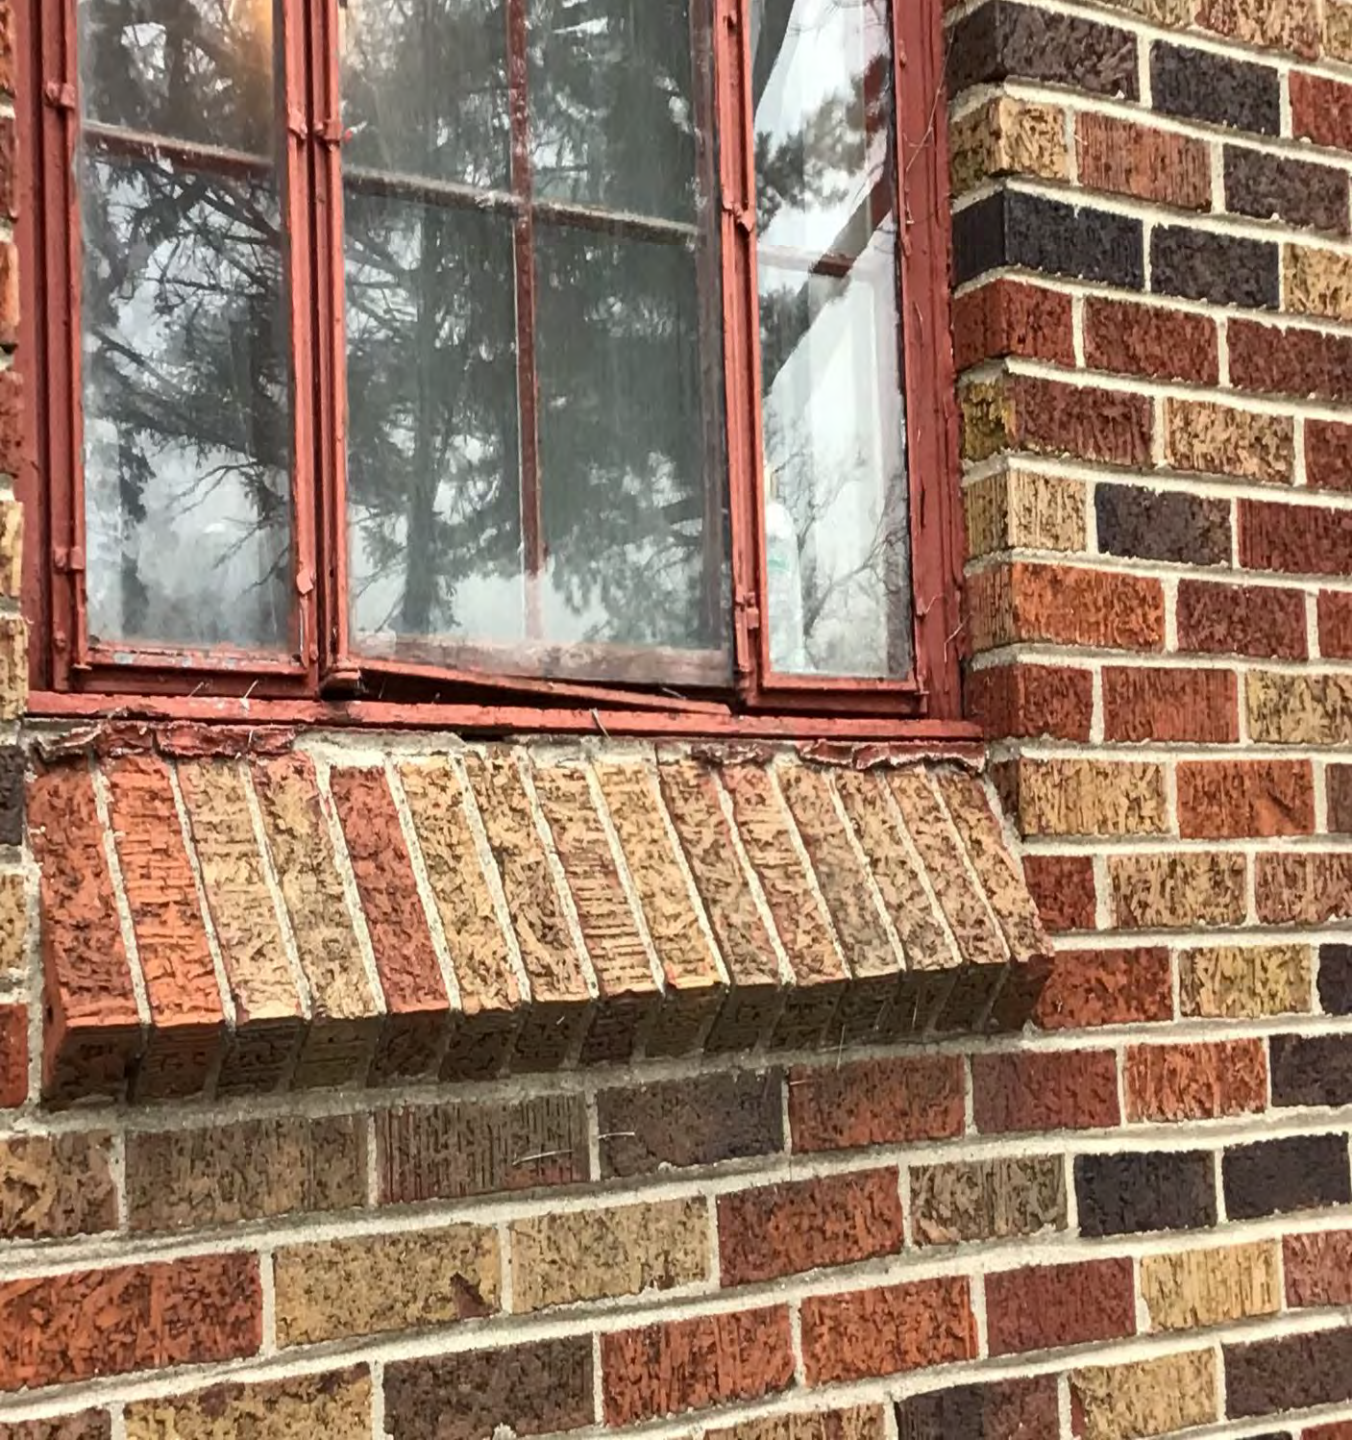
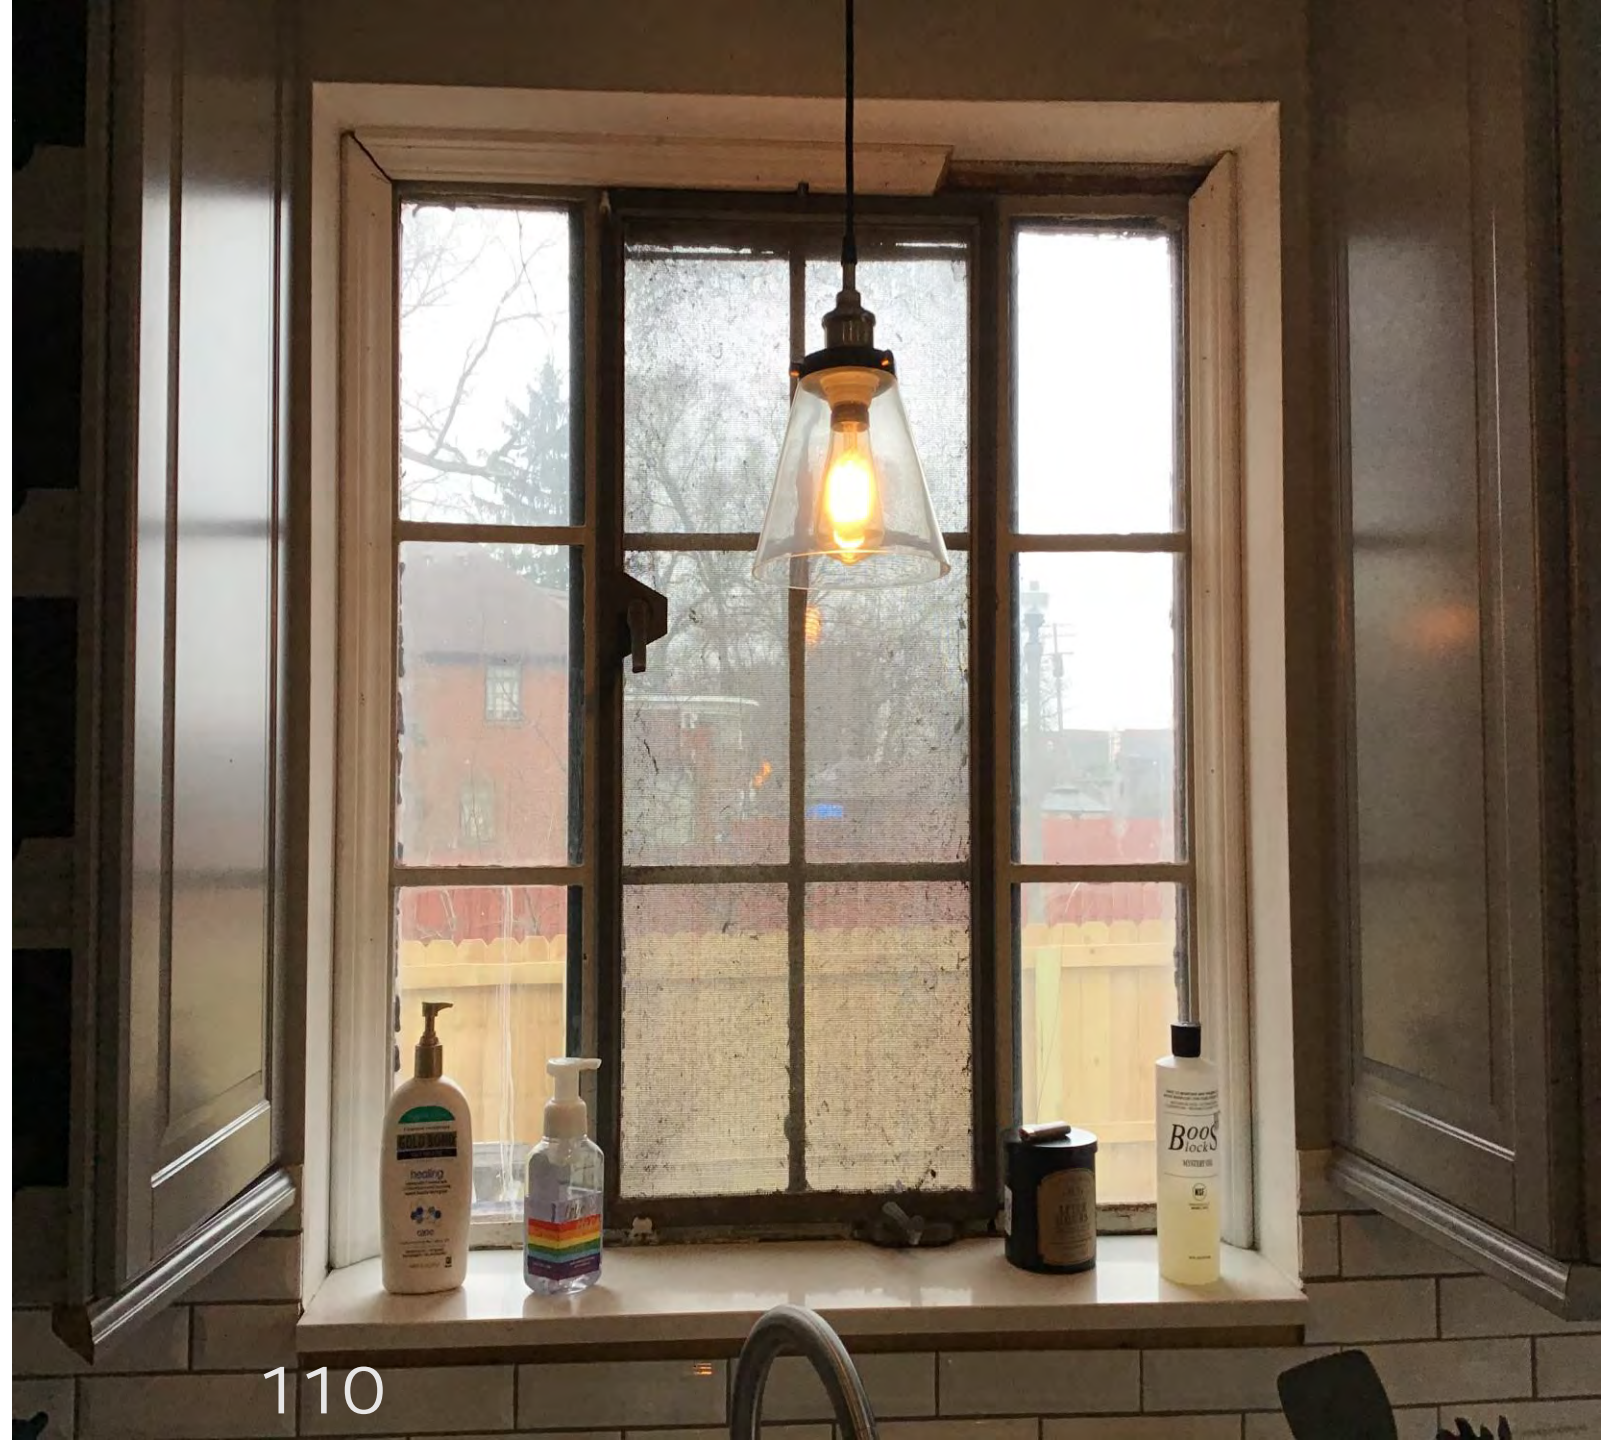
110

- Single Casement Window
- Window is in Kitchen
- Window won't open
- Exterior of window showing signs of rotting around frame and exterior window shows breakage
- Interior casing is missing/broken

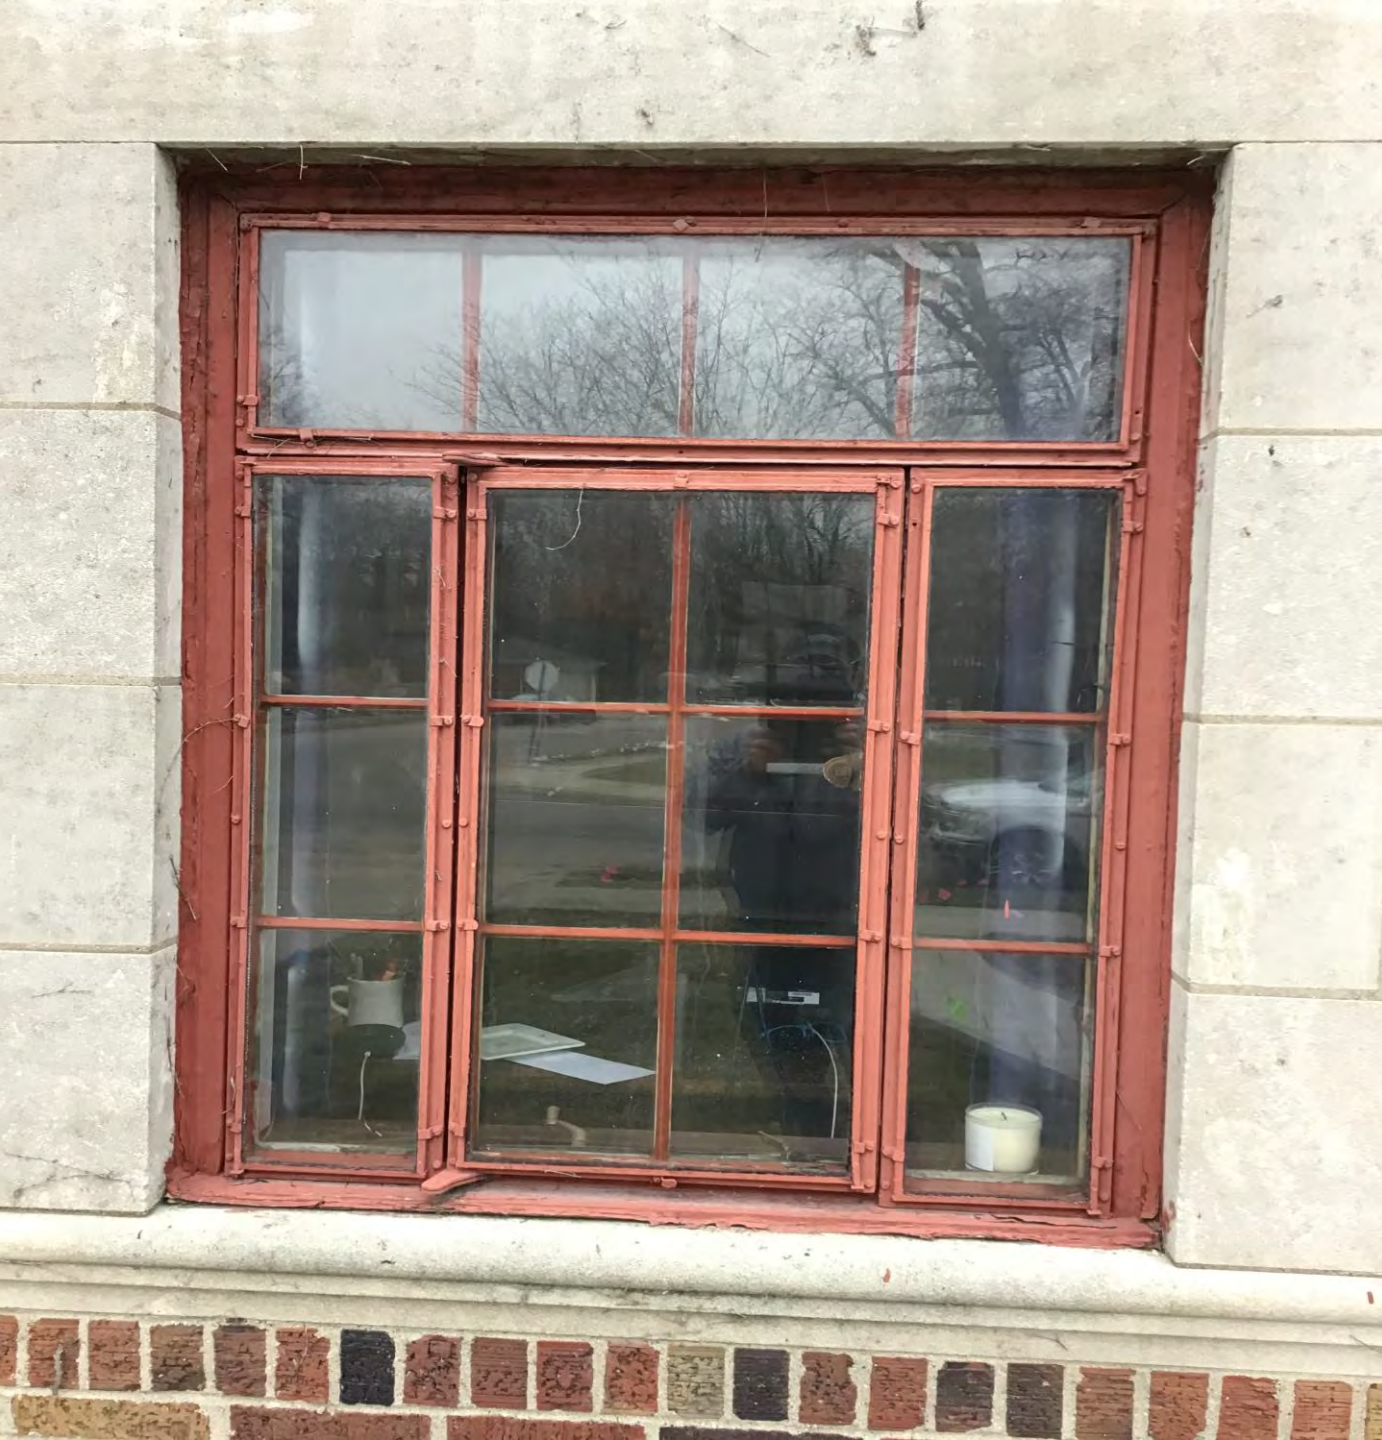
- Fixed window – Steel casement
- Window is in an office
- Ivy stuck between window and storm
- Exterior of window showing signs of rotting around frame

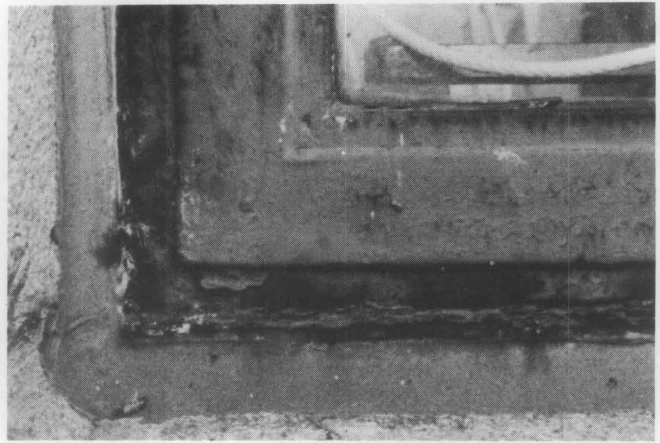
Fig. 6 b. View from the exterior showing the deteriorated condition of the lower corner of a window prior to repair. While the sash was in relatively good condition, the frame behind was rusted to the point of inhibiting operation.

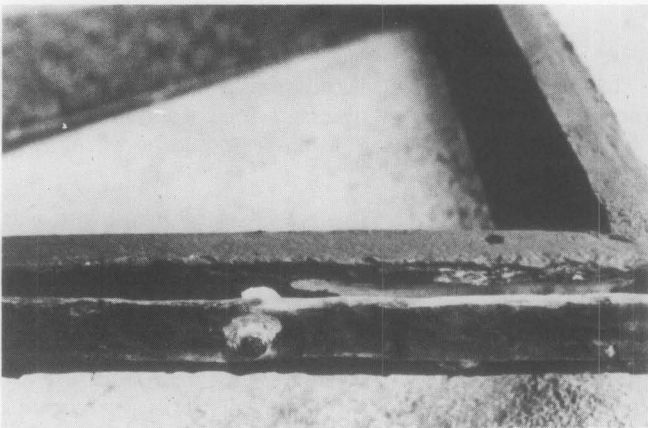
Fig. 6 c. View of the rusted frame which was unscrewed from the subframe and removed from the window opening and taken to a workshop for sandblasting. In some cases, severely deteriorated sections of the frame were replaced with new sections of milled bar steel.

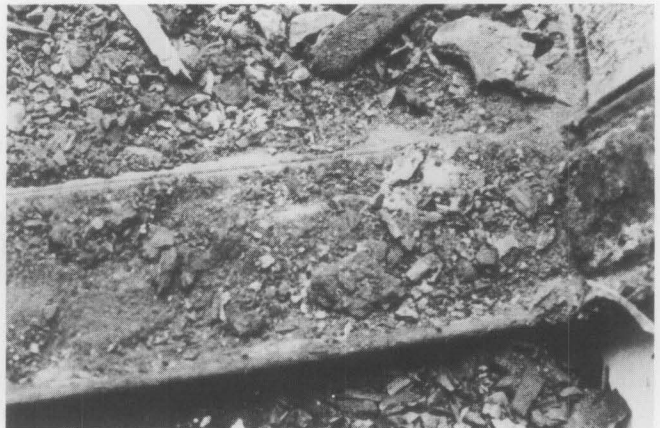
Fig. 6 d. View looking down towards the sill. The subframes appeared very rusted, but were in good condition once debris was vacuumed and surface rust was removed, in place, with chemical compounds. Where necessary, epoxy and steel filler was used to patch depressions in order to make the subframe serviceable again.

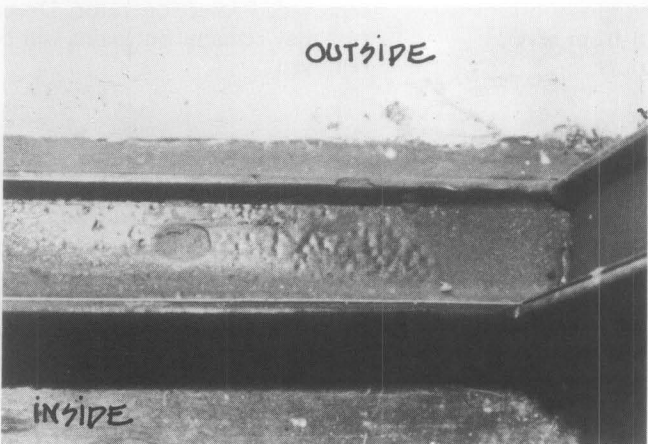
Fig. 6 e. View looking down towards the sill. The cleaned frame was reset in the window opening. The frame was screwed to the refurbished subframe at the jamb and the head only. The screw holes at the sill, which had been the cause of much of the earlier rusting, were infilled. Vinyl weatherstripping was added to the frame.

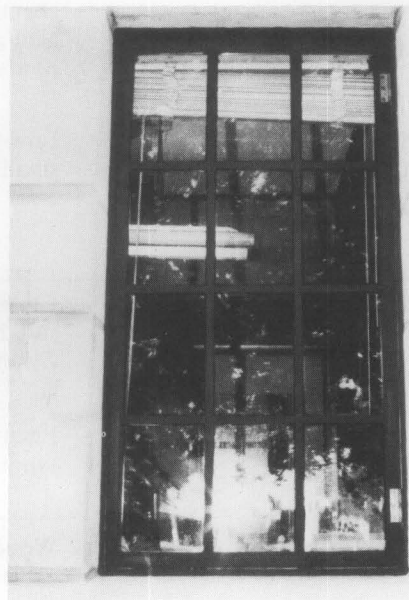
Fig. 6 f. View from the outside of the completely refurbished window. In addition to the steel repair and the installation of vinyl weatherstripping, the exterior was caulked with polyurethane and the single glass was replaced with individual lights of thermal glass. The repaired and upgraded windows have comparable energy efficiency ratings to new replacement units while retaining the historic steel sash, frames and subframes.
