STAFF REPORT: FEBURARY 17, 2021 MEETING

APPLICATION NUMBER: 21-7096 & 21-7104

ADDRESS: 15327 WARWICK

SCOPE OF WORK: REPLACE 6 WINDOWS WITH VINYL WINDOWS (21-7096);

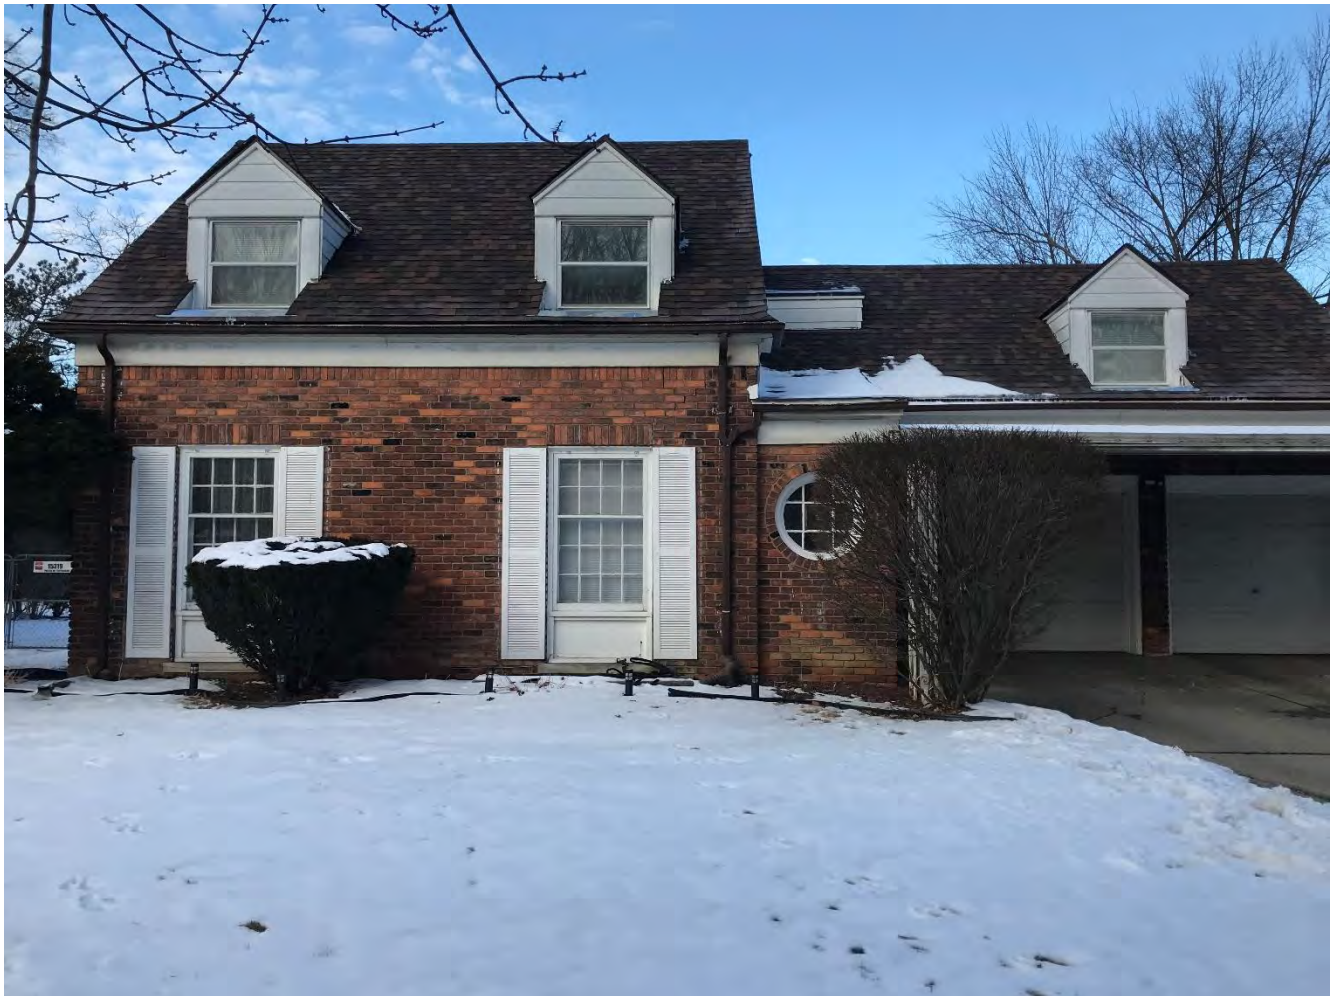
15327 Warwick, front (west) elevation, staff photo.

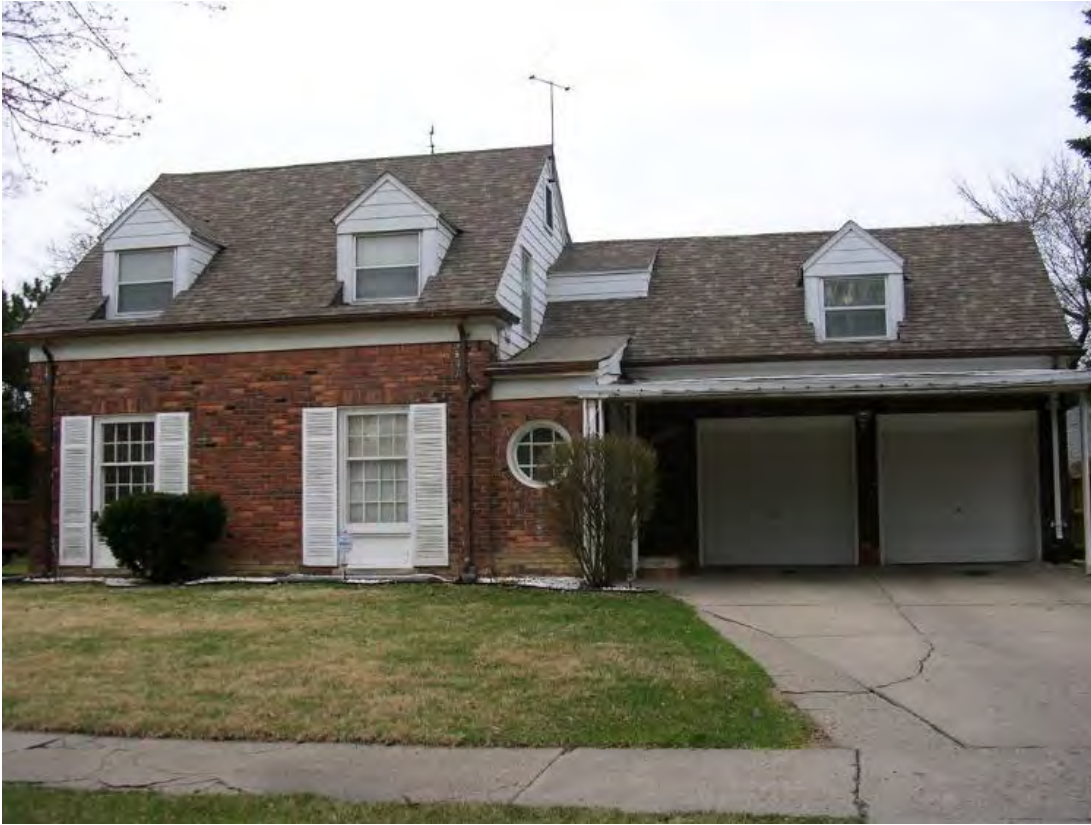
15327 Warwick, 2007 HDC designation photo.

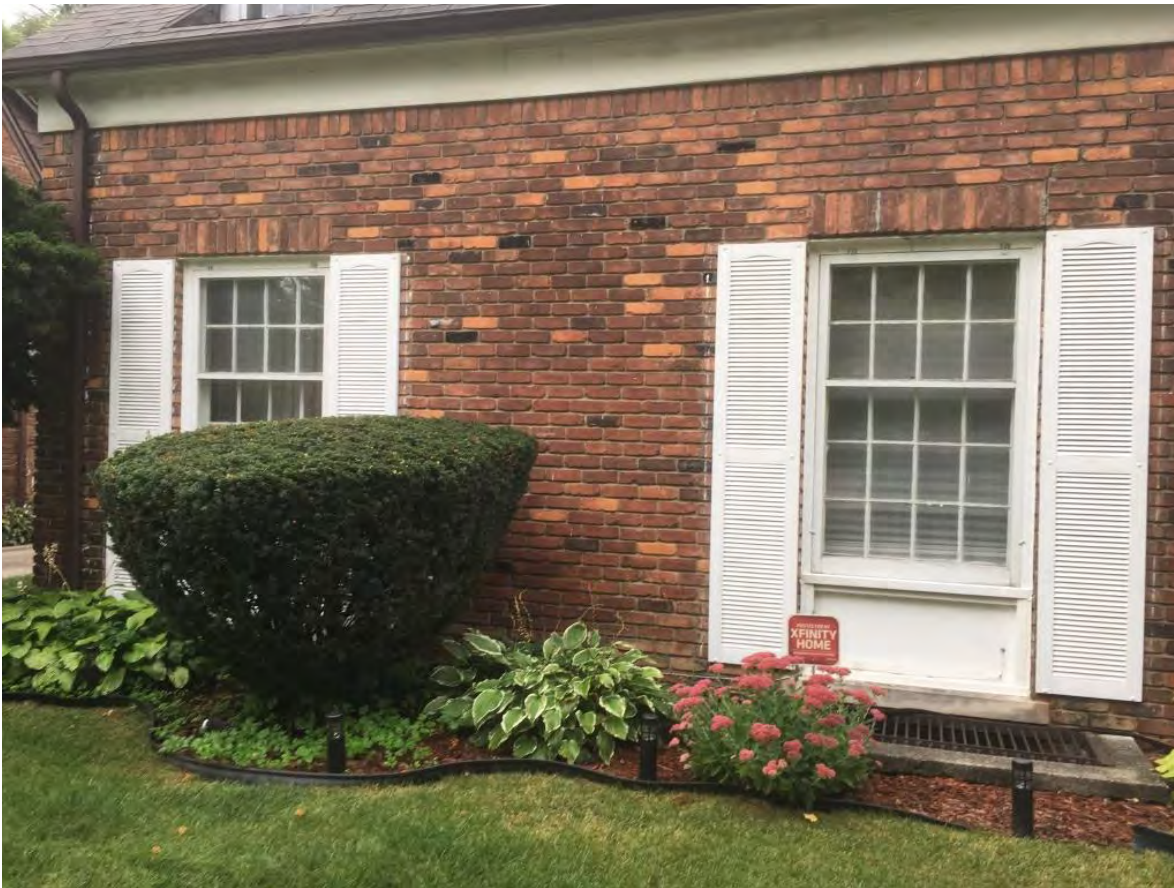
- **Window 1 – First floor, Front of home-** wood, double hung – grid pattern 8/12 -- to be replaced with Vinyl Max double-hung vinyl window, as proposed, with unspecified grid pattern.

- **Window 2- First Floor, Front of home** - wood, double hung – grid pattern 8/12 -- to be replaced with Vinyl Max double-hung vinyl window, as proposed, with unspecified grid pattern.

15327 Warwick, windows proposed for replacement, west elevation, applicant photo.

Recommendation 1: Windows (21-7096 & 21-7104):

- Staff recommends that the proposed replacement of original wood, true divided light windows with vinyl replacement windows will eliminate character defining features of the home and will not be appropriate according to the standards of review set forth in the state and local legislation. Therefore, HDC staff recommends that the Commission issues a denial for the proposed work, as the proposed work fails to meet the Secretary of the Interior’s Standards, specifically Standard 6) *Deteriorated historic features shall be repaired rather than replaced. Where the severity of deterioration requires replacement of a distinctive feature, the new feature shall match the old in design, color, texture, and other visual qualities and, where possible, materials. Replacement of missing features shall be substantiated by documentary, physical, or pictorial evidence.*

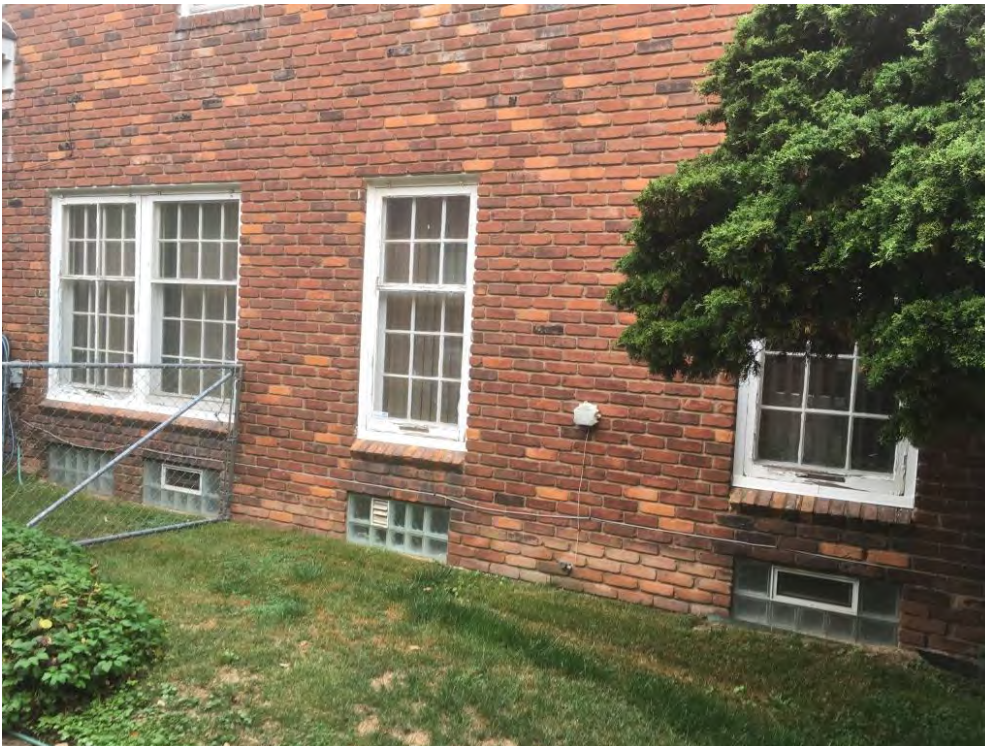
- **Window 3- First Floor, South Side (1)** - wood, double hung – grid pattern 6/9 -- to be replaced with Vinyl Max double-hung vinyl window, as proposed, with unspecified grid pattern.

- **Window 4- First Floor, South Side (2)** - wood, double hung – grid pattern -- 6/9 to be replaced with Vinyl Max double-hung vinyl window, as proposed, with unspecified grid pattern.

- **Window 5- First Floor, South Side (3)** - wood, double hung – grid pattern 8/12 -- to be replaced with Vinyl Max double-hung vinyl window, as proposed, unspecified grid pattern.

- **Window 6- First Floor, South Side (4)-** wood, double hung – grid pattern 8/12 -- to be replaced with Vinyl Max double-hung vinyl window, as proposed, unspecified grid pattern.

15327 Warwick, windows proposed for replacement, south elevation, applicant photo.
