STAFF REPORT: 2/17/2021 MEETING PREPARED BY: D. RIEDEN

APPLICATION NUMBER: #21-7051 ADDRESS: 1531 EIGHTH STREET HISTORIC DISTRICT: CORKTOWN

SCOPE: PORCH/DECK, FENCE/GATES, GENERAL REPAIR

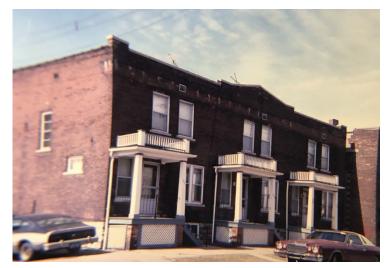
Since the building's designation, features that have changed over time include the following: the balustrade above each porch roof has been removed, the metal porch railing has been replaced with wood railing, the color scheme has changed from cream and black to a red and cream combination. Original windows were replaced with vinyl windows.

Site Photo 1, Designation photo: (East) front side

Site Photo 2 by Staff February 2, 2021: (East) front side.
