**STAFF REPORT:** 4/14/2021 MEETING  
**APPLICATION NUMBER:** #21-7154  
**ADDRESS:** 2489 ATKINSON  
**HISTORIC DISTRICT:** ATKINSON AVENUE  
**APPLICANT:** JOHN MCCARTER  
**PROPERTY OWNER:** ANNE CALAHAN  
**DATE OF PROVISIONALLY COMPLETE APPLICATION:** 03/05/2021  
**DATE OF STAFF SITE VISIT:** 3/24/2021

**SCOPE:** SOFFIT, SIDING, FASCIA, & TRIM REPLACEMENT – WORK DONE WITHOUT APPROVAL

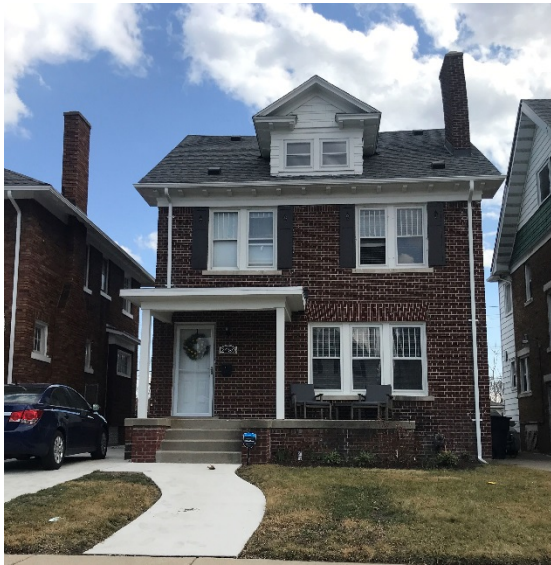
Site Photo 1, by Staff March 24, 2021: (North) front side

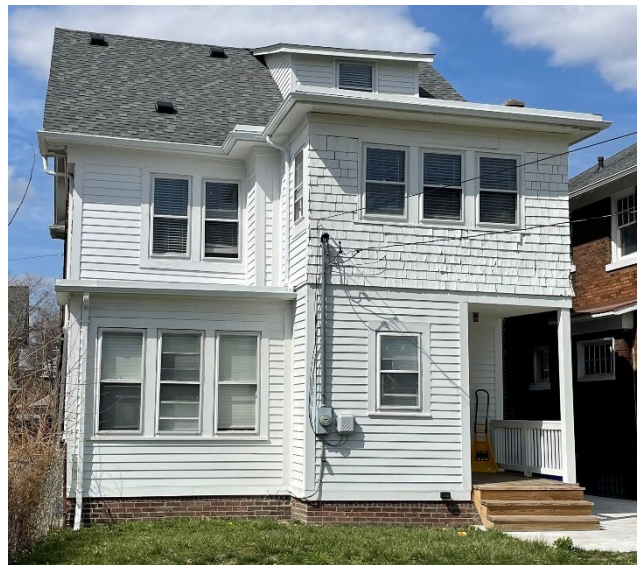
Site Photo 2 by Applicant: (South) side/rear, work complete.

- It is staff’s opinion that the original cedar shake siding on the second floor is a character-defining feature of the house and therefore the pine lap siding is not an appropriate use of material for replacement of the cedar shake siding.

Because the cedar shake expression at the rear second story is a distinctive character-defining feature, it should not be replaced with horizontal lapped siding. Staff therefore recommends that the Commission issue a Denial for this proposal as it does not meet the Secretary of the Interior's Standards for Rehabilitation, specifically Standards:

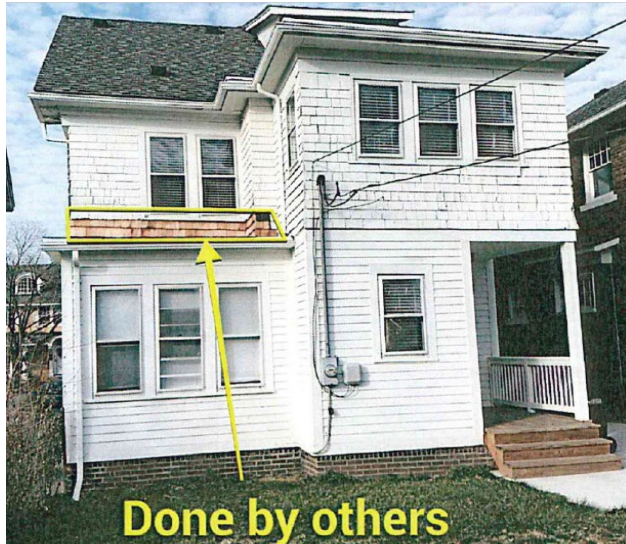
Site Photo 3 by Applicant: (South) side/rear, before work complete.

- From the older photo (see above) it appears that the original trim for the side of windows is 2” at the base and sill, but 4” at the mullion (separation between the two windows). It is staff’s opinion while the pine trim is an appropriate material, but the increase in the trim’s width from 2” to 4” all around both sets of windows is not an appropriate size for the existing context of these windows.

Description of the existing conditions prior to the repairs: wood trim around windows was rotted. Cedar shake siding was previously repaired by others incorrectly and was water-logged. Soffit and fascia was rotted above 1<sup>st</sup> story flat roof.

- The applicant will provide dimensions and specifications to replace window trim for HDC staff review and approval prior to an issued permit.
- The applicant shall provide a paint color to HDC staff that meets Color System C color guidelines for the rear siding and trim.

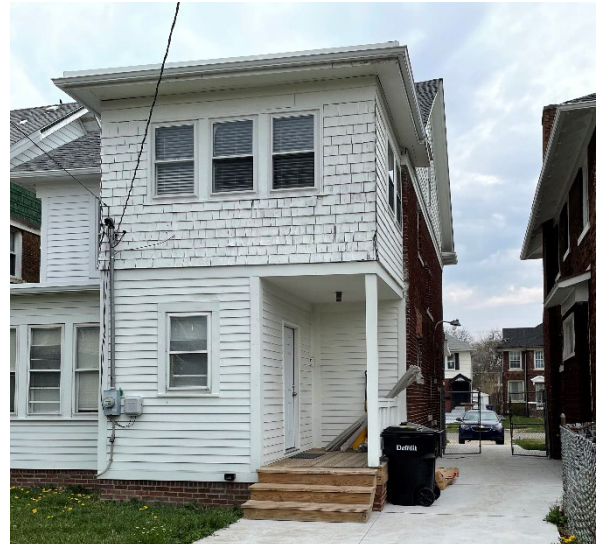
Site Photo 4, by applicant March 24, 2021: (South) rear.
