STAFF REPORT: 4/14/2021 MEETING

ADDRESS: 1627 (1627-1639) LEVERETTE

HISTORIC DISTRICT: CORKTOWN

SCOPE: ERECT NEW CARPORTS; REHABILITATE BUILDING

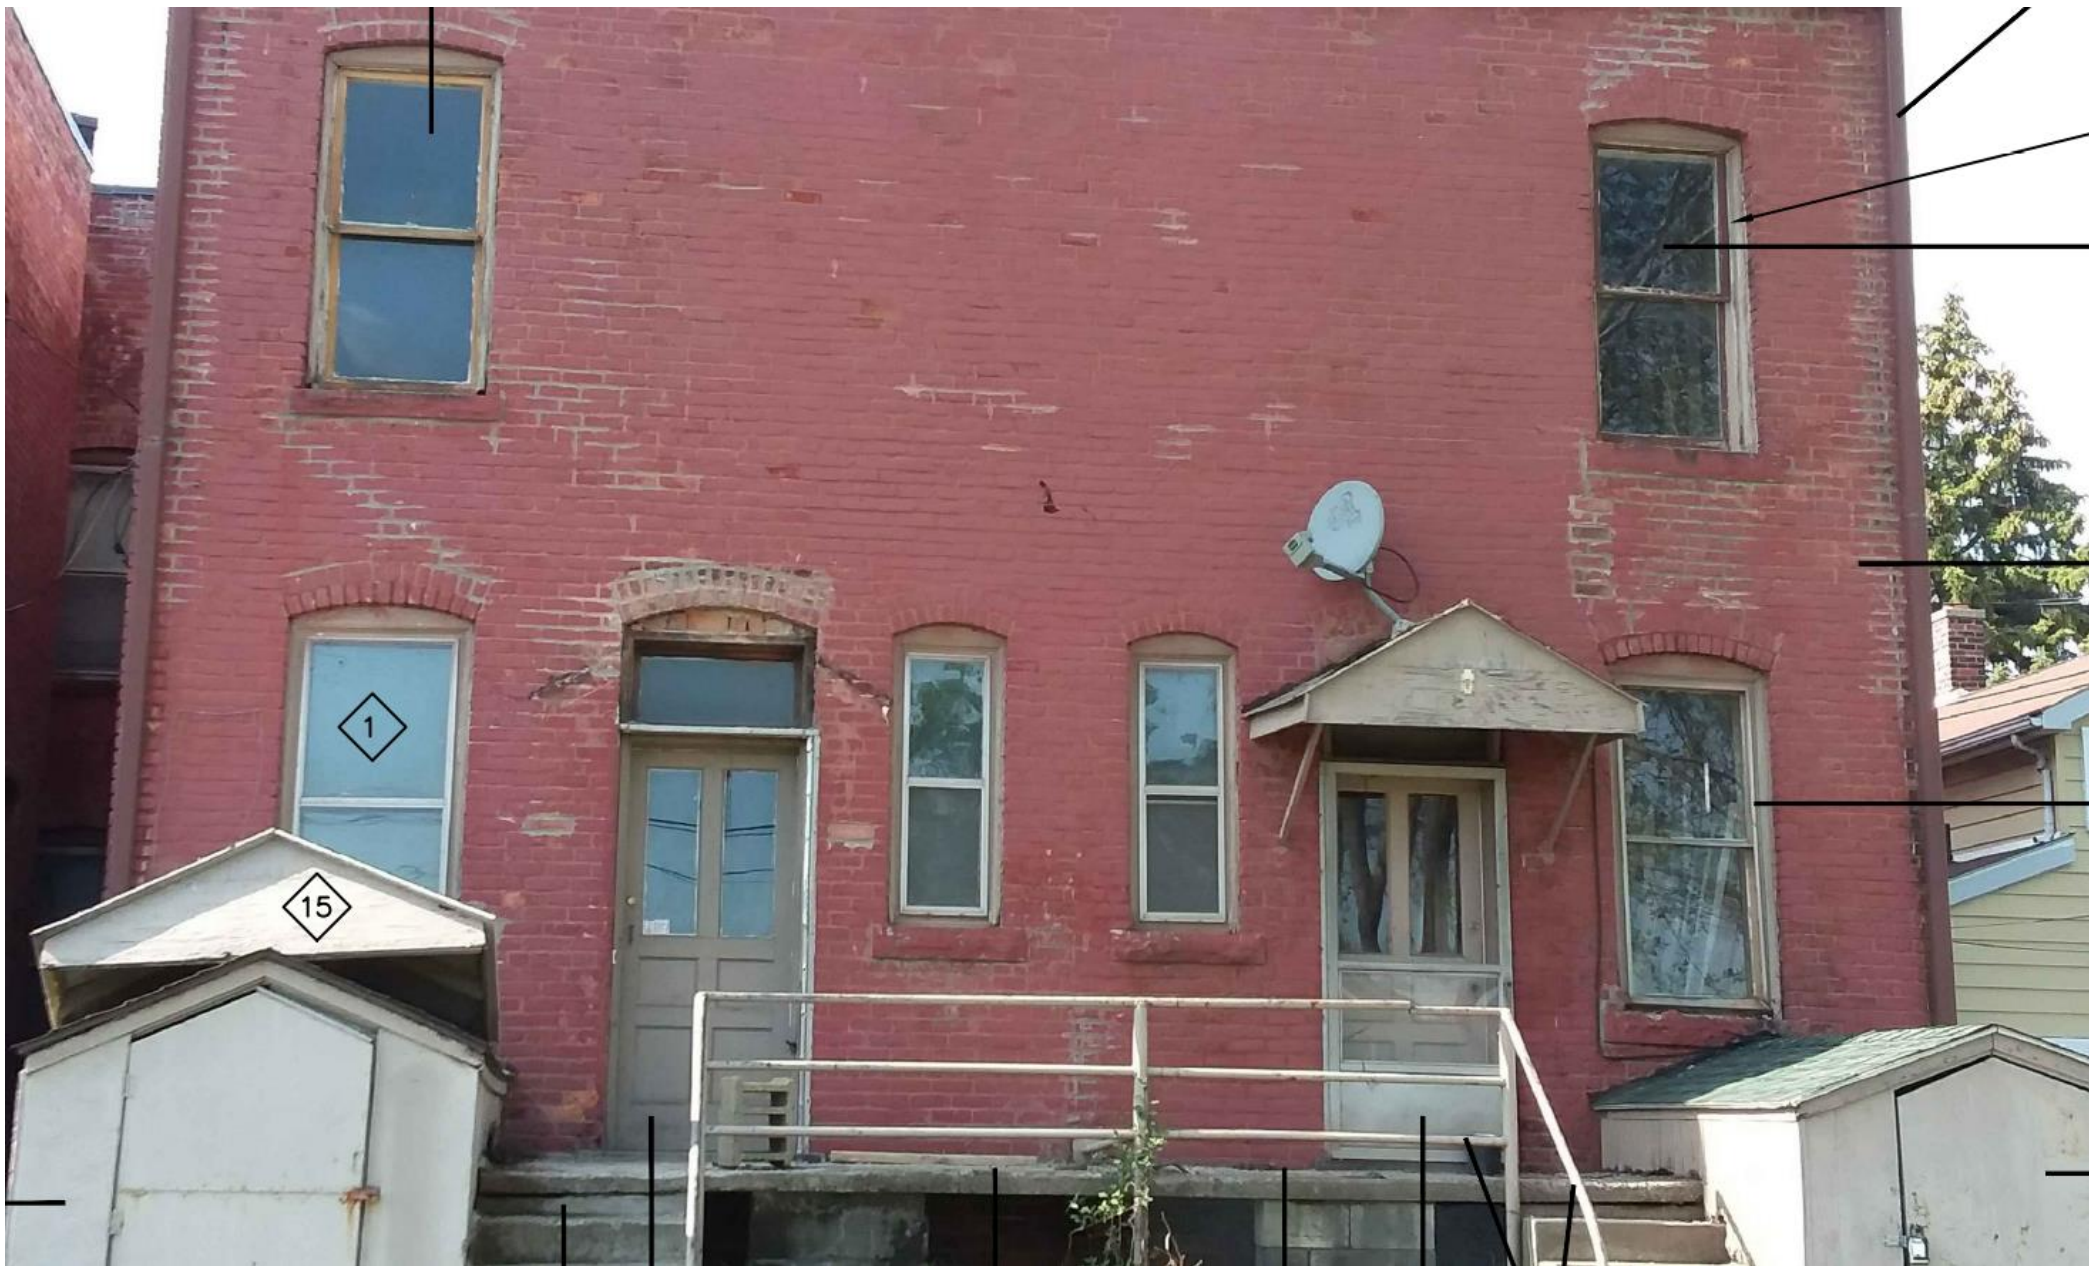
Rear elevations prior to unapproved work. Note painted brick, basement enclosures, porch, windows, door overhang windows and doors

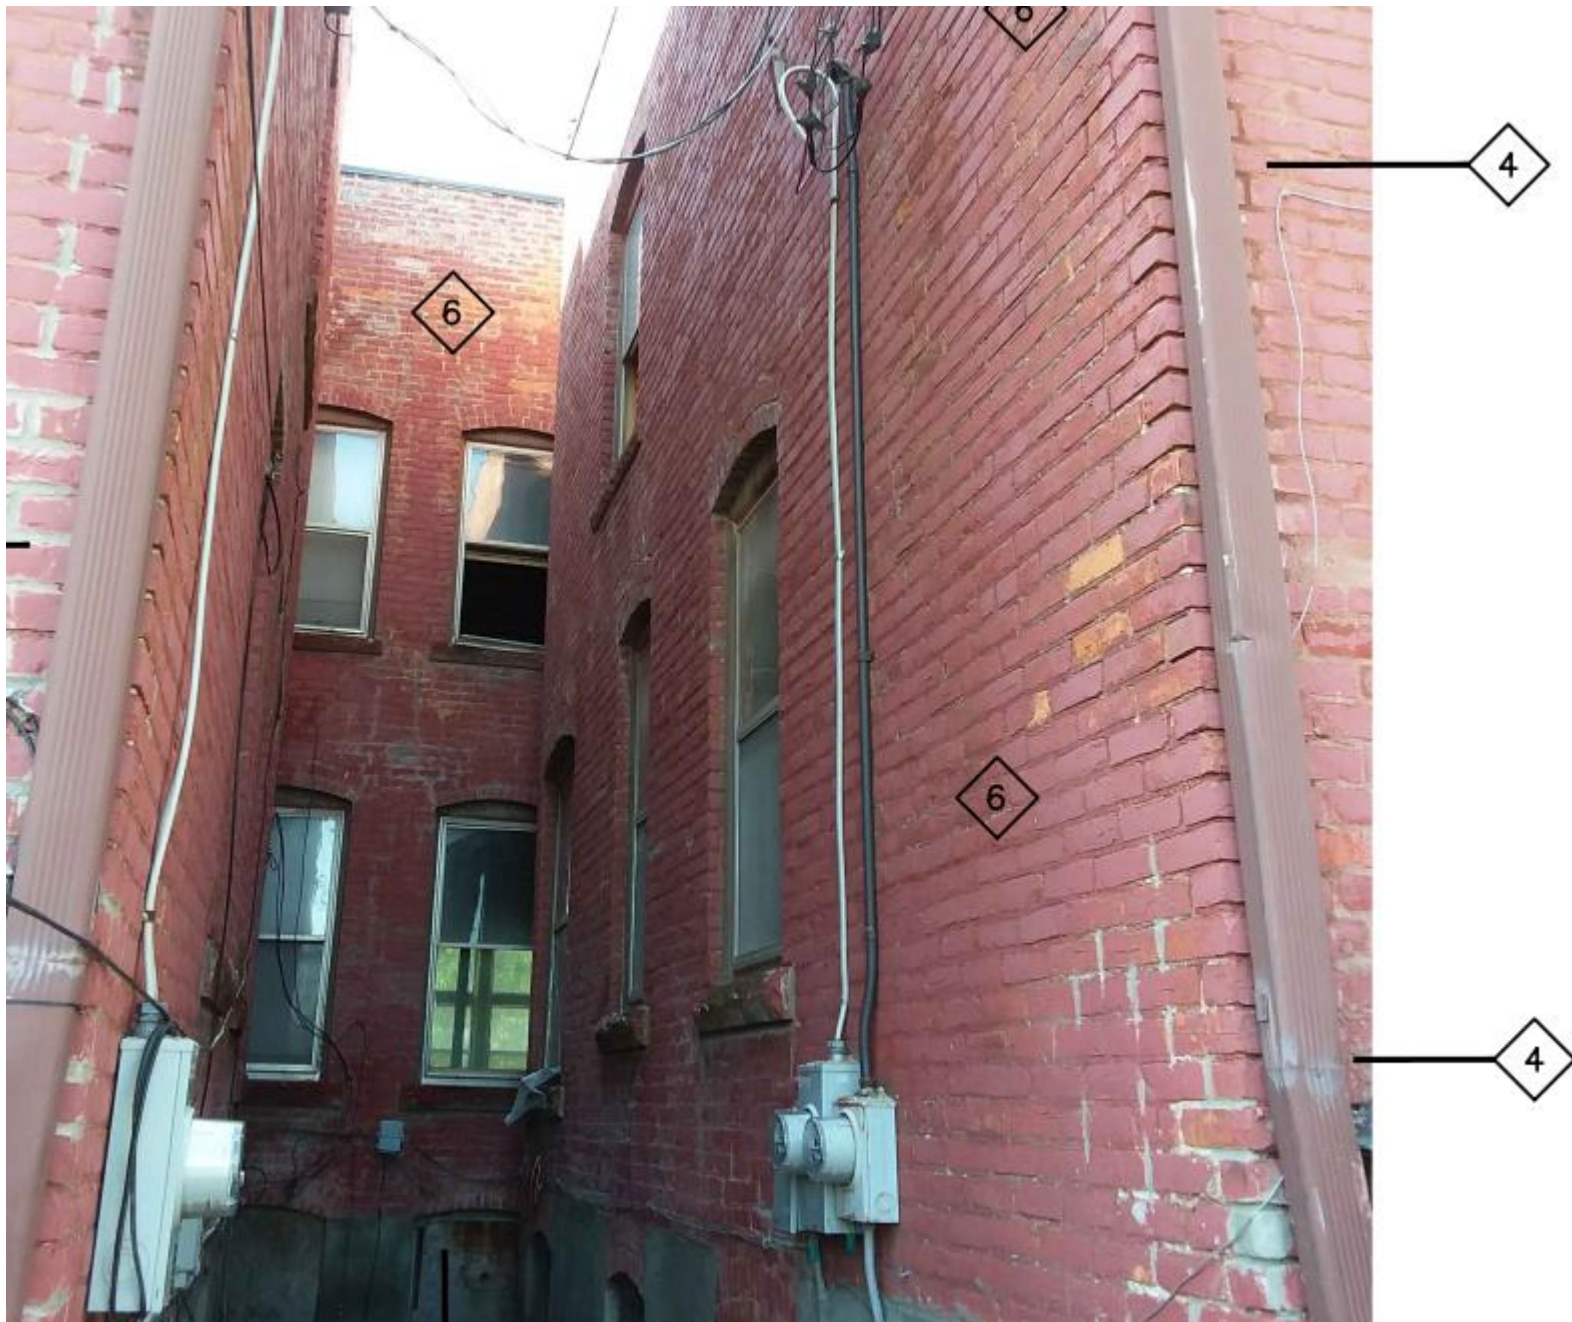
Rear elevation lightwell, prior to unapproved work. Note painted brick

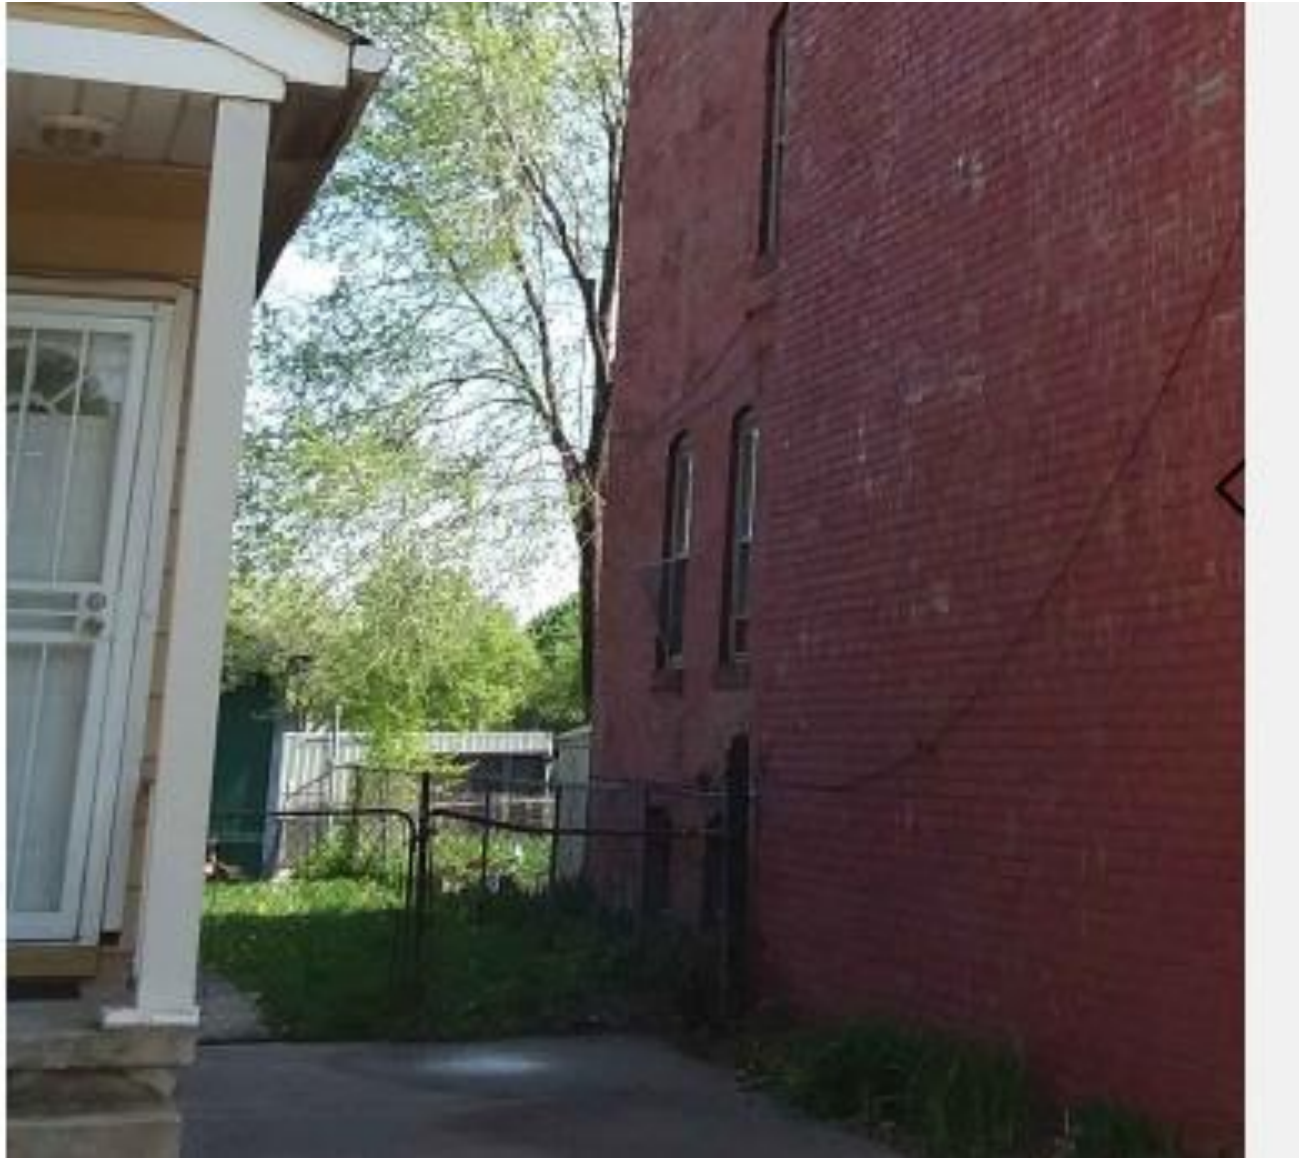
Side elevation, prior to unapproved work. Note painted brick

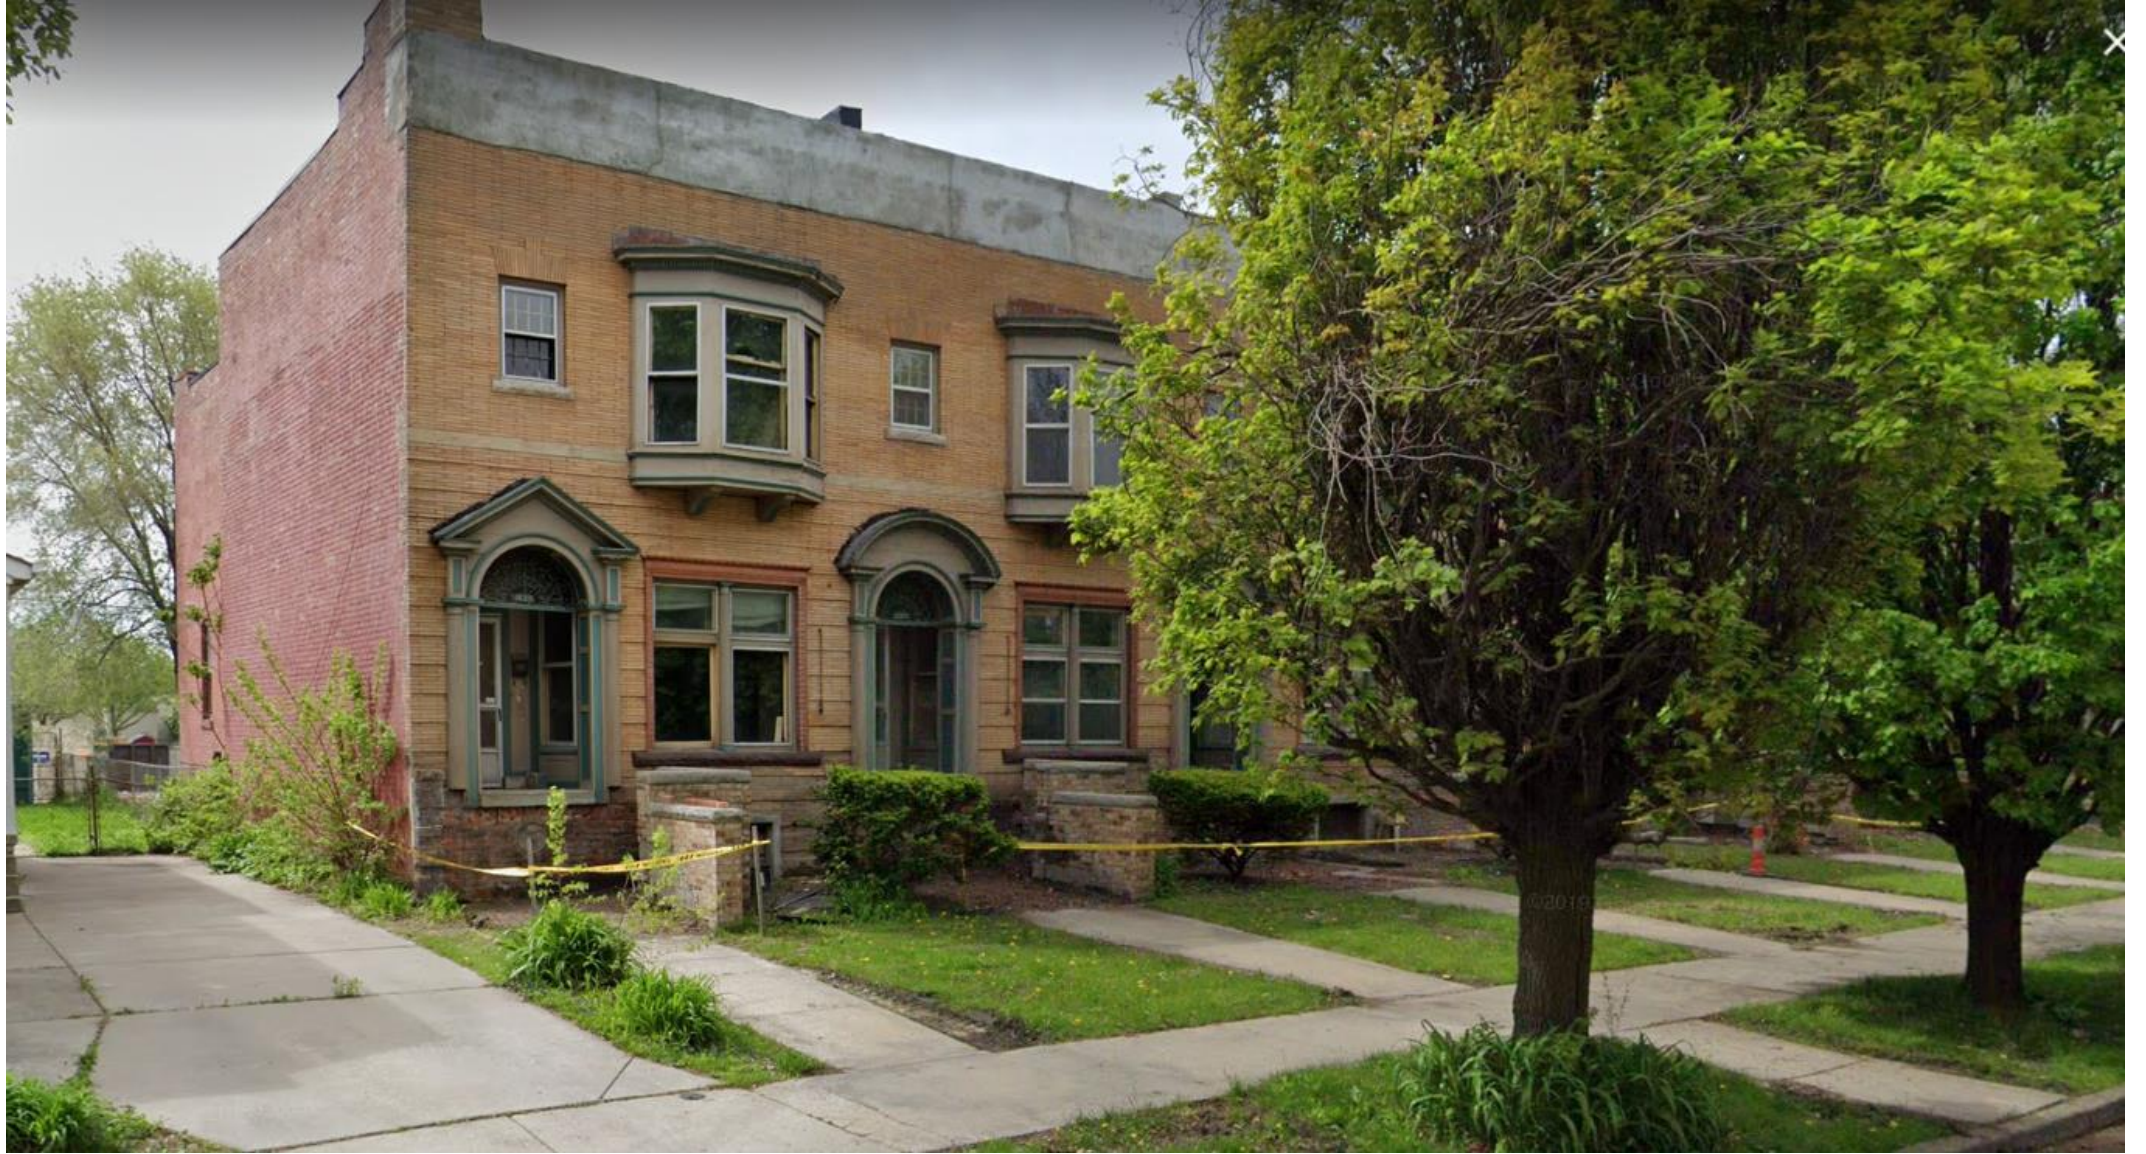
Front elevation, dating from 2019 after the unapproved removal of the original cornice

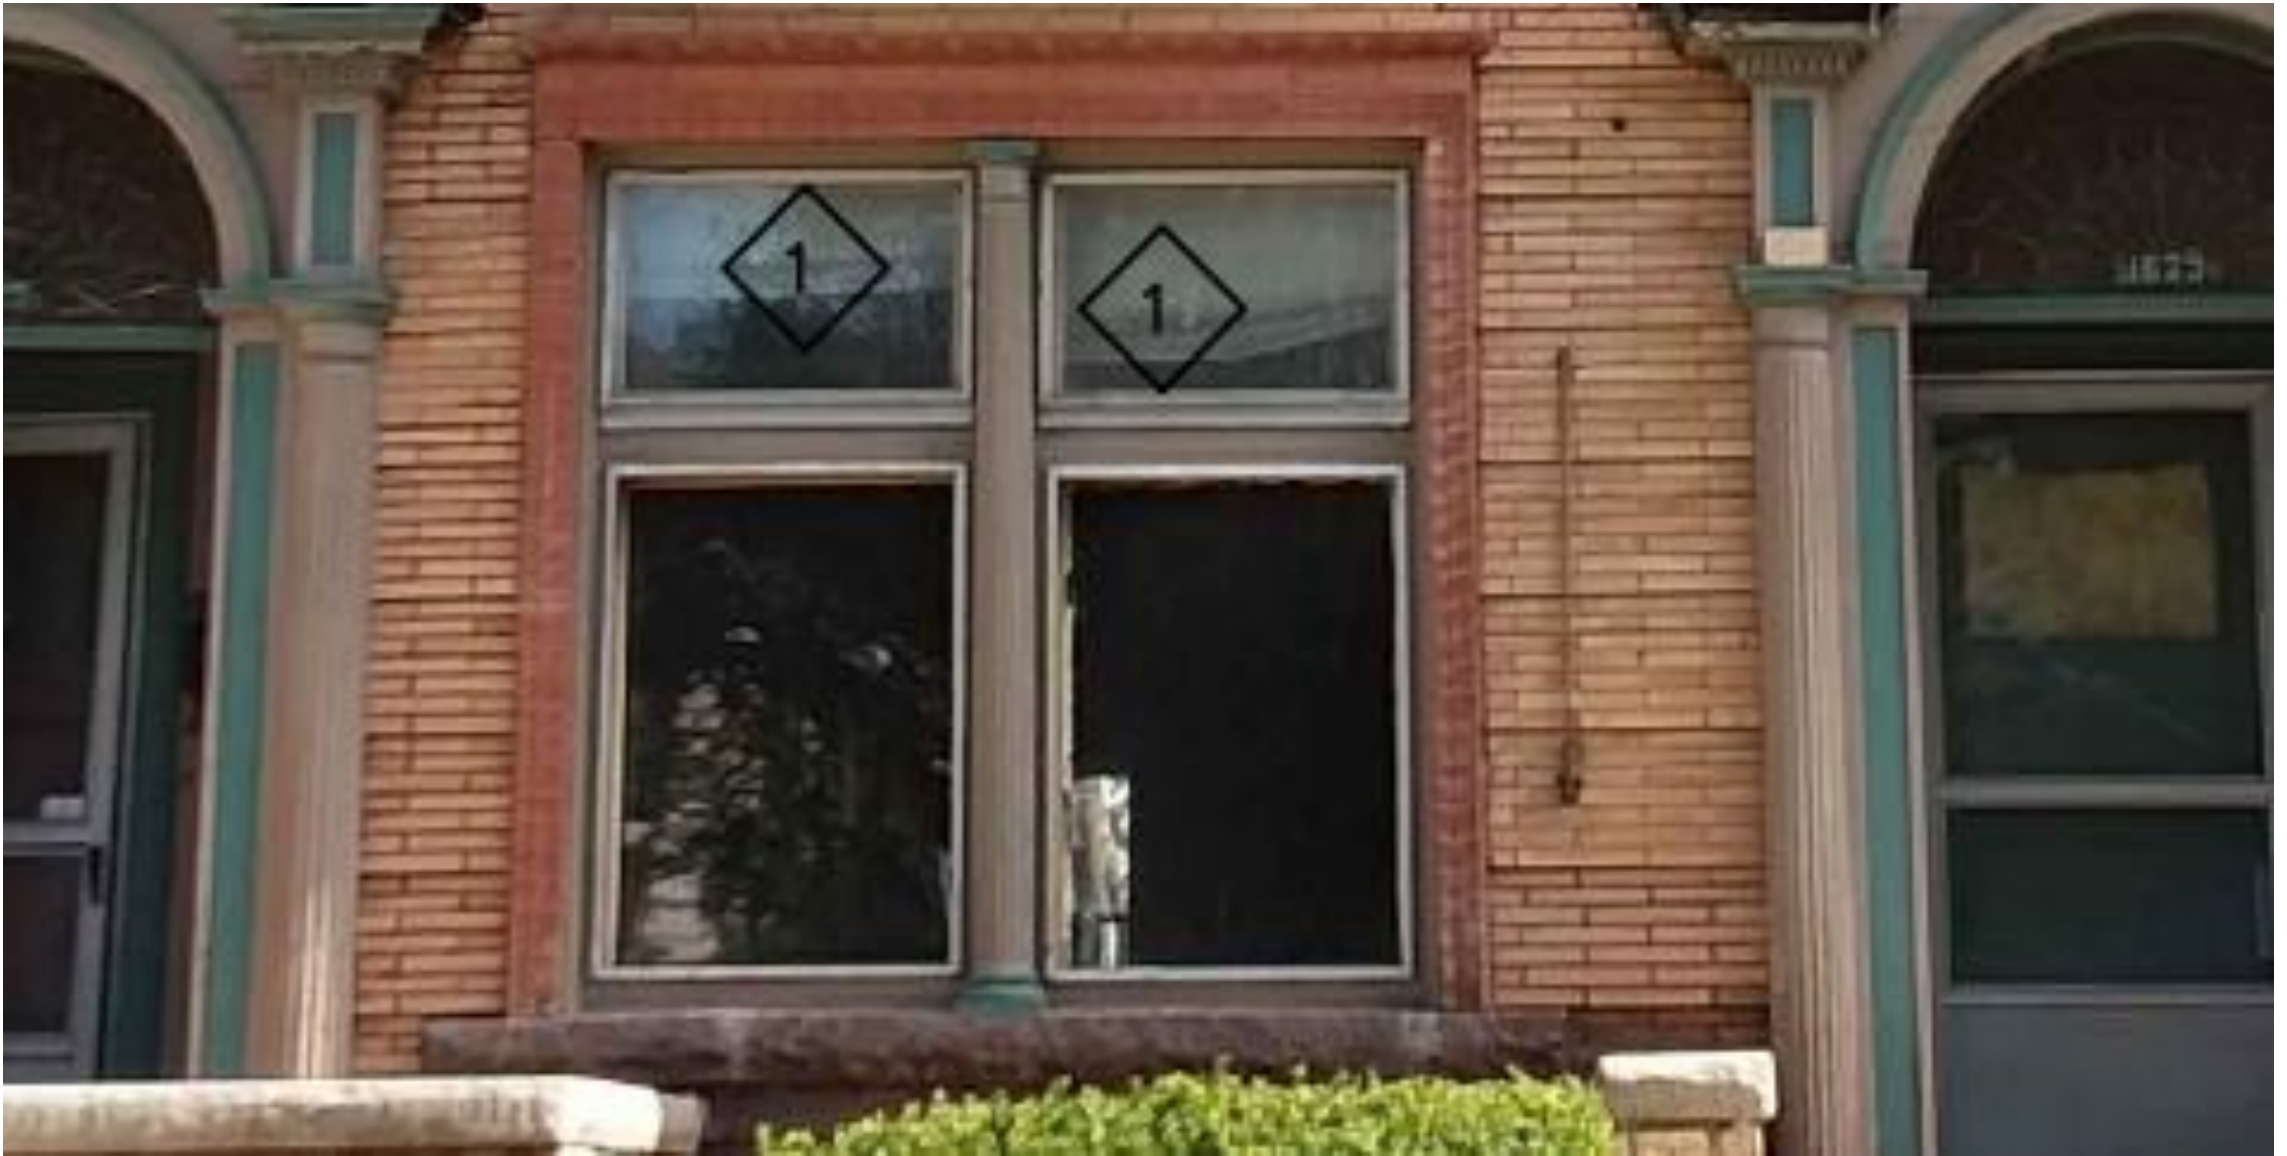
Front elevation window at first story, prior to unapproved work. Note, pilaster, wood trim, fixed windows and fixed transom

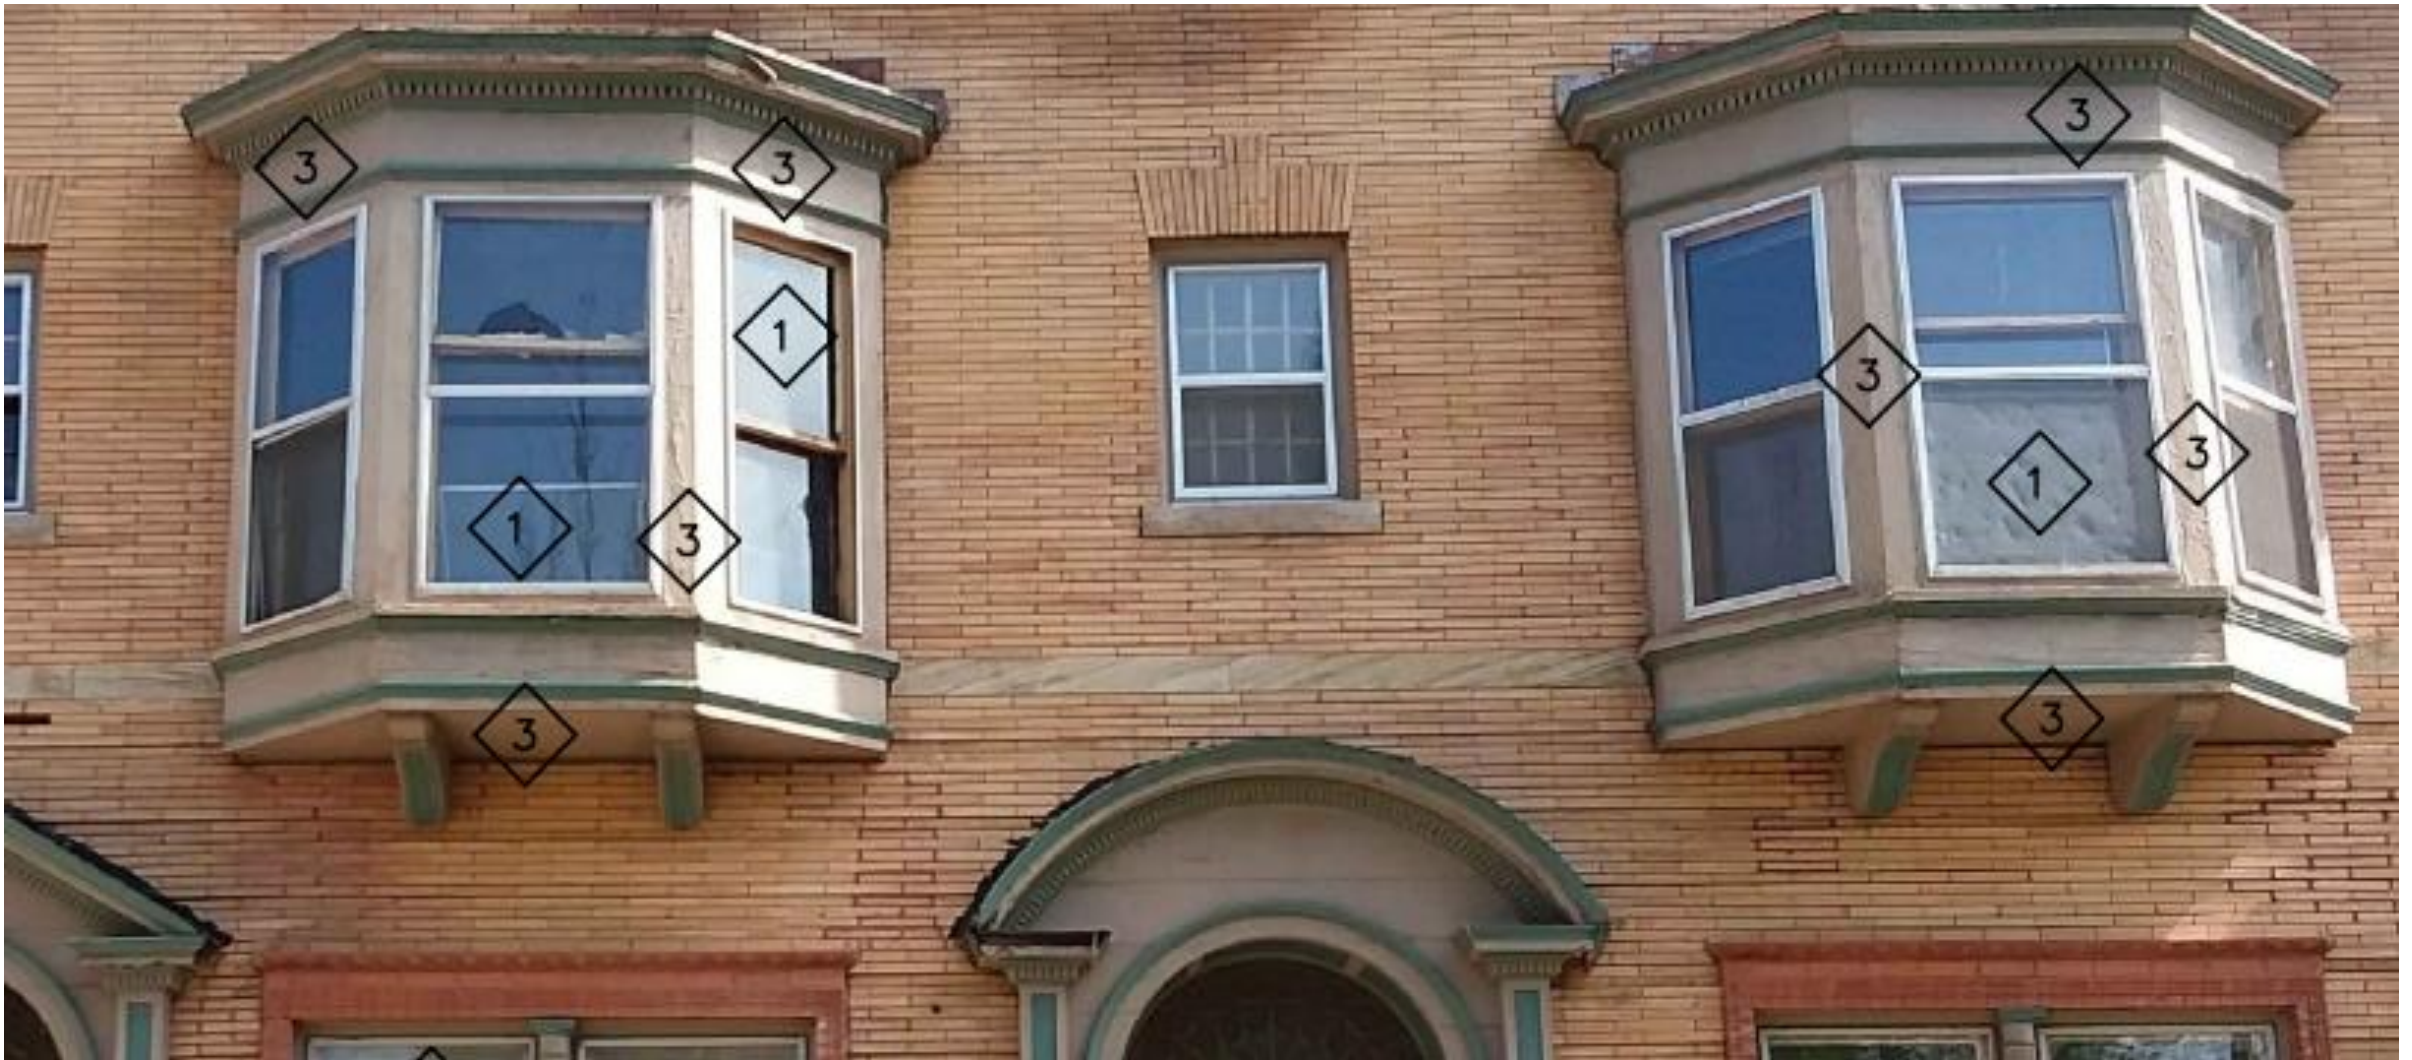
Front elevation window at second story, prior to unapproved work. Note 1/1 and 8/8 wood windows

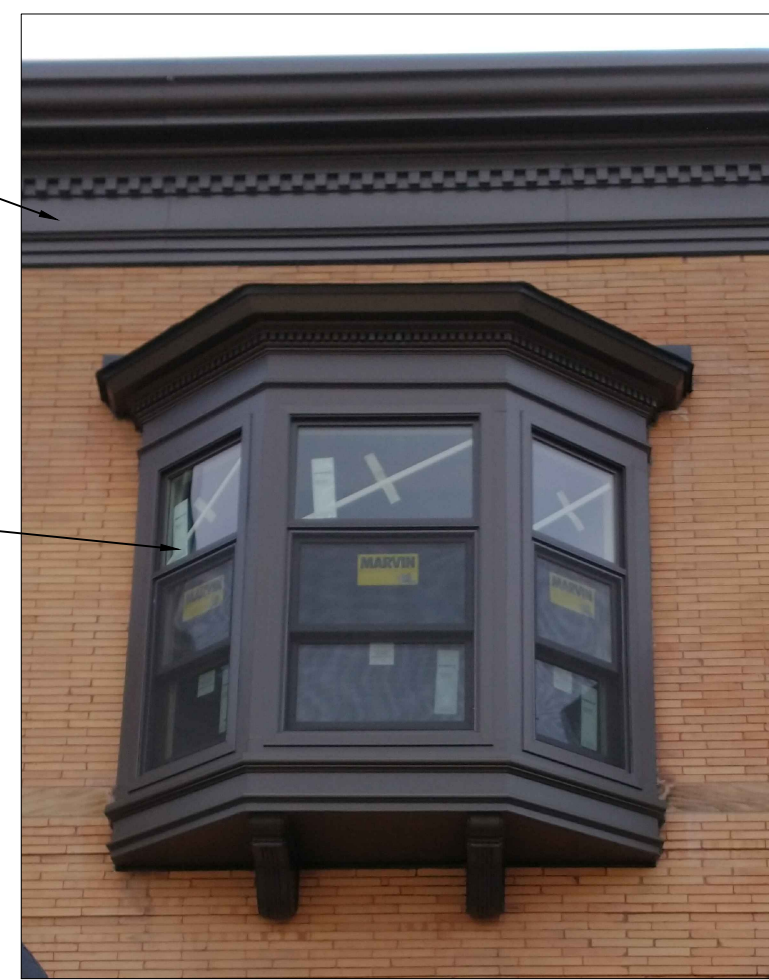
**(Currently Installed)
 Bay Windows To Be Removed**

REMOVE & REPLACE CURRENT BAY WINDOWS WITH UNIT MATCHING THE ORIGINAL WINDOW

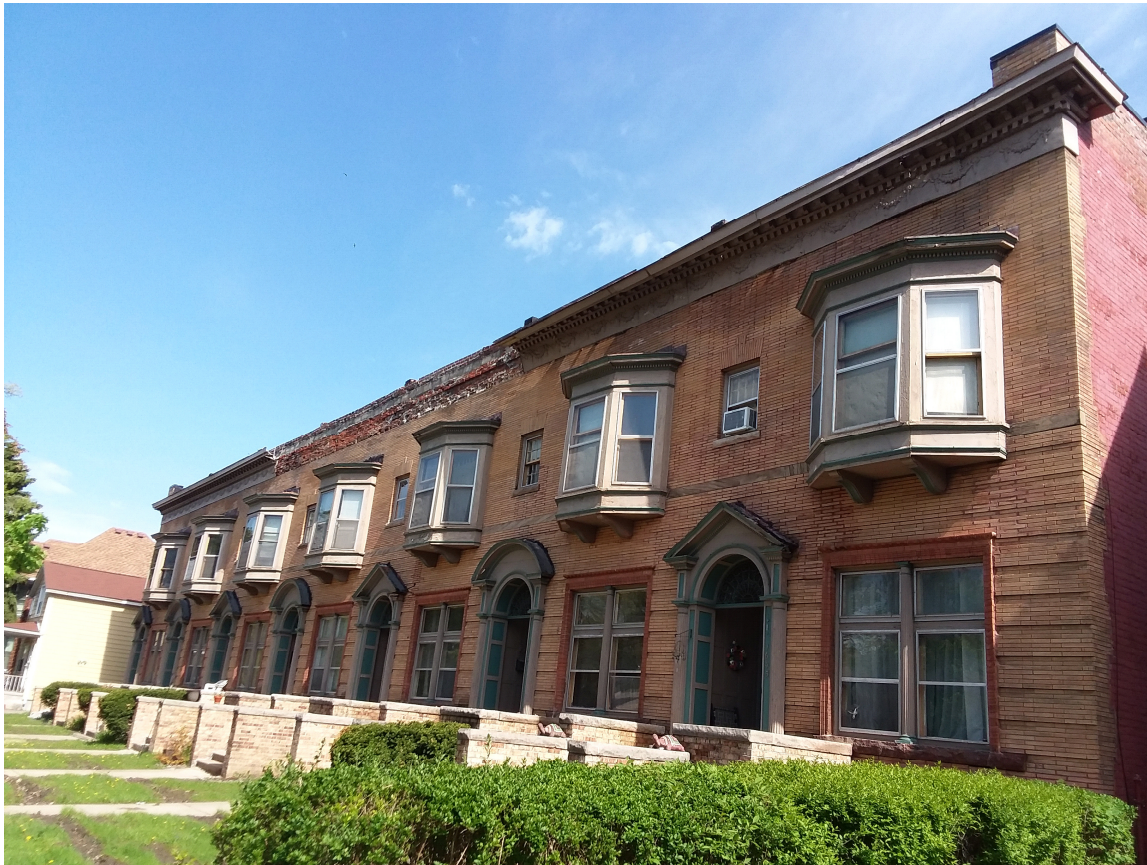
Overall Front View (North Elevation - looking east)

Existing Wood Windows with aluminum storm windows. Terracotta trim around 1st floor window openings. Existing failed cornice (to be replaced).

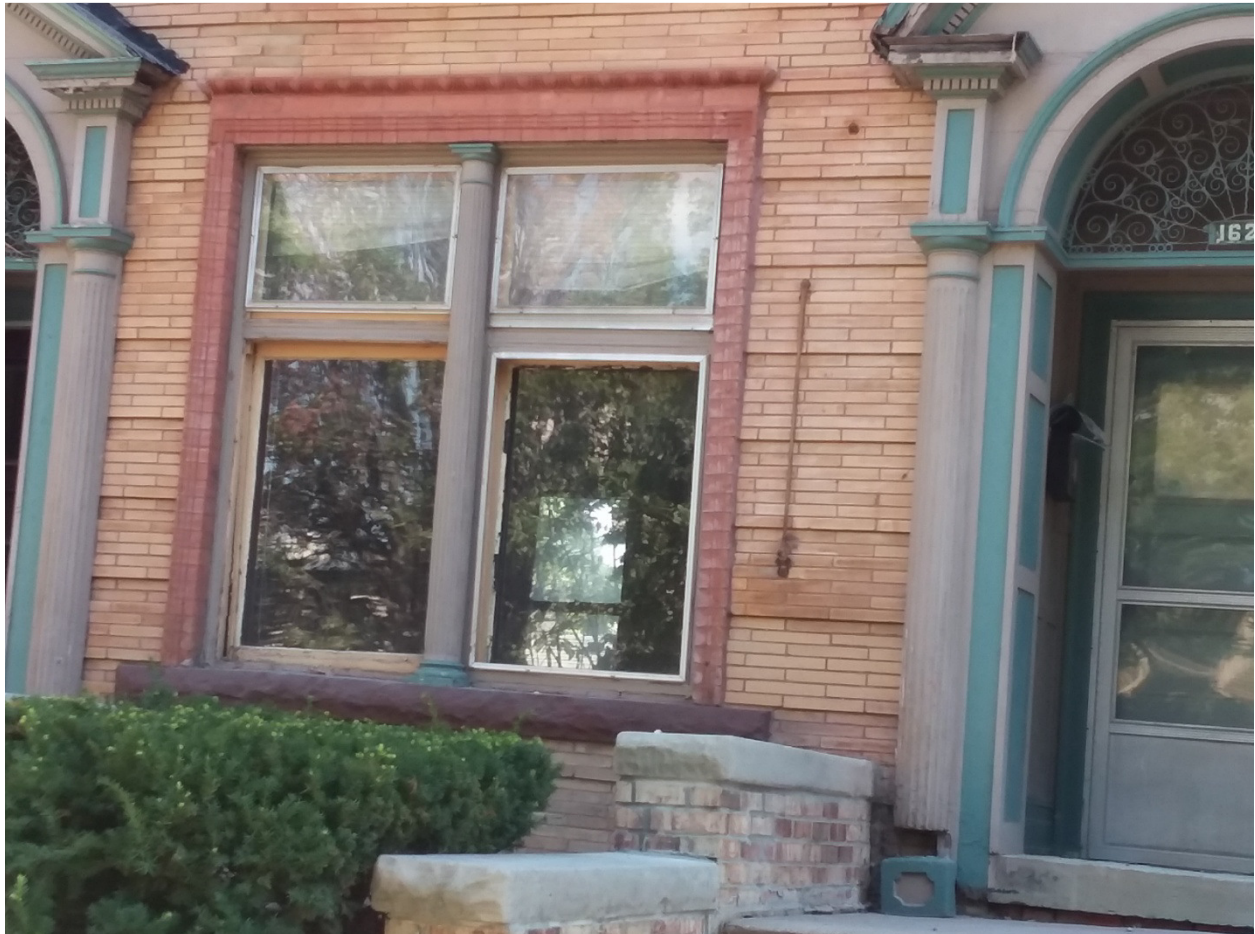
Existing Front Wall at Living Room

Porch repairs performed by previous owner installed on bad foundations, not installed level & plumb to building & has excessive gaps along stairs & window porch walls. Existing porch deck pitches in wrong direction. Excessive gaps has allowed water &/or ice to cause further damaged.

All porches have been removed & replace with brick work that is a closure match to the existing walls.

Perimeter of all window openings have been repaired & rebuilt as required.

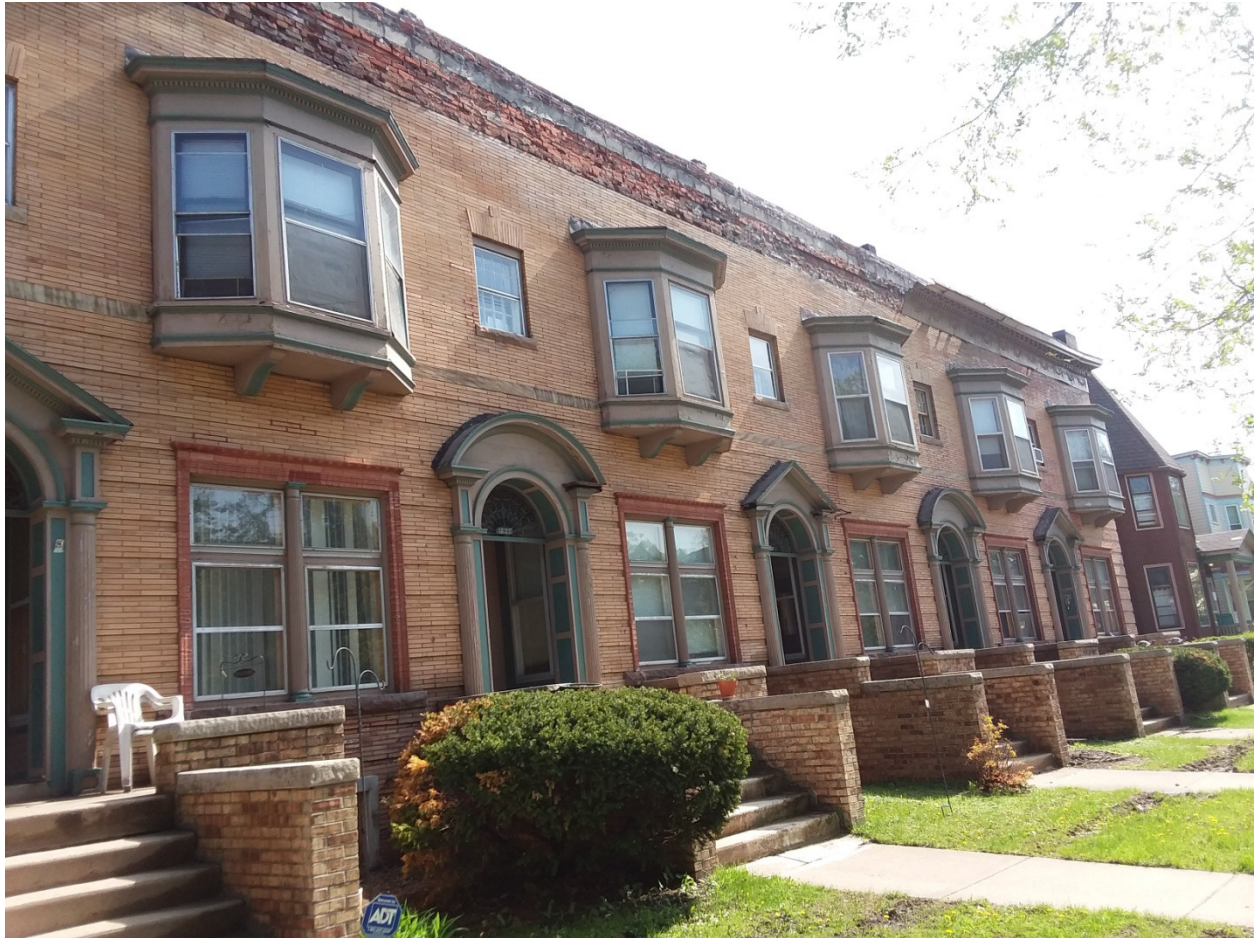
Front Elevation View (looking west)

Due to failed parapet wall, failed roof flashing & leaking water all 2nd floor bays had extensive damaged at main supports & framing. All dormers are to be completely removed & rebuilt in order to proper anchor & replace supports of offset wall framing.

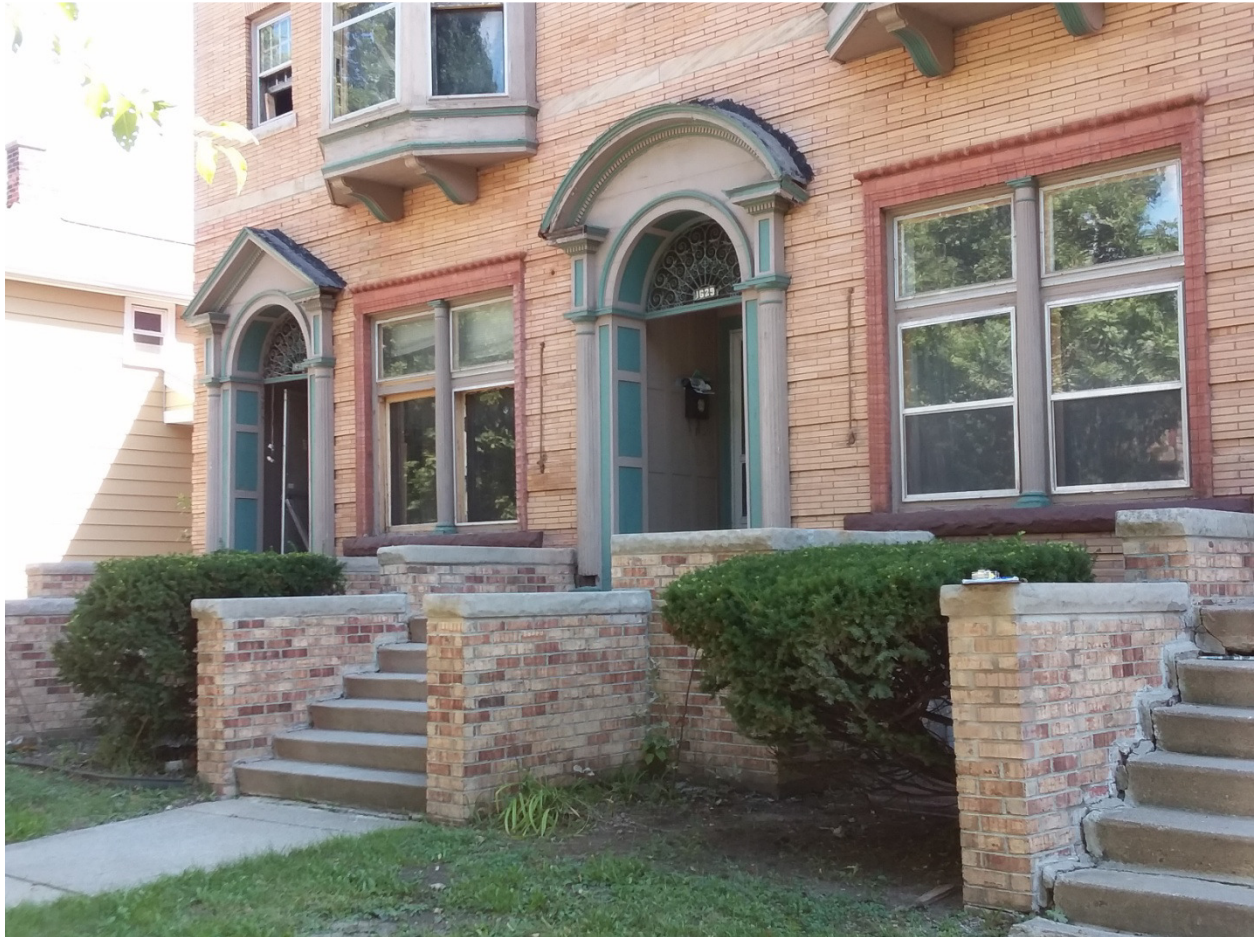
Front Elevation (East Corner)

Previous Owner brick Repairs (to be removed & re-installed)

Existing 2nd floor window bay framing to be removed & replaced as required.

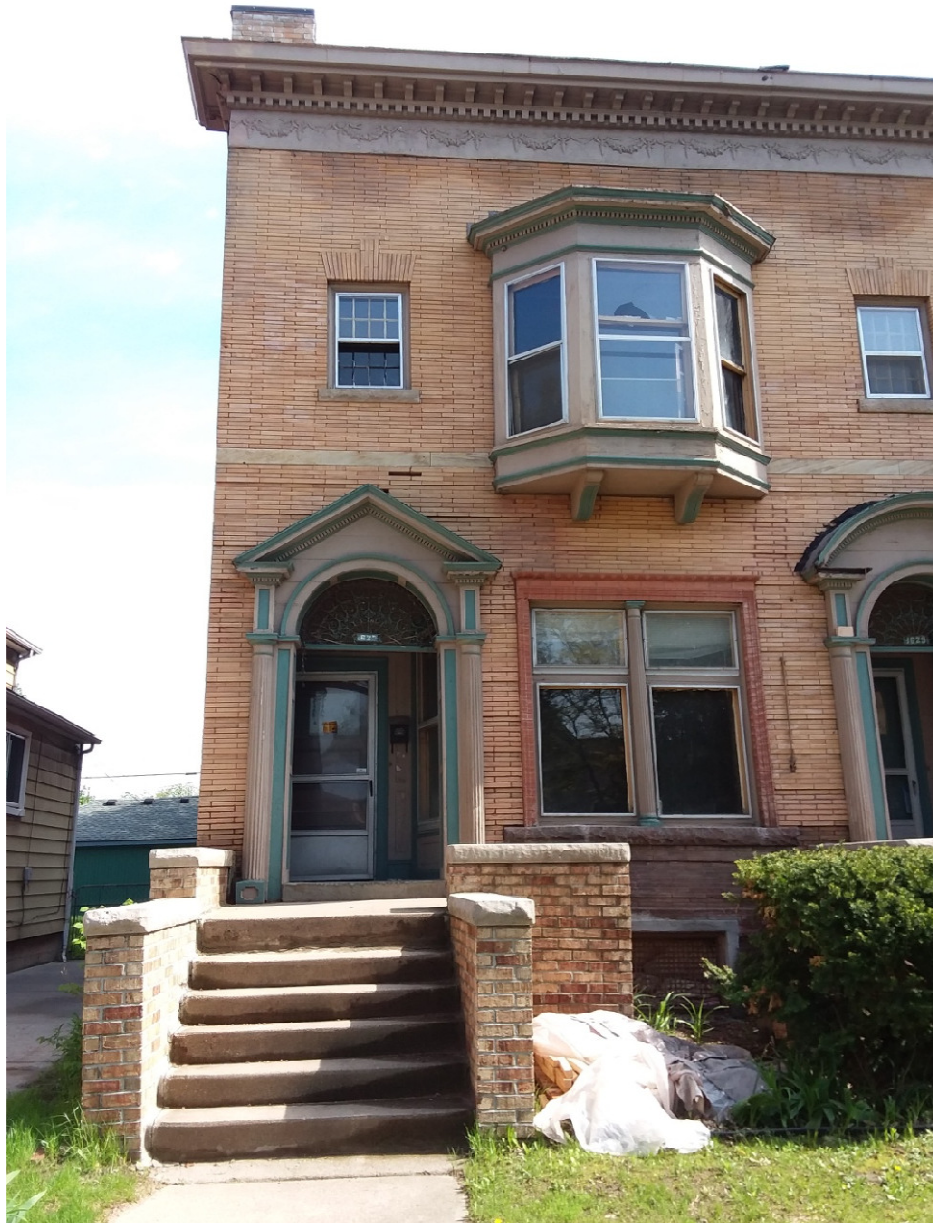
Damaged Parapet - Note water saturation marks on masonry.

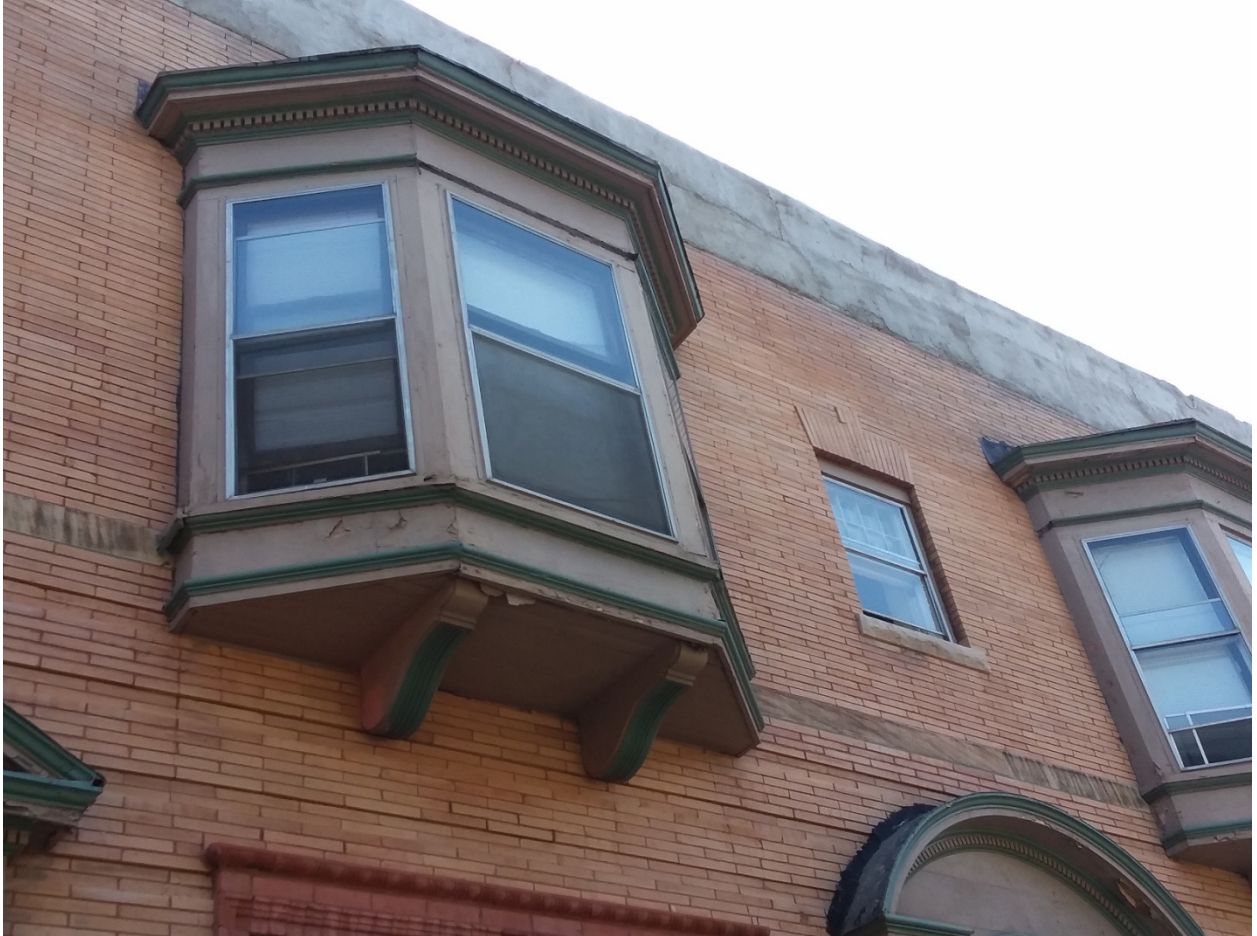
2nd Floor Bay Window

Parapet repairs underway

Note: Bay framing & anchorage locations are damaged & require repairs &/or replacement.

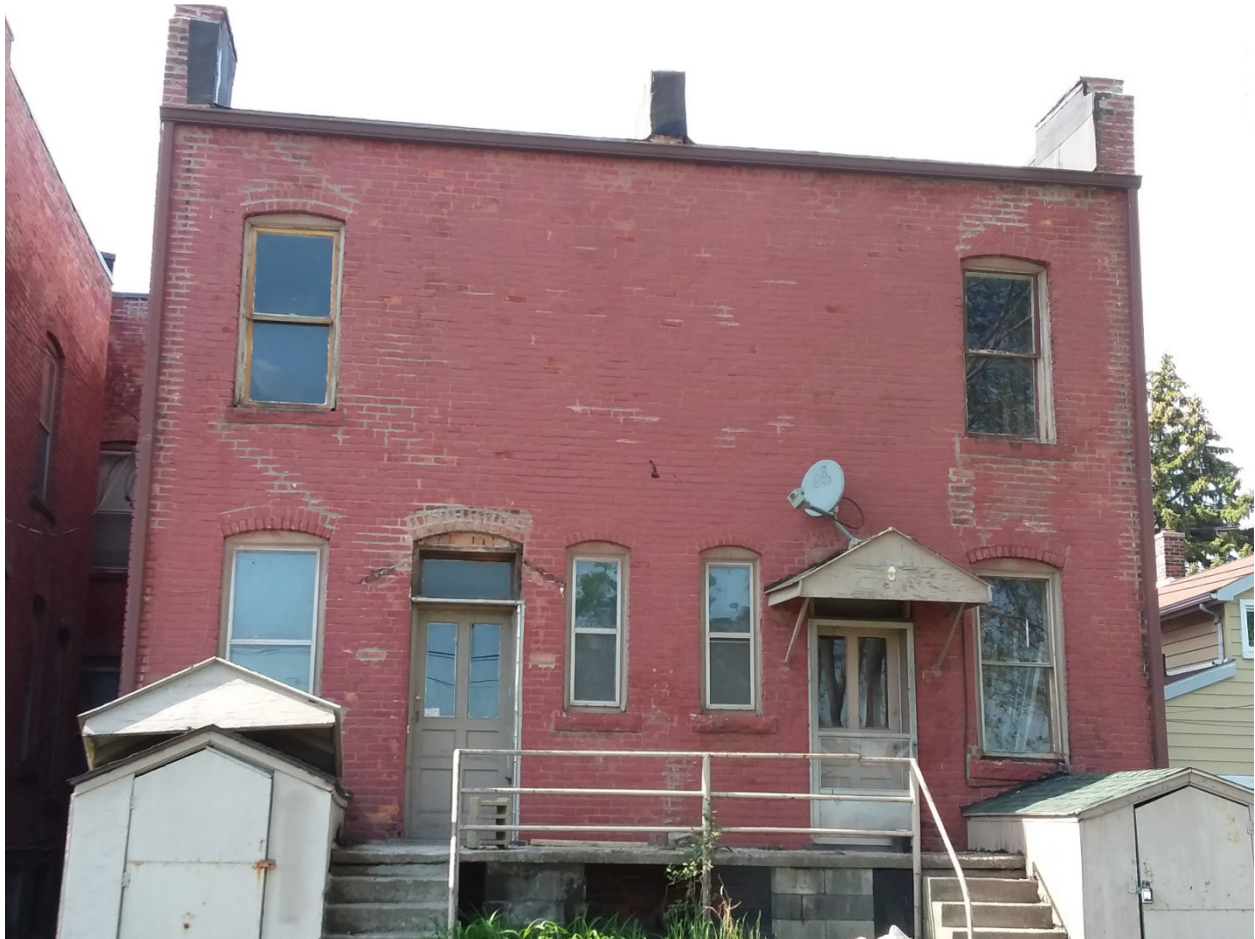
Units 1 & 2 (East - Units #1 & #2)

Existing windows to be replaced (excessive damaged along sills & interior wall & framing). Sills, framing & sashes have both water & insect damage.
