STAFF REPORT: 4/14/2021 MEETING

ADDRESS: 1627 (1627-1639) LEVERETTE

HISTORIC DISTRICT: CORKTOWN

SCOPE: ERECT NEW CARPORTS; REHABILITATE BUILDING

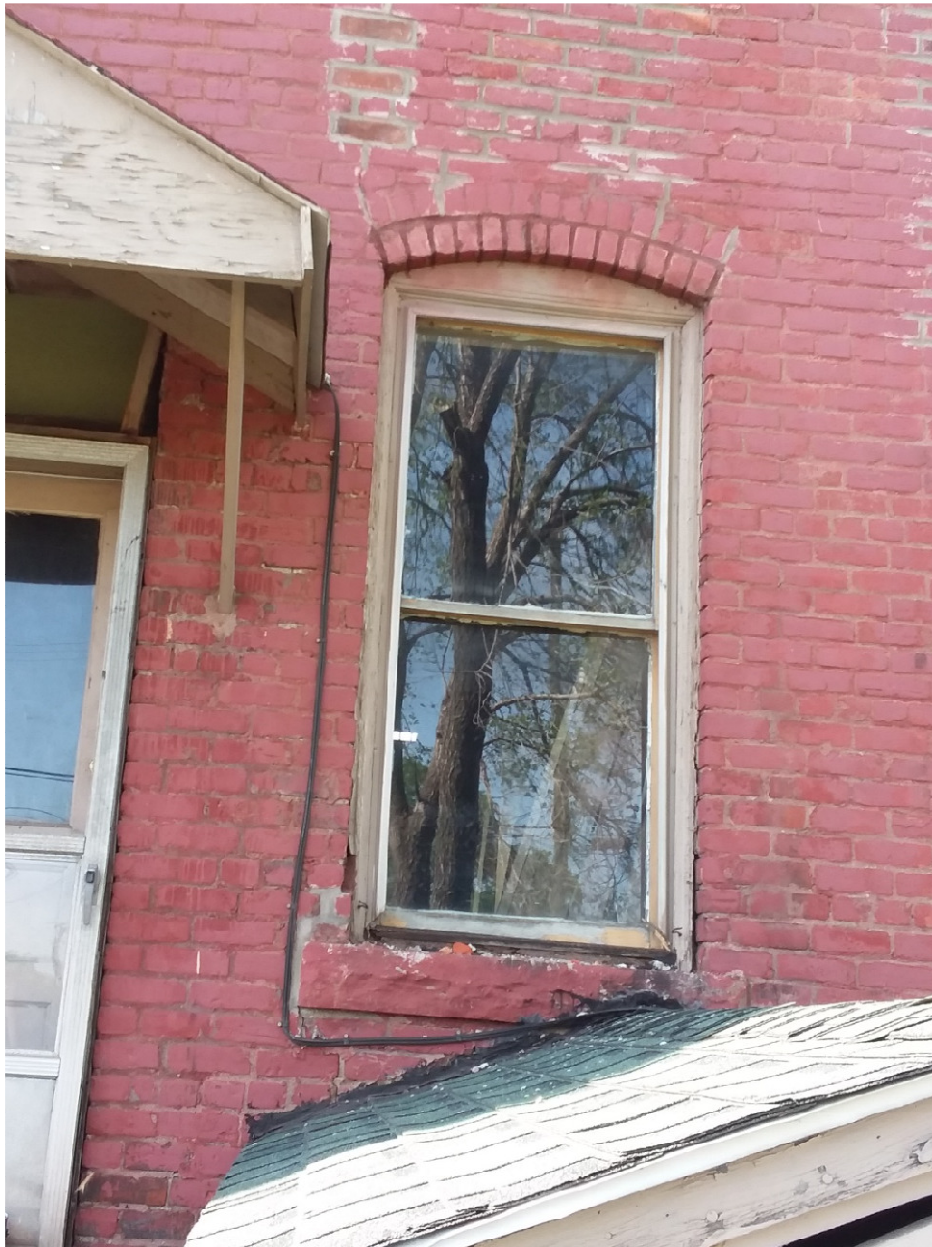
Rear Wall - Typical Conditions

Note: Water damaged & water logged wood sill.

Window Sills are water & insect damaged. Jambes & Blocking is damaged
(water &/or insect) typical at most openings.

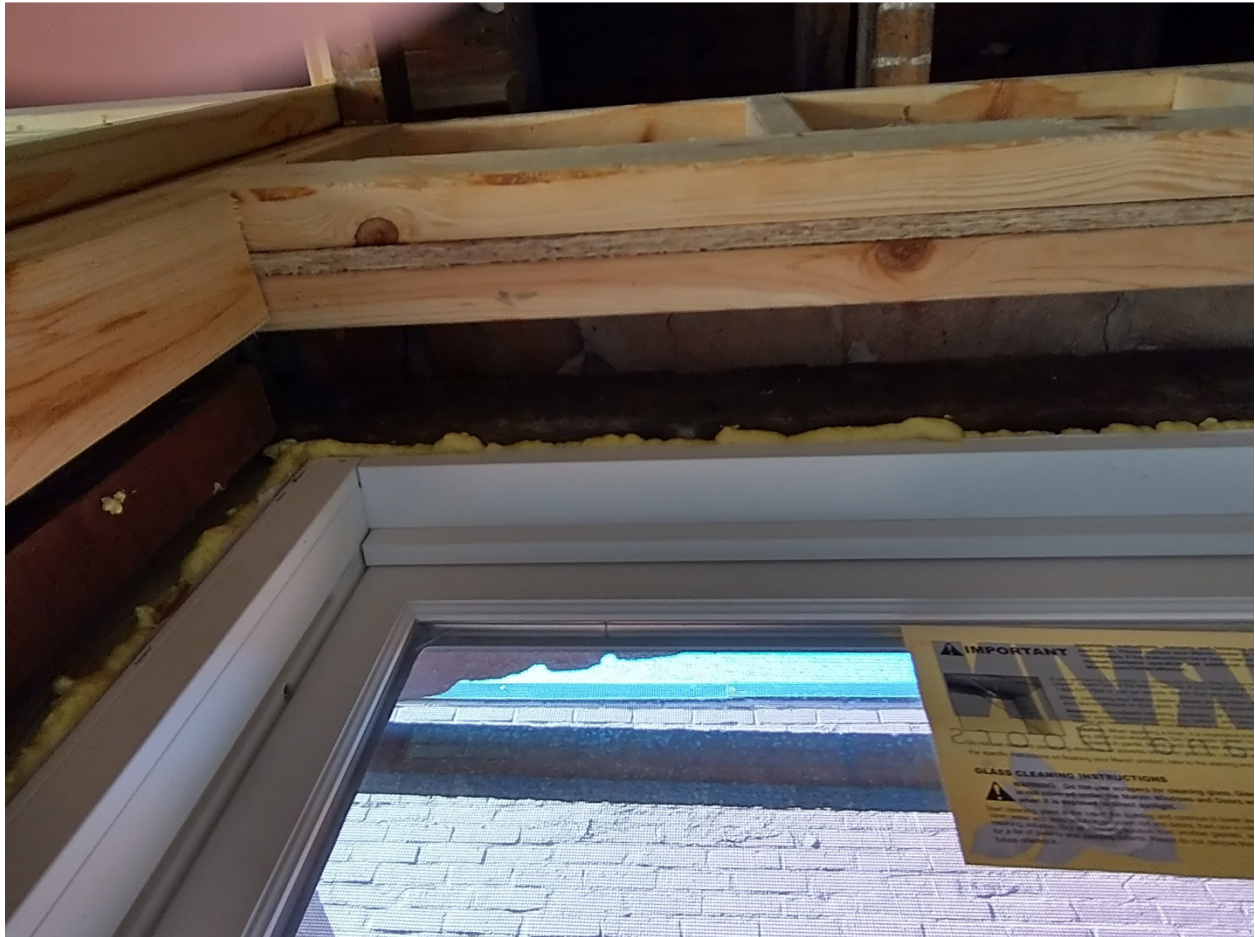
View at Head (Interior)

Removed damaged wood framing / blocking & nailers at window openings

Installed new nailers inside brick cavity to anchor window

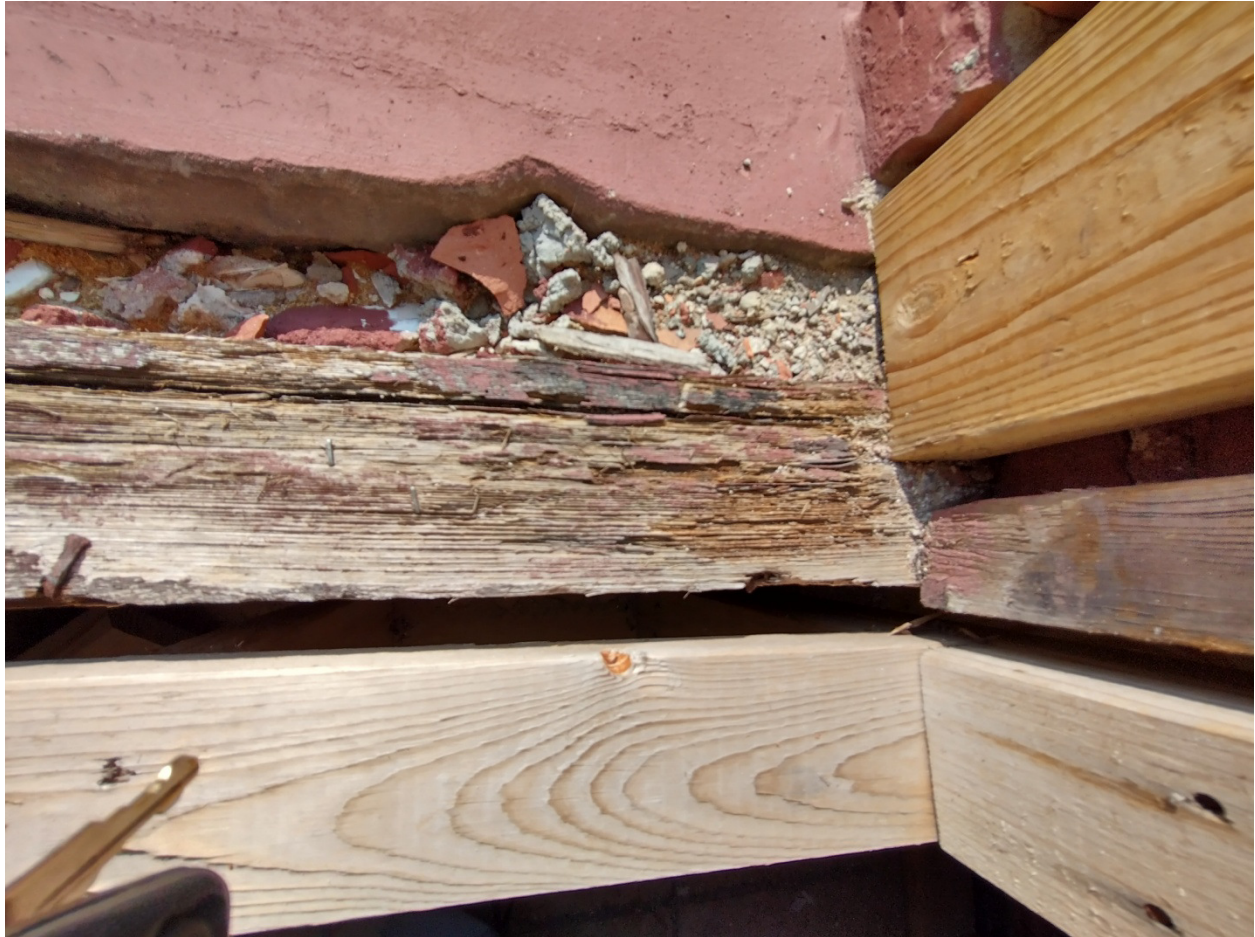
Typical Wall Cavity View

Existing sill nailer / blocking - water or insect damage (to be removed & replaced)

Note: New interior framing & new vertical framing @ exterior brick
