STAFF REPORT: 5/12/2021 MEETING PREPARED BY: D. RIEDEN

APPLICATION NUMBER: #21-7215

ADDRESS: 1670 BAGLEY

SCOPE: FRONT/SIDE PORCH MODIFICATIONS, WOOD FENCE INSTALLATION, PAINT

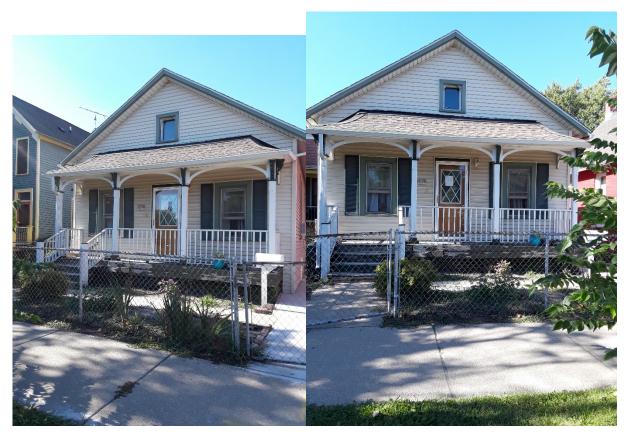
Front top window plus front of house.

Picture of front porch.

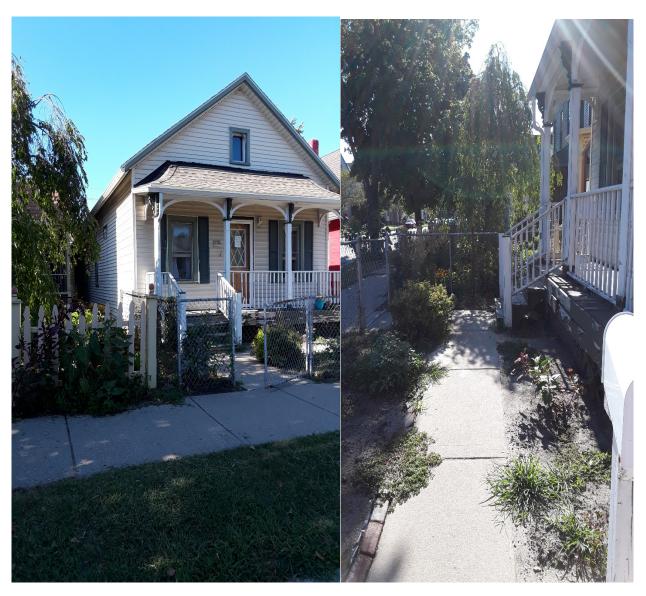
West corner of the front of the house. Metal gate and will be replanced by painted white wood gate and fence.

Paint peeling from front bottom fence

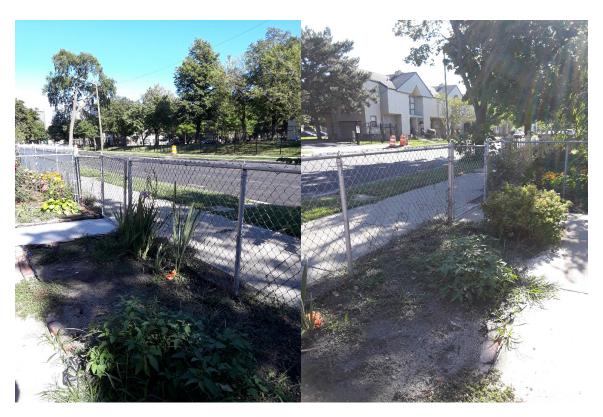
Side gate and fence.

Front gate and fence.

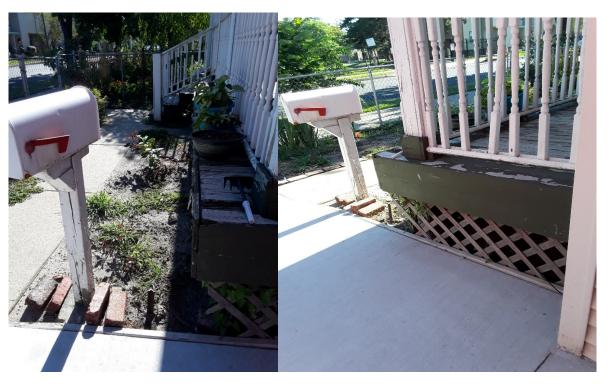
Porch floor is wider than overhang and rail.

Porch is falling into the ground.

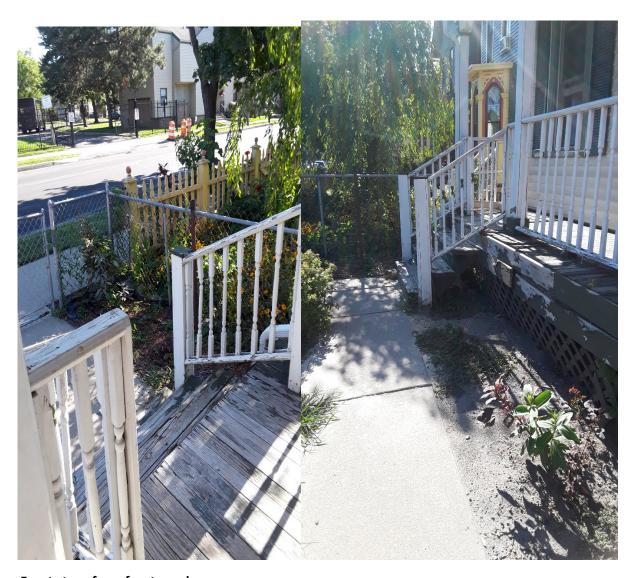
Front steps from front porch.

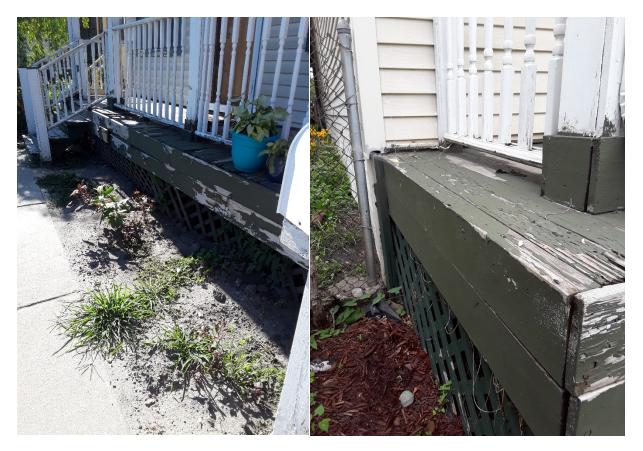
Front porch rail, skirt, and floor siding.

West side of porch.

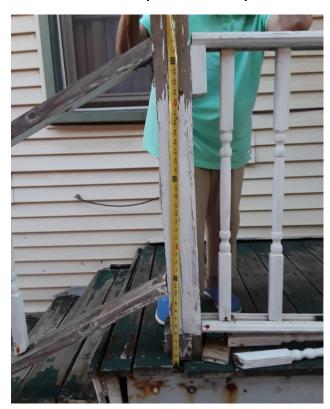
This is my mother helping me take measurements for this project. This is the rail post which will be replaced by a new wood post.

It is 42 inches long inserted into a block wood square which will also be wood.

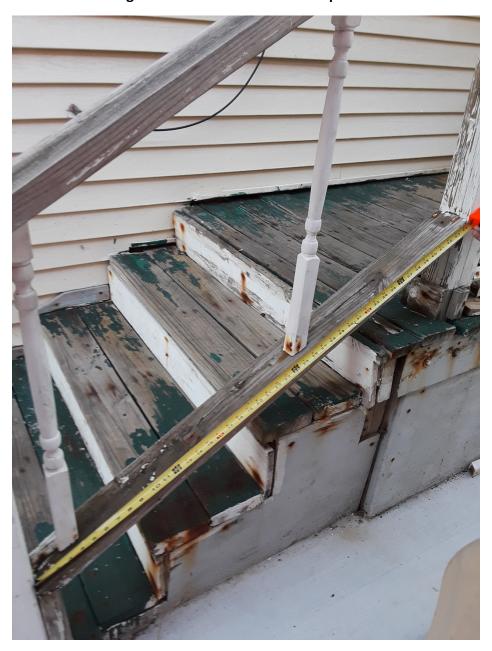
Bottom rail is 45 inches long, being replaced by new wood.

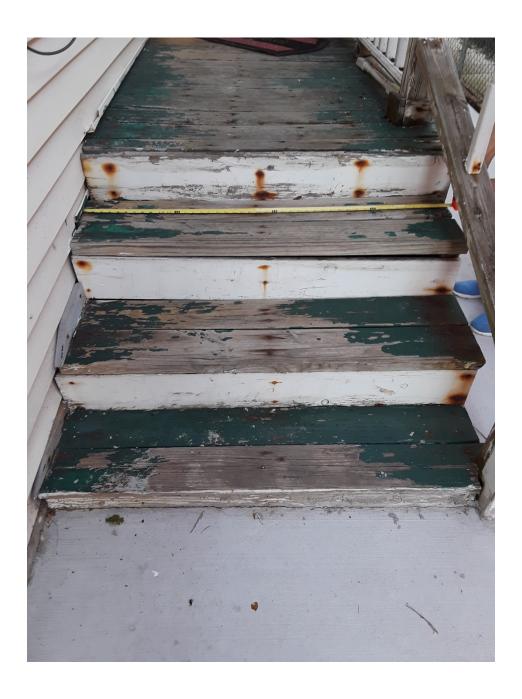
Top of steps are 45 inches wide and top of deck is 46 inches wide. I am requesting to add two more inches in width to the deck of side porch for added space. I am requesting Trex composite for the floor deck and top of steps. I am also requesting Trex composite for the stepping kick board since it has a tendency to fall apart.

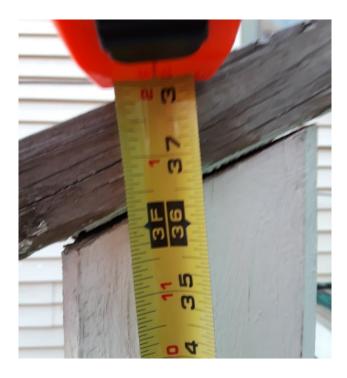
Post for side porch rail is 38 inches. It will be replaced by new wood rail.

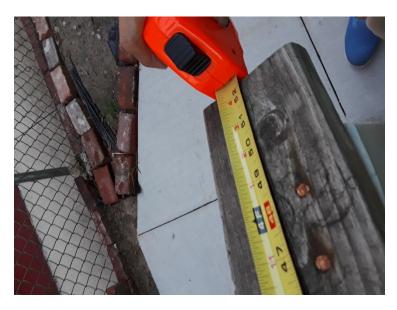
End of top rail for side porch is 52 ½ inches long. It will be replaced by a new wood rail.

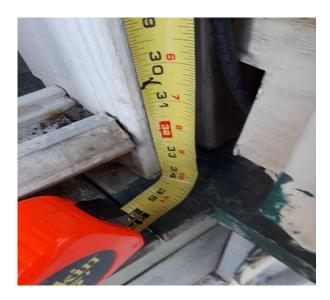
This is the beginning of the rail attach to the house. A wood board attach to the house and rail from top to bottom it is 34 ½ inches long. It will be replaced by a new wood board.

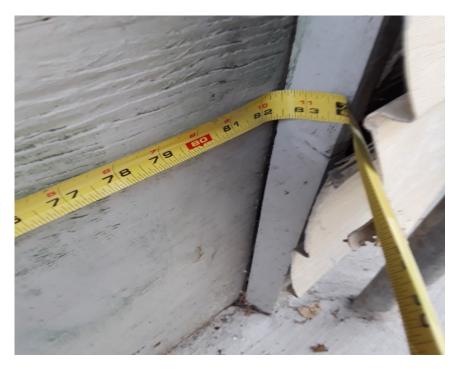
The bottom side porch measures at 82 ½ inches long and 26 inches from top to bottom. It will be replaced with and hopefully with the same kind of design.

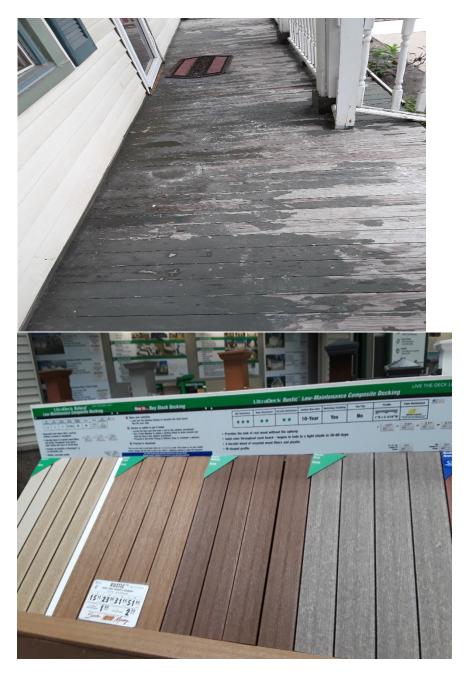
The front porch deck is 22 feet long. I am requesting Trex composite to replace the damage wood deck for both front and side porch in order to keep the deck from deteriorating.

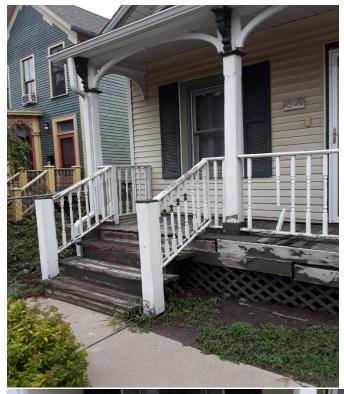
Front steps are 5 feet long and 11 $\frac{1}{2}$ wide. I am requesting Trex composite for the top of the steps for both front and side porch to keep from deteriorating. I am also requesting that the kick of the steps be composite.

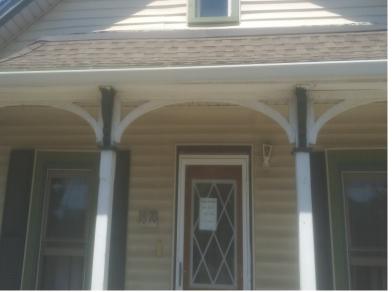
Picture - 1 Front entry

Picture 1: Posts will be replace with new posts. Overhang is going to be extended to cover extended front porch.

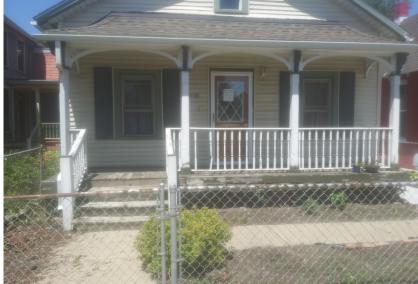
Picture - 2 Steps and railing

Picture 2: Fence is going to be replaced with picket fence. Gate is going to be moved and centered with porch steps. Porch steps are going to be centered with main entry door to home.

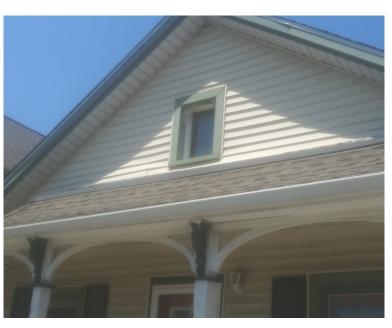
Picture 3 - Front Entry Overhang

Picture 3: Damaged window will be replaced with new octagon shaped window
