STAFF REPORT: 05-12-21 MEETING

APPLICATION NUMBER: 21-7222

ADDRESS: 1920 ATKINSON

SCOPE: REHABILITATE HOUSE FOR ADAPTIVE REUSE AS RESTAURANT/APTS; BUILD EXTERIOR PATIO AT REAR

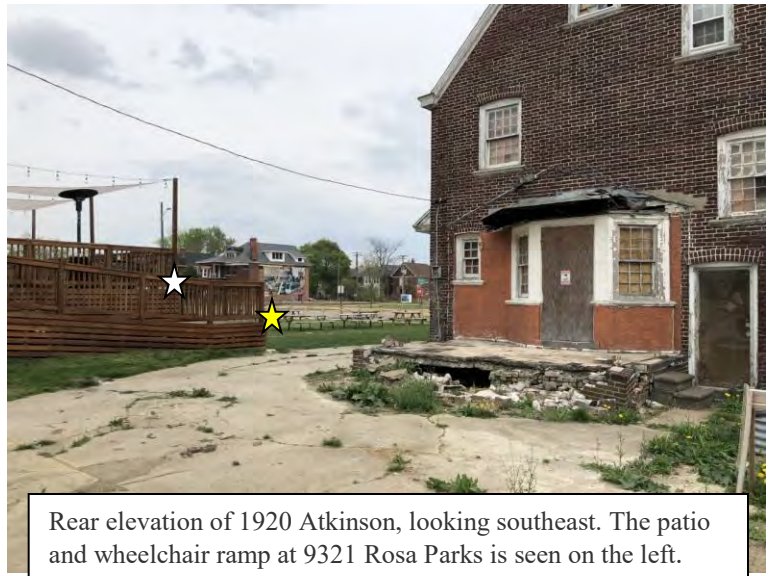
- The applicant confirmed the existing brick finish adjacent the rear bay window will remain.
- It is staff’s opinion the double-hung window and at-grade door on the rear elevation are not character-defining features of the house.

Rear elevation of 1920 Atkinson, looking southeast. The patio and wheelchair ramp at 9321 Rosa Parks is seen on the left.

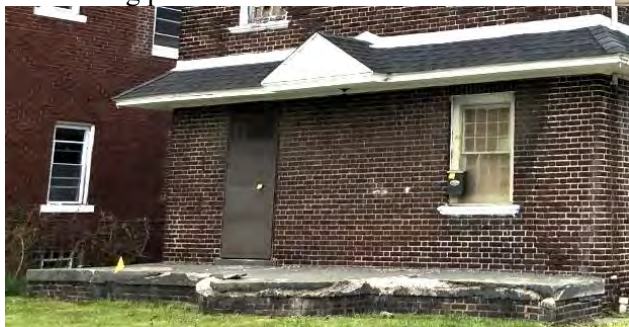
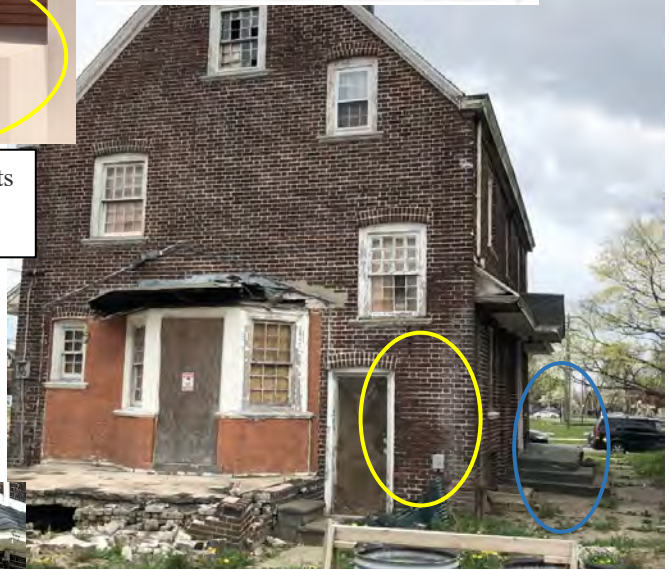
- The applicant proposes to keep the remaining concrete porch surfaces in place. Staff photos show the evidence of highly deteriorated edges, so staff isn't sure how successful it will be to add new concrete to the existing platform.

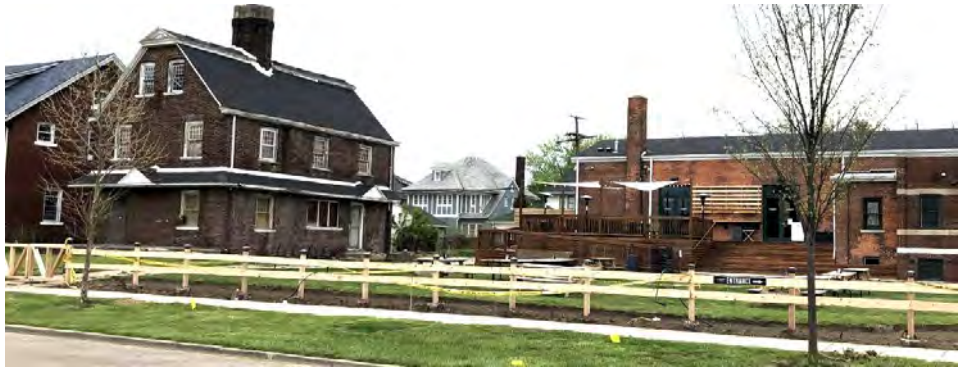
- While conducting the site visit for 1920 Atkinson, HDC staff noticed recent work within the open area of the lot at 9321 Rosa Parks (Congregation Cafe). The most noticeable items include a perimeter wood fence and gate (installed at the driveway which opens onto Atkinson), and wooden picnic tables. HDC staff does not see that HDC approval or a building permit were issued for these items, nor that an application was submitted through Open Detroit, the city’s expedited outdoor dining program related to COVID-19. The projects completed at 9321 Rosa Parks are not part of this application.

HDC photo, April 28, 2021. Looking northwest from Atkinson, near Rosa Parks.

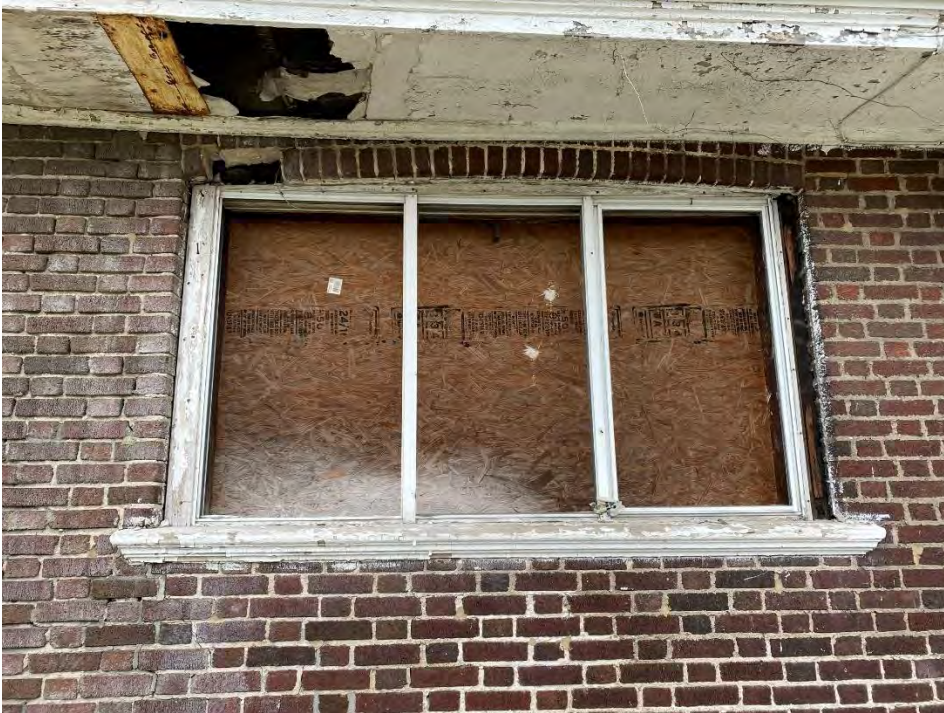
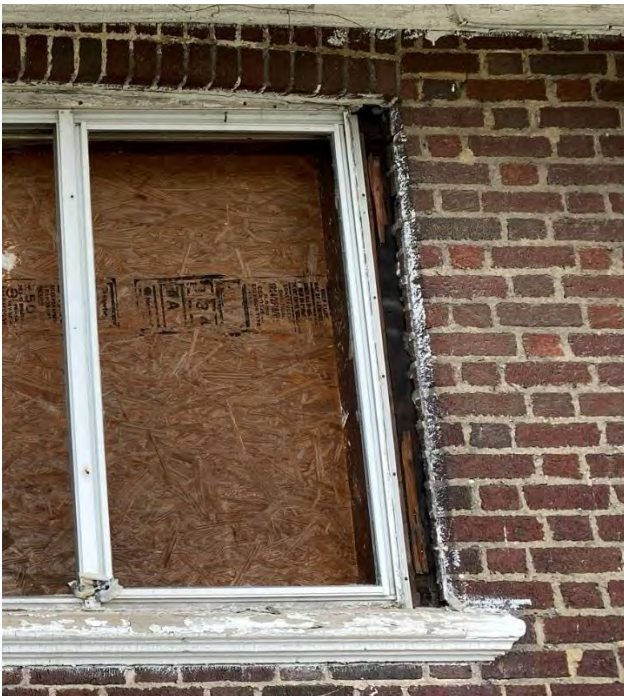
Are the windows within the three-unit opening (W22) in place? Can you please provide an interior photo showing the existing window sash?

No, the windows are non-existent with the window opening being boarded up. Please see pics of the current state below.

- The three windows that need to be fabricated for window opening W22 will be wood (with wood exterior), double-hung windows with true-divided, or simulated divided, light glass. Mullions, similar to the dimensions of structural historic mullions will be fabricated and installed. The existing wood window casings will remain and be repaired as needed. Finish color for this opening will match the remaining windows and trim.

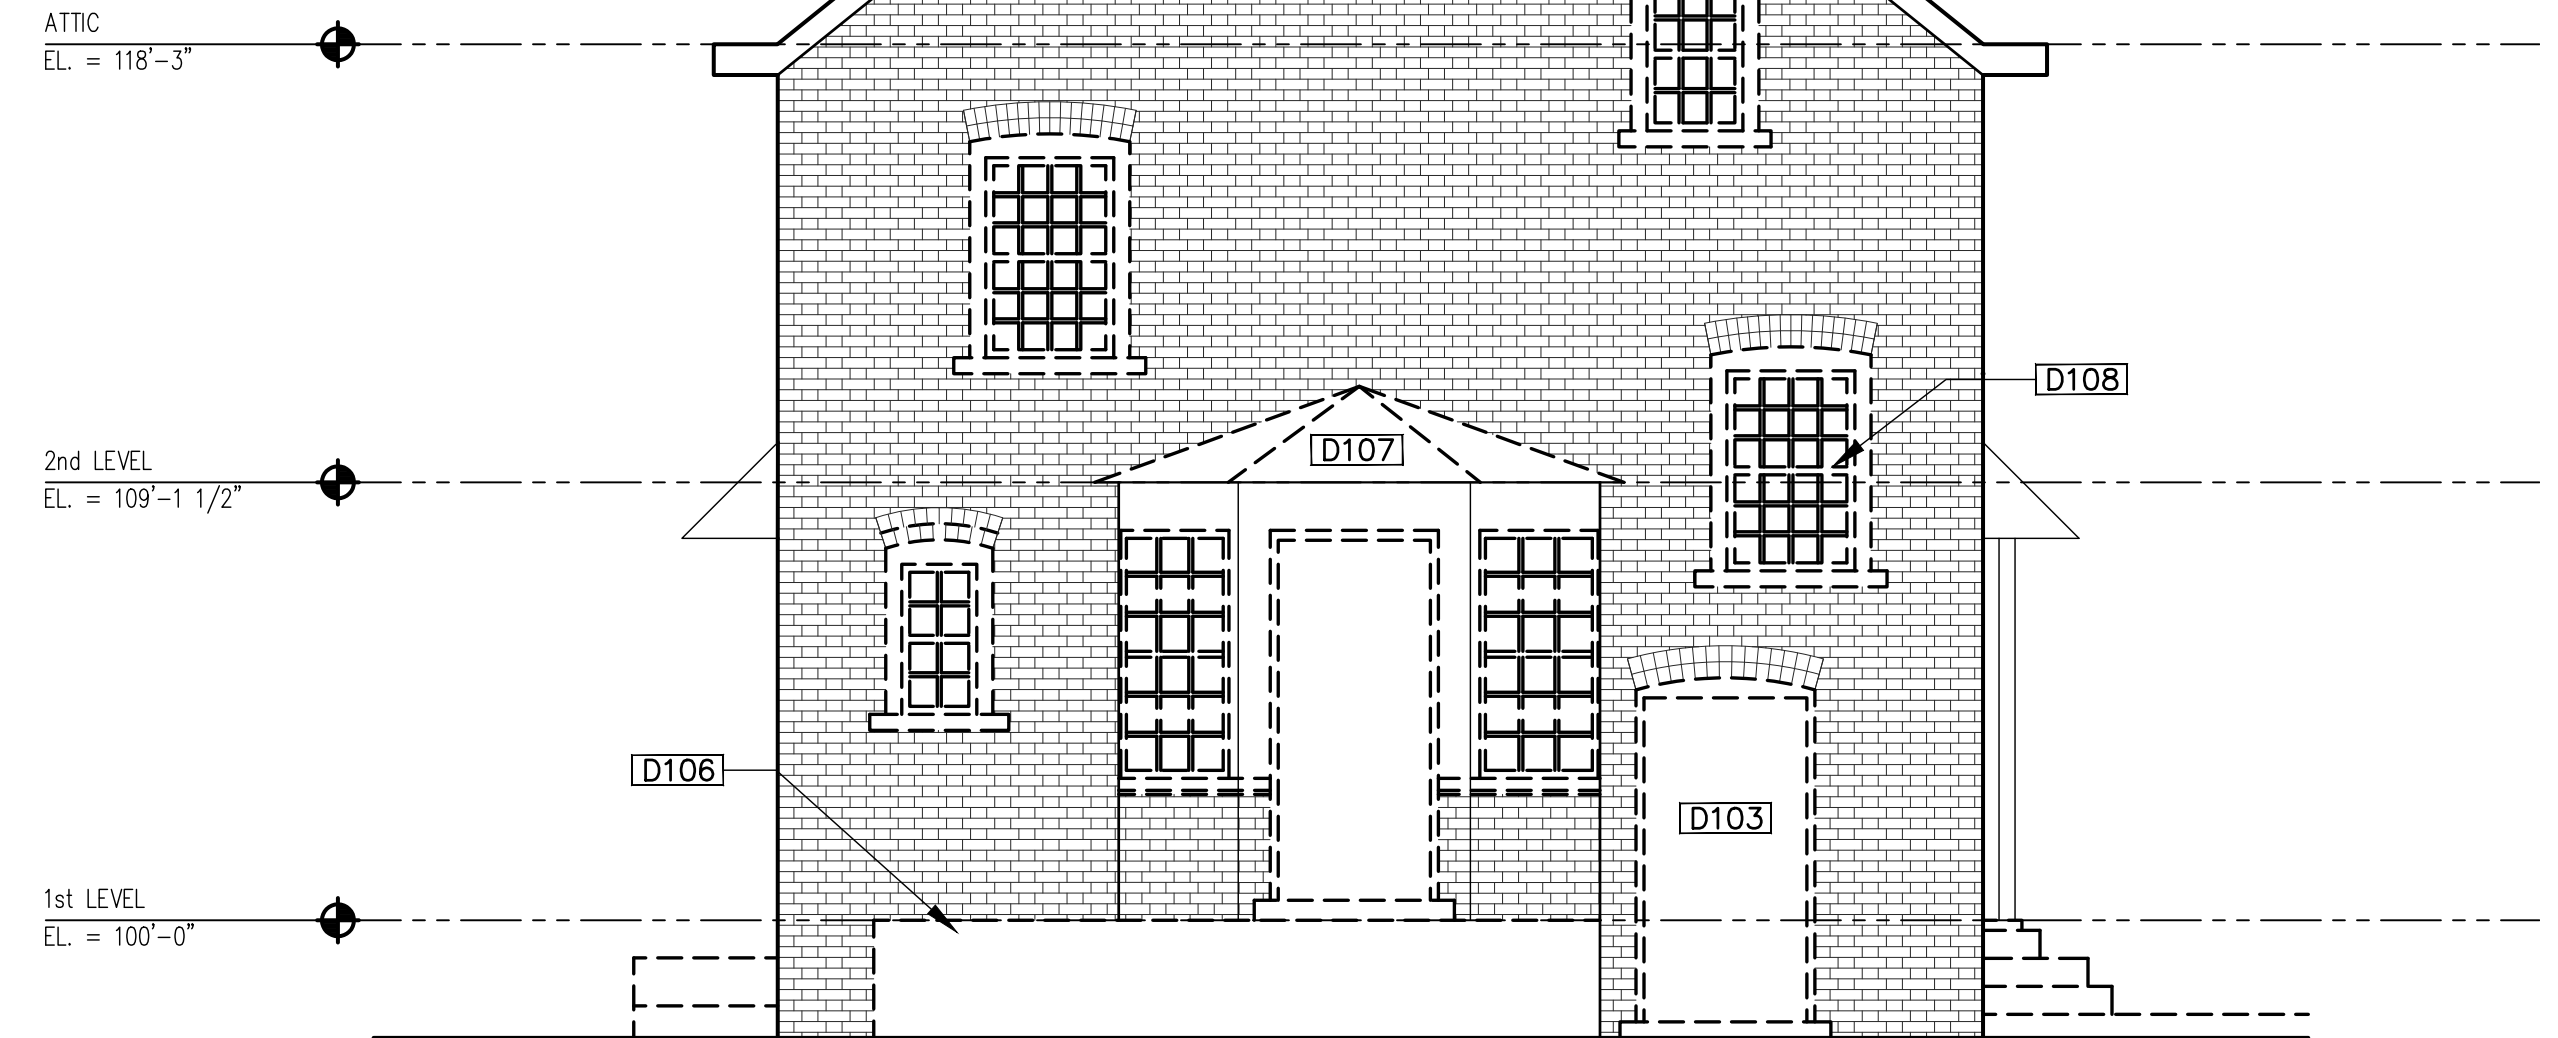
1 Demo. North Elevation
D2.0 1/4" = 1'-0"

- Window and door removal on rear/north elevation. The elevation drawing shows the two openings removed (including double rowlock headers and brick toothed in), erasing all evidence of the historic openings. Per the proposal, it appears the sloping pergola roof (shown on the elevation as a sloping black line) will cross the window opening creating the need for a flat surface.

D108 REMOVE EXISTING WINDOW. FILL IN WITH MATCHING HOUSE BRICK

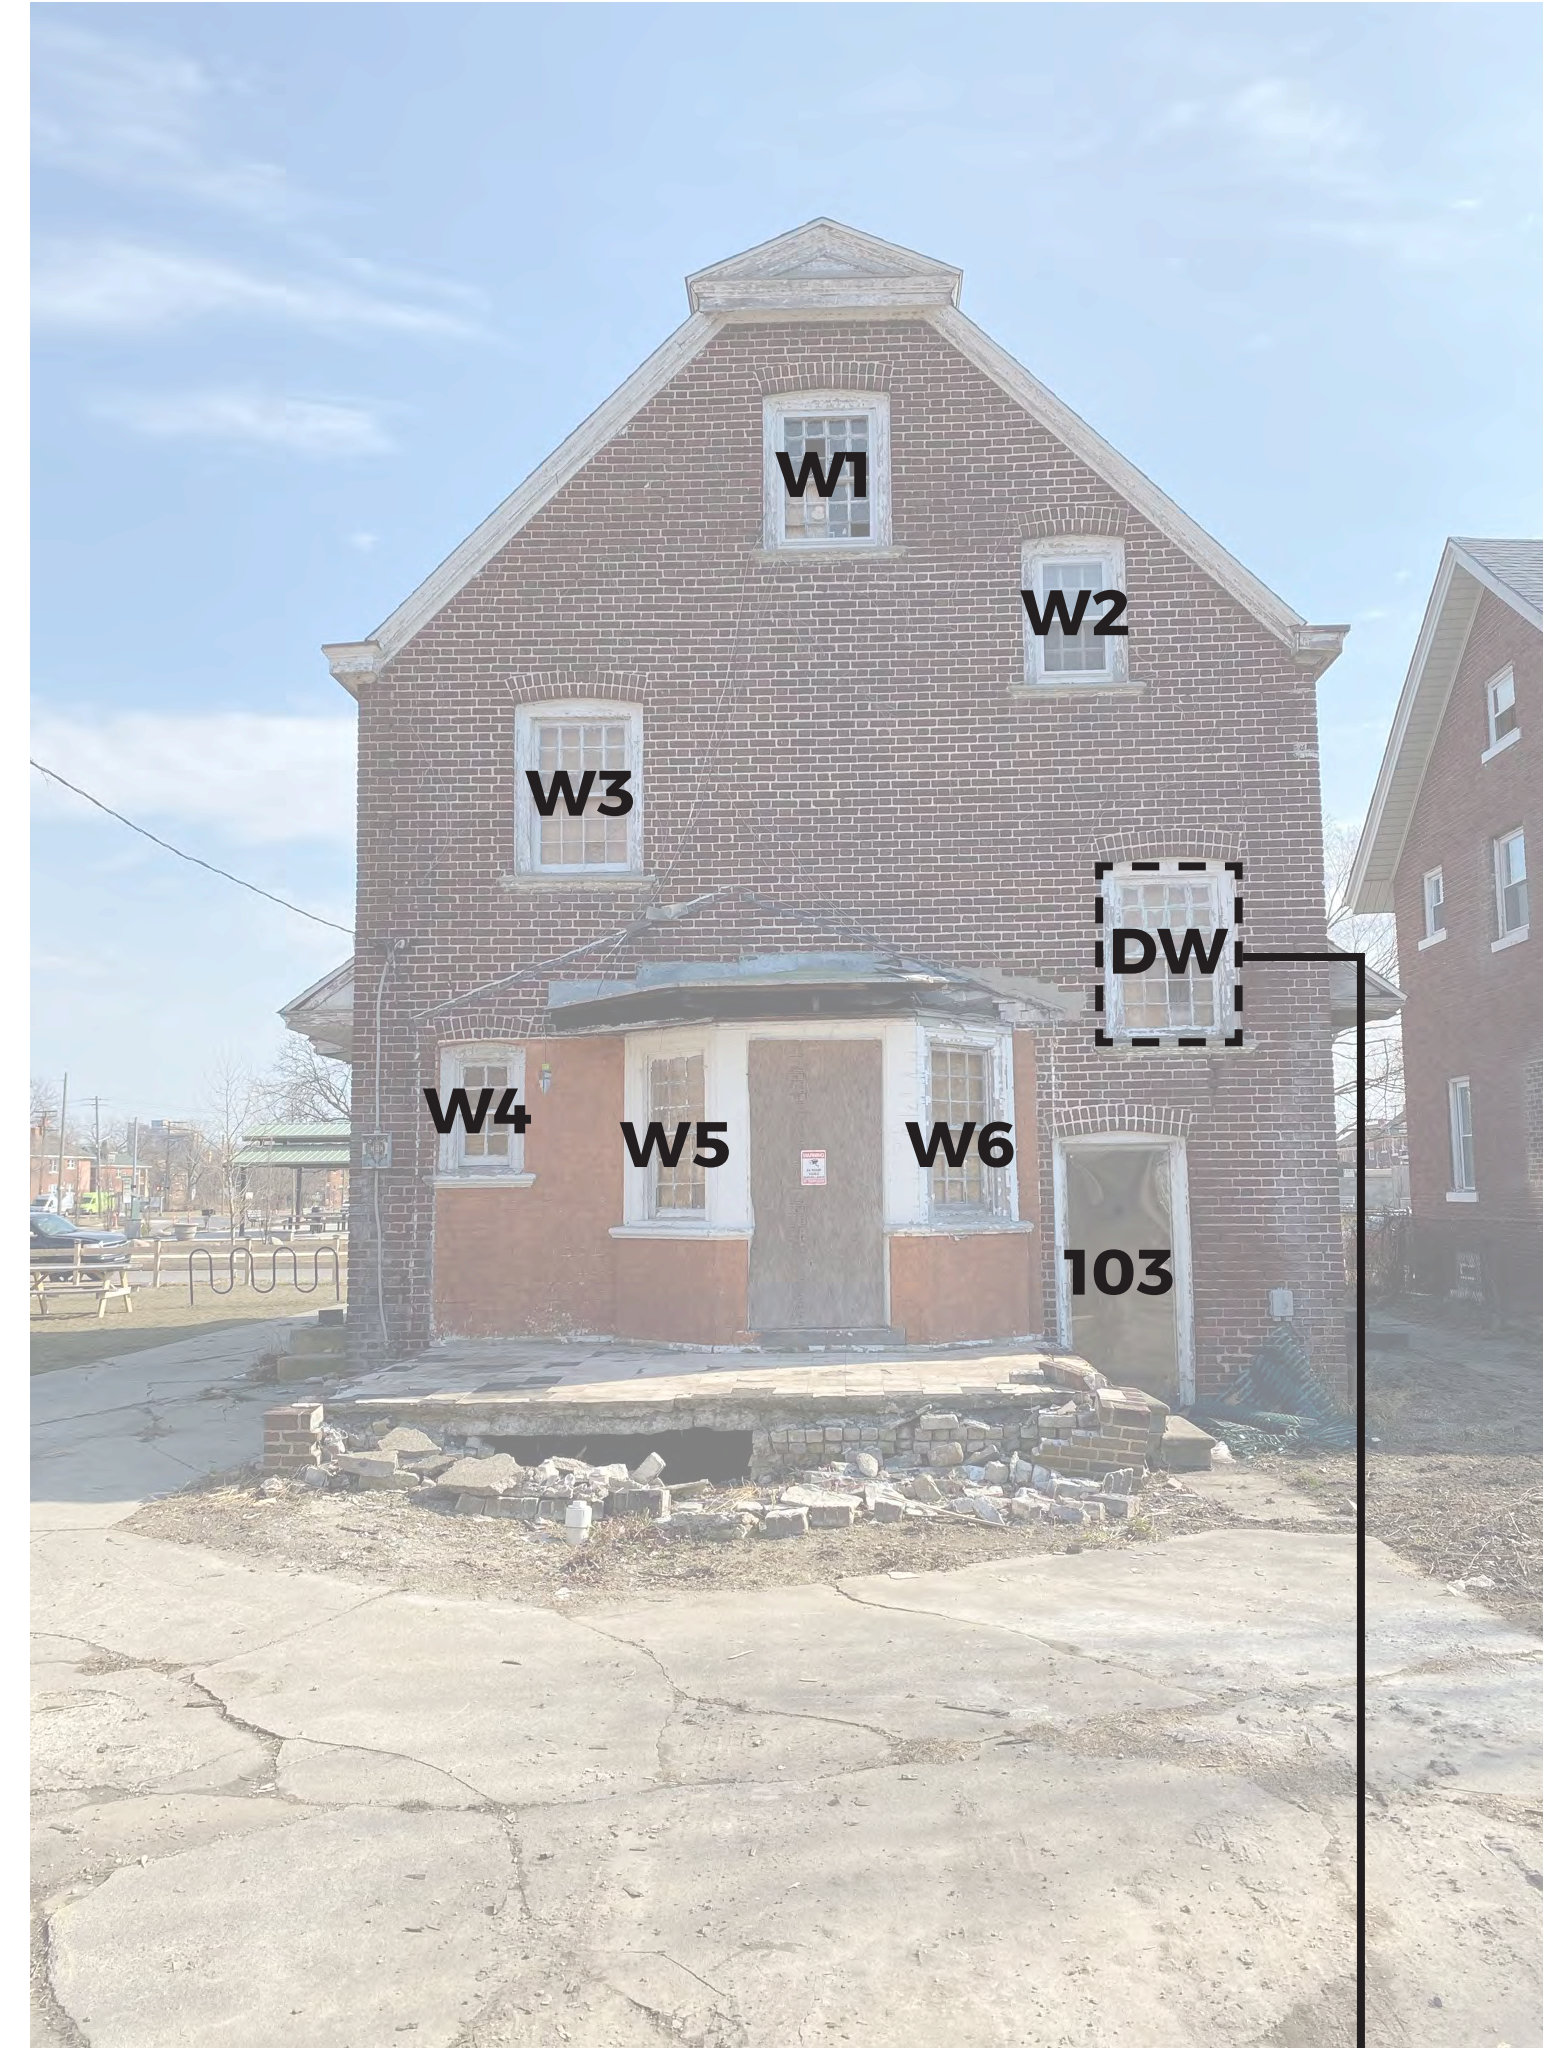
NORTH ELEVATION

REMOVING WINDOW TO
MOVE DOOR 103 UP FOR
NEW PATIO - SEE
ELEVATIONS AND PLANS

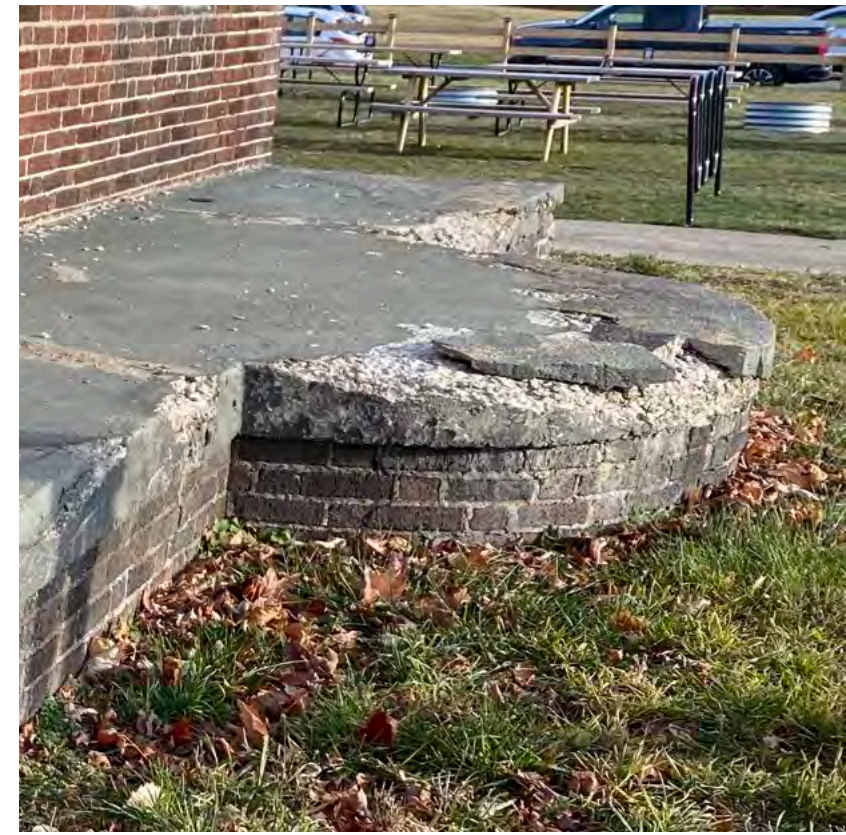
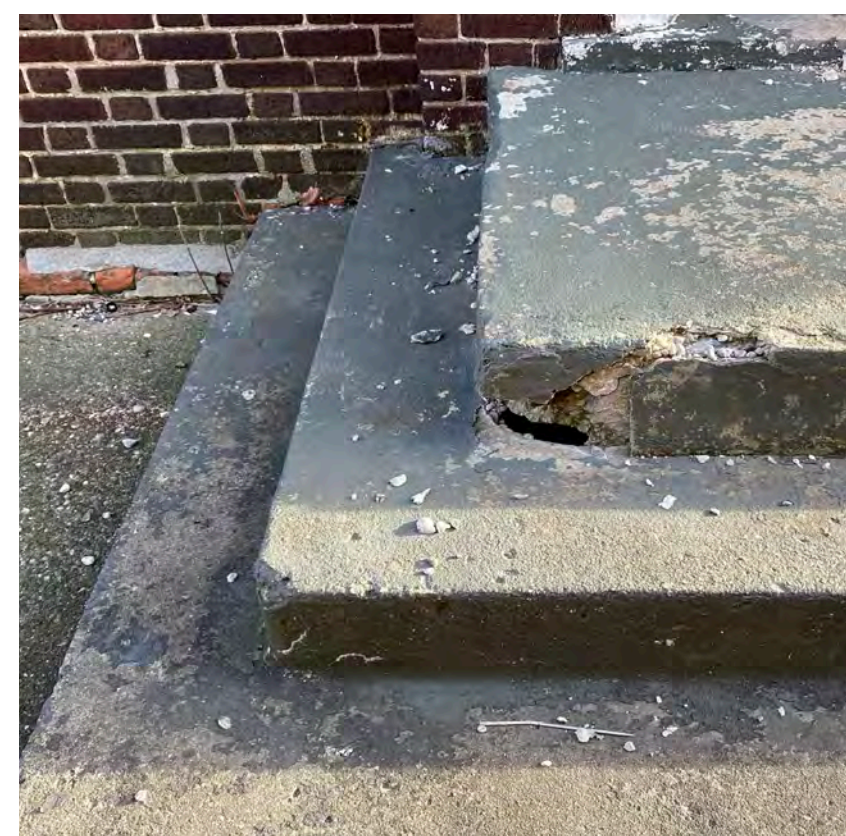
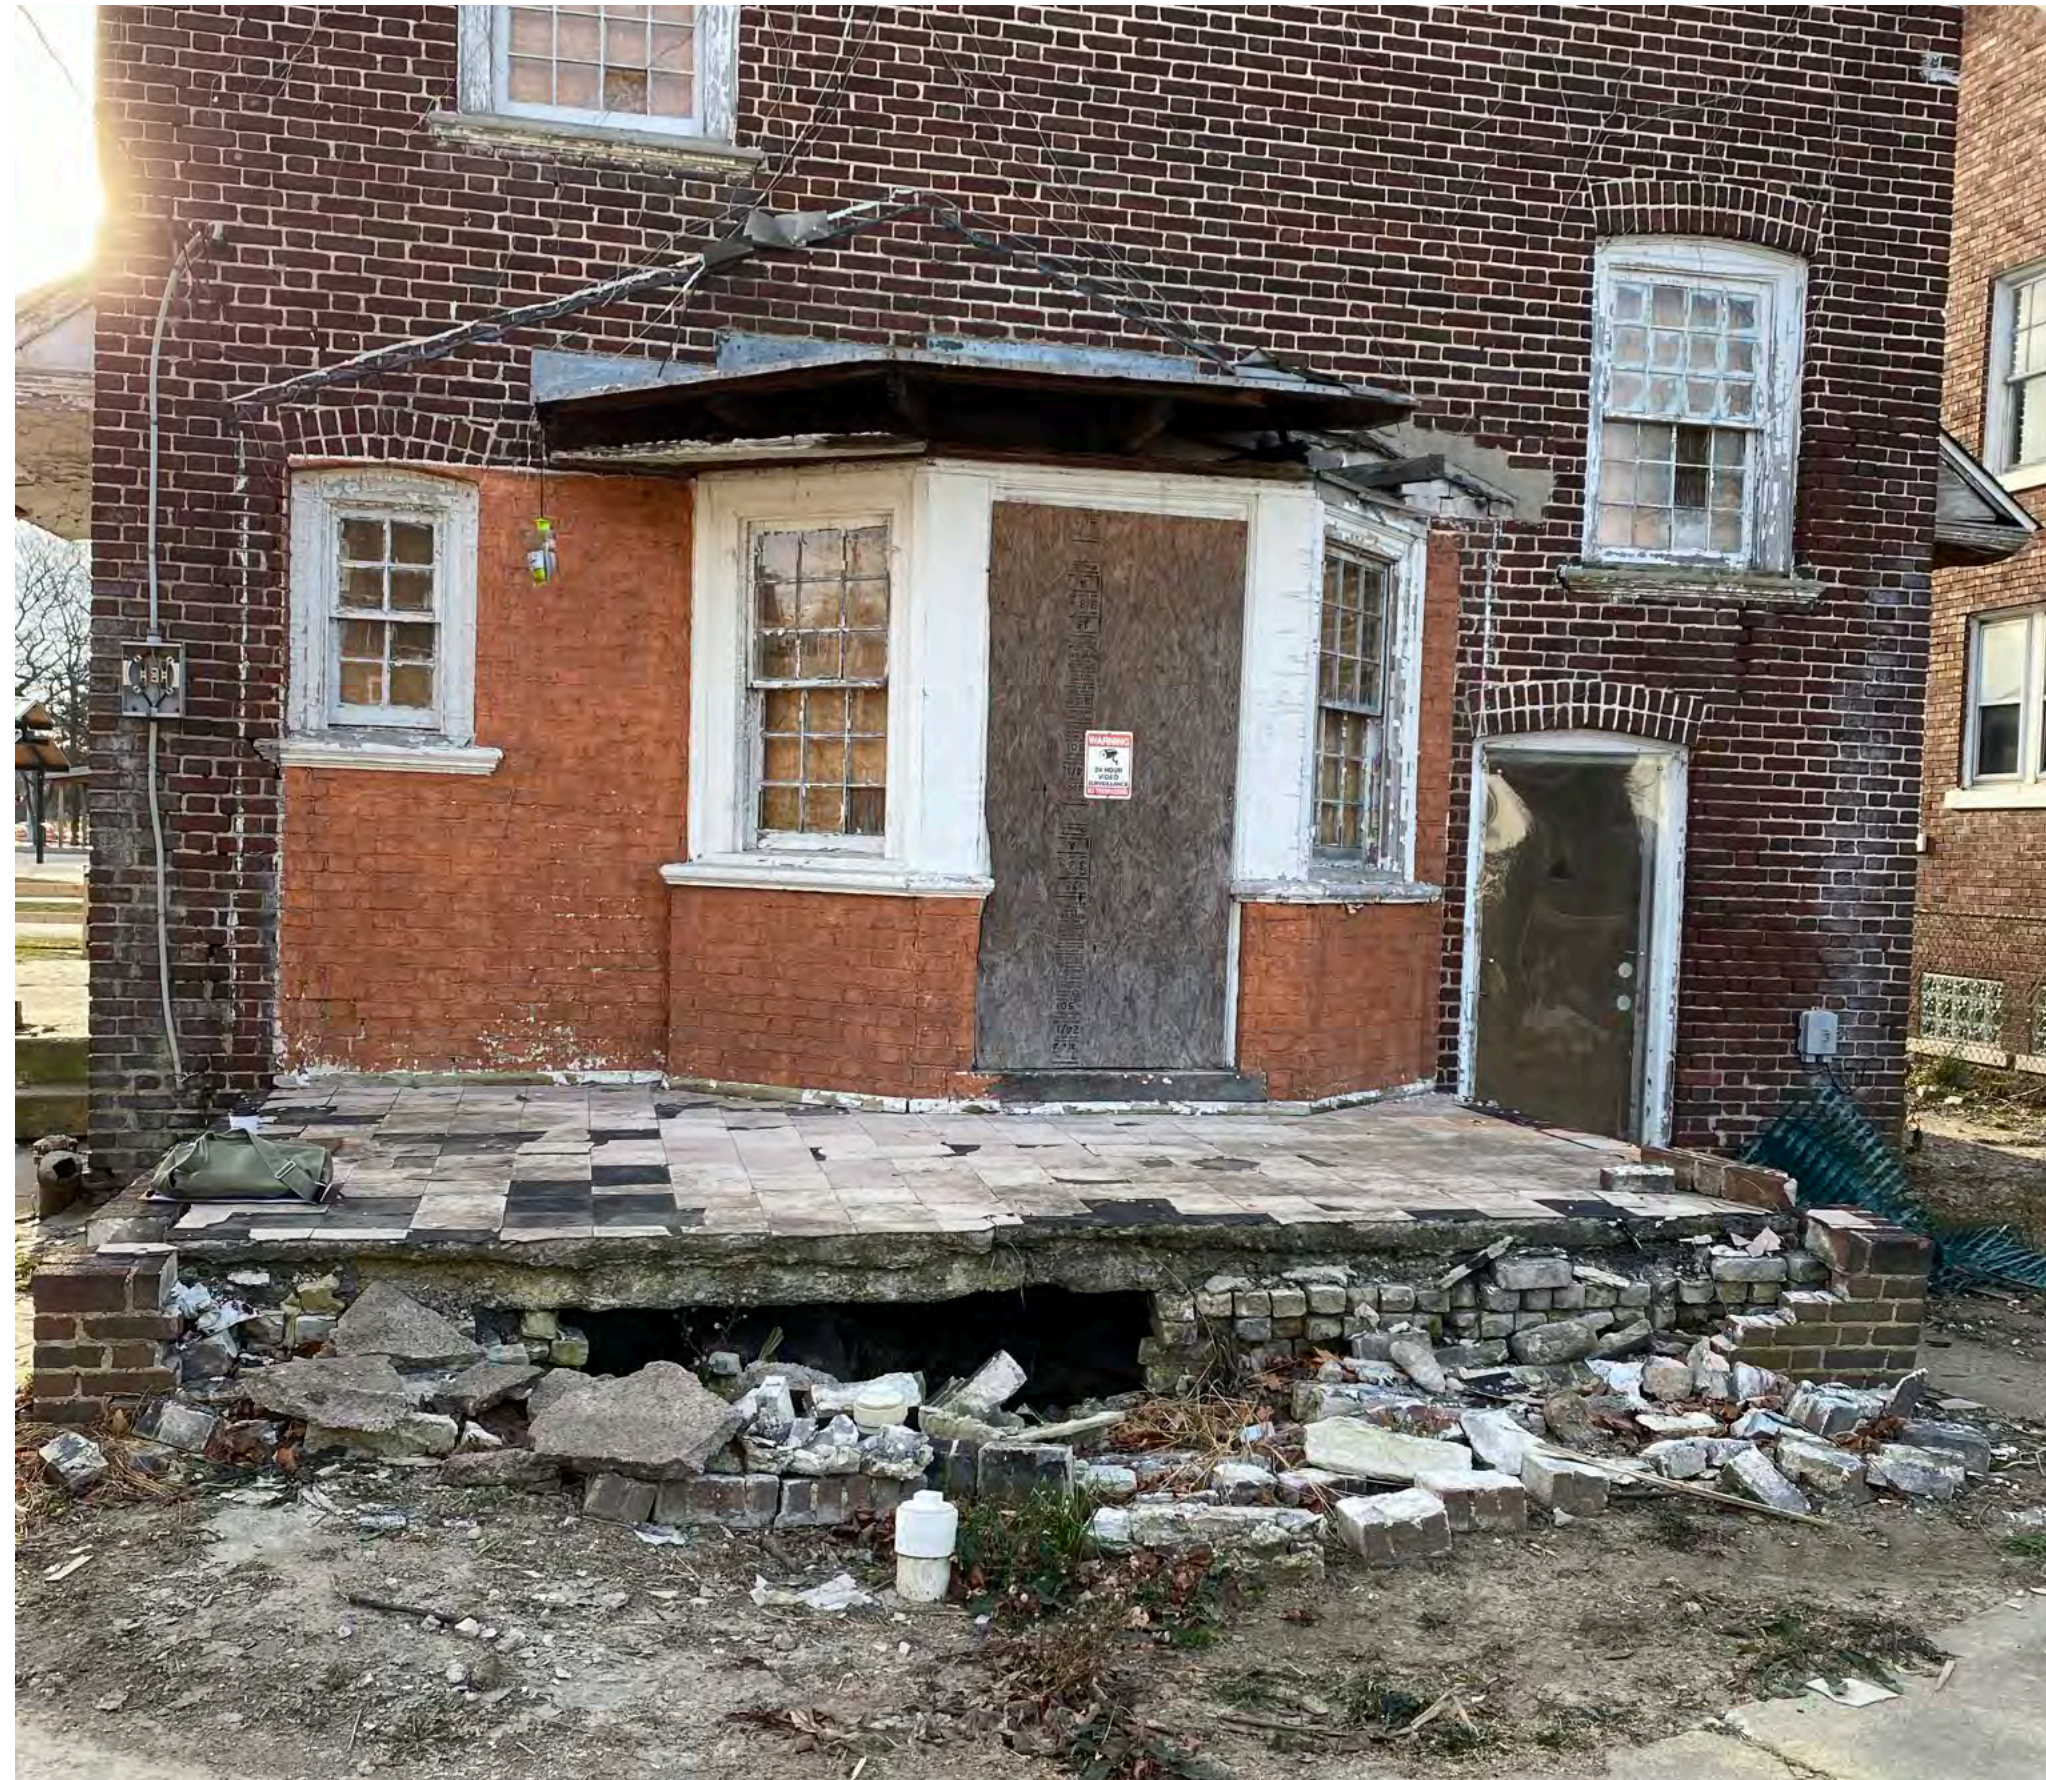
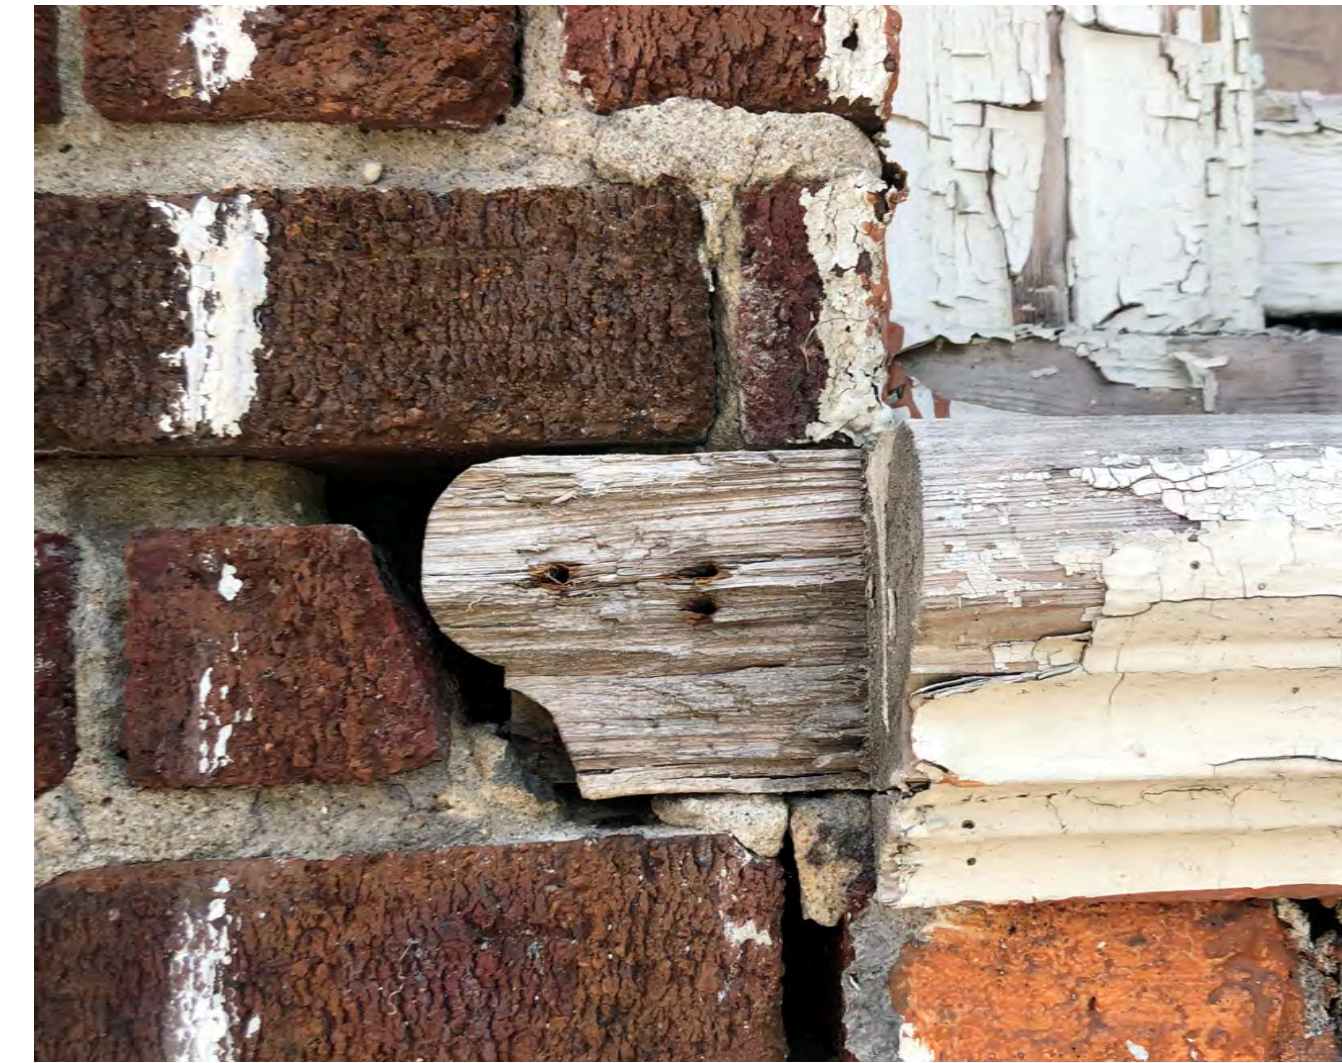
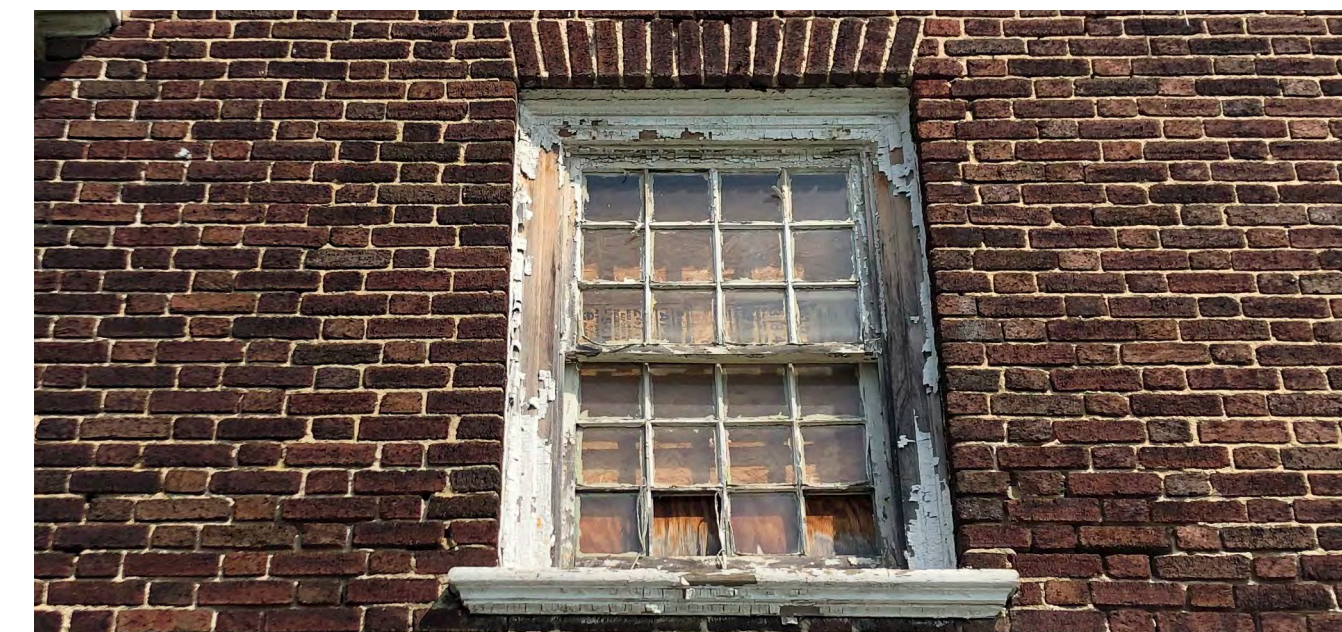
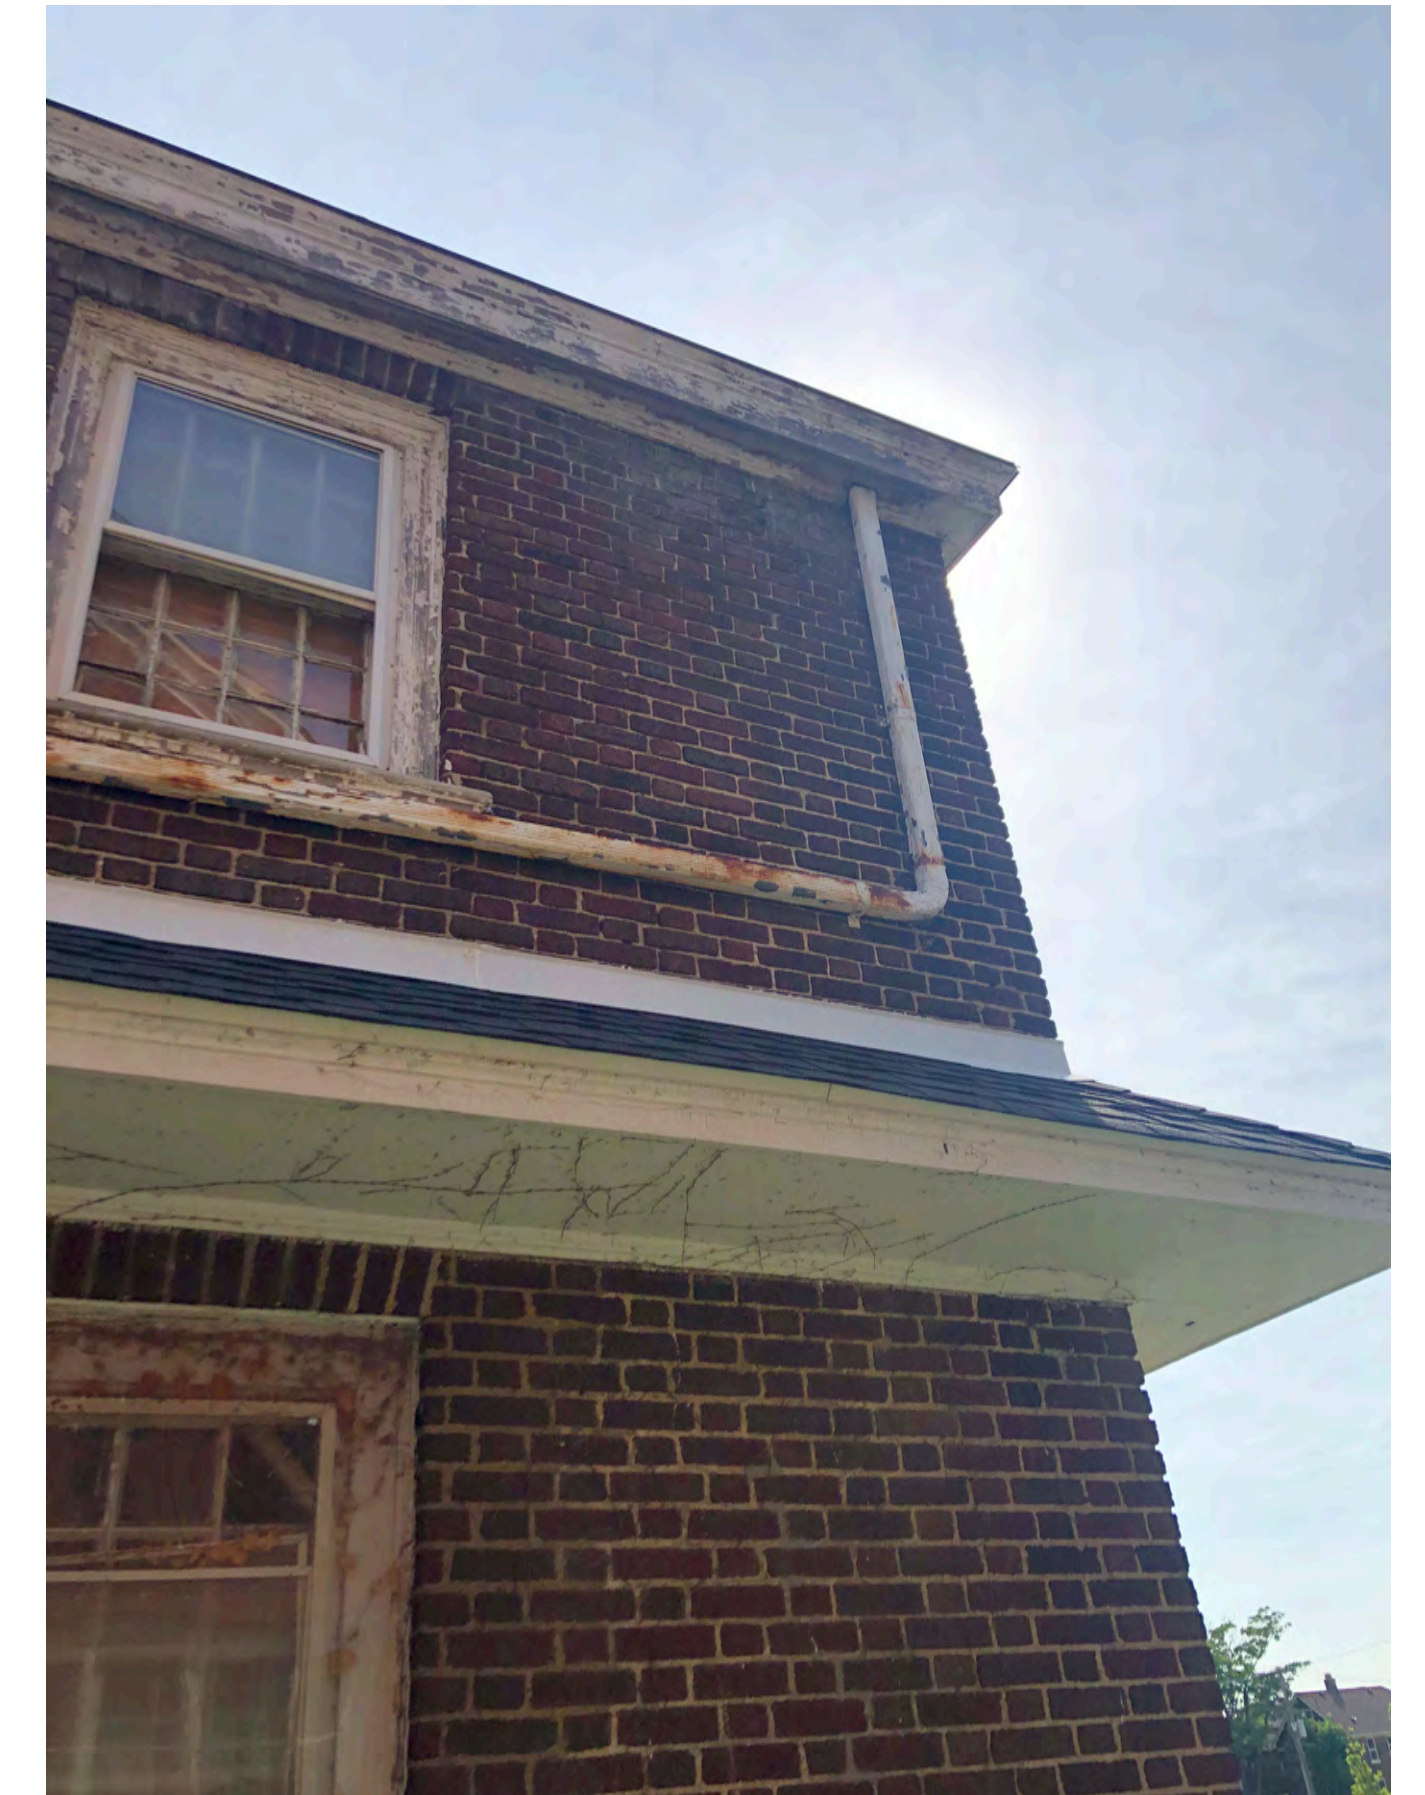
PORCHES

SALVAGE BRICK FROM CRUMBLED BACK PORCH TO USE IN FRONT PORCH AND OR WINDOW CLOSURE (D108)

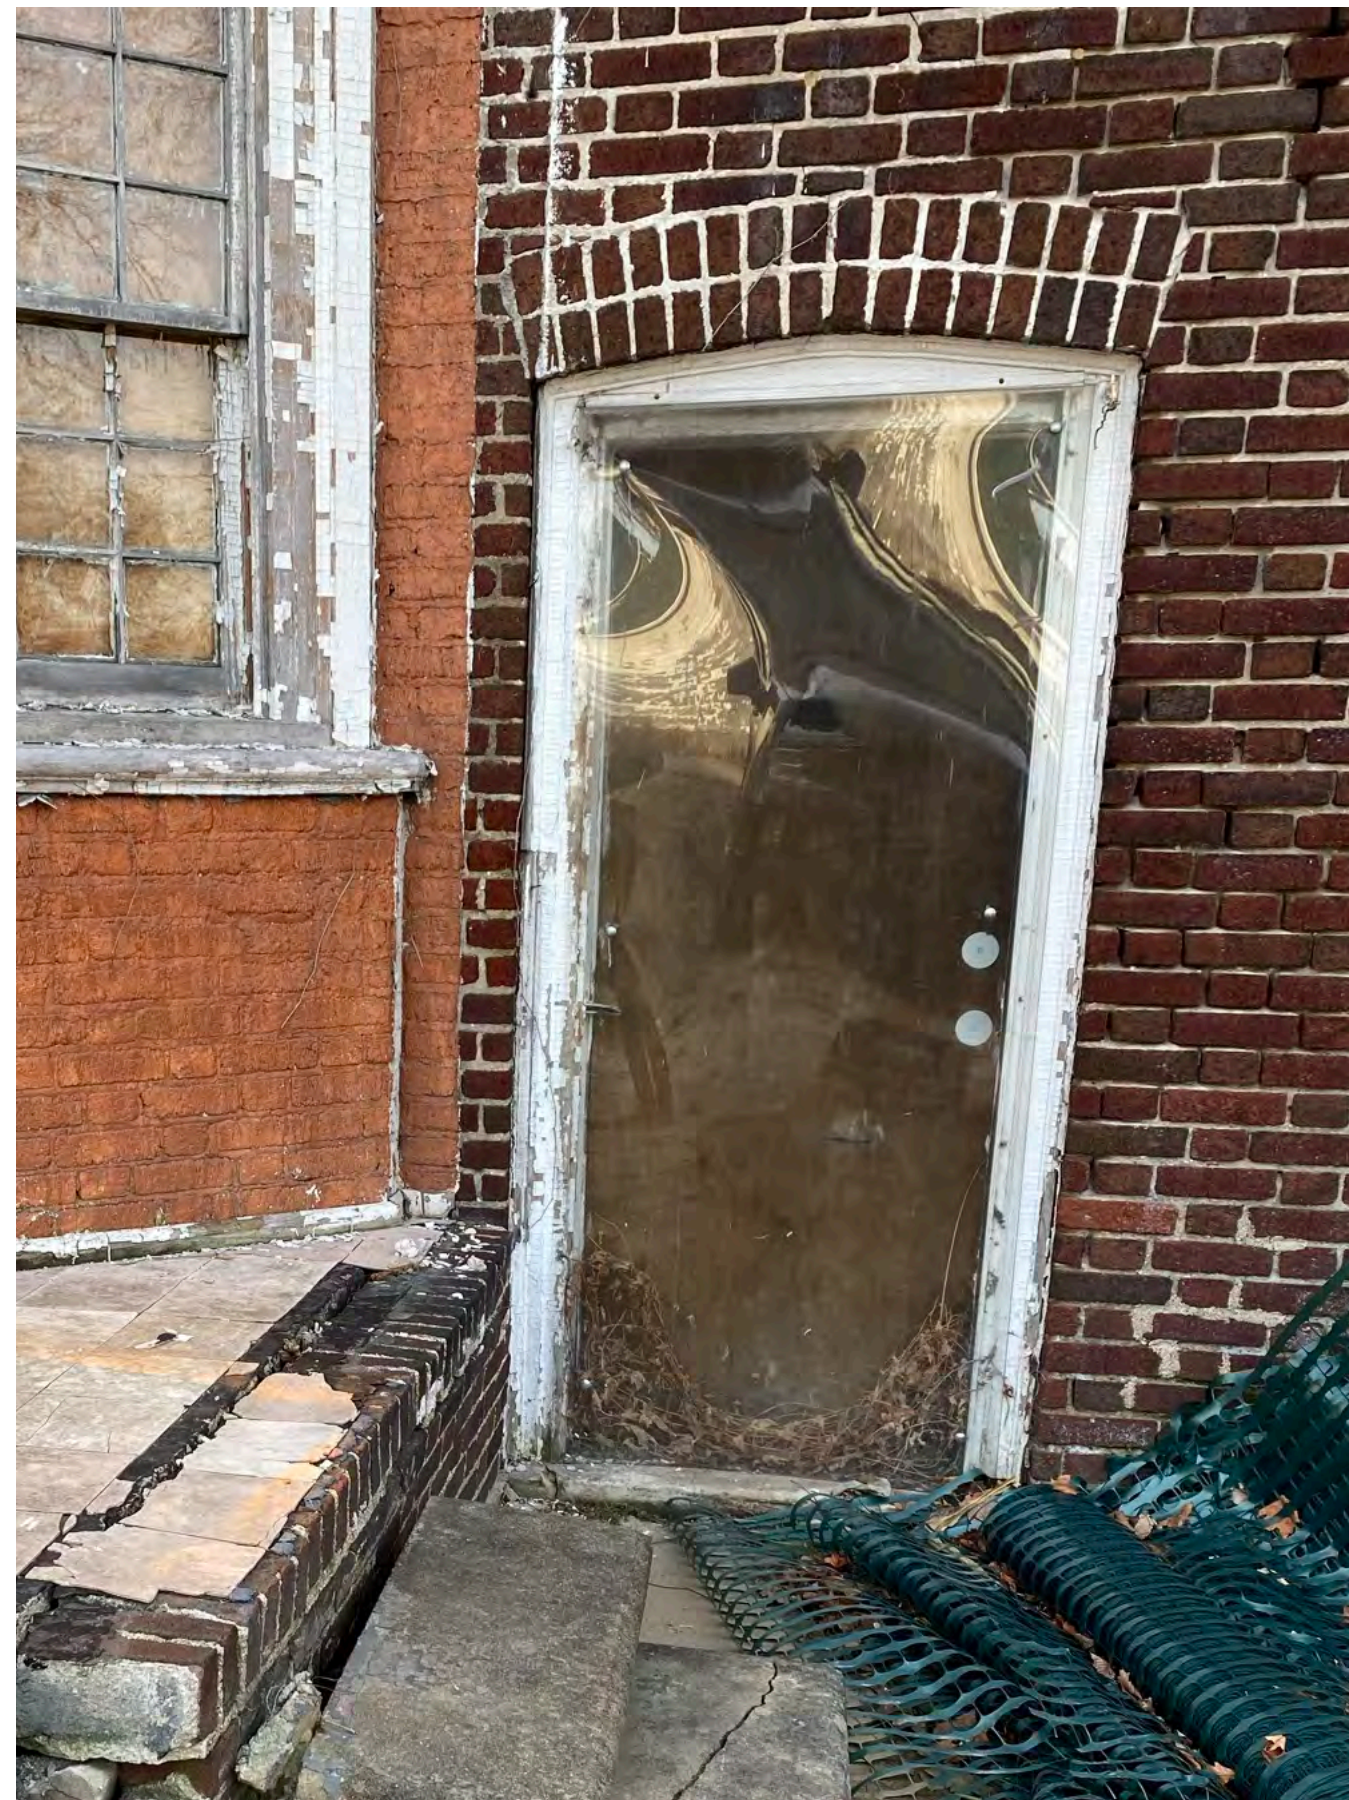
DOOR A - NEW DOOR SILL HEIGHT AND DOOR (103) FOR RESIDENTIAL TENANTS - SEE DOOR SCHEDULE FOR DETAILS

EXISTING MATERIAL: WOOD
