STAFF REPORT: 05-12-21 MEETING

APPLICATION NUMBER: 21-7222

ADDRESS: 1920 ATKINSON

SCOPE: REHABILITATE HOUSE FOR ADAPTIVE REUSE AS RESTAURANT/APTS; BUILD EXTERIOR PATIO AT REAR

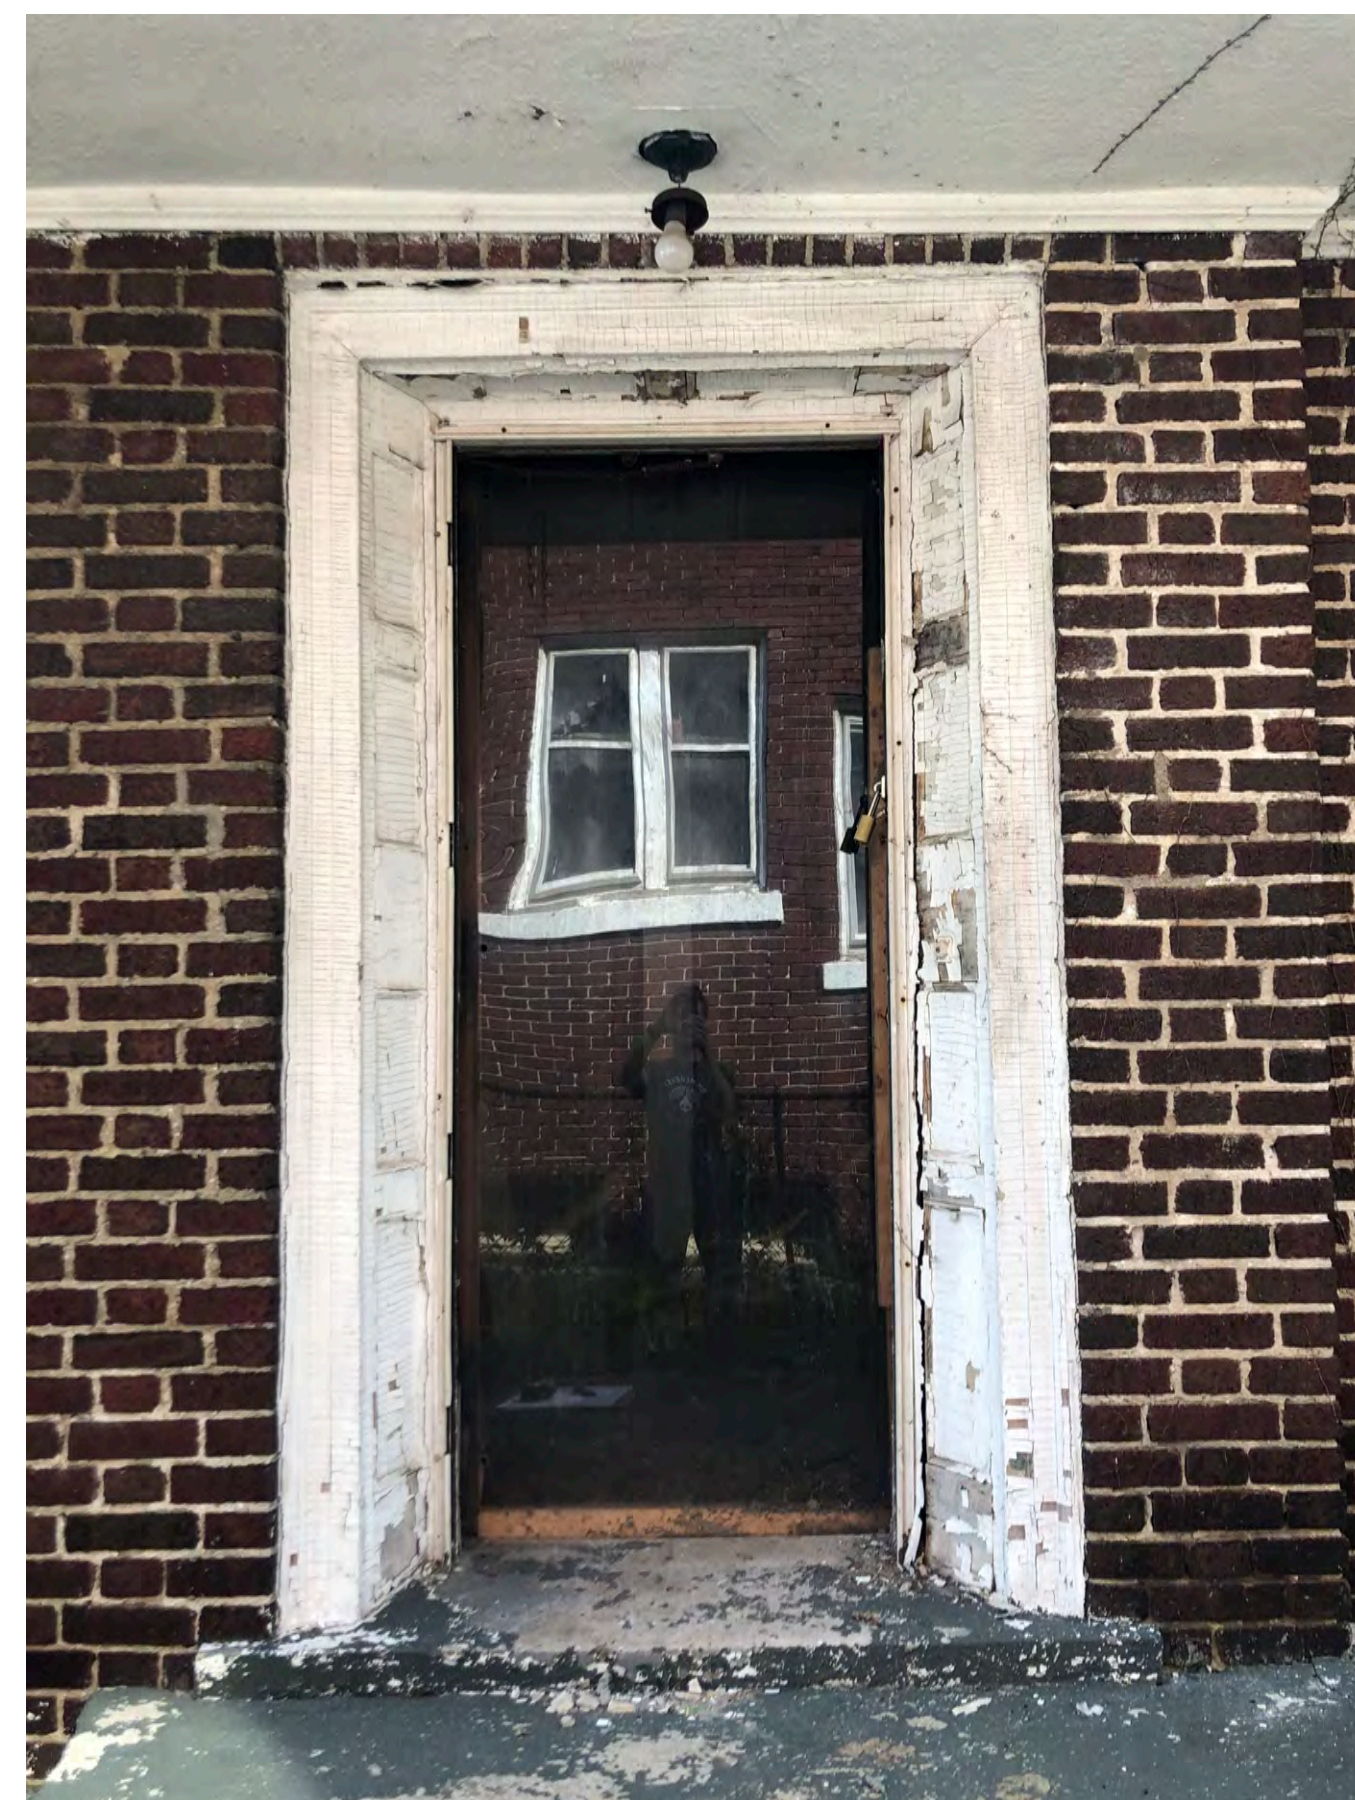
DOOR B - NEW DOOR (102) FOR SECONDARY ENTRANCE TO RESTAURANT - SEE DOOR SCHEDULE FOR DETAILS

EXISTING MATERIAL: WOOD; CURRENT DOOR IS MISSING AND IS HELD BY AN ACRYLIC PIECE

THE DOOR WOOD TRIMS ARE ROTTED AND NEED TO BE REPLACED AS WELL. BECAUSE THE FIRST FLOOR WILL BE A COMMERCIAL SPACE, ALL EXISTING DOORS ARE NOT TO CODE AND MUST SWING OUT. NEW DOORS WILL MIMIC ADJACENT WINDOW DESIGN.

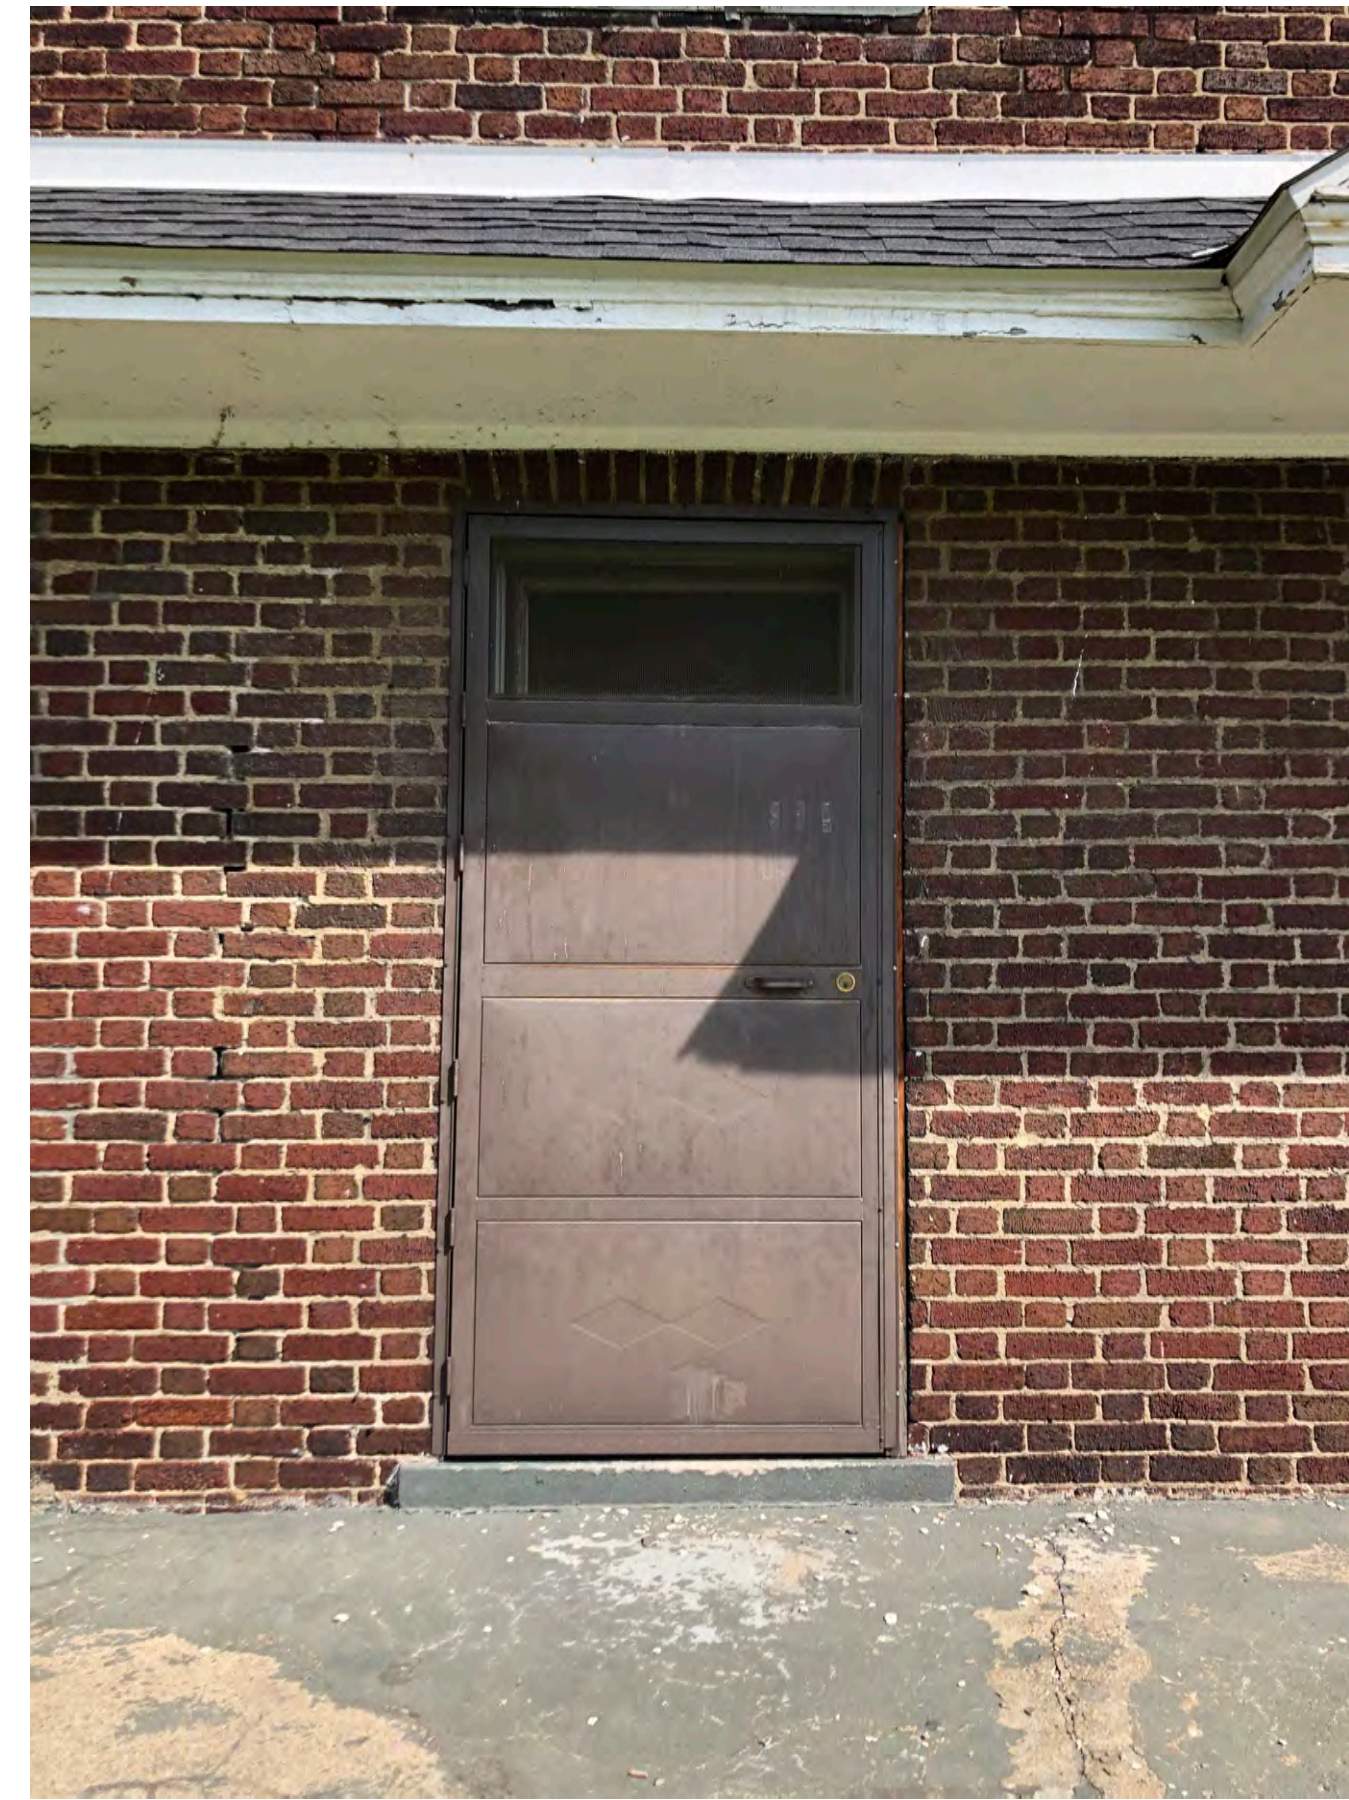
DOOR C - NEW DOOR (104) - SEE DOOR SCHEDULE FOR DETAILS

EXISTING MATERIAL: METAL

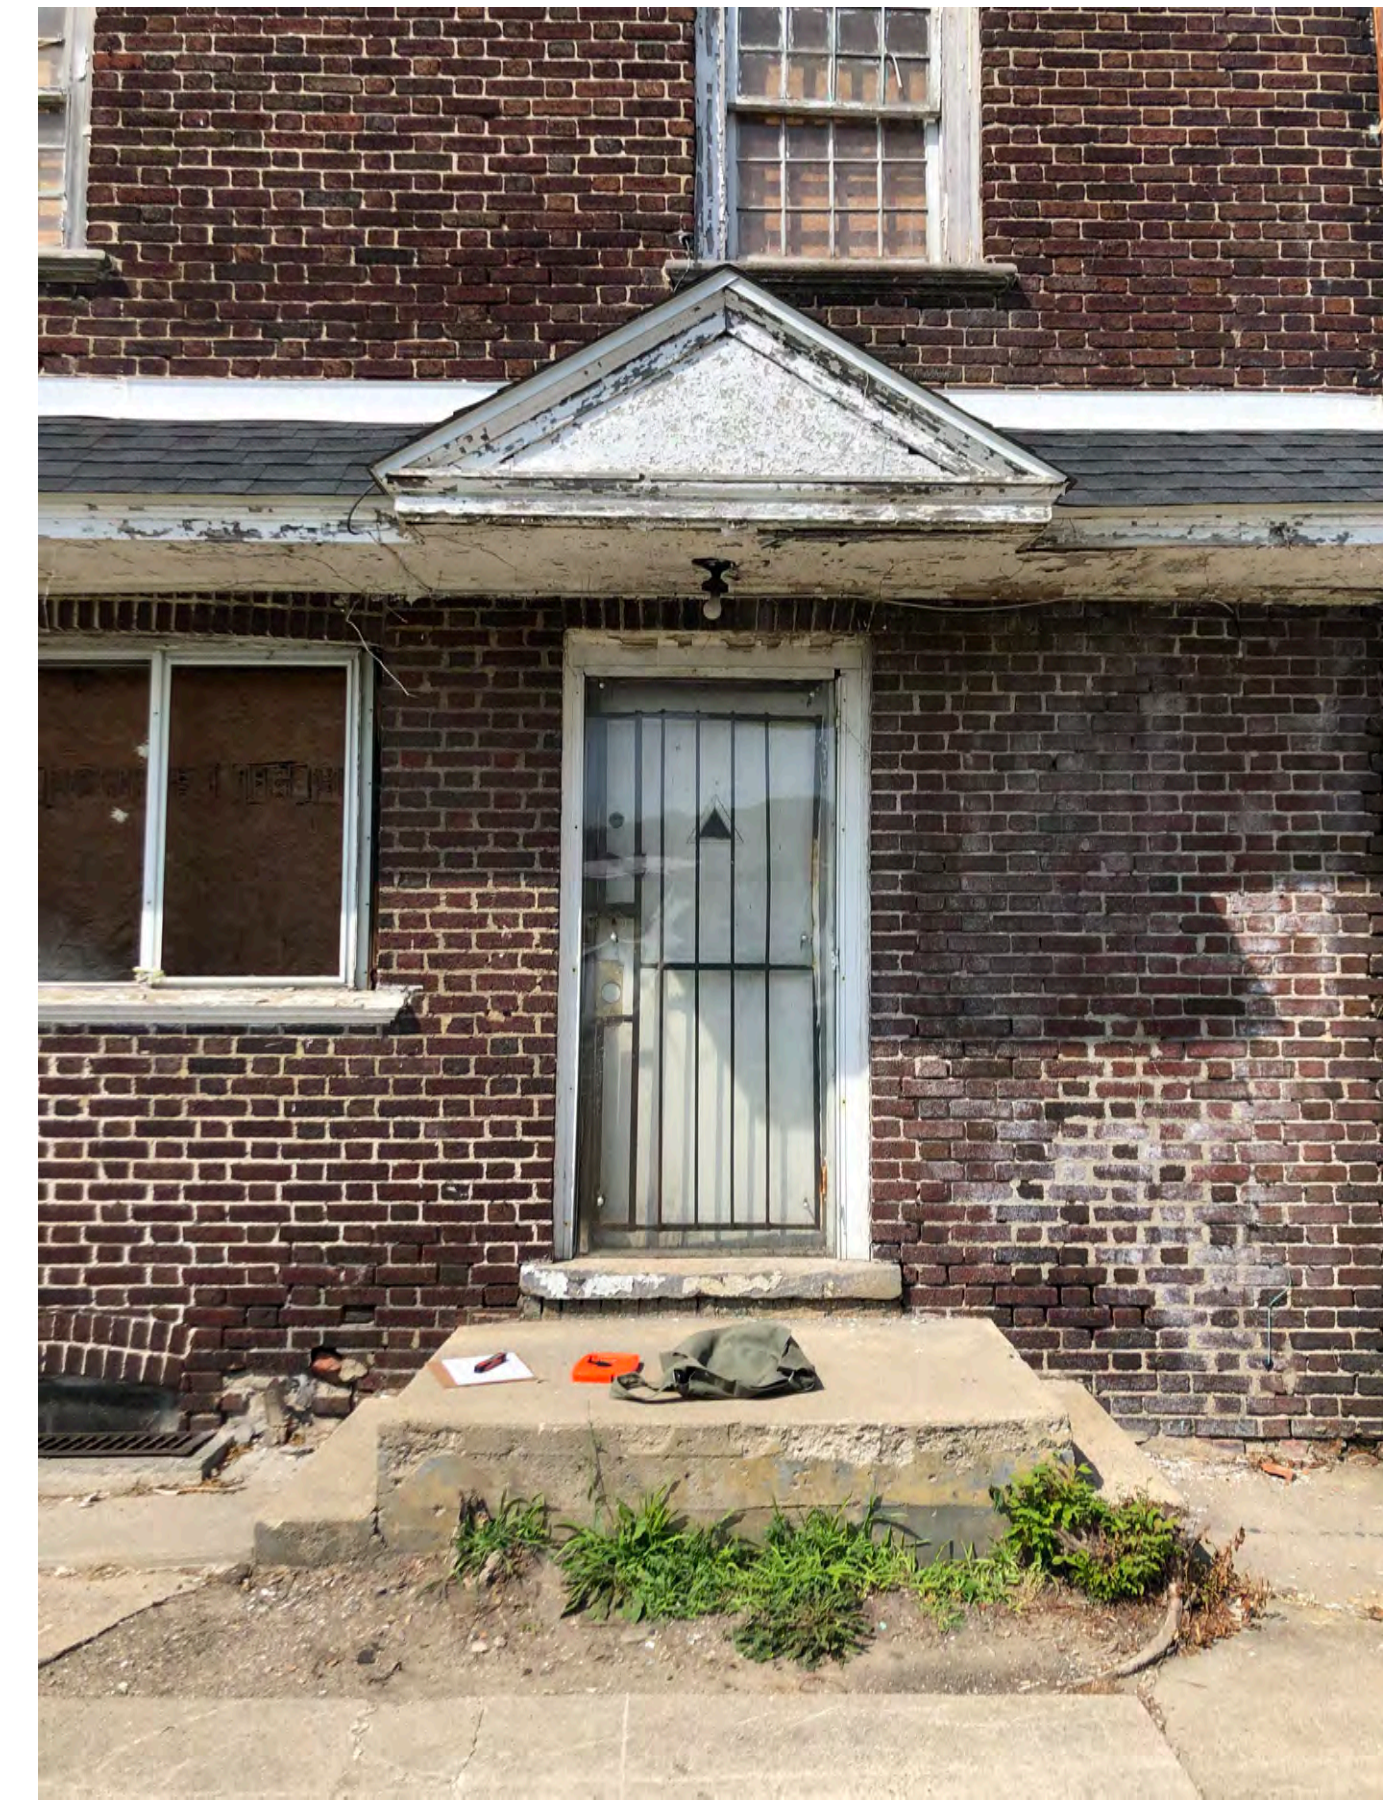
DOOR D - NEW DOOR (105) - SEE DOOR SCHEDULE FOR DETAILS

EXISTING MATERIAL: WOOD
