STAFF REPORT 06-09-2021 MEETING PREPARED BY: G. LANDSBERG

APPLICATION NUMBER: 21-7307

ADDRESS: 858 EDISON

SCOPE: NEW PROPOSAL TO REVISE PREVIOUSLY APPROVED ADDITION, PER WORK

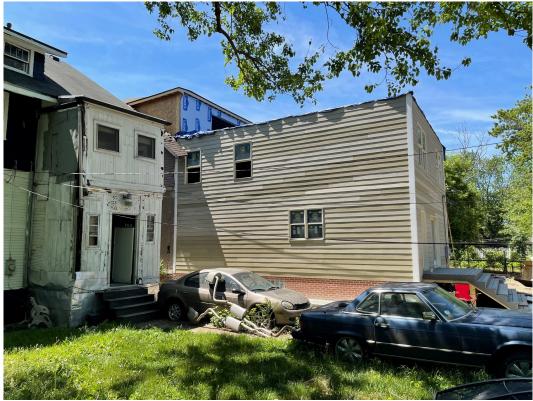
View of existing conditions at rear, view to the southwest. Applicant photo.

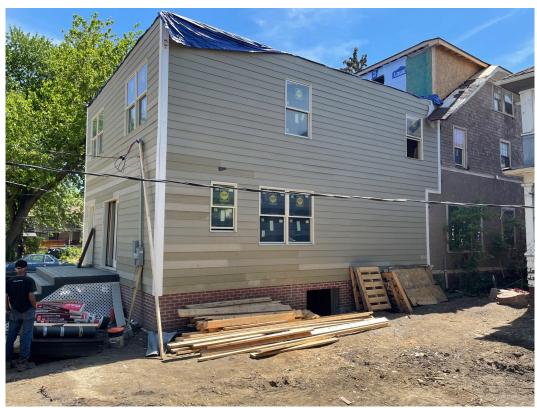
View of existing conditions at rear, view to the southeast. Applicant photo.

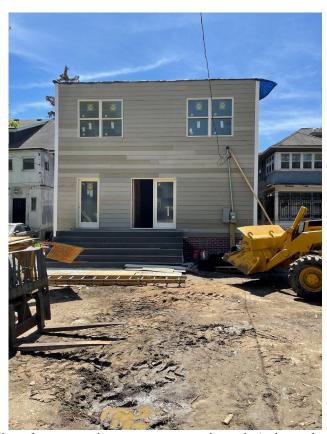
View of existing conditions at rear, view to the south. Applicant photo.

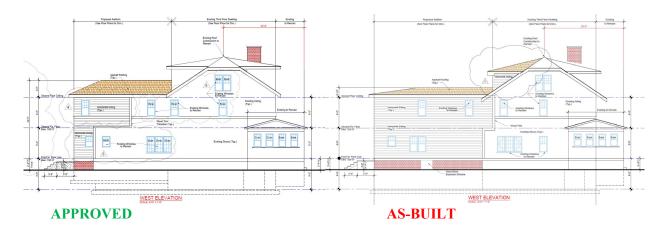
- O The addition was built fully 6'-6" longer (i.e., deeper into the rear yard) than what was approved. Additionally, the "transition line" between the addition and the historic material was moved substantially closer to the rear of the historic house, destroying historic fabric at the side which was meant to be preserved in order to keep the addition subordinate to the main house. The combined effect of both a longer addition and the truncated original house created a far more prominent addition than approved. Also, windows actually installed at the addition are simple 1-over-1 sash instead of the multilight windows as indicated on the elevations provided in both the approved and new submission.

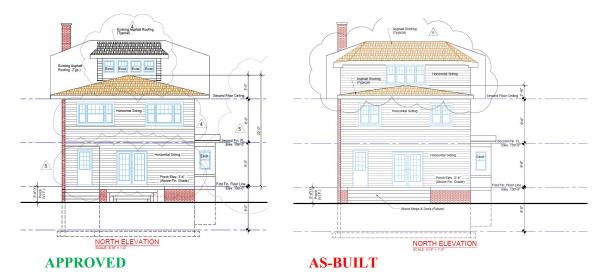
- The rear dormer, an original historic feature of the home specifically identified for retention during the Commission's second review of the project, was removed. A far larger opening, aligned with the 1st and 2nd floor walls below, was created in the roof deck and a full-width rear-facing third floor was erected. This creates the effect of an additional 3rd story at the rear, rather than a true dormer, further destroying the character of the original house and amplifying the prominence of the addition.
- At the rear elevation, northeast corner, the inset alcove porch was not built as approved.
 Windows are different types and smaller.

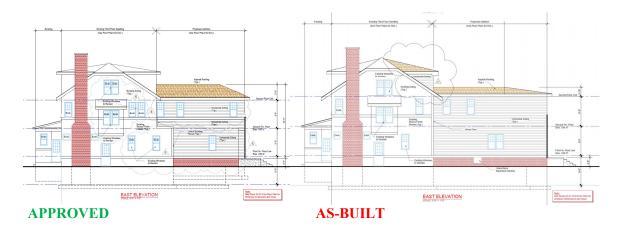
- O A shallower roof pitch than approved is proposed. The roof overhang (eave) is also smaller than approved, further accentuating the inappropriately boxy quality of the built addition.
- The height at the top of the second story is 1'-0" taller than what was approved.
