**STAFF REPORT: SEPTEMBER 8, 2021 MEETING**

**APPLICATION NUMBER: 21-7468**

**ADDRESS: 360 LODGE**

**SCOPE: REMOVE CONCRETE DRIVEWAY; NEW ASPHALT DRIVEWAY**

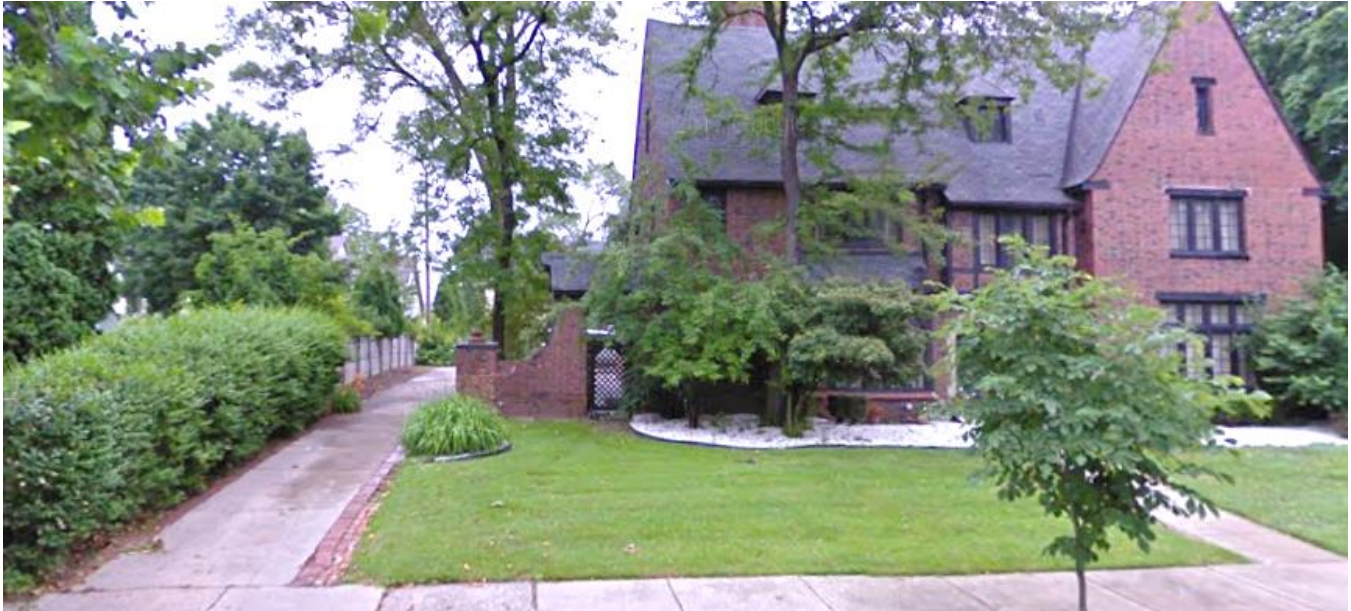
Google Street View, July 2009 – This picture shows the garden gate in situ. The left masonry pier is hidden by the hedge.

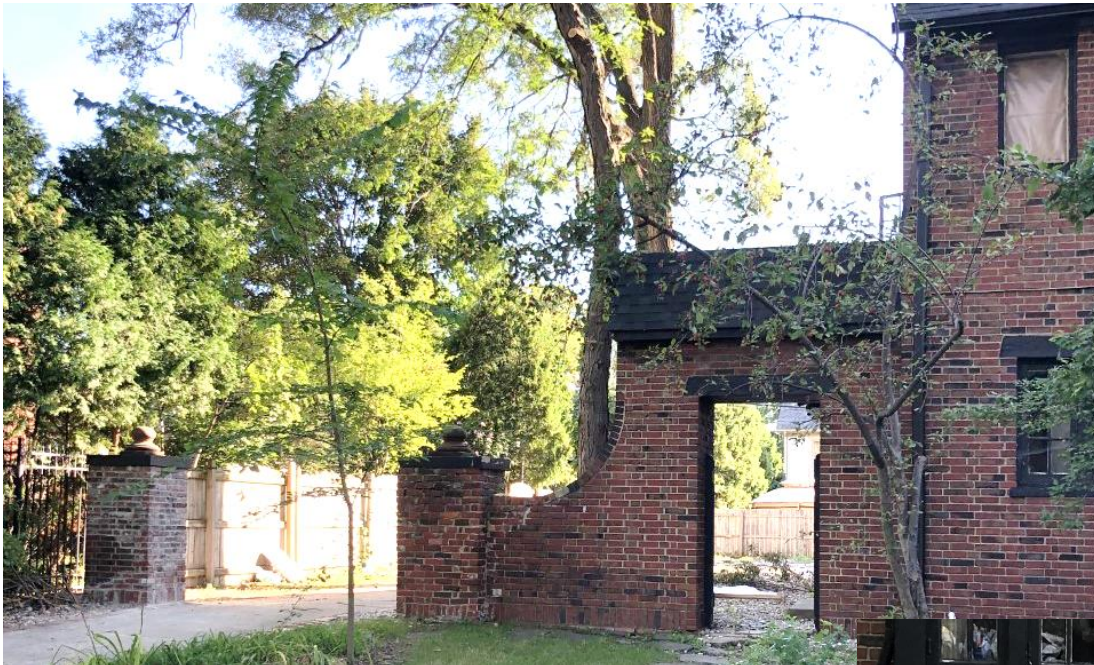
HDC staff photo, September 1, 2021. While the gate is not in place, staff noticed it laying nearby in the front yard.

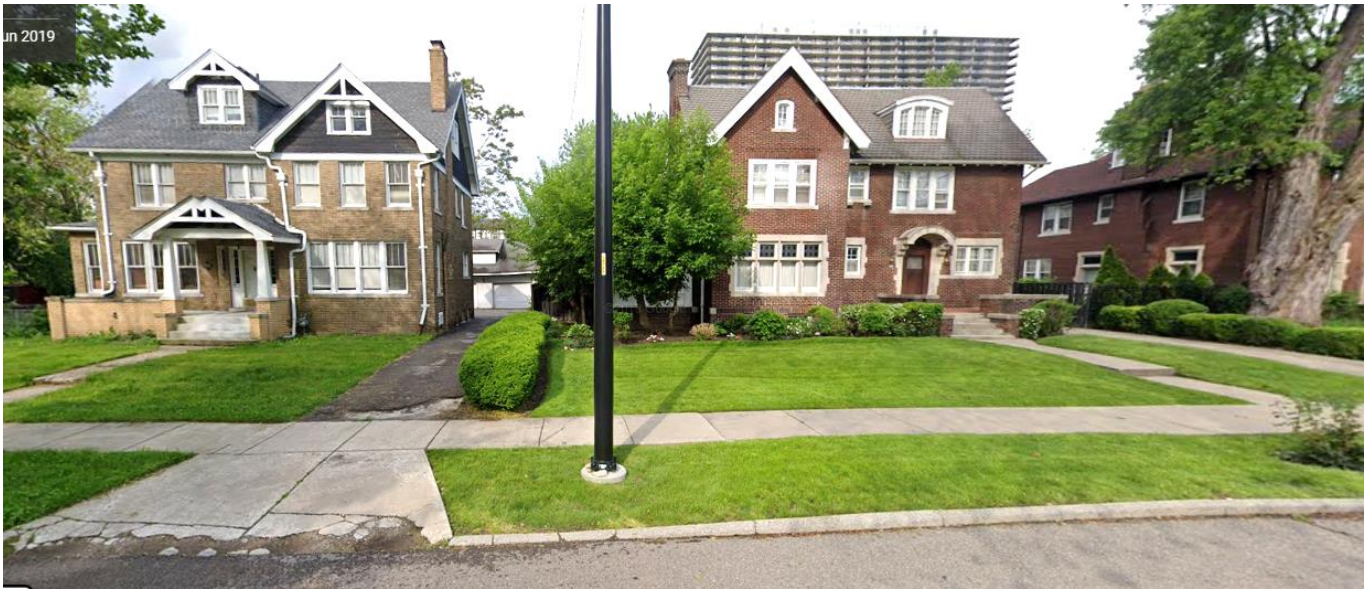
2019 Google Street View of HDC-approved asphalt (over concrete) driveway at left, approved in 2000.

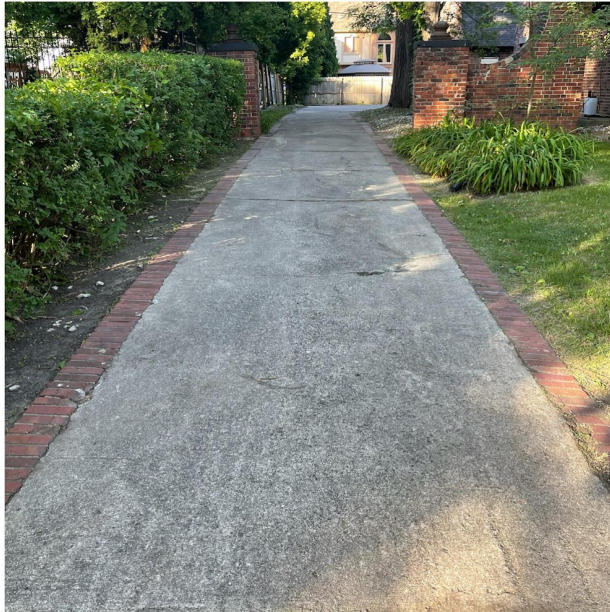
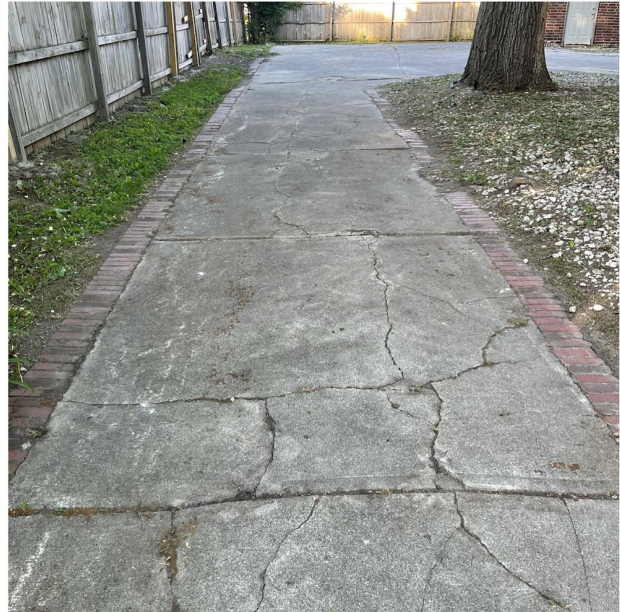
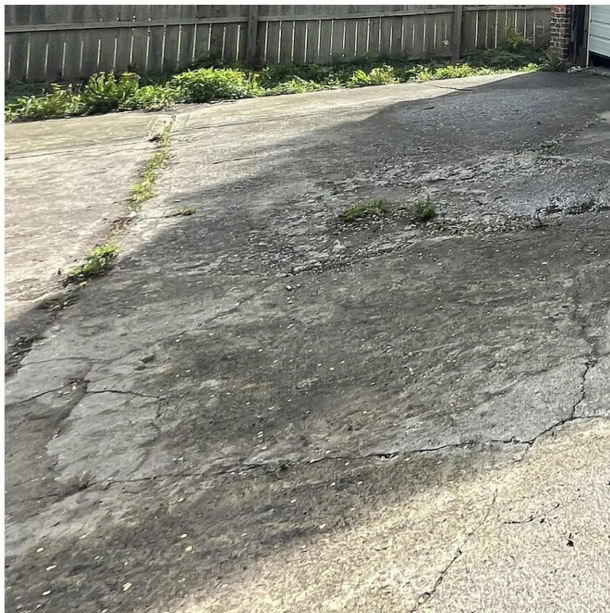
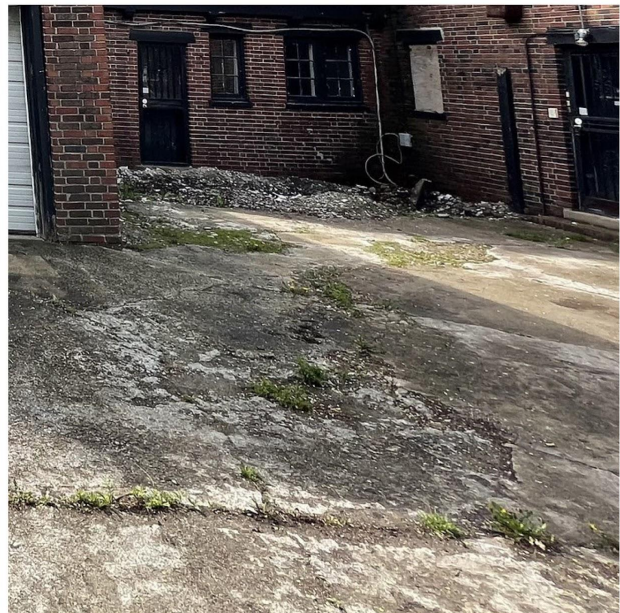
**DRIVEWAY**

- The concrete and brick pavers lining the driveway were in place at the time of district designation.
- The concrete blocks between the street and the masonry pier do show some cracks but are primarily intact. From the sidewalk, and confirmed in the applicant's photographs, the concrete beyond the masonry piers are at a higher level of deterioration.

Current Condition with Pictures:  
Concrete all damaged and broke

Driveway And pad by the garage concrete is going to be removed and replaced with Black Asphalt.
