**STAFF REPORT 09-22-2021 SPECIAL MEETING**

**APPLICATION NUMBER: 21-7479**

**ADDRESS: 1801 WABASH**

**SCOPE: REPLACE SIDING (WORK STARTED WITHOUT PERMIT)**

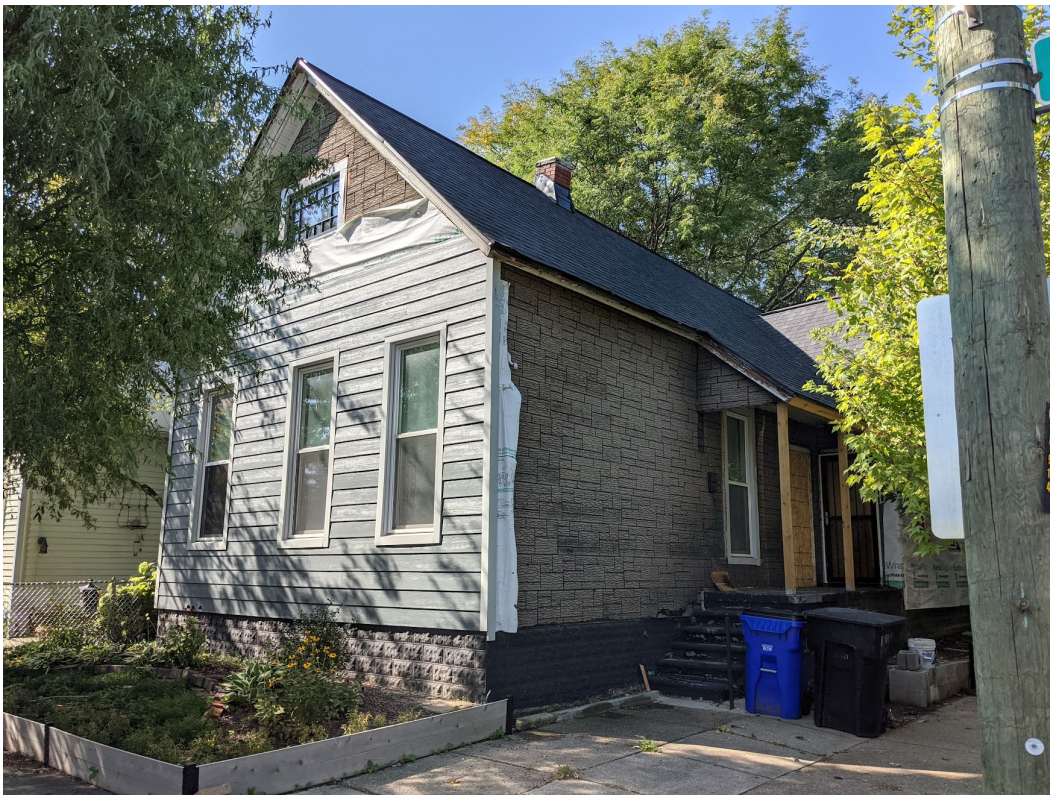
*View of existing conditions at 1801 Wabash, view to the southwest. Staff photo, September 17, 2021.*

Per the designation slide shown on the next page, the building was sheathed in aluminum siding prior to district designation. Earlier this year, work without permit was undertaken at the house, including the removal of all of the aluminum siding and some porch elements. Building wrap was applied over the older asphalt siding, and cementitious “hardieboard” siding in a wide profile and wood imprint design began to be installed. The new siding covers all of the south elevation, most of the north (Wabash) elevation, and about half of the garage. Upon application to the Commission after BSEED enforcement, this body denied the partially completed work.

- Given the current situation, staff continues to recommend that the best (and possibly easier than expected) approach is removal of the asphalt siding; cleaning and repair of the original wood siding and trim; and repainting in a historically appropriate color scheme. Should large areas of original cladding be missing as claimed, they should be renewed with appropriately cut wood siding and wood trim. This treatment will yield an authentic, historically appropriate exterior with proven durability.

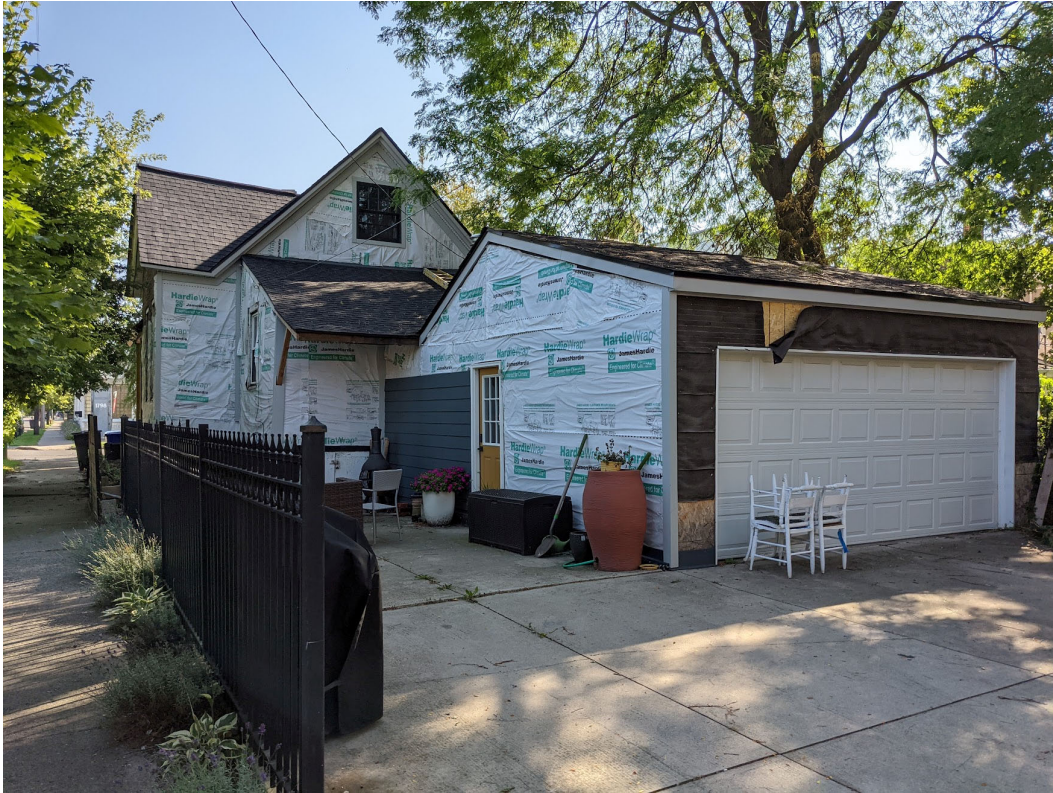
*View of existing conditions at rear of 1801 Wabash, view to the east from Marantette. Staff photo, September 17, 2021.*

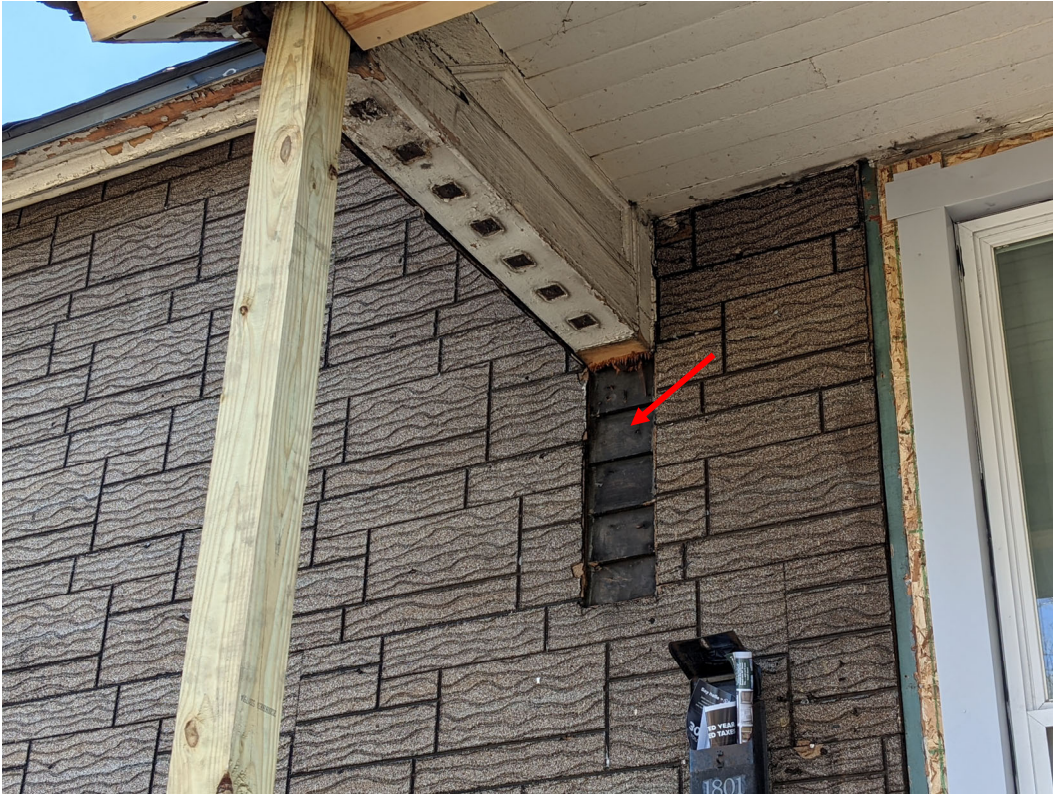
- The applicant states that the original clapboard siding may be deteriorated in large areas (leaving only 20-25% remaining), and additionally require infill and reframing of previously closed openings. No direct evidence is given for the percentage number, and staff would be surprised if it was as low as 25%, given the durability of this old-growth siding and substantial previous experience in removing later layers on similar late-19<sup>th</sup> century clapboard houses in Detroit.

*Detail view of porch along Marantette, showing new pressure-treated post and an evident area of original wood siding intact below the asphalt cladding. The siding is dirty with soot, and can likely be cleaned and painted.  
Staff photo, March 29, 2021.*
