**STAFF REPORT 10-13-2021 REGULAR MEETING**

**APPLICATION NUMBER: 21-7512**

**ADDRESS: 1091 SEMINOLE STREET**

**SCOPE: DEMOLISH EXISTING REAR SIDE PORCH AND ERECT NEW REAR SIDE PORCH; MODIFY EXISTING REAR ADDITION**

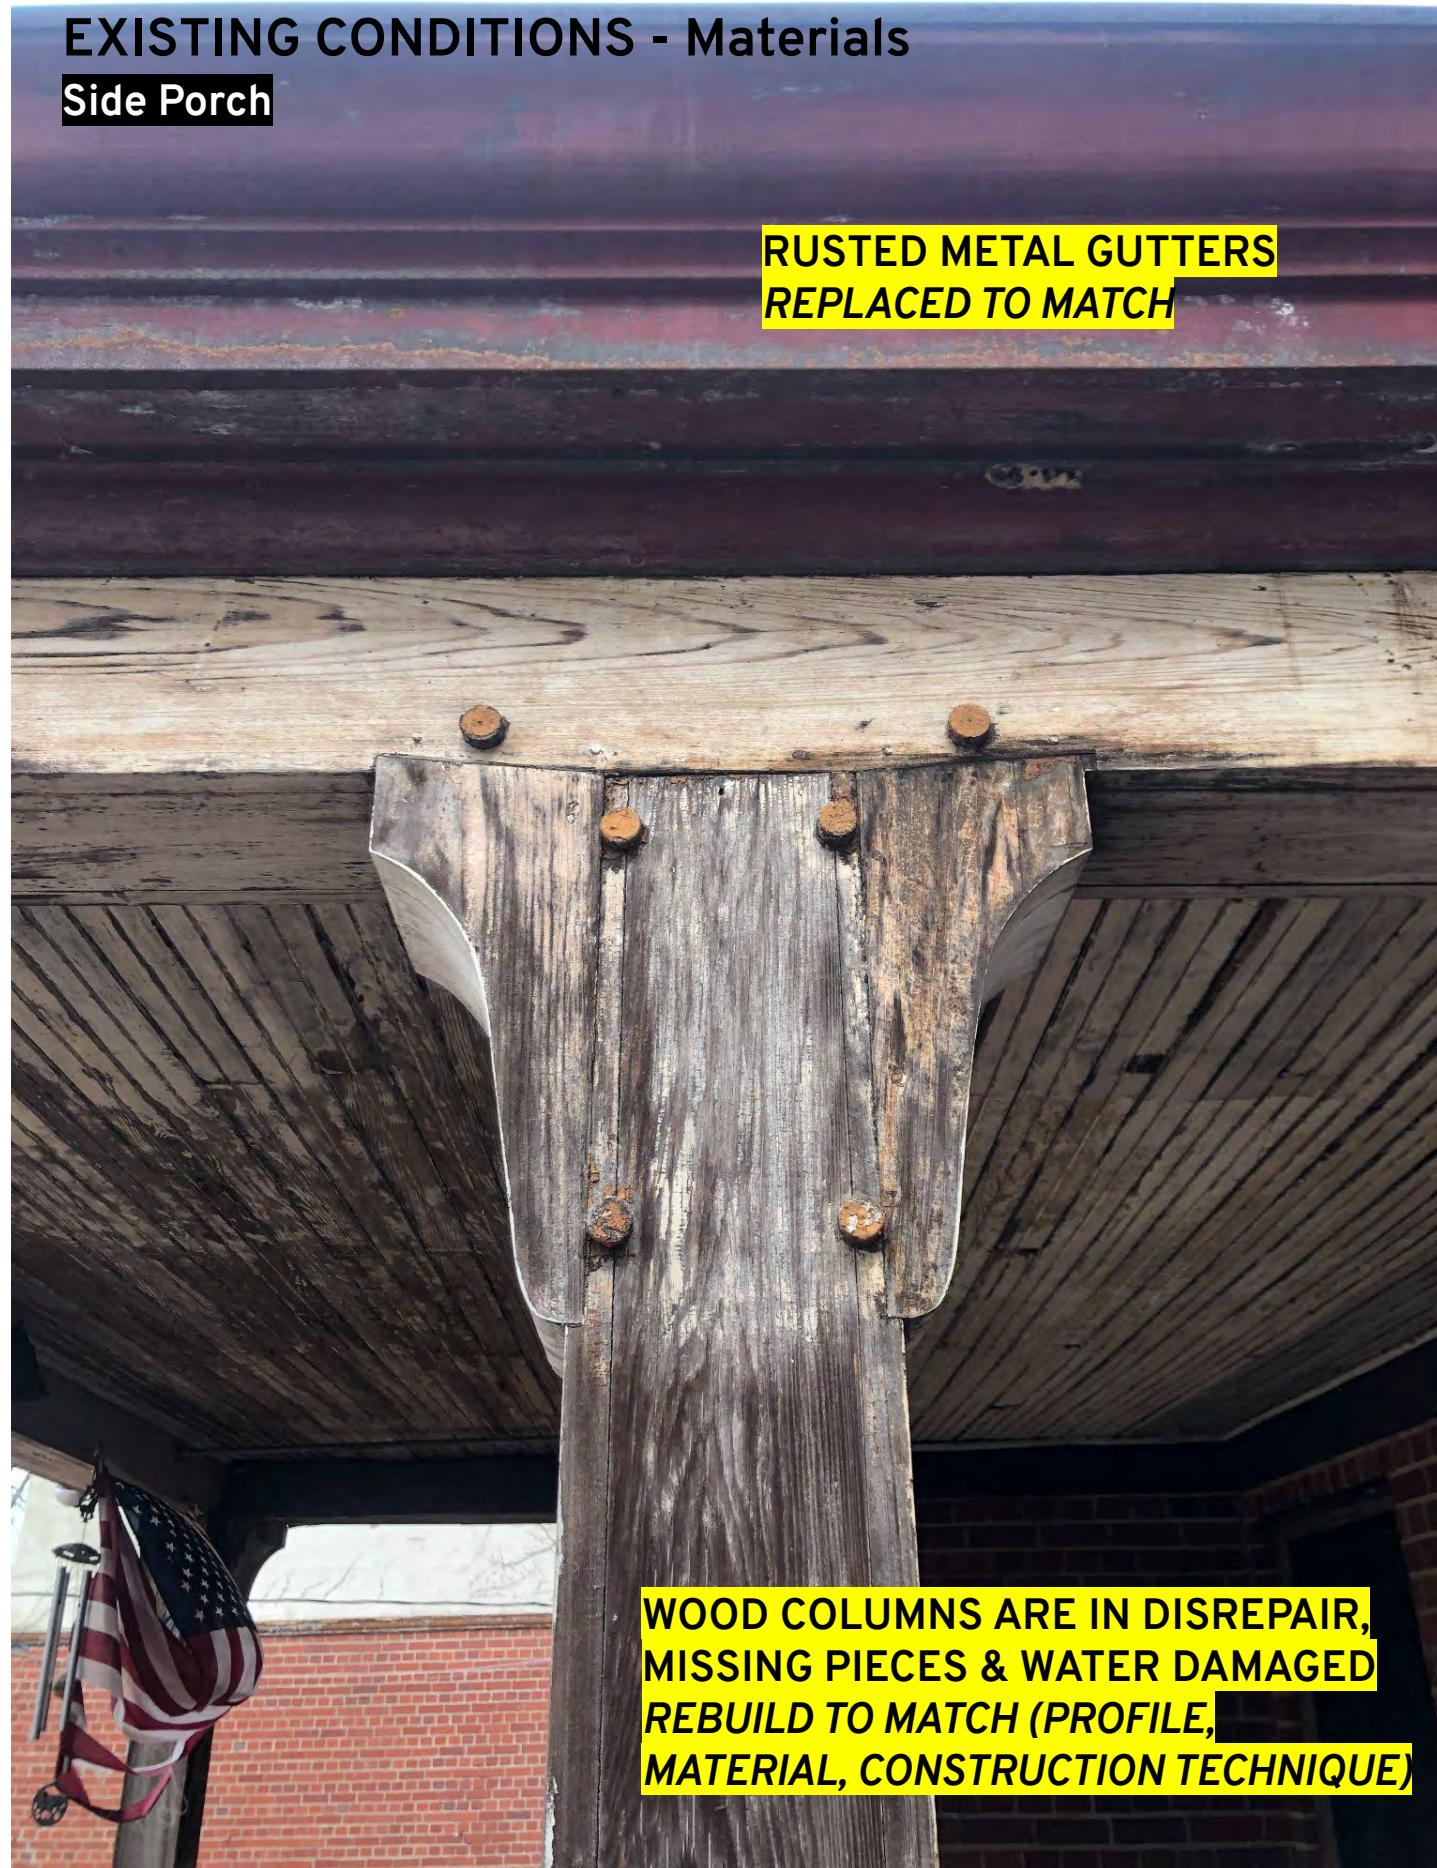
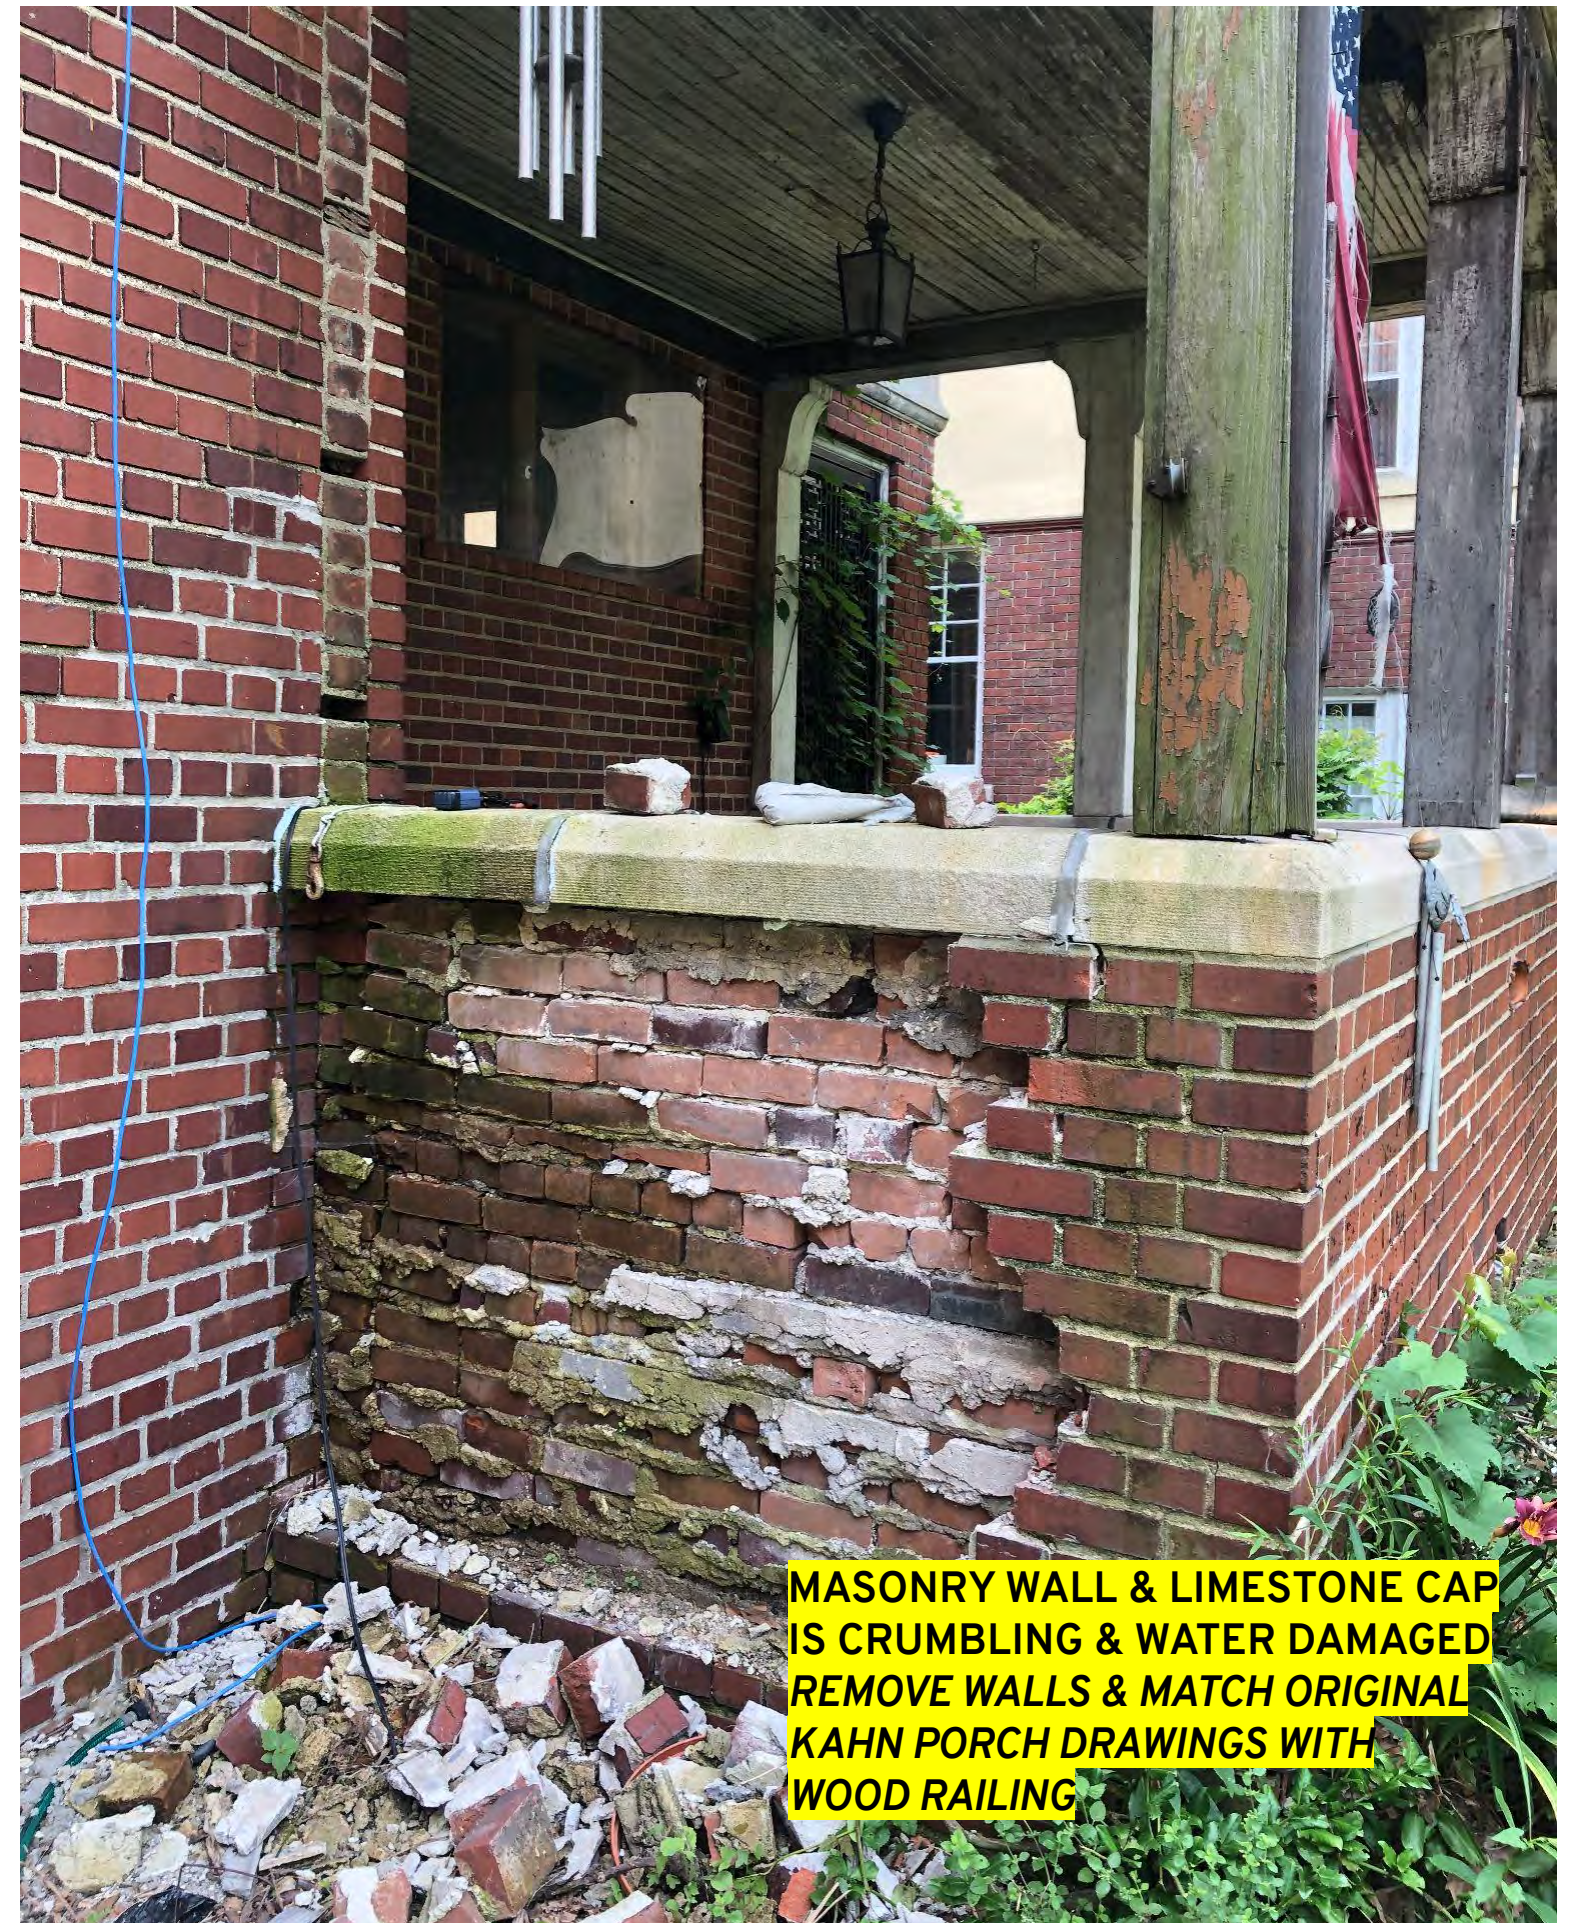
**RUSTED METAL GUTTERS  
REPLACED TO MATCH**

**WOOD COLUMNS ARE IN DISREPAIR,  
MISSING PIECES & WATER DAMAGED  
REBUILD TO MATCH (PROFILE,  
MATERIAL, CONSTRUCTION TECHNIQUE)**

**MASONRY WALL & LIMESTONE CAP  
IS CRUMBLING & WATER DAMAGED  
REMOVE WALLS & MATCH ORIGINAL  
KAHN PORCH DRAWINGS WITH  
WOOD RAILING**
