STAFF REPORT: 10/13/2021 MEEETING

ADDRESS: 1427 RANDOLPH

APPLICATION: #21-7525

SCOPE: REPLACE STOREFRONT AND WINDOWS AT FRONT ELEVATION

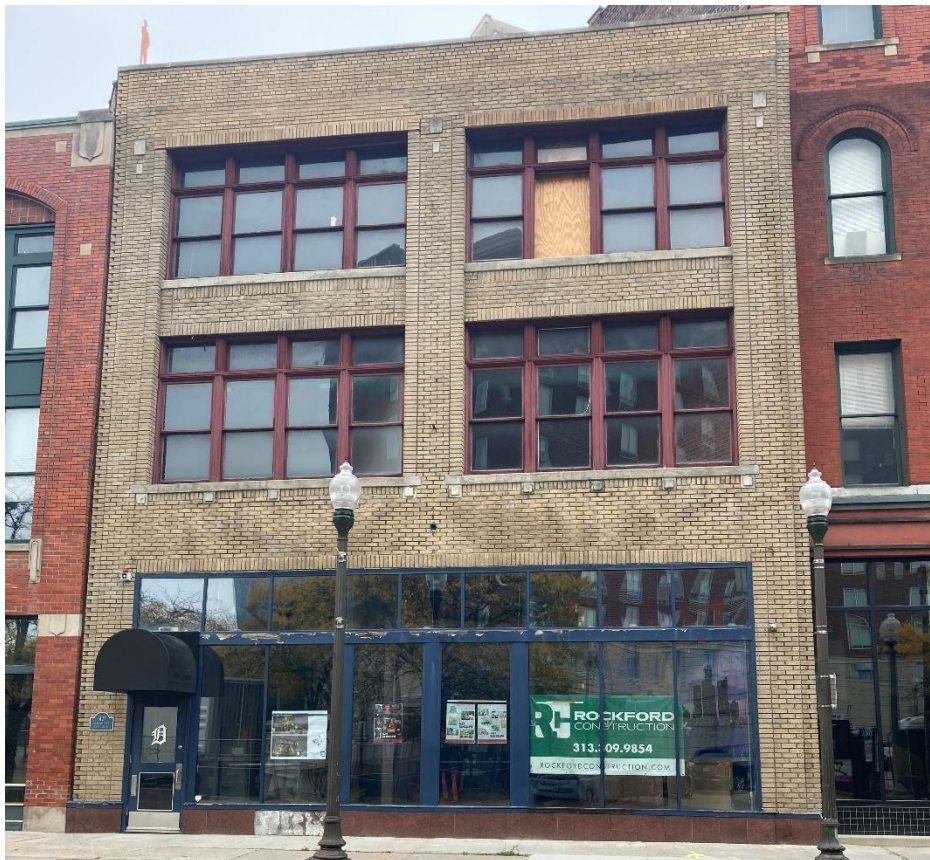
Erected in 1914, the building located at 1427 Randolph is a three-story, commercial building that is located within the Madison-Harmonie historic district. The building features a flat roof and buff brick exterior walls. The building's first story displays a non-historic wood storefront with a stone tile base. The building's 16 original, primary elevation windows remain at the second and third stories. Specifically, these windows are 1/1, double-hung, wood units with wood transoms, mullions and brick mould/trim.

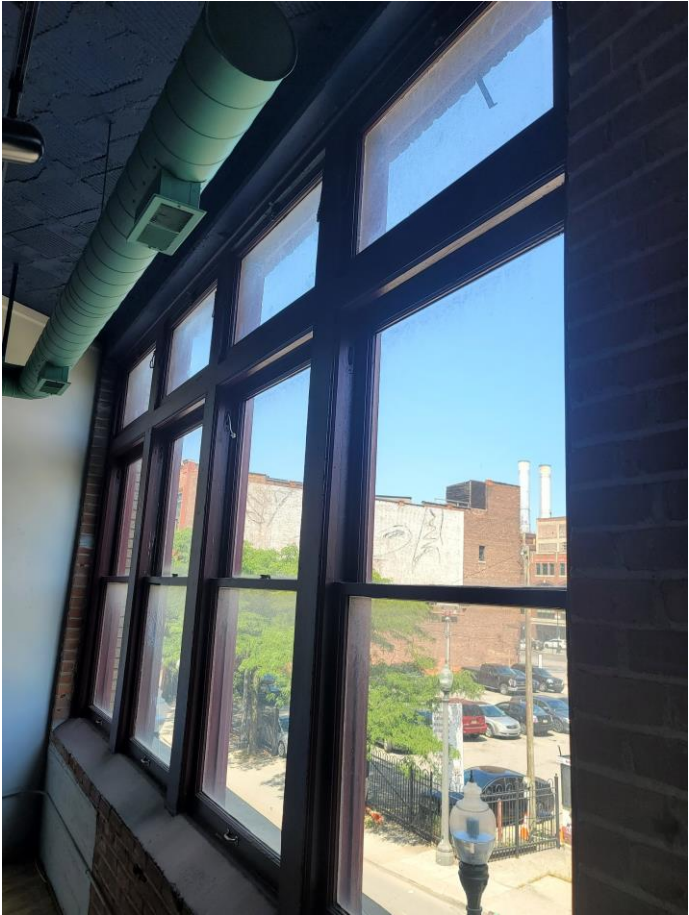
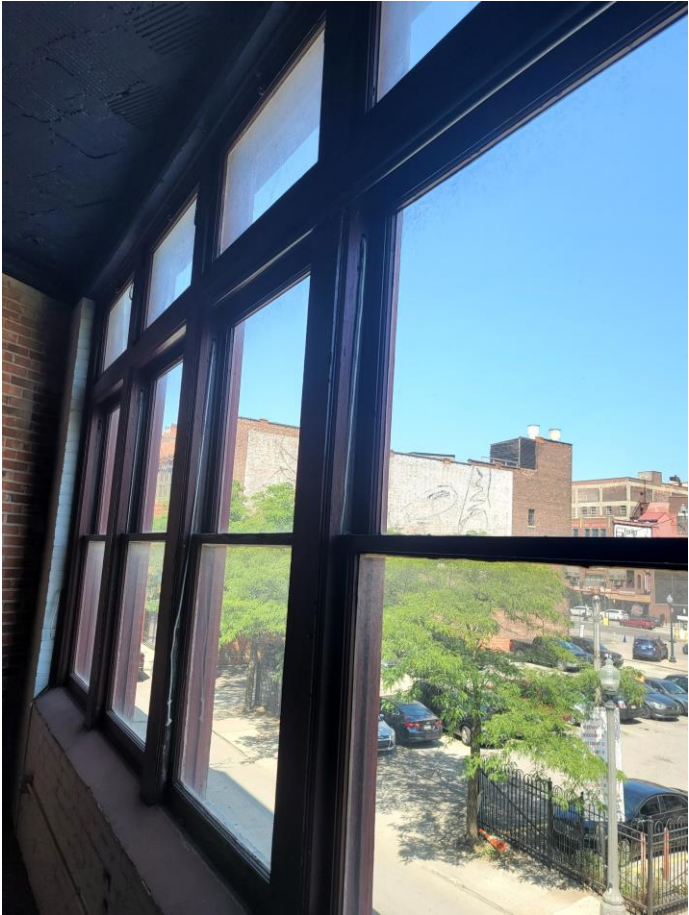
SECOND FLOOR

- Windows all have deteriorated paint finish that likely contains lead based paint that would need to be abated prior to being re-finished.
- All windows are either painted shut or are otherwise inoperable, all sash balance cords are missing or broken.
- Nearly all vertical window mullions are structurally deficient and have steel straps that were bolted to the interior side of the framing to prevent them from blowing out of the openings (See photos that illustrate this).
- Exterior wood brick molding, mullions, and sash components show obvious signs of decay that is directly related to the main frame and vertical mullion failure.
- One opening is missing the operable sash and is boarded up.
- Several windows have broken panes of glass and are missing glass stops.
- Sash locks are broken or missing on most of the windows, and no limit stops are present.

- We propose complete removal of existing window assemblies including brick moldings and structural mullions.
- Provide and install new aluminum panning that closely replicates existing.
- Provide and install new hung aluminum Historic windows to replicate size, configuration, and function of existing wood windows (See included Quaker Window Shop drawings and details).
