**STAFF REPORT: NOVEMBER 10, 2021 MEETING**

**APPLICATION NUMBER: 21-7586**

**ADDRESS: 1713 SEYBURN**

**SCOPE: REPLACE SIDE AND REAR ENTRANCE DOORS**

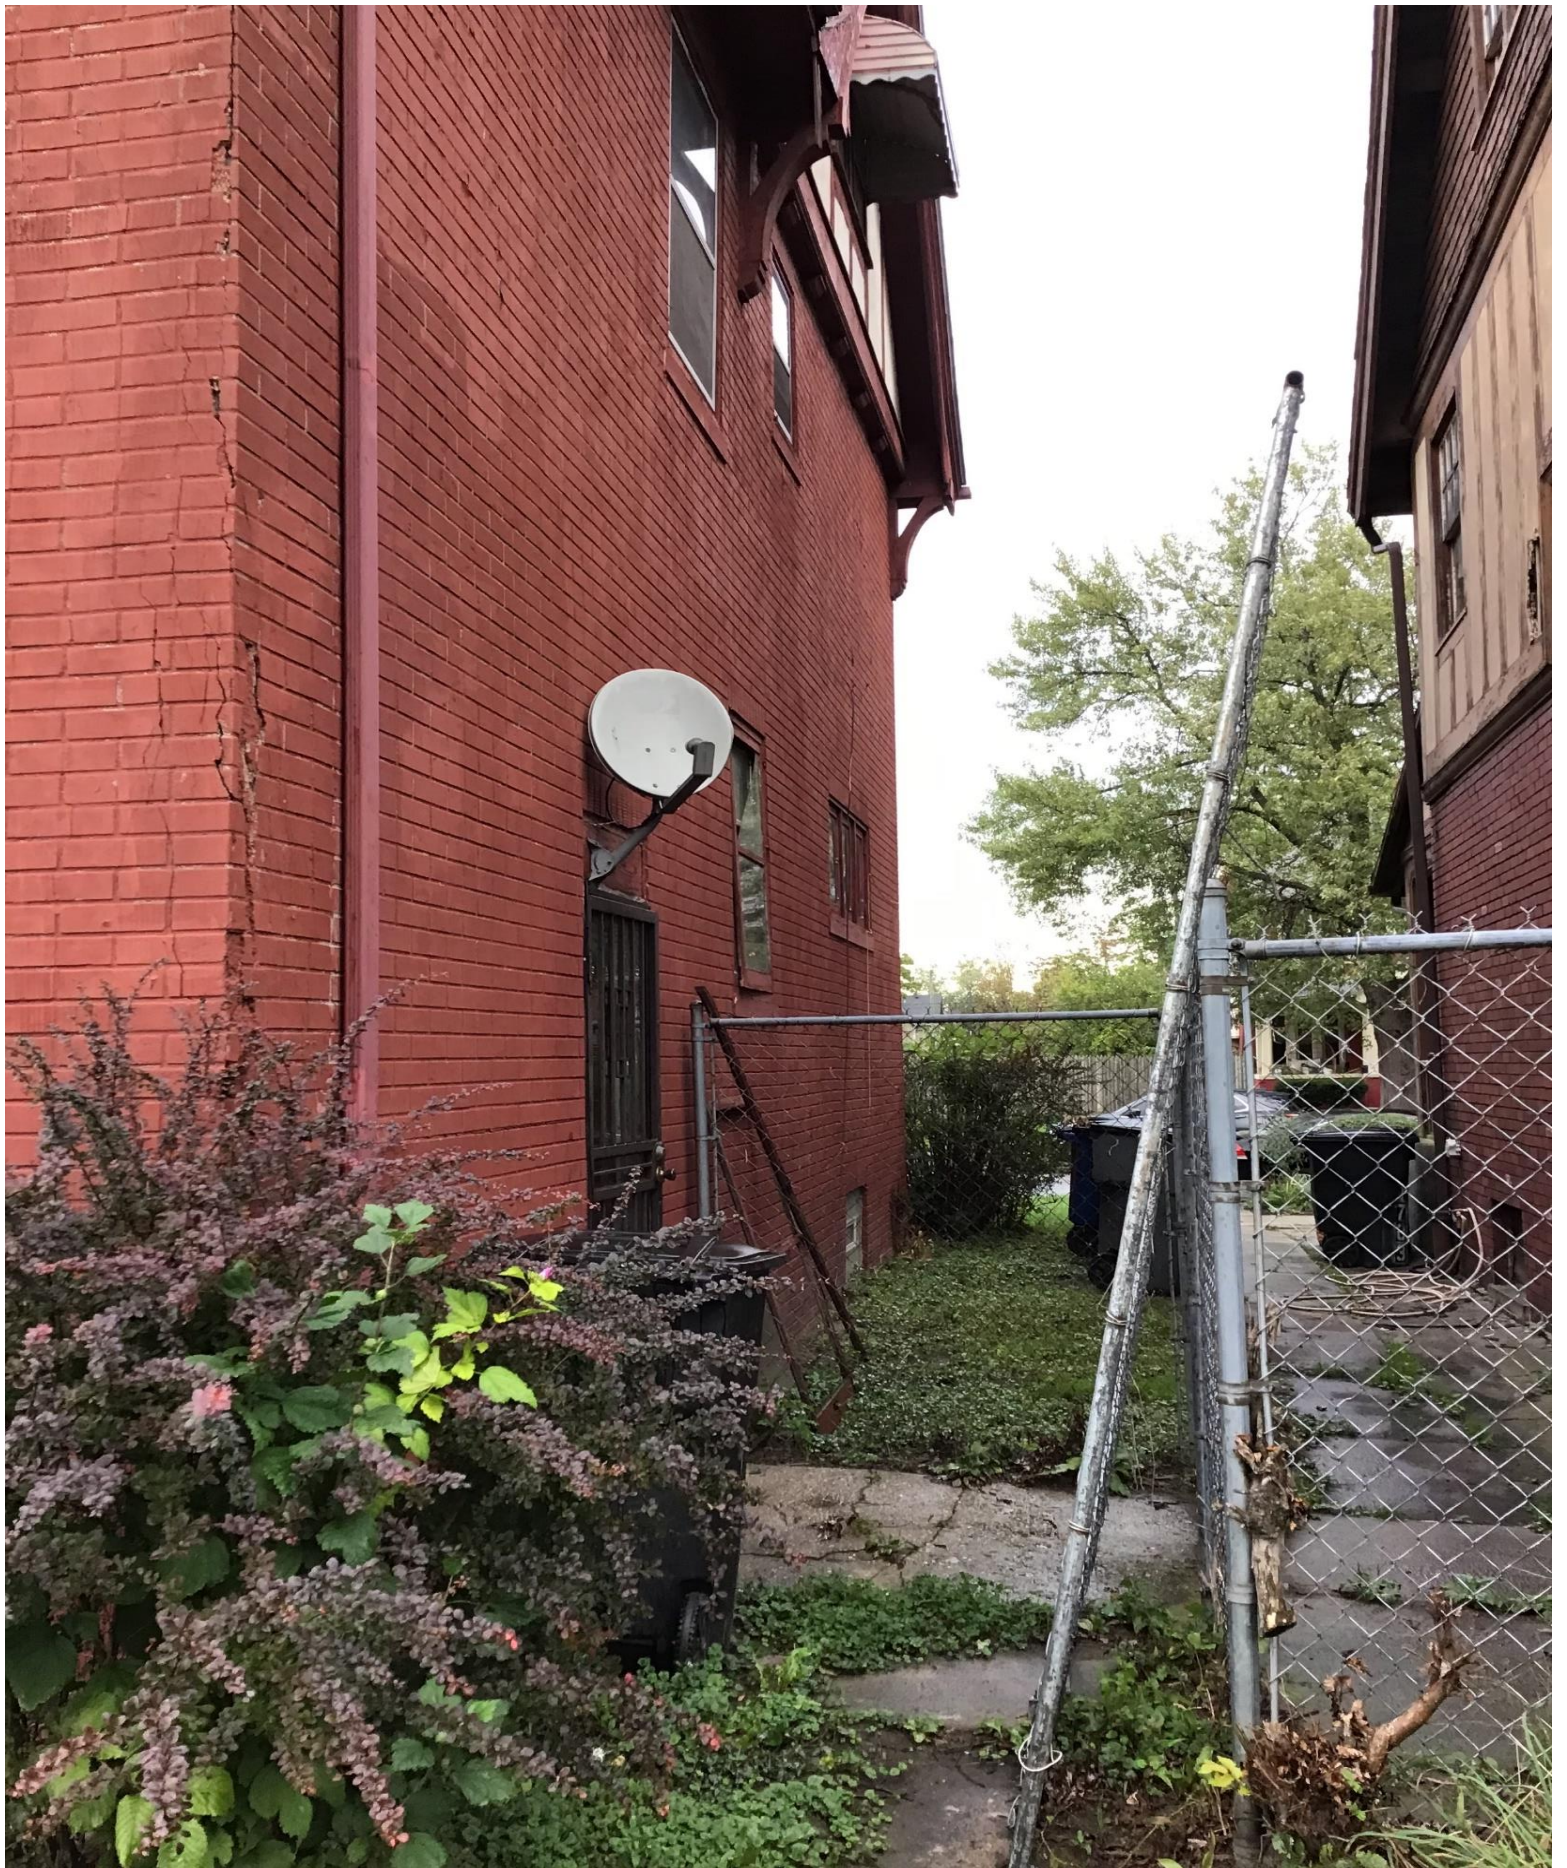
SIDE DOOR

**Side Entry door - (Current)** Solid wood interior door, exterior is delaminating (see pictures). Dead bolt looked to be added on (you can see where the deadbolt use to be on the frame). Door is a dark wood finish.

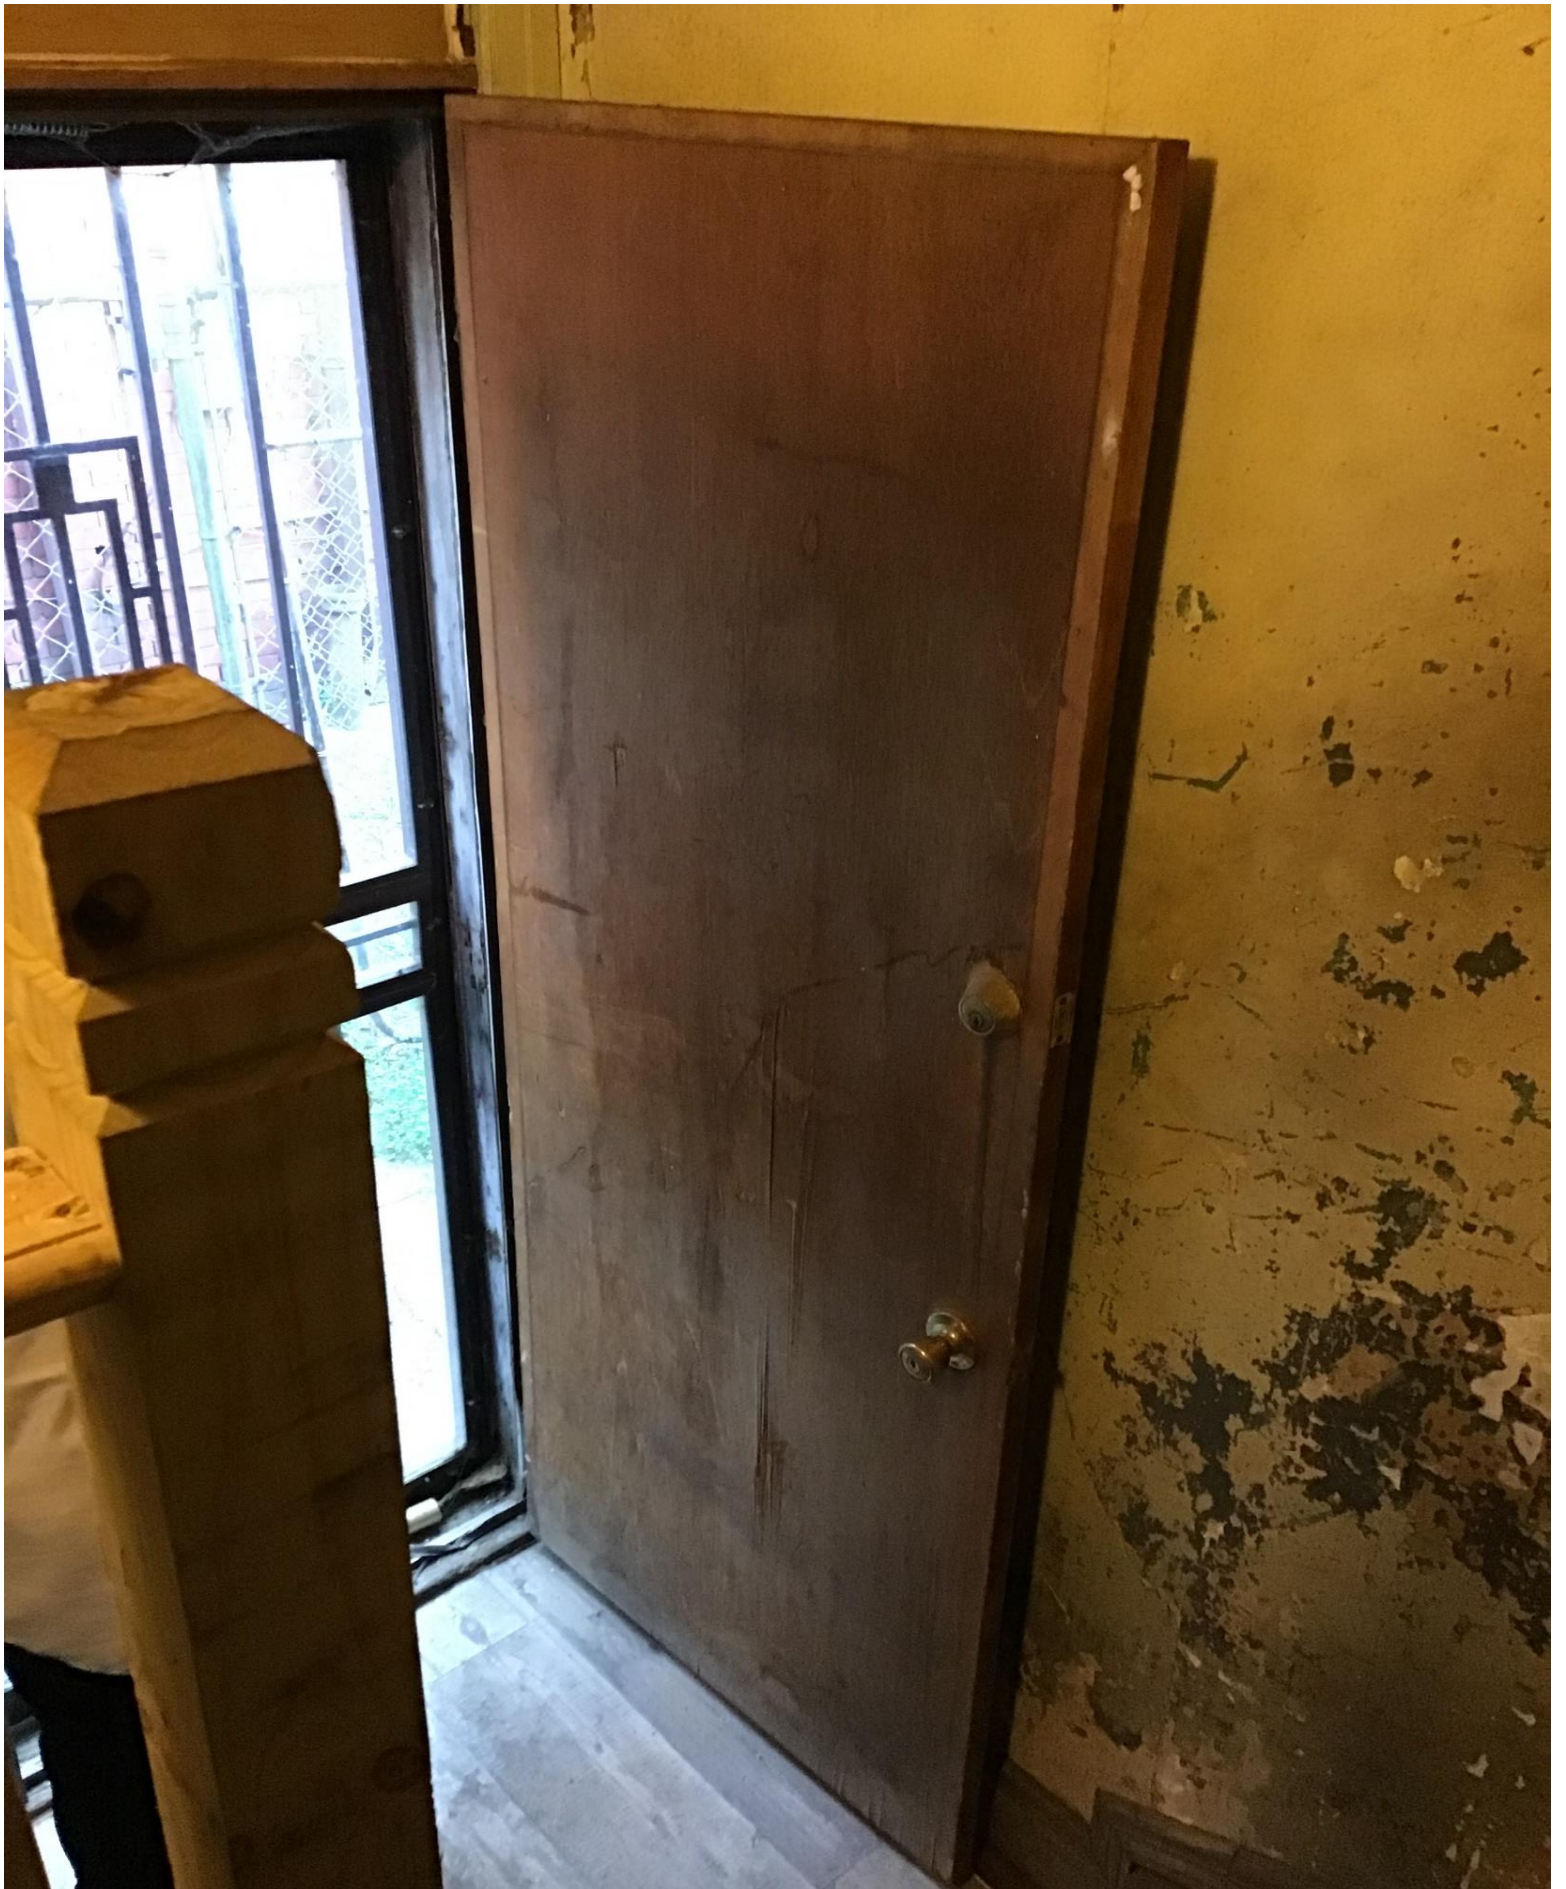
SIDE DOOR

Looks like a Solid-wood interior door

Door handle and dead bolt are not spaced normal

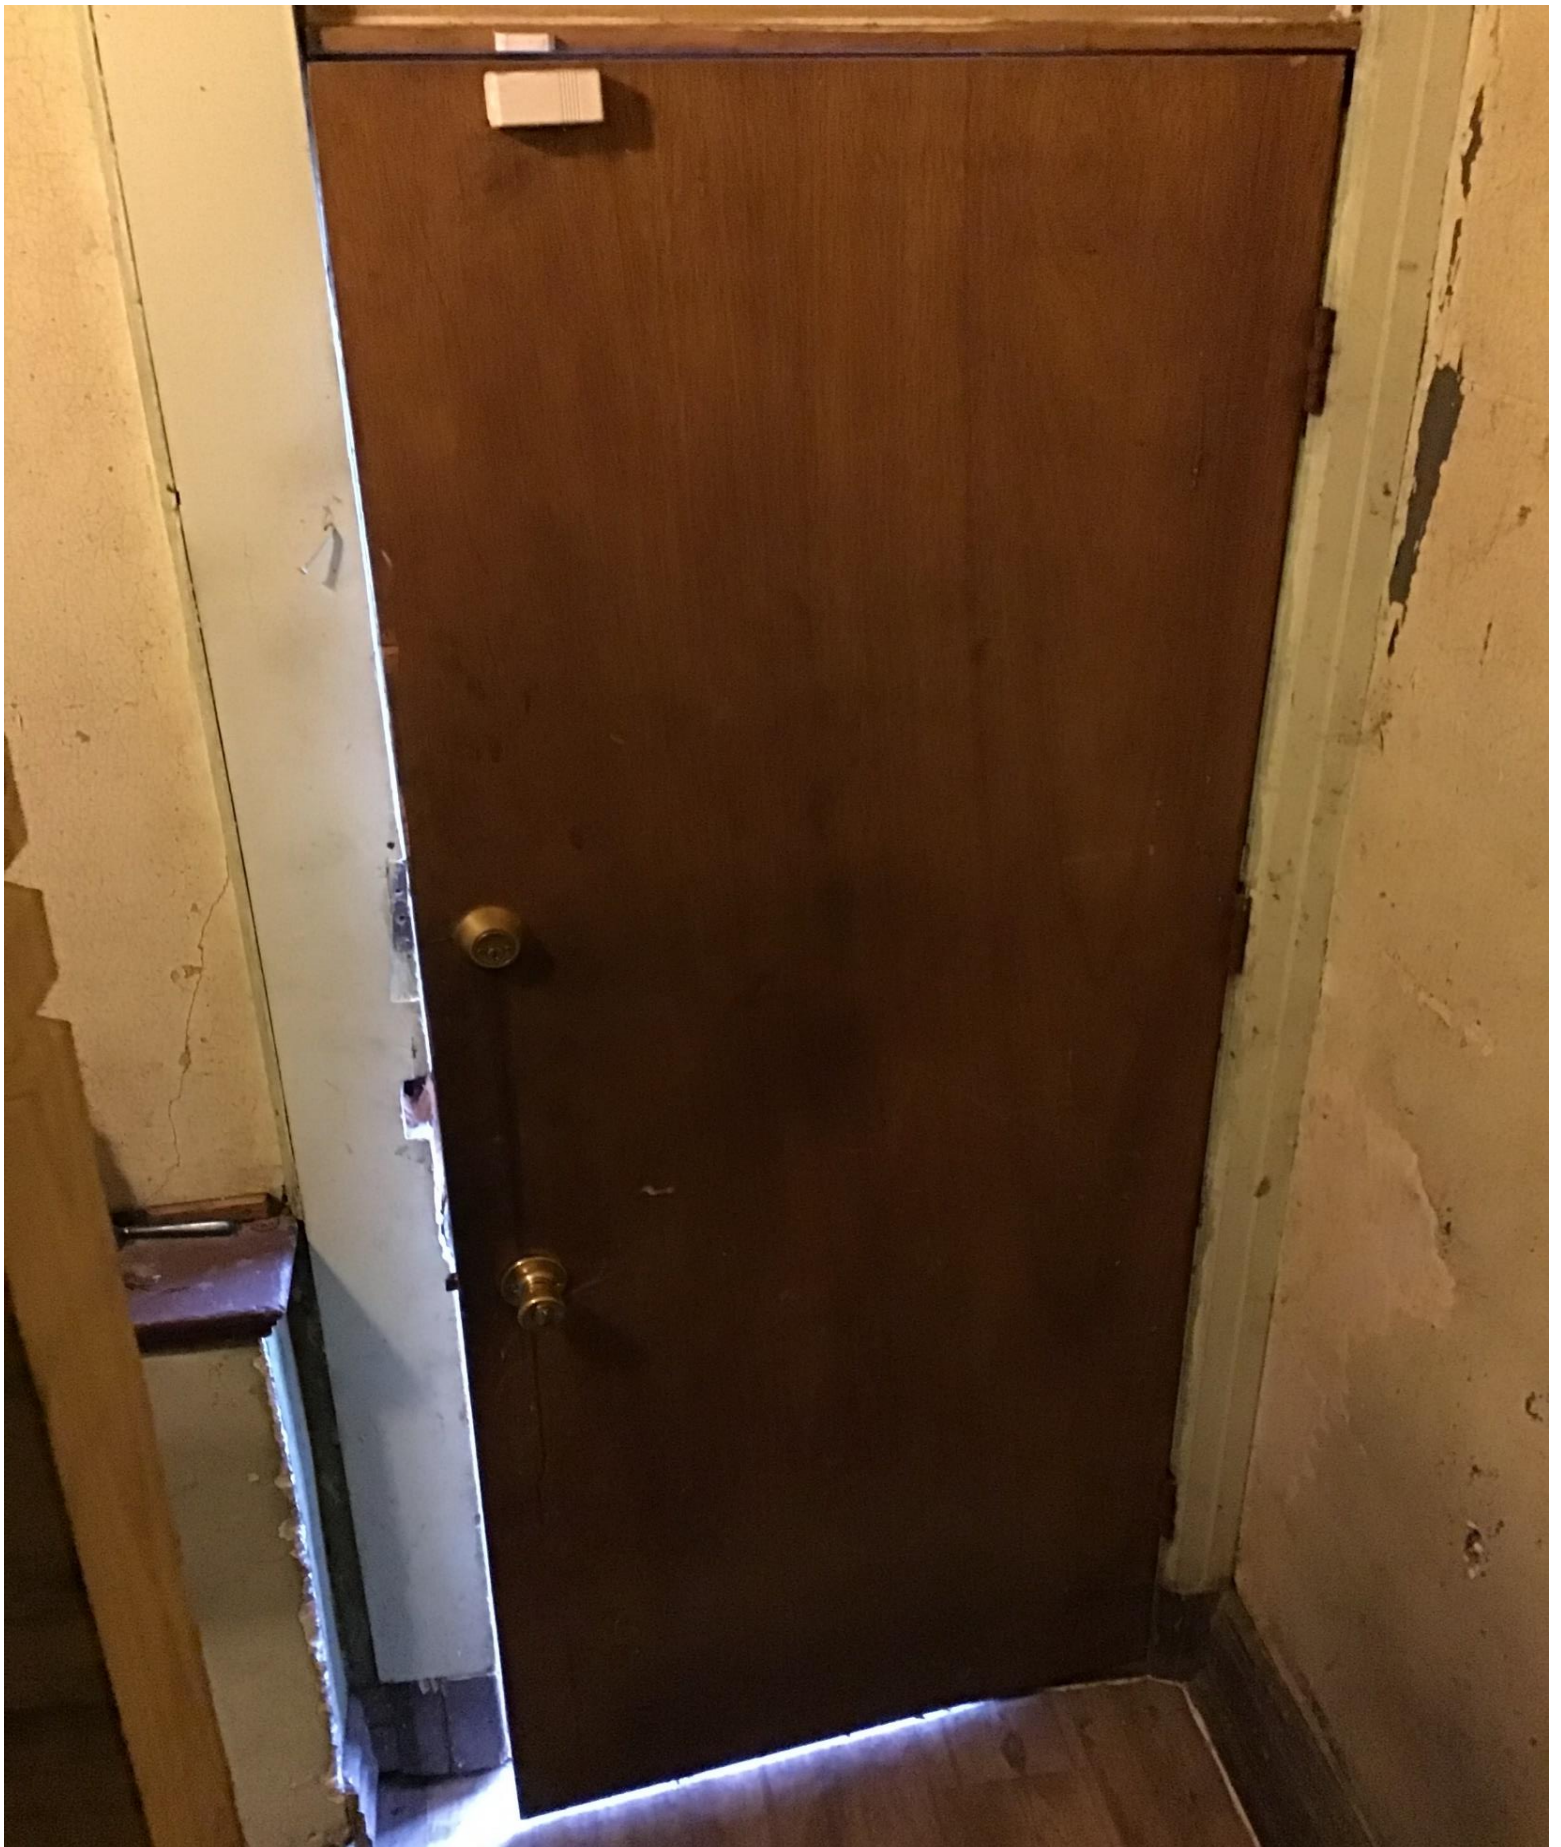
**SIDE DOOR**

Looks like a Solid-wood interior door

Door handle and dead bolt are not spaced normal

You can see where dead bolt should be located on a normal entry door in this picture

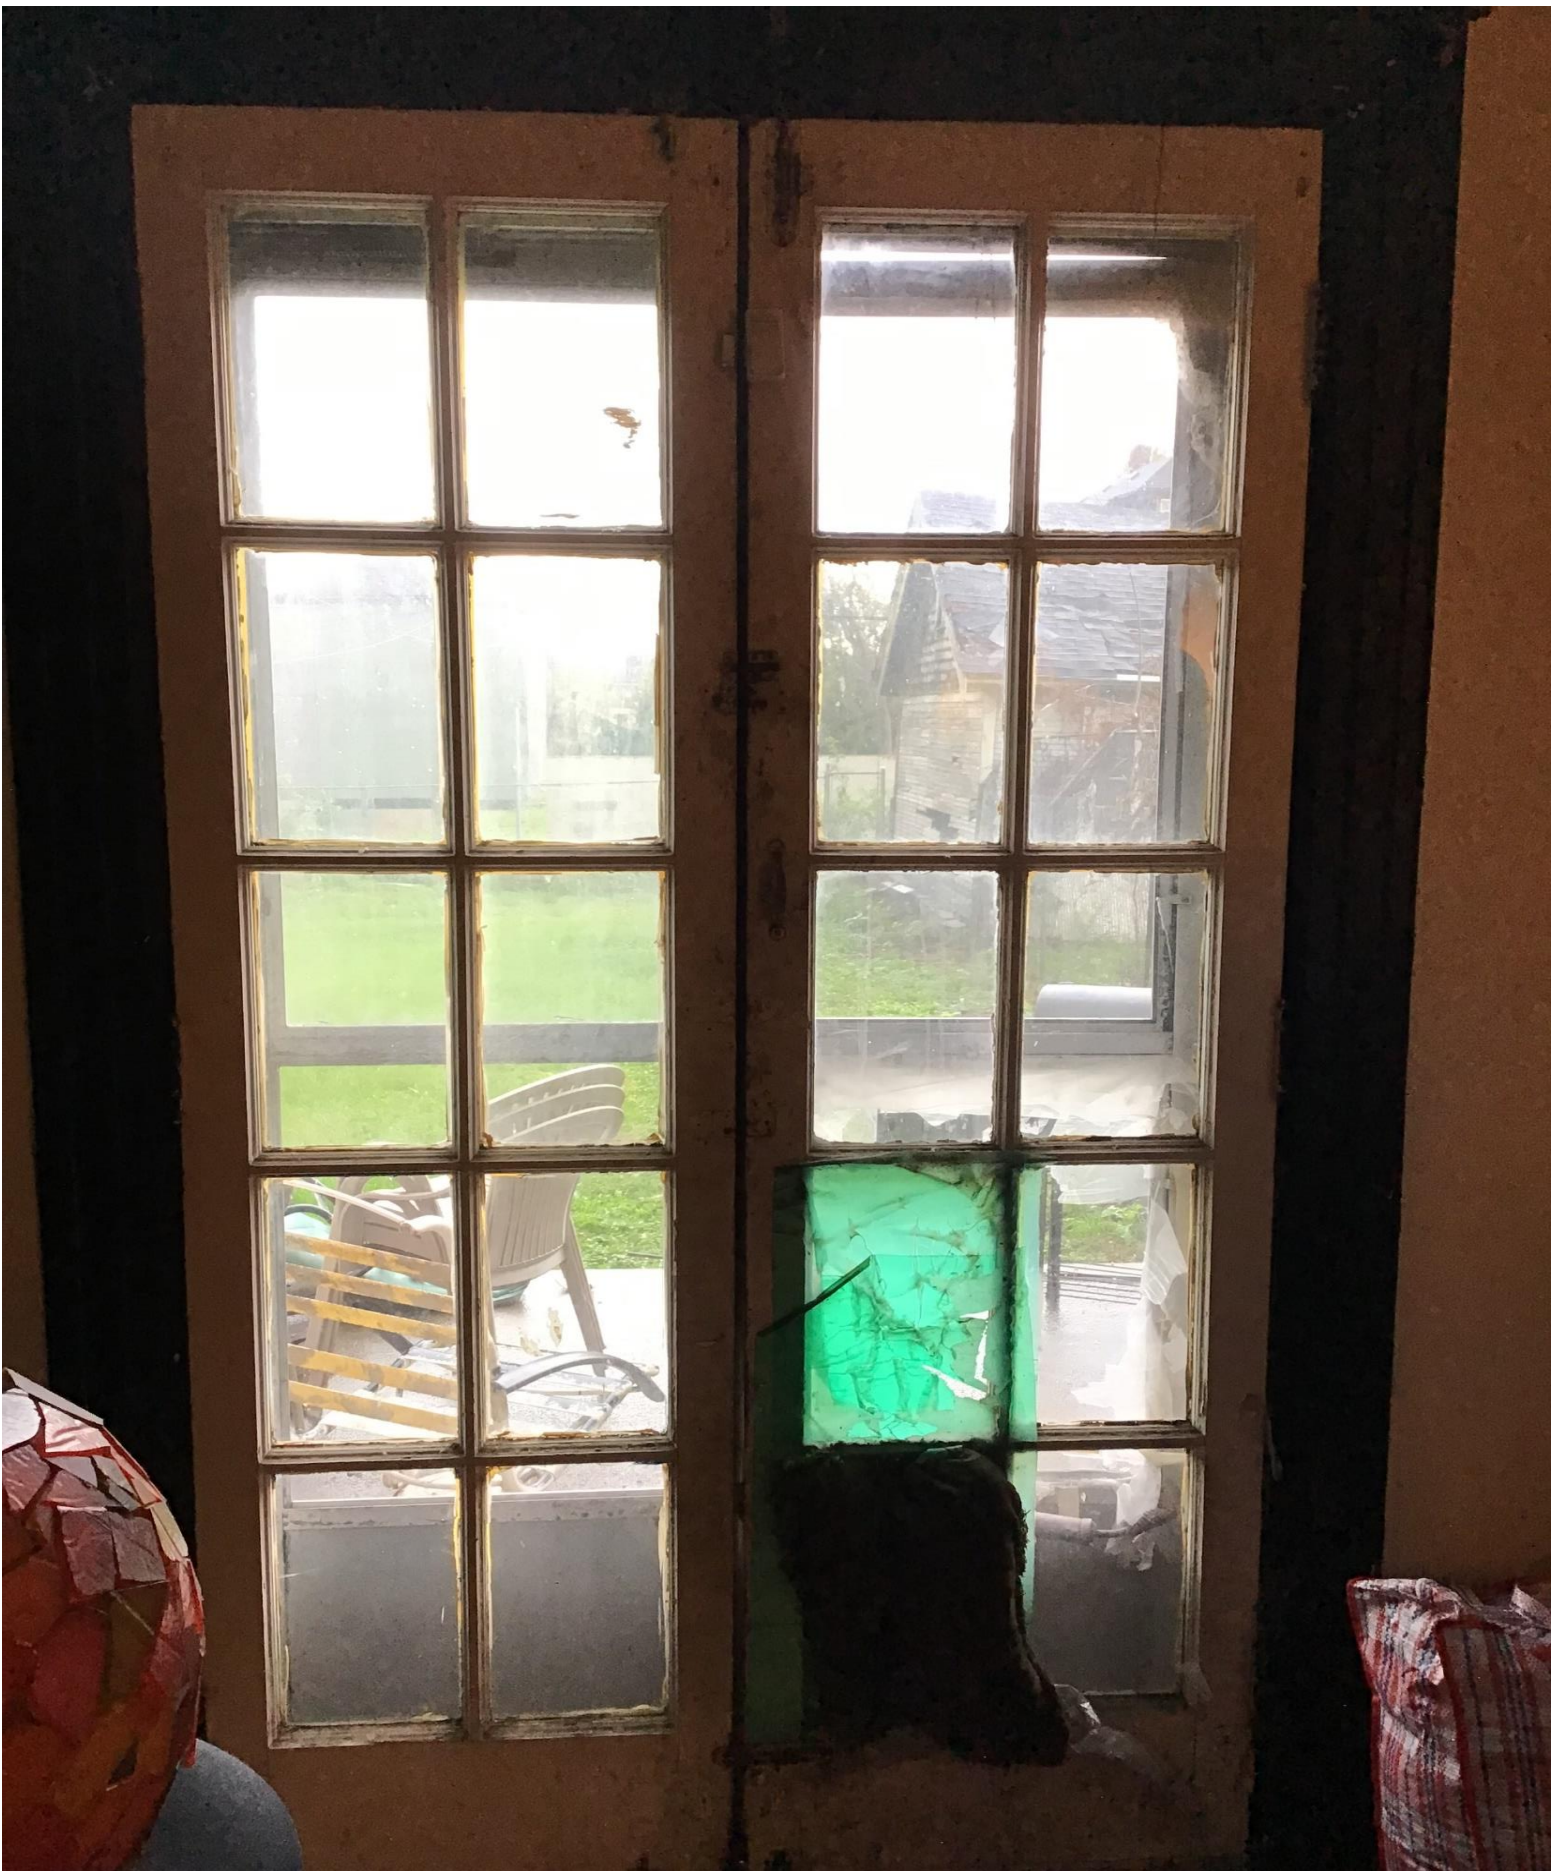
BACK DOOR

No door knobs, not a "real" entry door

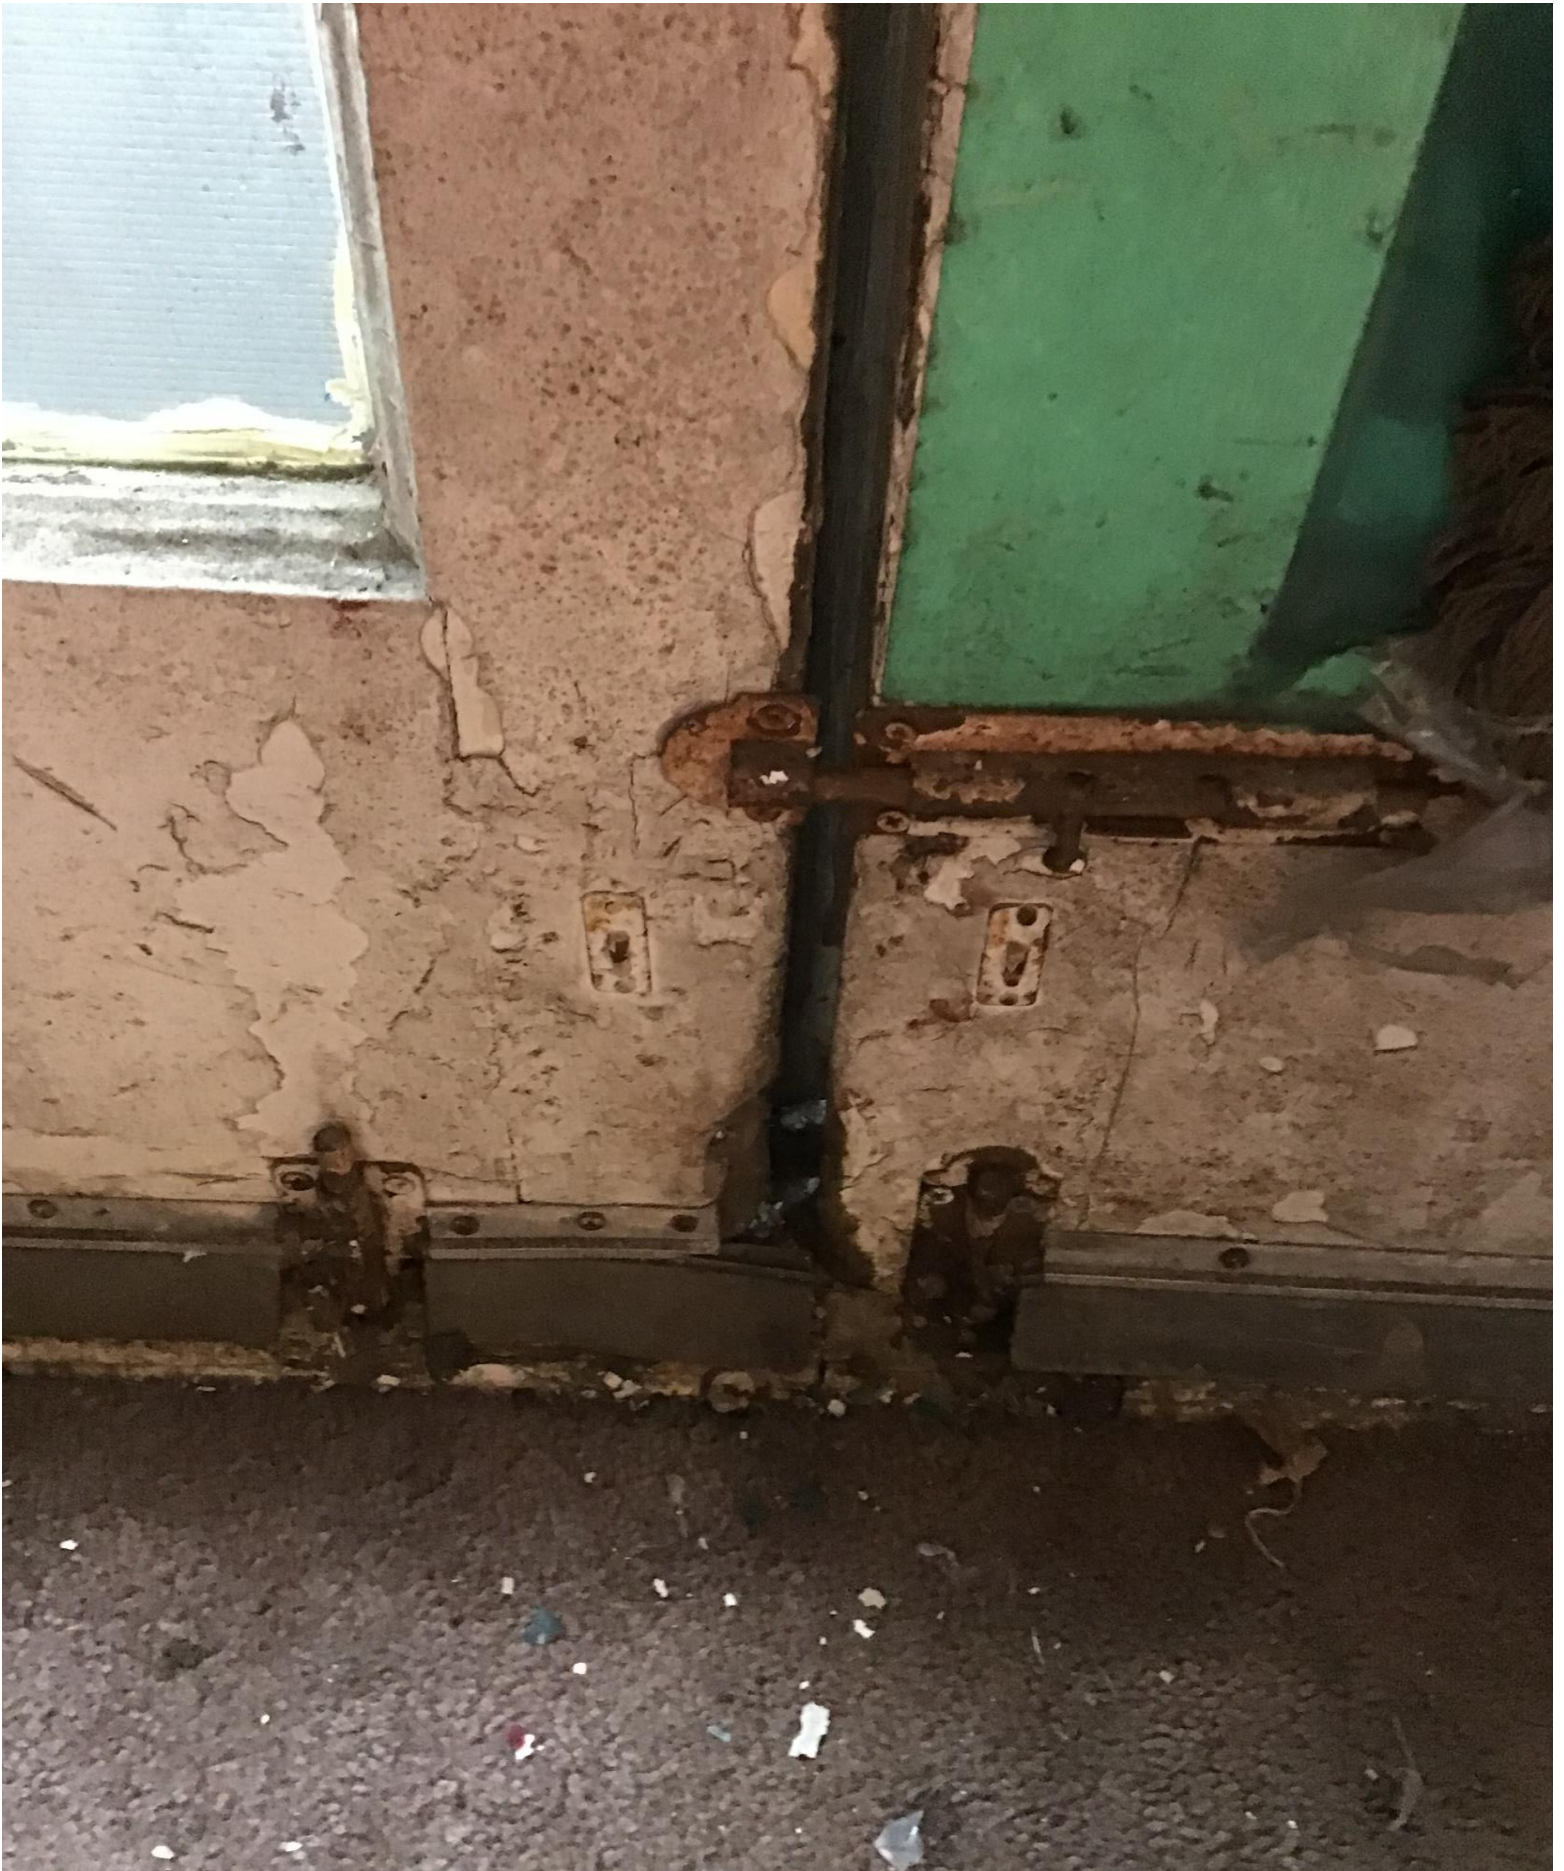
Several barrel bolts are used to keep door lock/shut

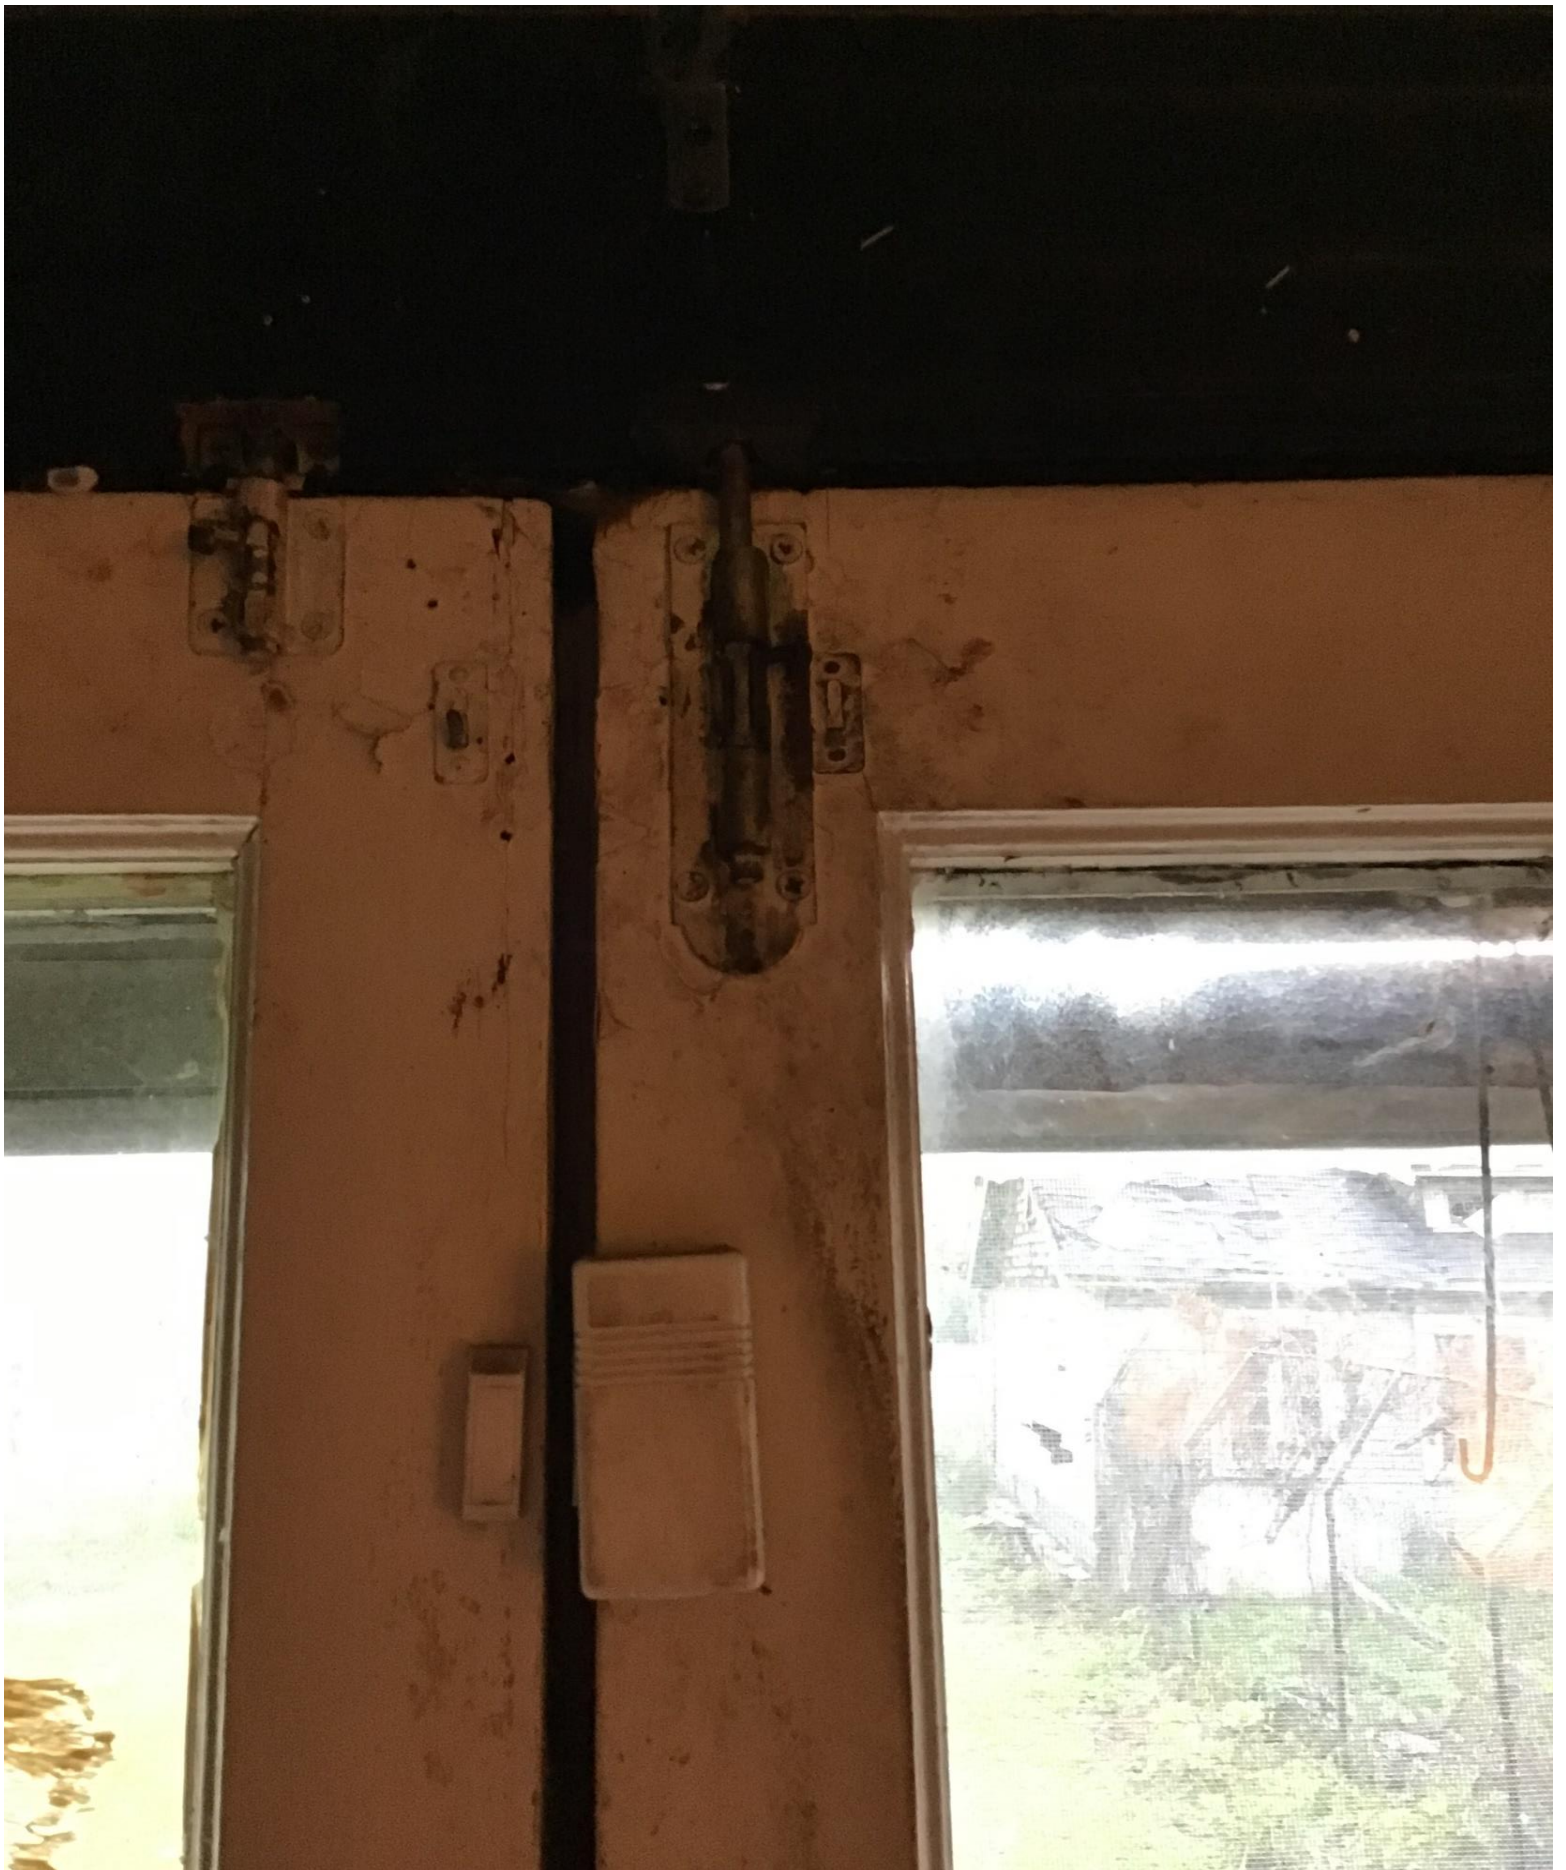
Several barrel bolts are used to keep door lock/shut
