STAFF REPORT: DECEMBER 8, 2021 MEETING PREPARED BY: A. DYE

APPLICATION NUMBER: 21-7613

ADDRESS: 1409 BAGLEY

HISTORIC DISTRICT: CORKTOWN

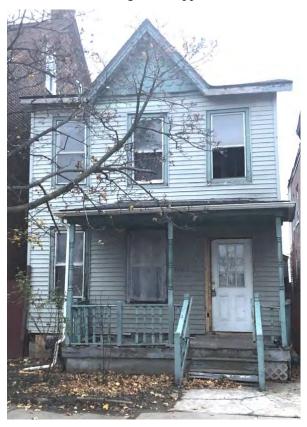
Left: Existing Conditions, HDC Staff

The three-bay house fills the width of the narrow lot and single-story additions extend from the rear elevation. The low pitch, side gabled roof is punctuated by a steeply pitched front gable. Three single window openings are evenly spaced across the front elevation's second floor, while identically placed openings on the first floor offer a not-quite symmetrical arrangement due to the front entrance. The majority of the windows are wood, one-over-one double-hung units. Based on the interior photographs submitted by the applicant, it appears a few windows are missing lower sash; a few openings on the rear elevation are filled with vinyl double (or single)-hung, one-over-one, replacement units.

The house is covered in vinyl siding (wood window casings remain visible) and aluminum storm windows cover wood double-hung sash. Wood, fishscale siding fills the wall surface of the front gable. A single-story porch expands across three-quarters of the front elevation and the current porch design presumably dates to 1989, per the Commission issued Certificate of Appropriateness.

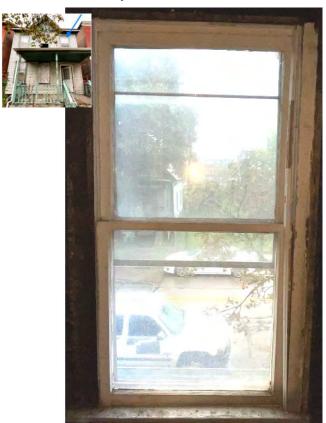
Applicant photos.

The upper left window unit remains intact, with minimal noticeable deterioration to the sash and sill.

The upper right window unit is missing the lower sash as well as the storm window glass. Due to exposure, the sill has deteriorated to the point that part of it is gone.

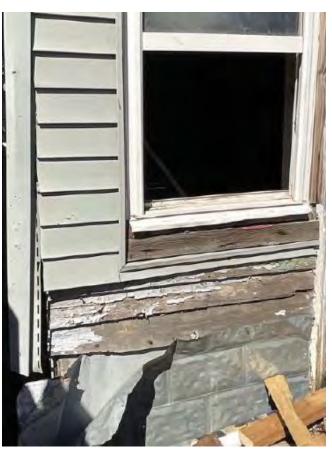
- The applicant didn't provide details or sections to show how the siding would be installed.
- The structure is around 140 years old, and asbestos and vinyl siding have been applied over the wood siding for 40+ years. It is very likely wood boards have deteriorated and been damaged (as seen to the right), and even removed in areas to

create flat surfaces for the synthetic product installation. The only way to know if the integrity of the historic wood siding has been retained or lost is to remove the vinyl siding and its underlying sheathing. If it is determined the wood siding cannot be repaired, then a substitute material can be considered.

It is staff's opinion the Commission approving a substitute material at this time is a premature decision. The applicant and Commission have the opportunity to determine if the house's wood siding can be repaired (or replaced in-kind) in a way to reinsert the building into the historic fabric of the district. It is quite common to uncover well-preserved historic siding under later inappropriate materials; indeed, this has occurred recently on some similar houses in Corktown.

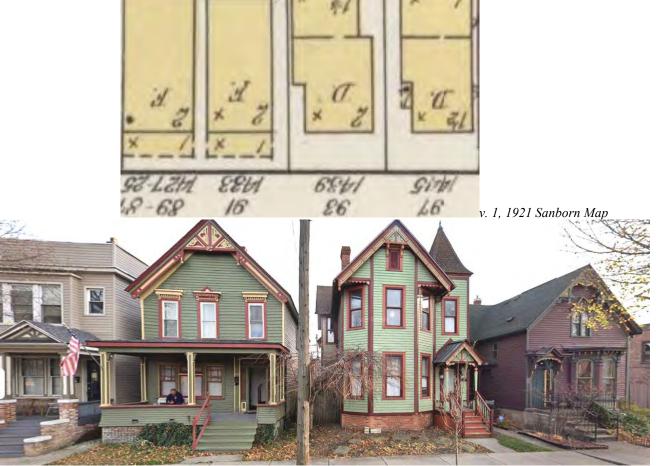
Google street view: From left: 1427 (partially shown), 1433, 1439 and 1445 Bagley. The property on the left, due to the vinyl siding installation, has lost (either by being covered or removed) character-defining details and stands in sharp contrast to the three houses to the right which retain wood siding and trim. These three houses were also constructed prior to the 1884, like 1409 Bagley. It is staff's opinion, that even though fascia and upper window casing trim details on 1409 Bagley might have been removed, retaining (whether original or in-kind replacement) wood siding, the existing flat trim and window casings can allow the building to regain a level of historic significance (akin to the neighboring structures further west on the street) and offer a truer identity as to its time of construction.

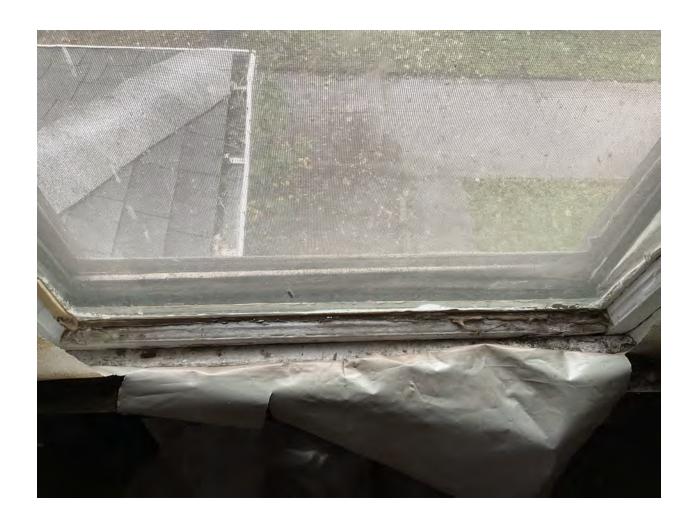
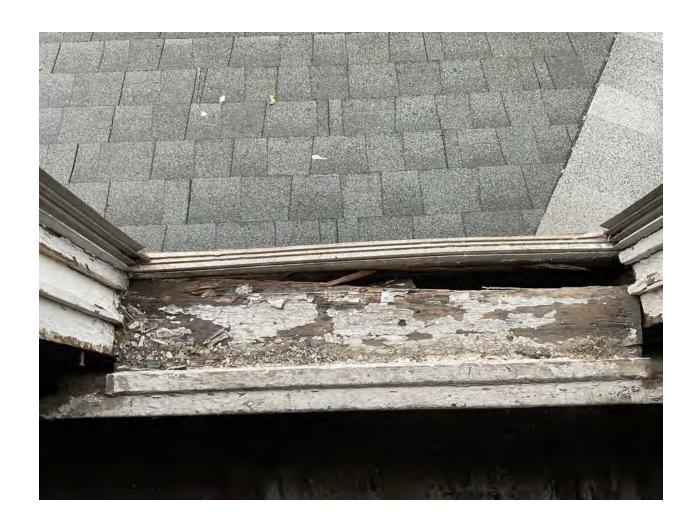
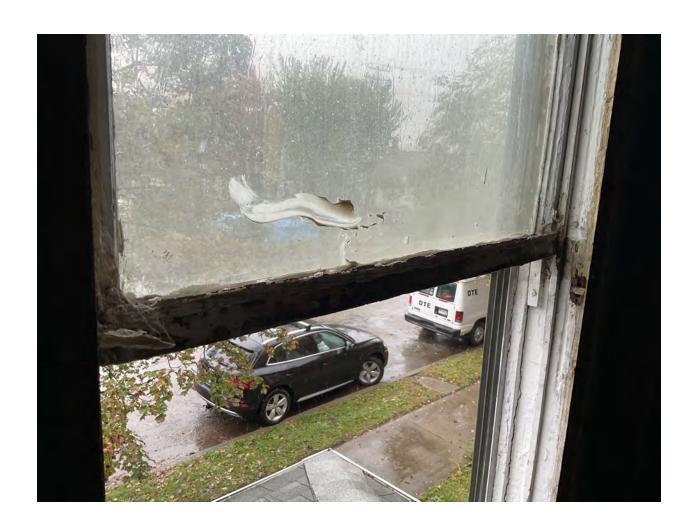
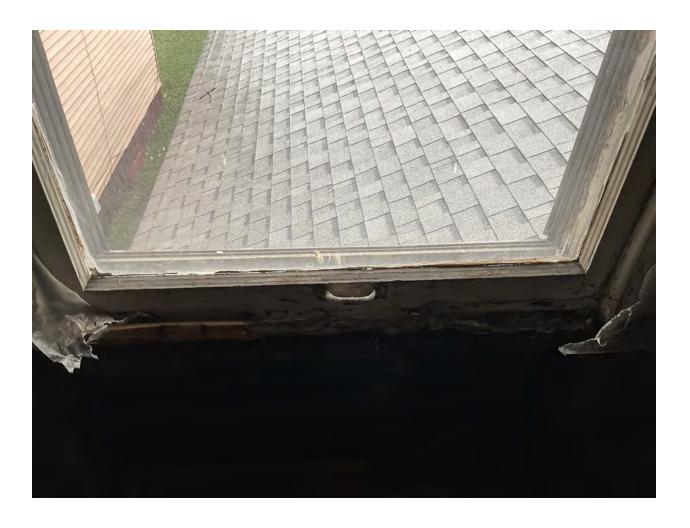
DETERIORATION TO EXISTING WINDOWS

There are currently 3 different types of windows - wood, aluminum & vinyl. There are some windows missing entirely and some missing the top or bottom panel.

Reason: Windows cannot be repaired.

Scope of work: We would like to replace all windows to vinyl.

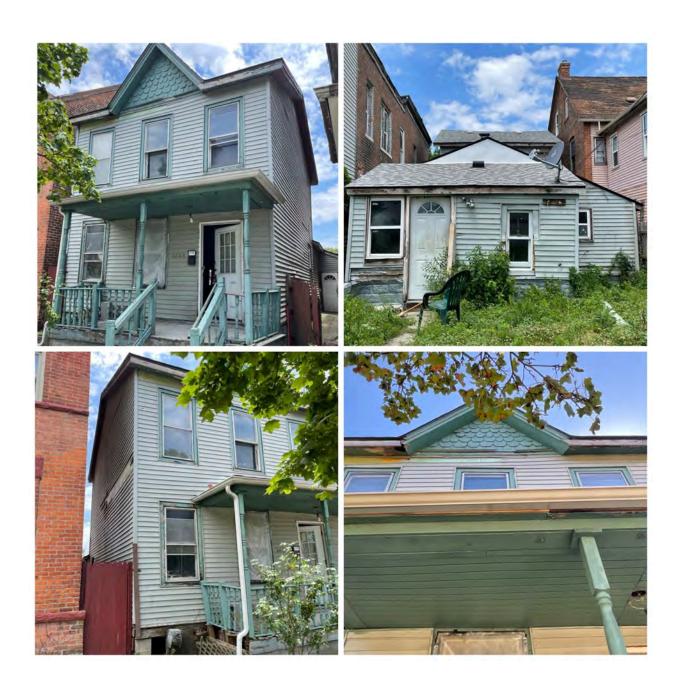
Missing gutters and damaged gutters throughout.

Scope: We would like to install 5" black seamless aluminum gutters where there are currently none, and paint current ones in black (B-19) Size of current gutters: 5"

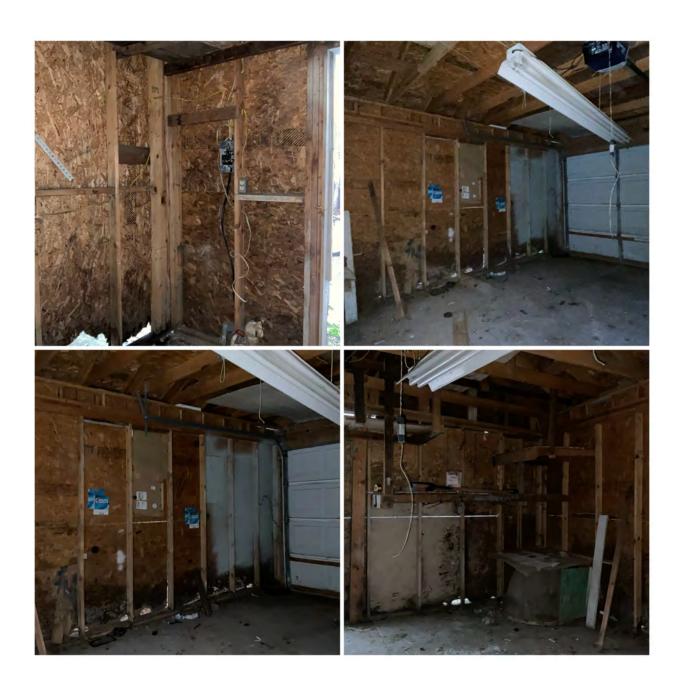
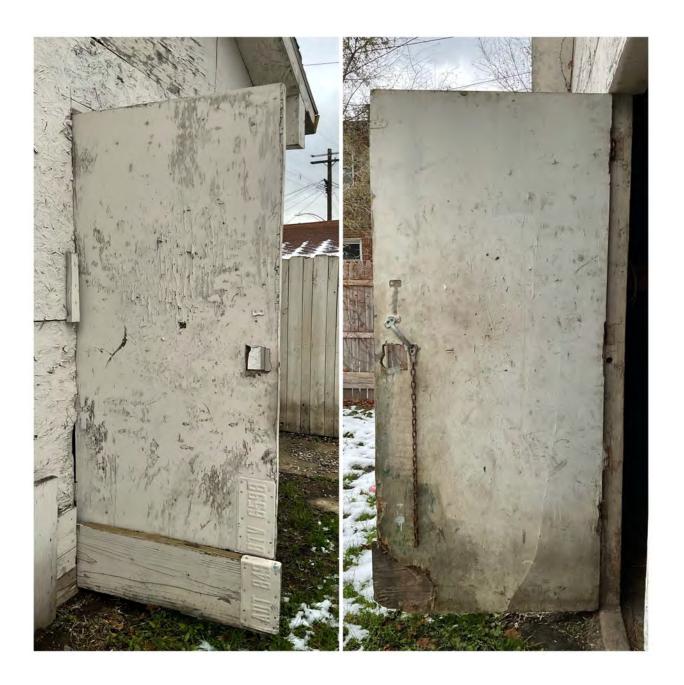
-The exposed plywood on the exterior is installed directly on top of the framing. There is no siding underneath

-We will remove the current pedestrian door as it's just plywood, rotted at bottom corner and no proper hole for a door knob, and we will replace with a new exterior aluminum door

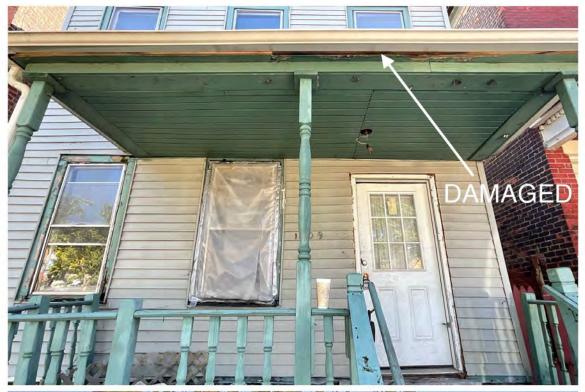
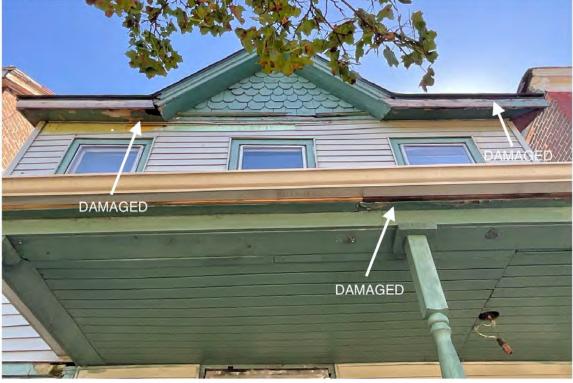
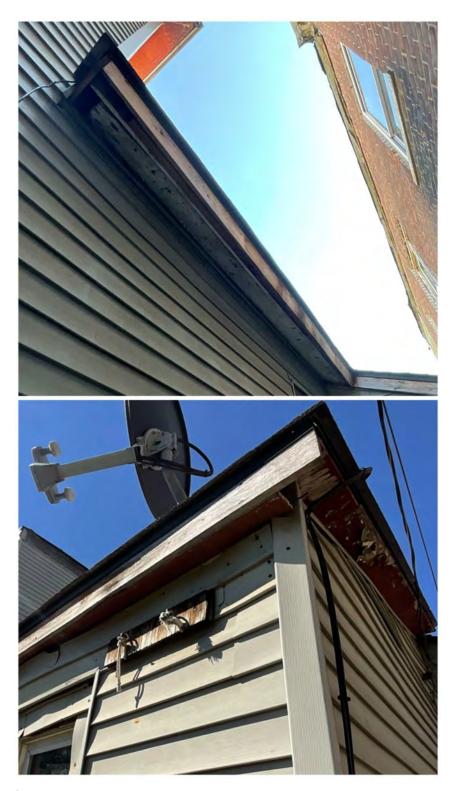
There is currently damage and deterioration to the soffits/fascia. Will need to replace it. Current materials used are wood and materials for

Replace all soffit and Fascia in the same size and material of current which is wood.

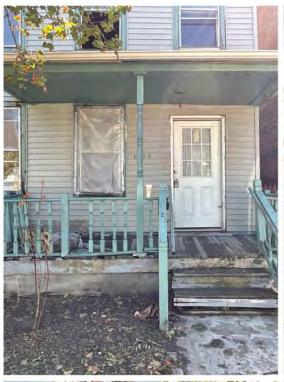
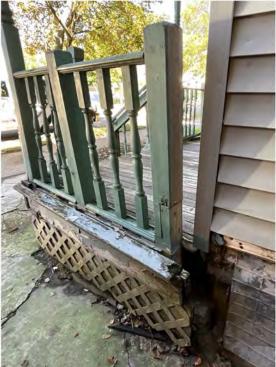
There is a lot of deterioration to the front porch currently and it is not structurally sound or safe. We will do an "in kind" repair.

- -Will use current <u>wooden</u> rails/<u>wooden</u> posts/<u>wooden</u> balusters. Will sand and paint them
- -Wood soffit & fascia
- -Pressure treated wood for the floor 1x4

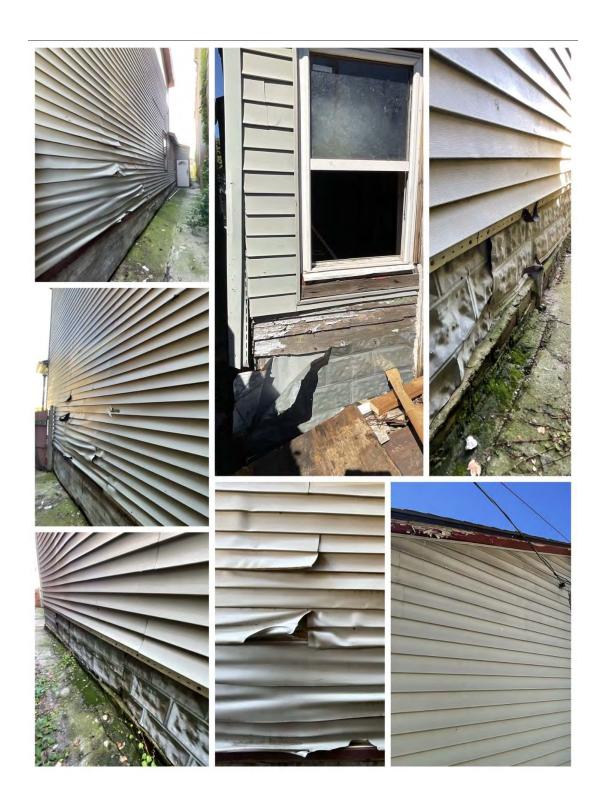
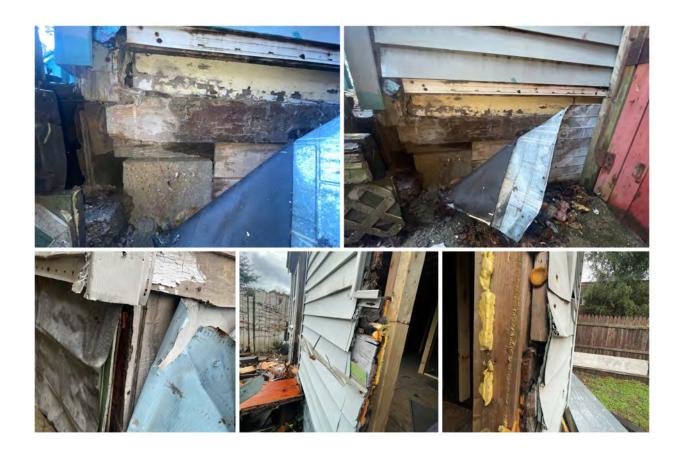
The siding is not in good condition. There are many spots around all sides of the house that are damaged or missing and not repairable. We would like to replace it with vinyl siding of an approved color.

- -The original wood siding underneath is deteriorating and cannot be repaired, or it is missing entirely. Photos above shows this.
- -The scalloped siding at top of the house will be retained. This is the only location on the house where there is decorative siding.
- -New vinyl siding will retain exposure of current wood window casings if we cannot replace with vinyl.
- -Between the foundation of the house and ground is a metal/aluminum material. We have checked several places online and were unable to find anything similar to match.

Scope: New siding will be installed in the color of A:7 Bluish Gray
