STAFF REPORT: FEBRUARY 9, 2022 MEETING

APPLICATION NUMBER: 22-7665, VIOLATION NUMBER: 543

ADDRESS: 715 VAN DYKE

SCOPE: DEMOLISH (WORK DONE WITHOUT APPROVAL) AND REBUILD FRONT PORCH

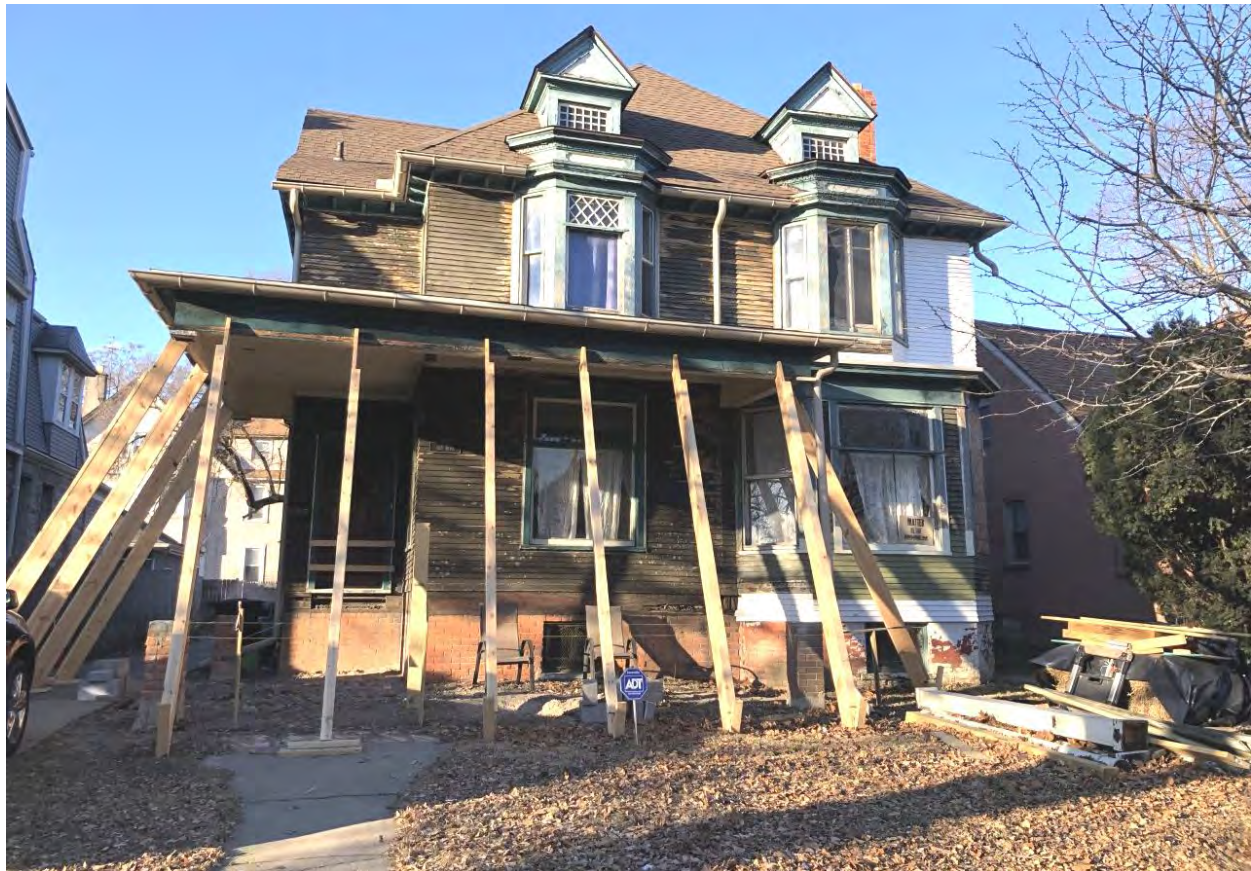
HDC staff photo, January 21, 2022

Erected ca. 1905, the building at 715 Van Dyke is a 2 ½-story, single-family dwelling. The building features a hipped-roof central mass with projecting gabled wings at the side elevations and a flat roof mass at the rear. Gabled-roof dormers top the front and rear roof. Decorative brackets are located within the roof's soffit. Flat roof dormers at the front and north elevations display decorative dentils at their cornices. A one-story, flat-roof wood porch with box columns wraps around the building's southeast corner. Windows at the front and side elevations are historic wood-sash units. Painted asphalt/insulbrick siding was present at time of district designation, but was more recently removed so that the historic wood siding could be restored.

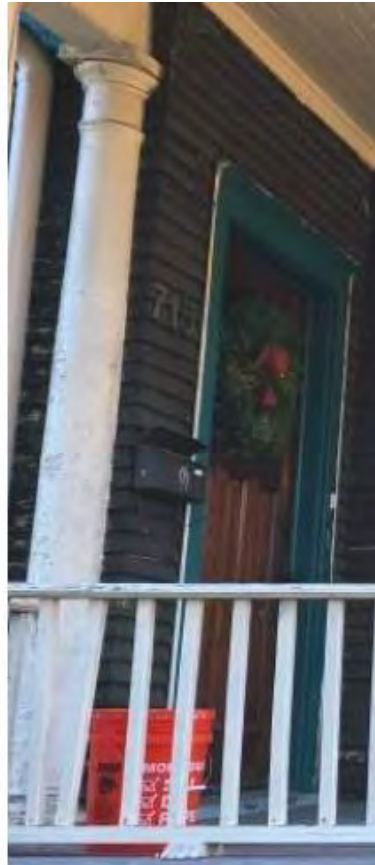
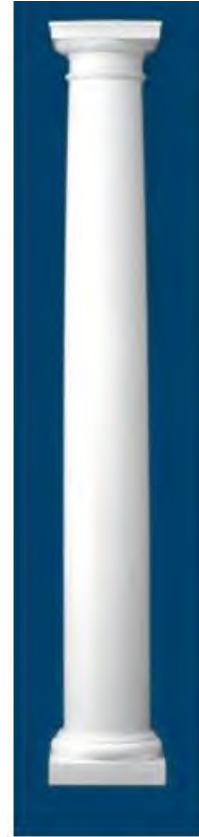
- The best and most appropriate replacement would be a turned-wood column to match the existing prototype. However, it is staff’s opinion the replacement column, while not a perfect match, is similar to the design and proportionality of the historic column and therefore, is reasonable and feasible.

Photo and catalog images supplied by applicant.
 The original pilaster appears to have a slightly tapered smooth shaft.
 The proposed fiberglass column has a similar Tuscan capital (with slightly different dimensions) and a smooth tapered shaft. The diameter at its widest point will be 8”, similar to the wood pilaster’s width.

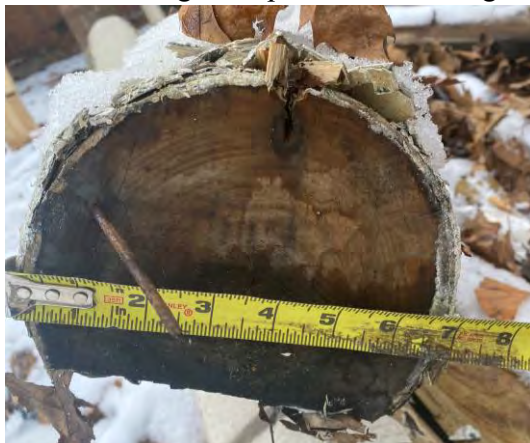
Diameter at the top of the pilaster – seven inches

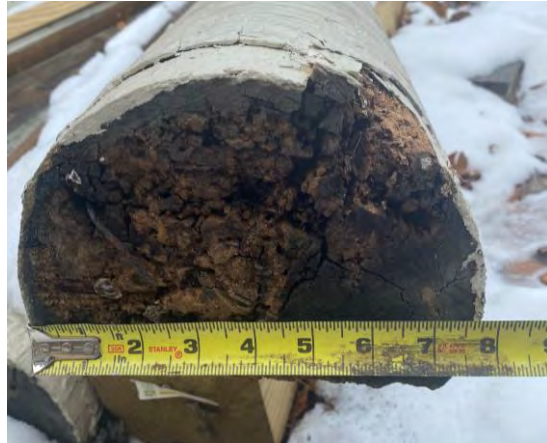
Bottom diameter of pilaster – eight inches

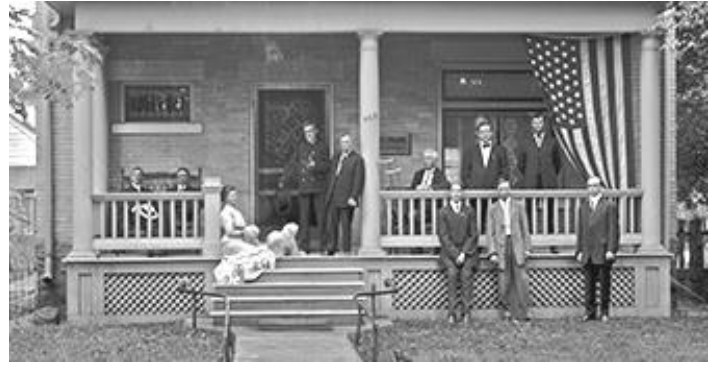
NPS Preservation Brief 45 *Preserving Historic Porches*

- The installation of the skirting as drawn offers a monolithic approach, and is counter to the age and design of the house. As stated under *Staff Observations and Research*, vertical boards comprising the skirting and its design, should be installed behind framing. Larger vertical boards should divide the skirting at the location of the columns/piers to continue the porch's vertical support line from roof-to-grade. The circa 1912 photo at the right gives a visual example of this method of construction.

- The skirting design will be revised to include framing and vertical boards at column/pier locations and will be submitted for staff review.
- The paint color/finish for each porch component (including decking) will be submitted for staff review.
- The porch elements won't be painted until the wood members have dried out.

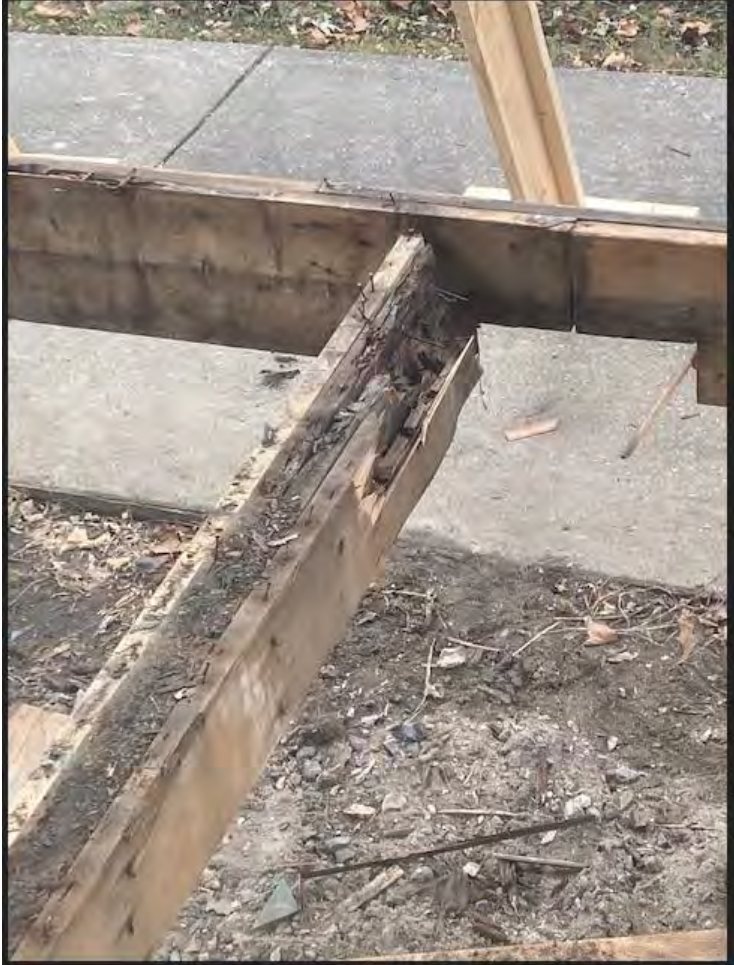
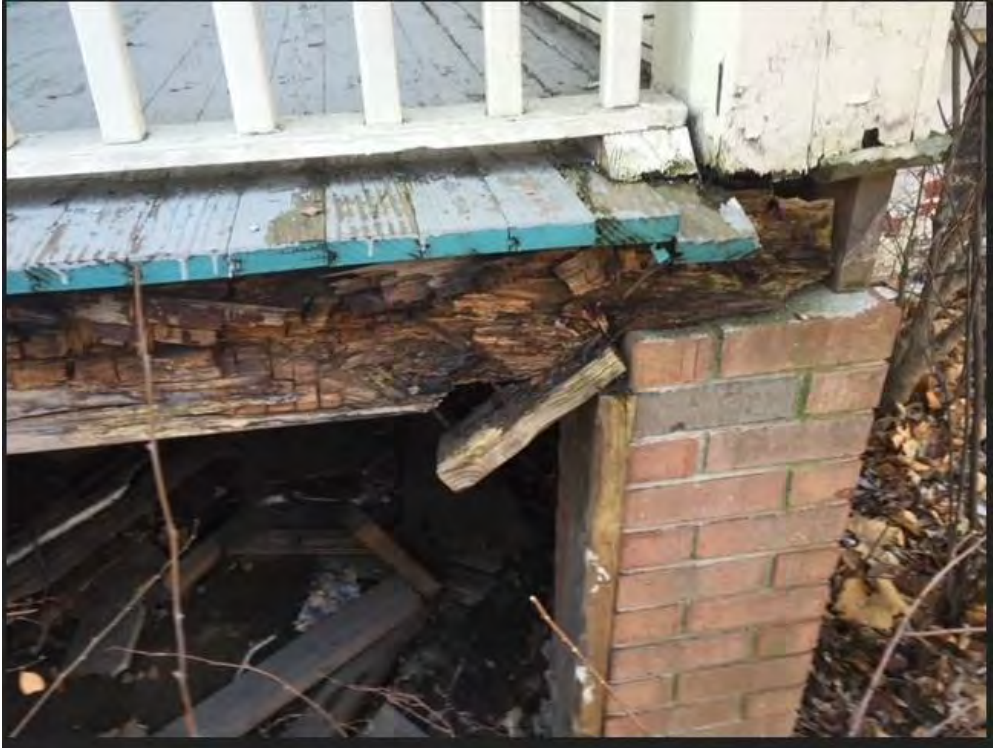
Condition of original porch: Rotten Wood / Missing Footing

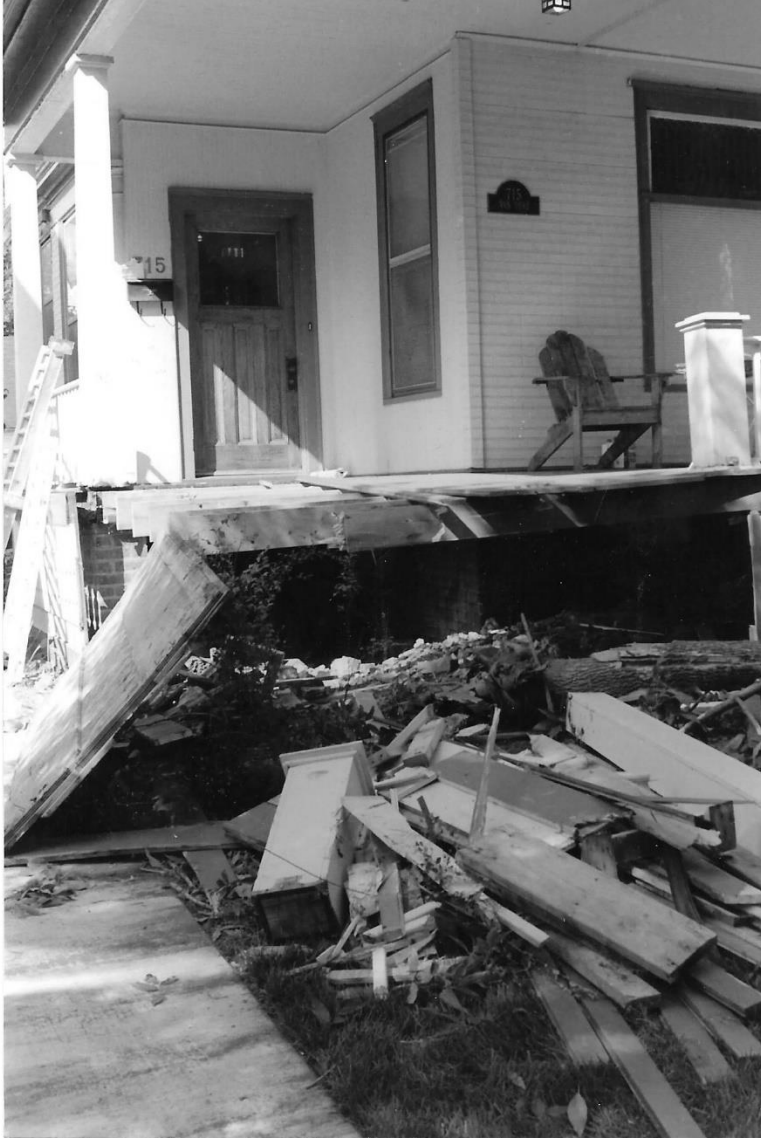
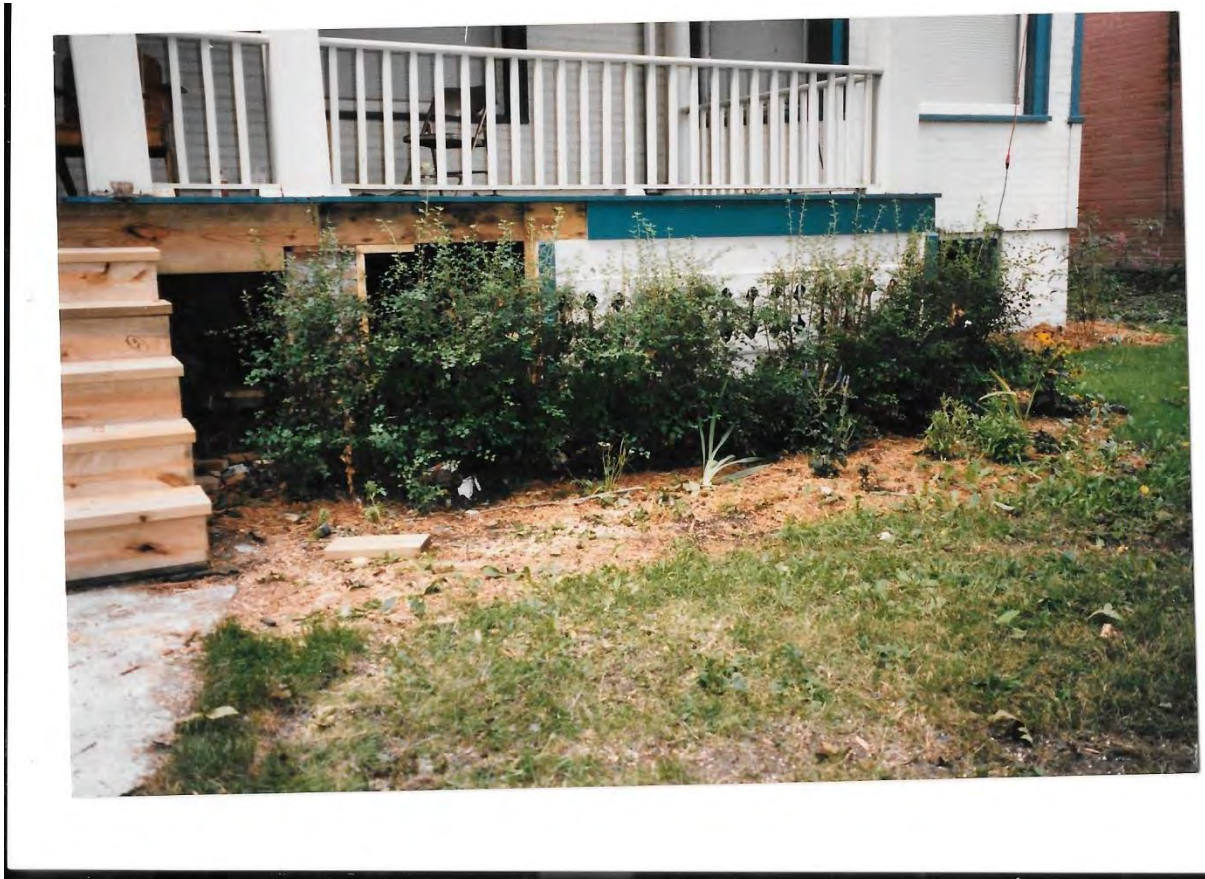
Porch Rebound in the 1990's

I received these pictures from the previous owner (Cheryl Huff). She rebuilt a large section of this porch in the 1990s. There are some scanned images of the rebuilding of the porch. As you can see – nothing is up to historical accuracy, or code.

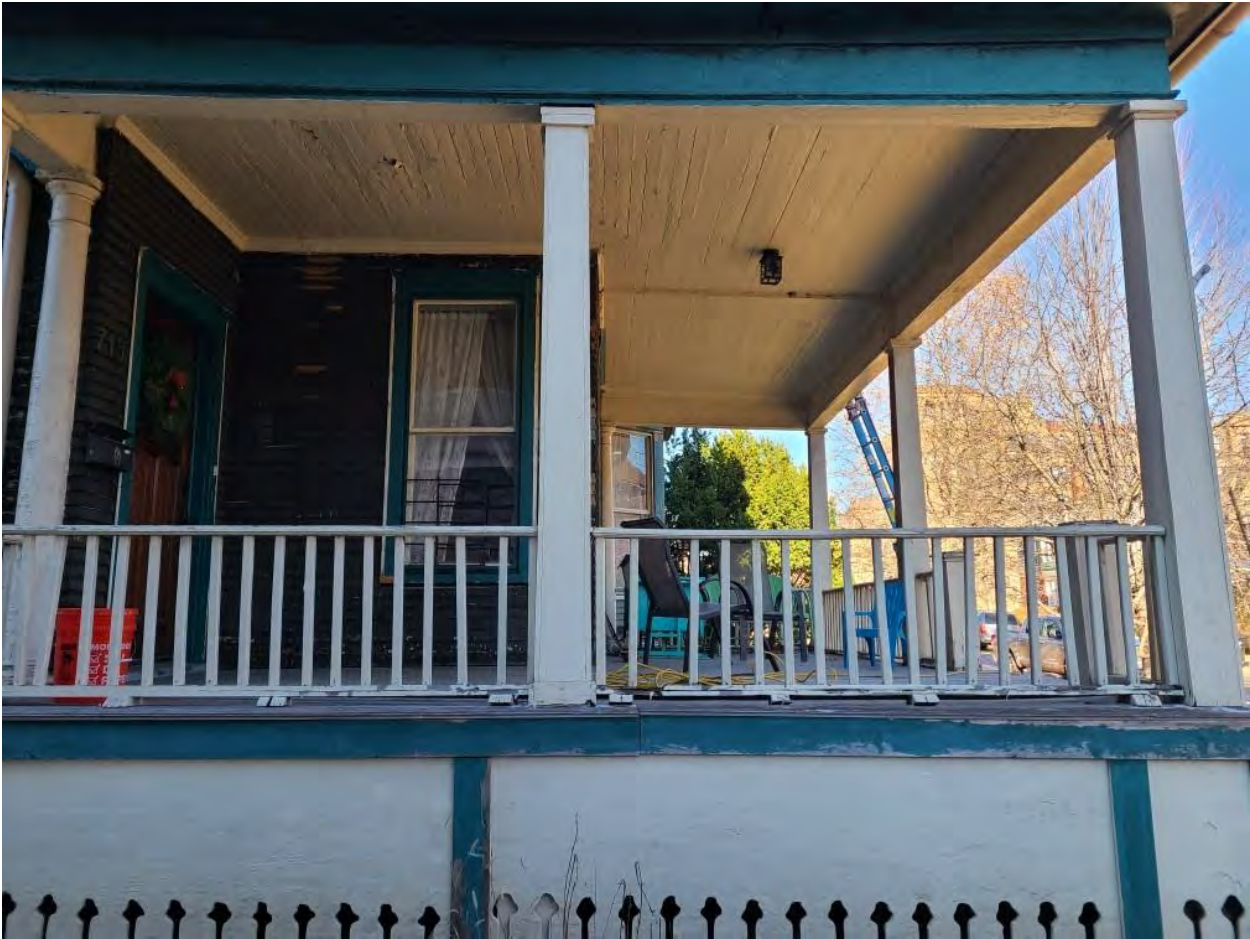
Not that I am that worried about the skirting at this point but as you can see the “decorative” Victorian that was added.

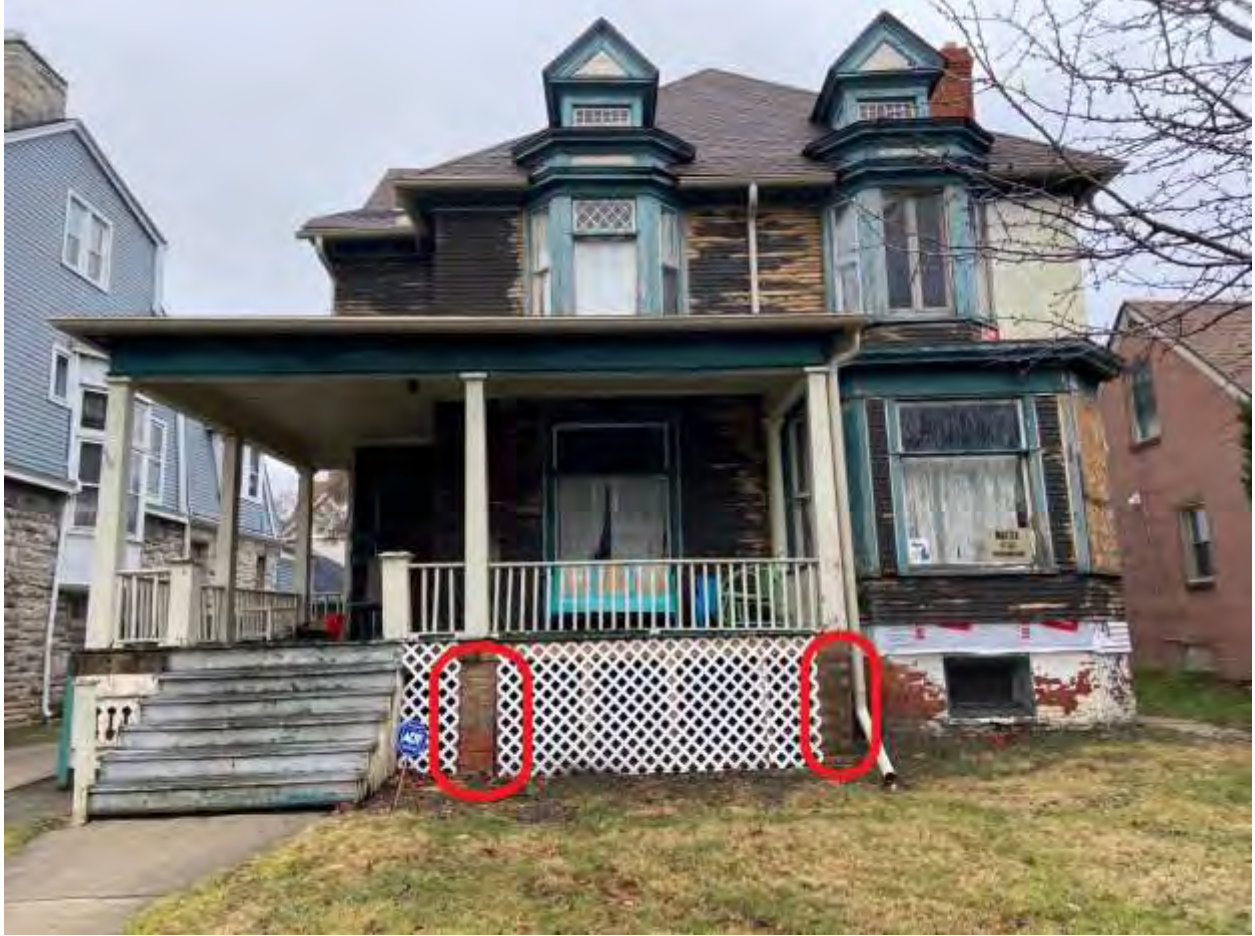
Original brick piers: you can see from this pic that they are angled and are off centered

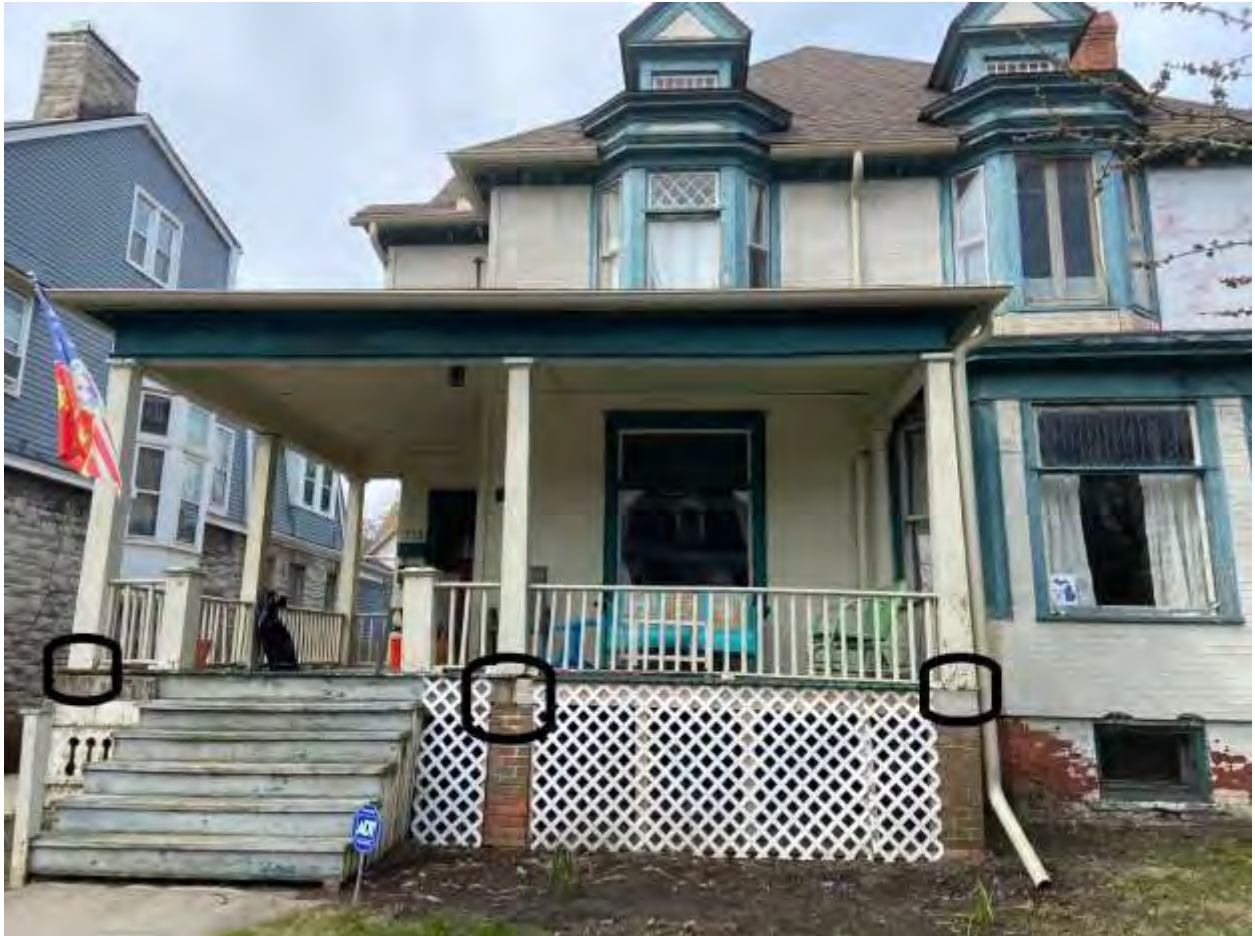
In this picture you can see the pillars have no bases, are not connect to porch and are rotting at the base
