**STAFF REPORT: FEBRUARY 23, 2022 MEETING**

**APPLICATION NUMBER: 22-7674**

**ADDRESS: 14831 WARWICK**

**SCOPE: REPLACE WOOD DOOR WITH FIBERGLASS DOOR**

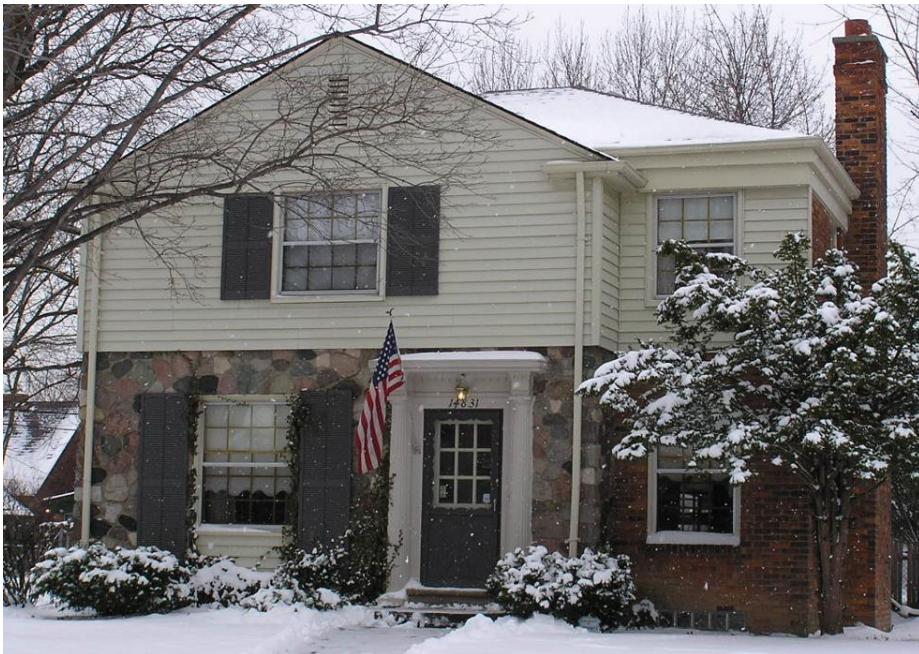
14831 Warwick designation photo, 2007. Photo shows original windows, all of double-hung operation.

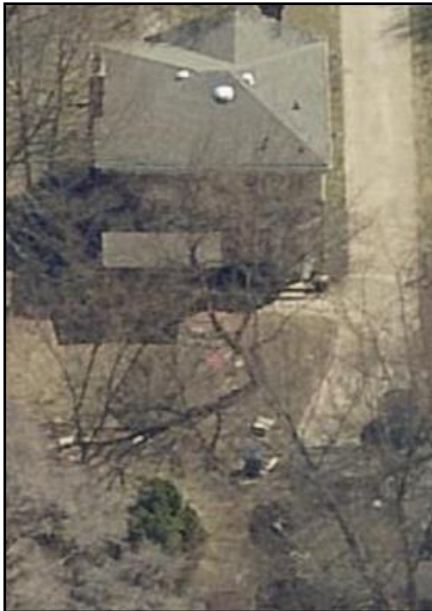
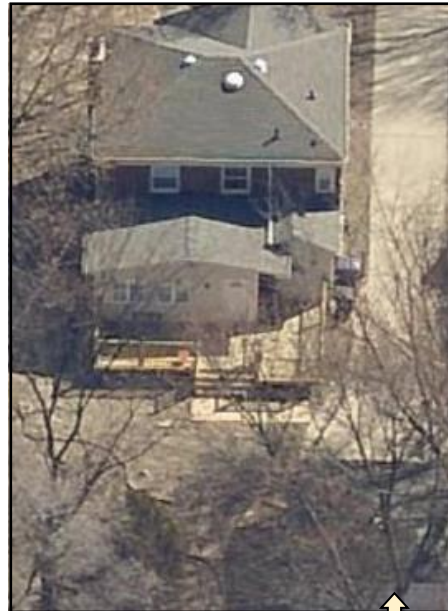
- When surveying the side elevations to confirm the extent of the window replacement, HDC staff also noted that a rear addition was erected between 2014 and 2018. Staff didn't locate an HDC approval nor a building permit for this addition.

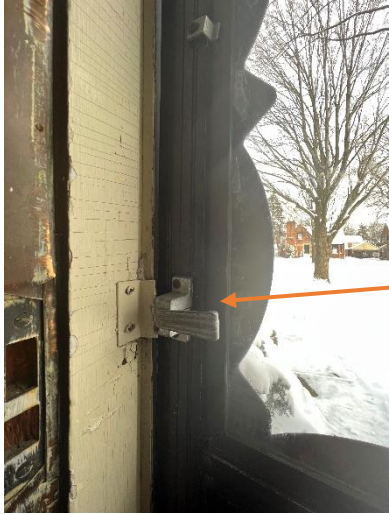
Screen door doesn't lock

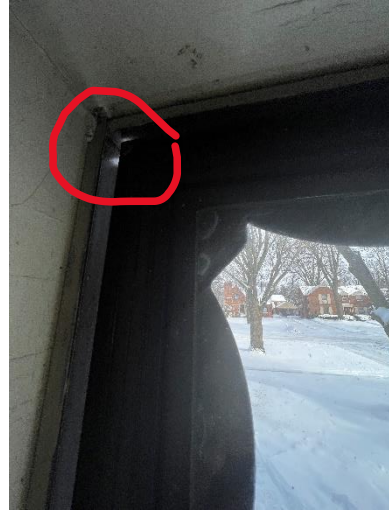
Screen door doesn't close all the way,

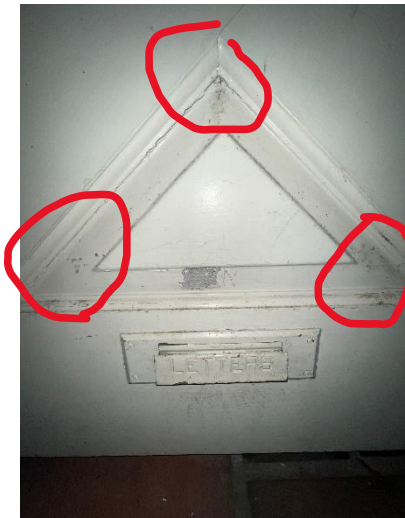
- The condition of the door does not appear to be deteriorated beyond repair. The mold on the door may likely be remediated by a cleaning (and maybe repainting) and the mold around the recently installed glass panel might be mitigated by the installation of laminated glass and subsequent repair to the seam created for the single pane glass installation.

Mold on door

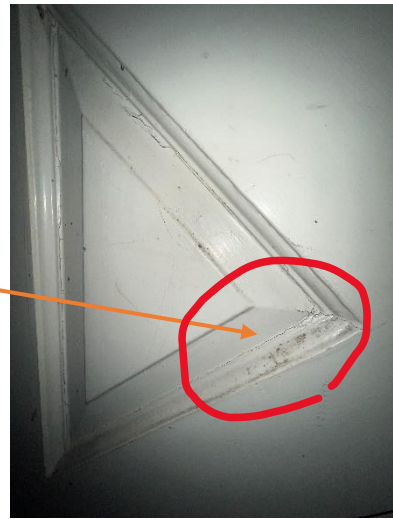
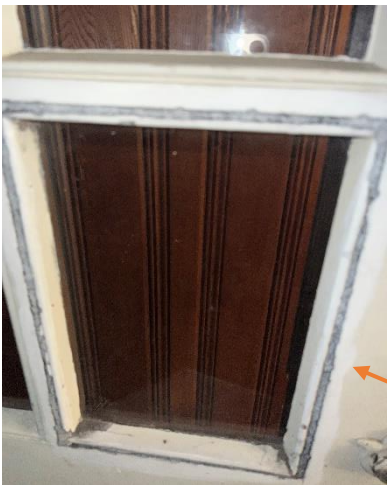
Mold growing around window pane that was replaced

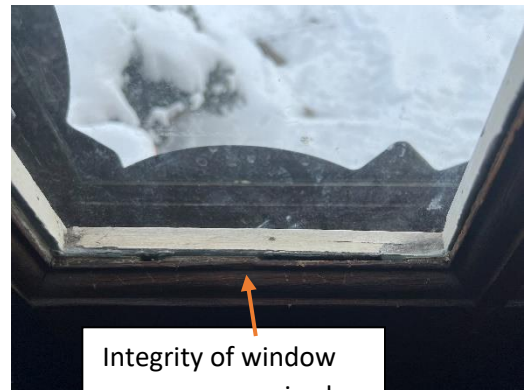
Integrity of window pane compromised after being replaced
