**STAFF REPORT:** 3/16/2022 SPECIAL MEETING

**ADDRESS:** 296 ELIOT

**APPLICATION NO:** #22-7663

**SCOPE:** REHABILITATE BUILDING

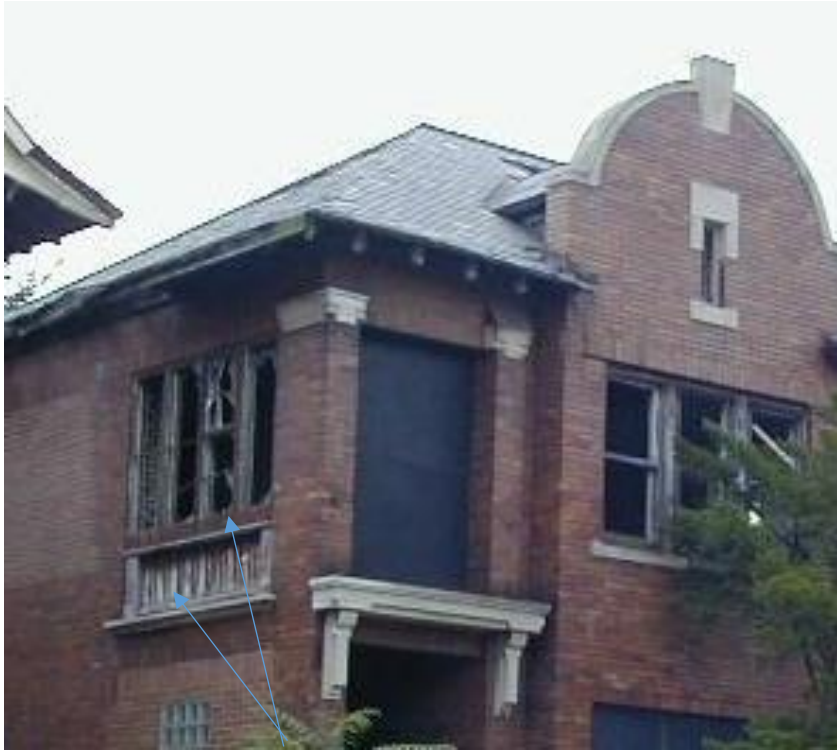
- See the below photos. Re: the northernmost window opening at the second story, east elevation, the applicant is proposing to remove the existing windows, trim and wood panel below to create a large window opening with 3, 1/1 mullied units. It is unclear if these windows will be fixed or double hung. It is staff’s opinion that the proposed introduction of large 1/1 windows at this location is inappropriate as it is unlikely that the proposed matches the original window configuration. As the original configuration is unknown, staff recommends that the size, light configuration, and operation of the current windows be maintained and that the area below, which is currently enclosed with wood panel, be infilled with brick and the current decorative stone sill be maintained at its current location.

**Condition in 2000. Note that this location included 4, double-hung, mullioned windows within this opening. There is a brick sill with an opening below that is infilled with wood paneling. Also, note location of historic/original stone sill**

- The new window proposed for installation at the northernmost window opening at the second story, east elevation, shall maintain the size, light configuration, and operation of the current windows. The area below the windows which is currently enclosed with wood pane and trim, shall be infilled with brick and the current decorative stone sill be maintained at its current location.

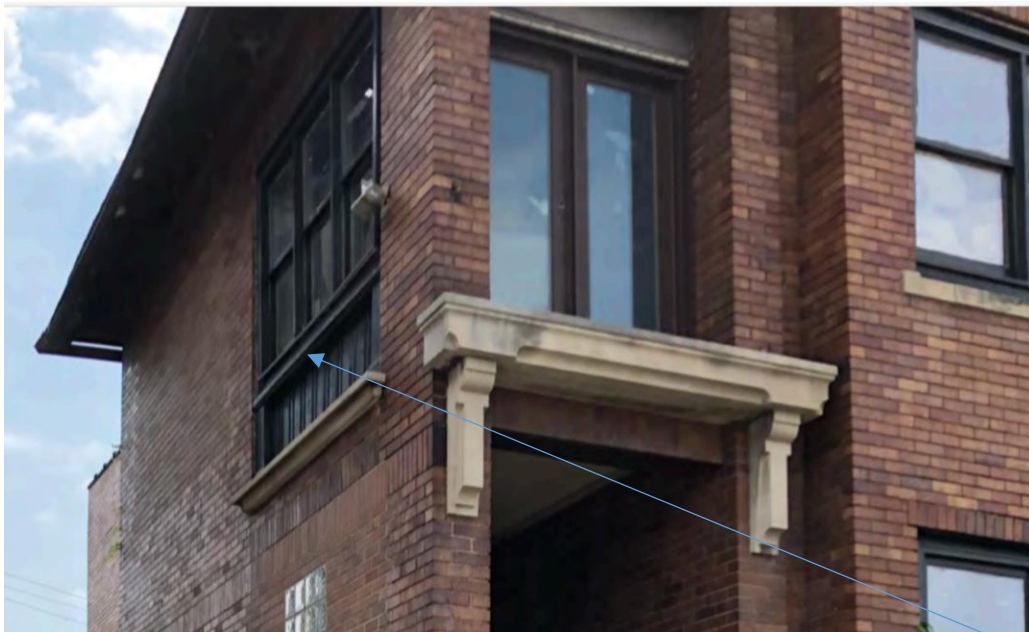
**Current condition. Note that 2001 rehab resulted in the replacement of the brick sill with wood trim and the installation of 3, double-hung windows.**

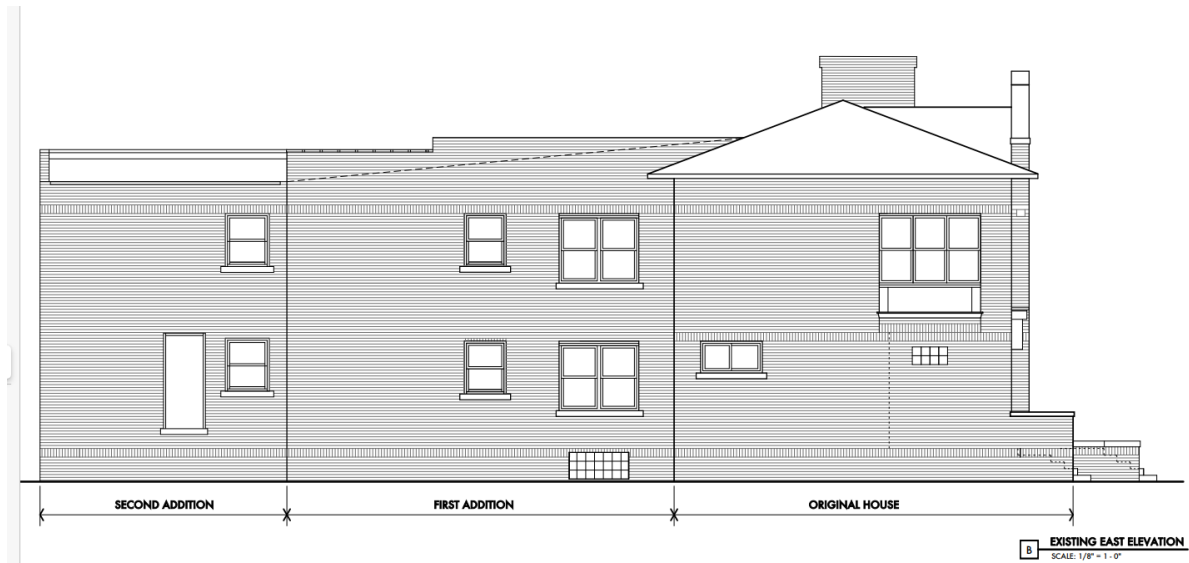
**Drawing, current condition**

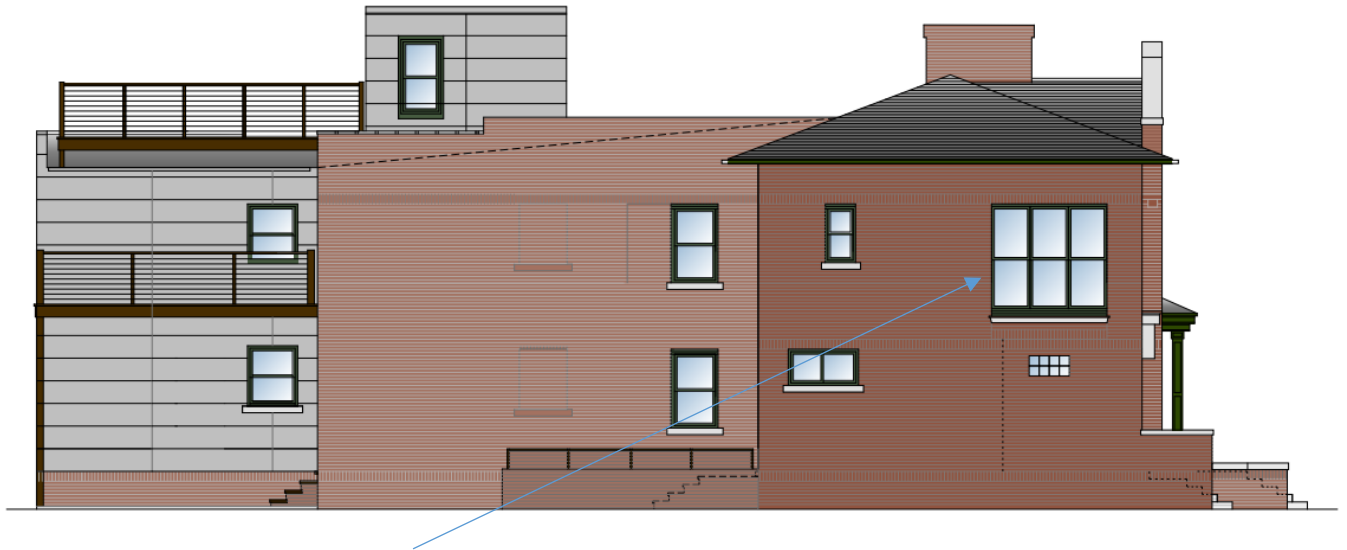
**Drawing, proposed condition. It is unclear to staff if these windows are fixed or double hung. Staff does not recommend that fixed windows be added at this location. Also, note the large size of these windows which will result from the removal of the existing windows, trim, and wood enclosure beneath the original window opening. It is staff's opinion that these windows are too large. Any new windows should be installed within/confined to the original opening size**

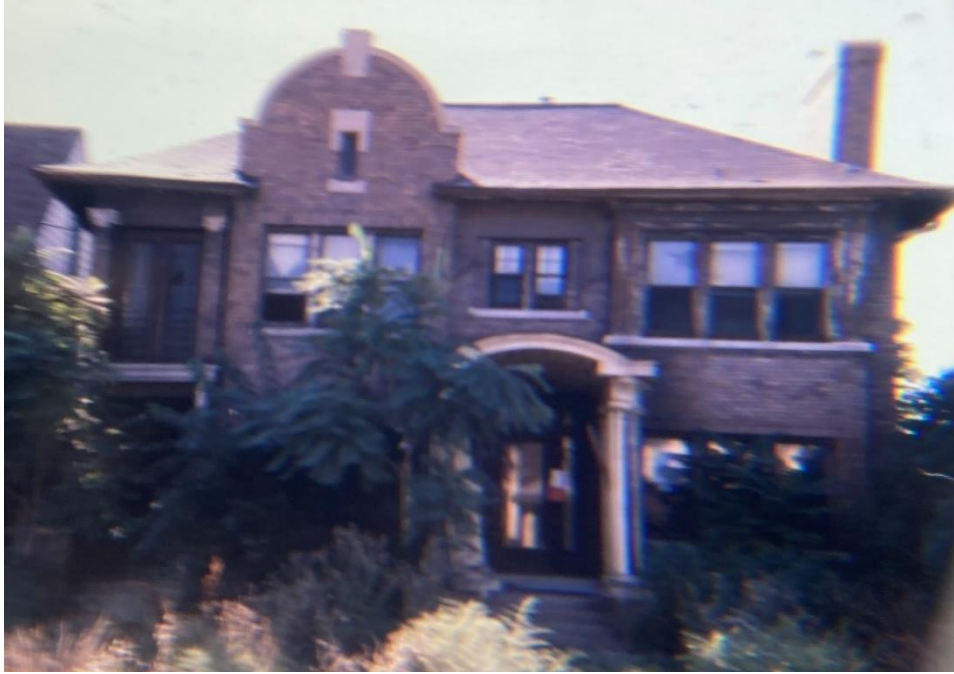
- The 2001 COA approved the installation of aluminum-clad, wood windows which matched the operation and light configuration of the original. Note that the current, centrally-located, small window at the second story is a 1/1 unit. Per the 2000 photo (and the designation photo), the windows at that unit consisted of a set of mullied, double hung units. The current application is seeking to install a single 1/1 unit at that location. However, staff recommends that the new window at this location meet the 2001 COA/that the windows shall be paired, mullied, 1/1 units.

**Designation slide. Appearance in 1980. Note window operation, light configuration and remaining surround at front-elevation, second-story western triple-sash window bay**

- If the current, centrally-located, small 1/1 window unit will be removed, it shall be replaced with paired, mullied, 1/1 units

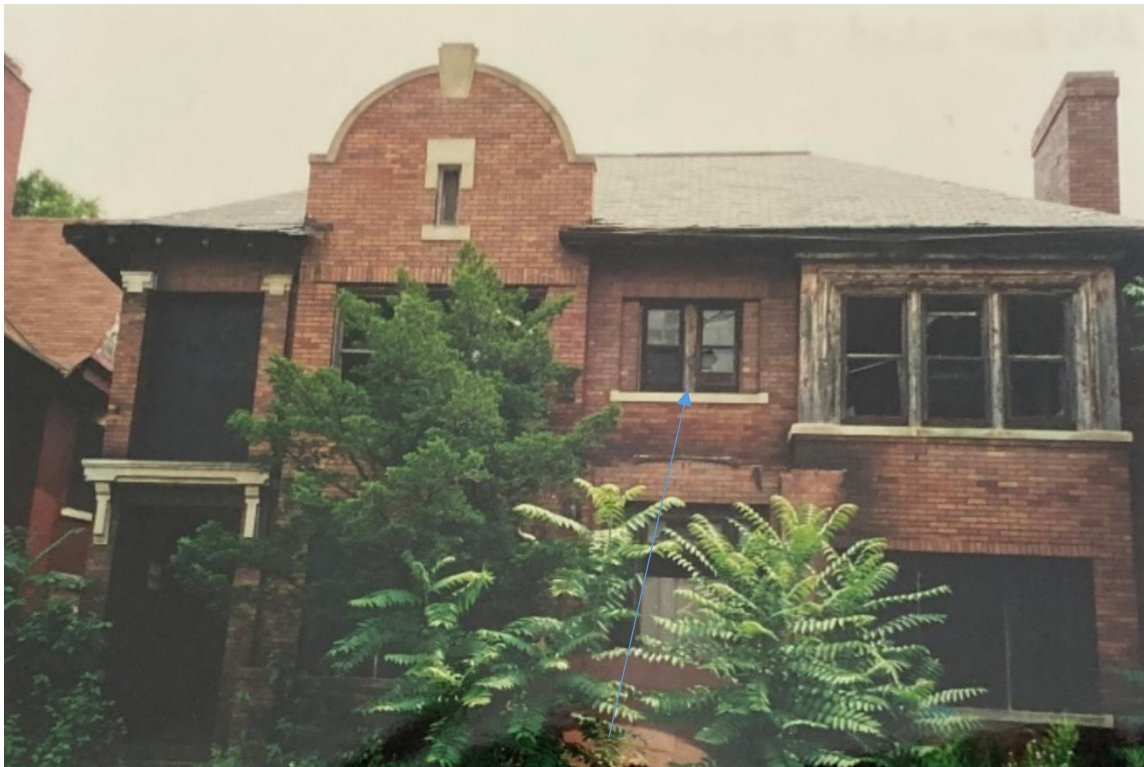
**Photo taken in 2000. COA required that new windows match designation slide conditions**

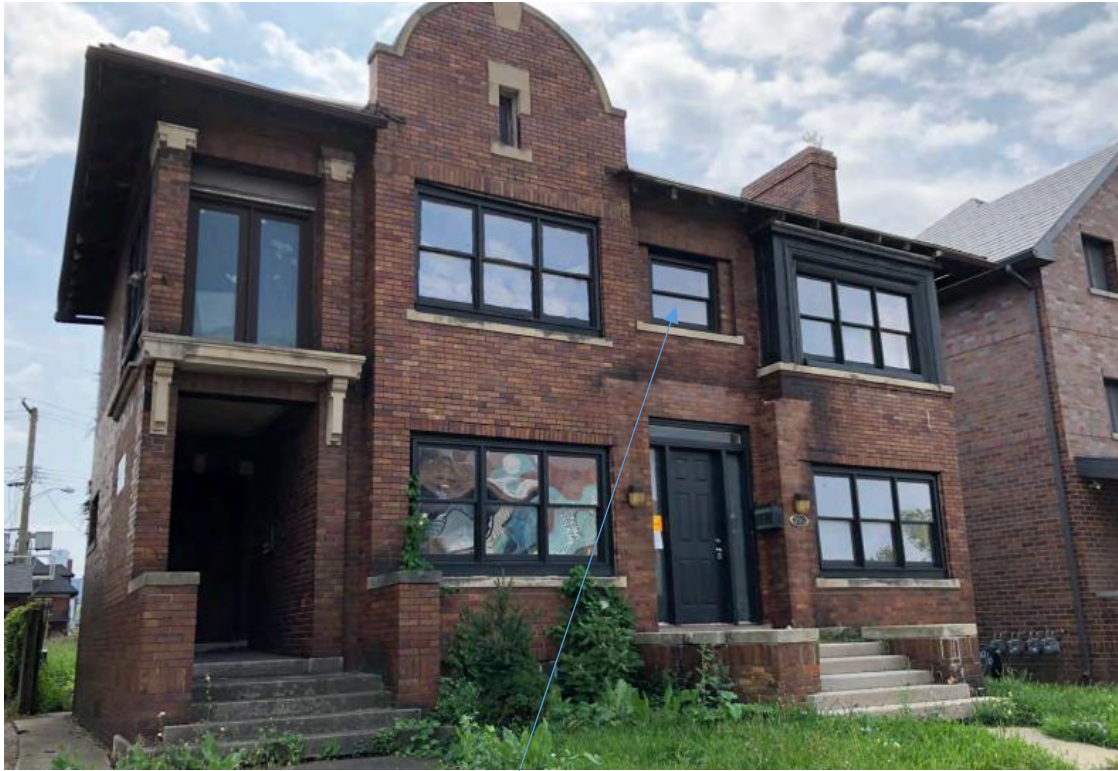
**Current condition. New windows proposed to match existing**

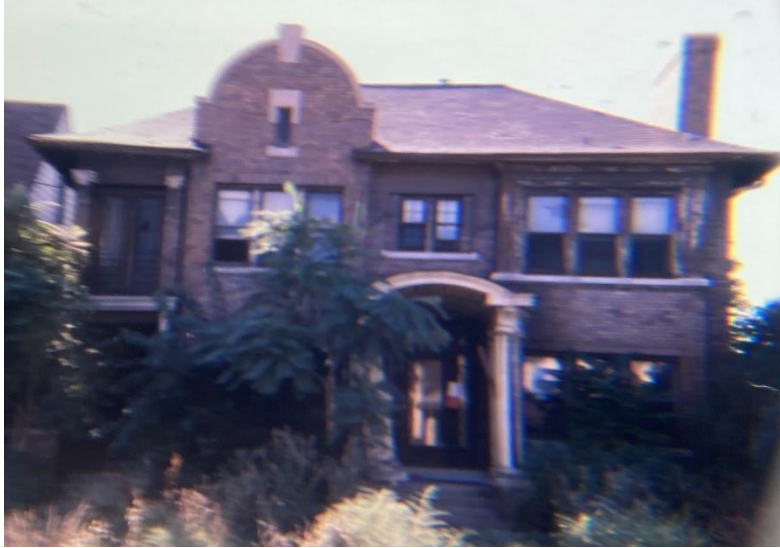
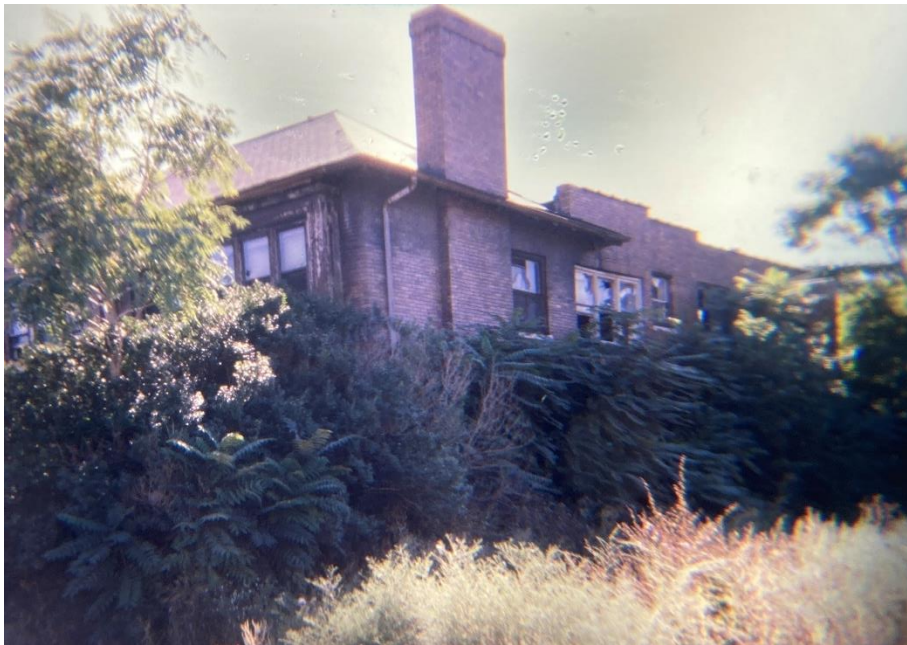
**Designation slides, taken in 1980. Note the level of deterioration at the building's windows**
