STAFF REPORT: 3/16/2022 REGULAR MEETING

ADDRESS: 86-92 E. FOREST

APPLICATION NO: #22-7716

SCOPE: DEMOLISH AND REBUILD EAST/SIDE ELEVATION ADDITION; REPLACE SLATE ROOF; REHABILITATE BUILDING; AND ESTABLISH NEW PARKING LOT

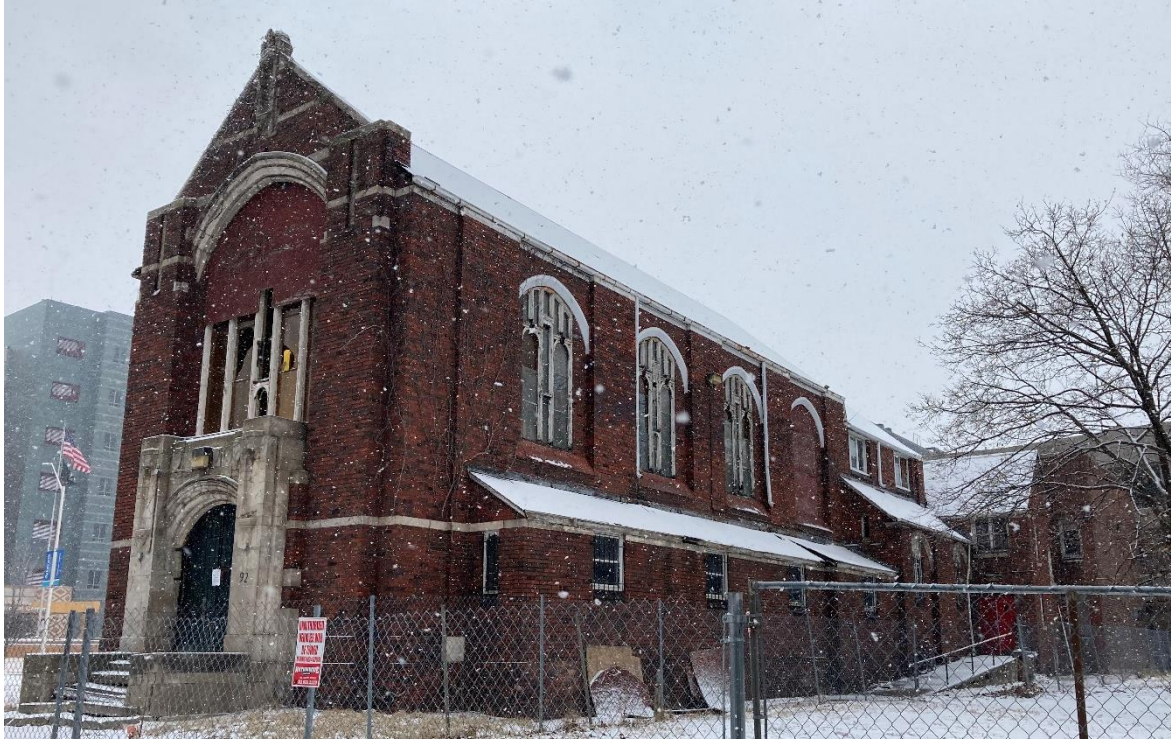
92 E. Forest, current conditions

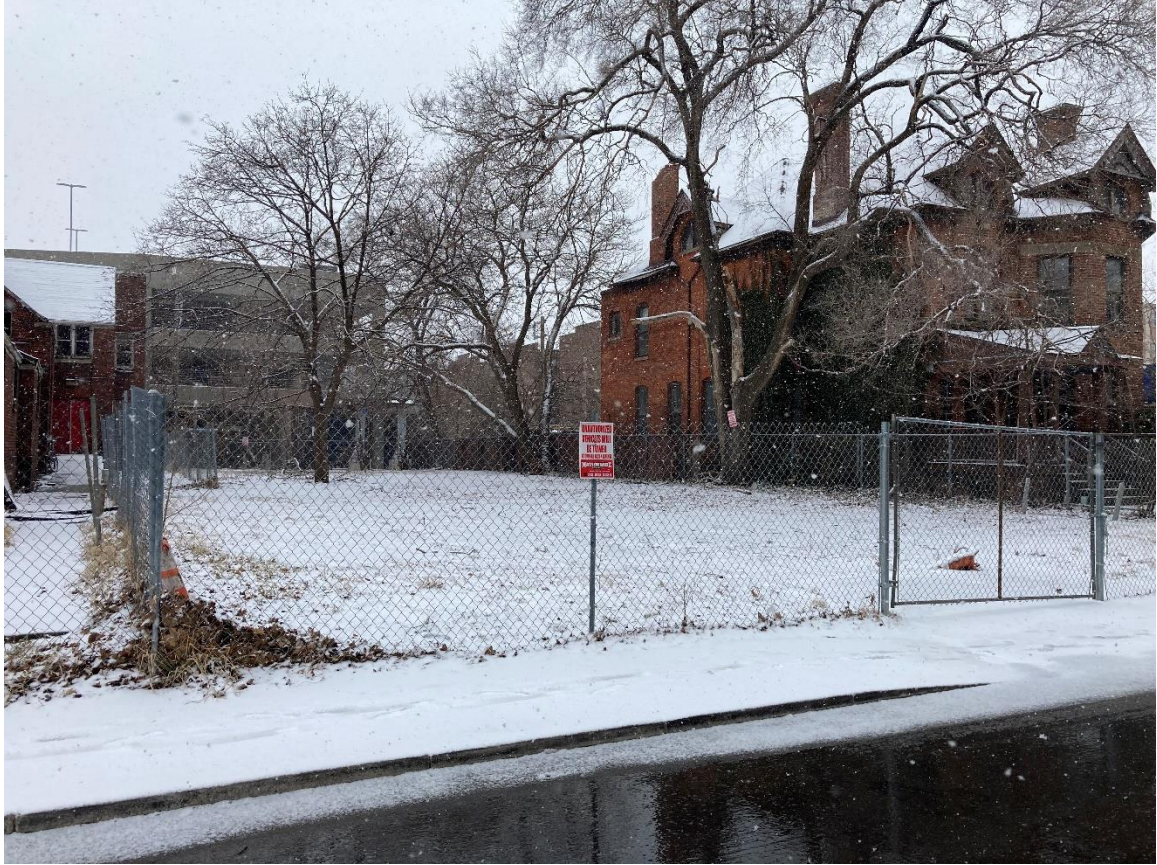
86 E. Forest, current conditions

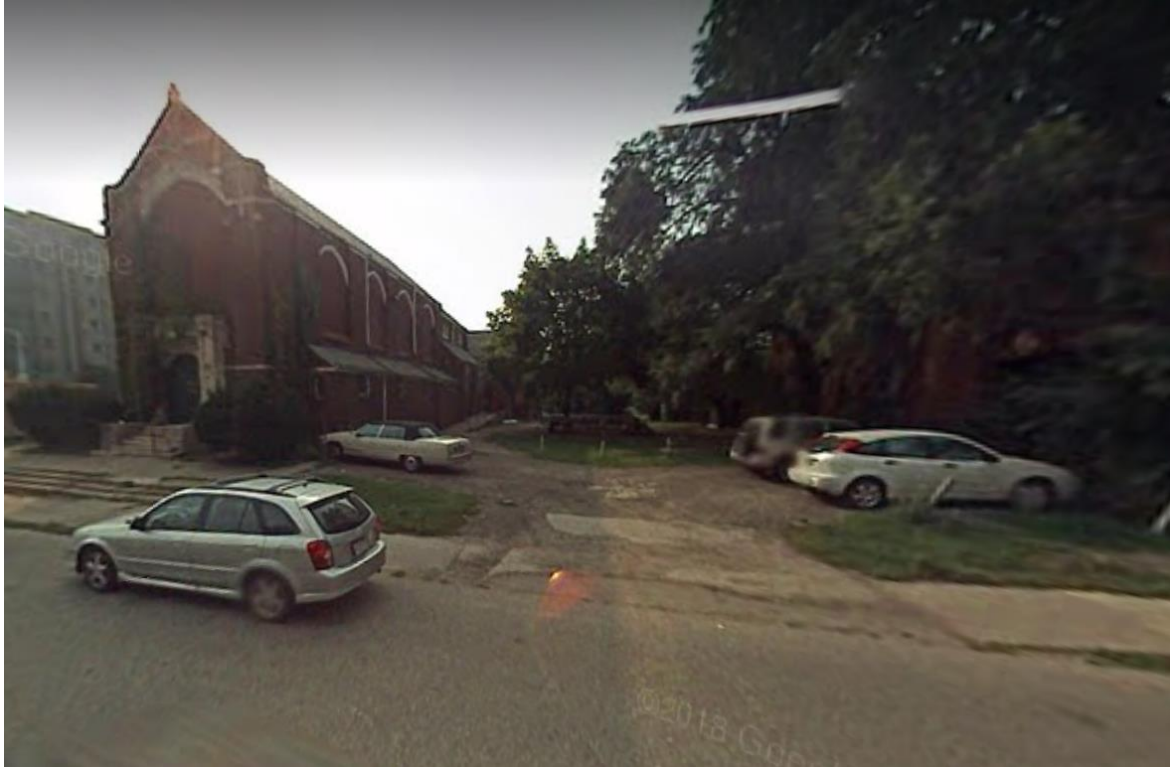
- See the below Google Streetview image, dating from 2007, which indicates that 86. E. Forest was used for parking prior to the designation of the district. The Sugar Hill/John R. Arts District was designated in 2009.

86 E. Forest, Google Streetview, 2007. Note presence of curb cut

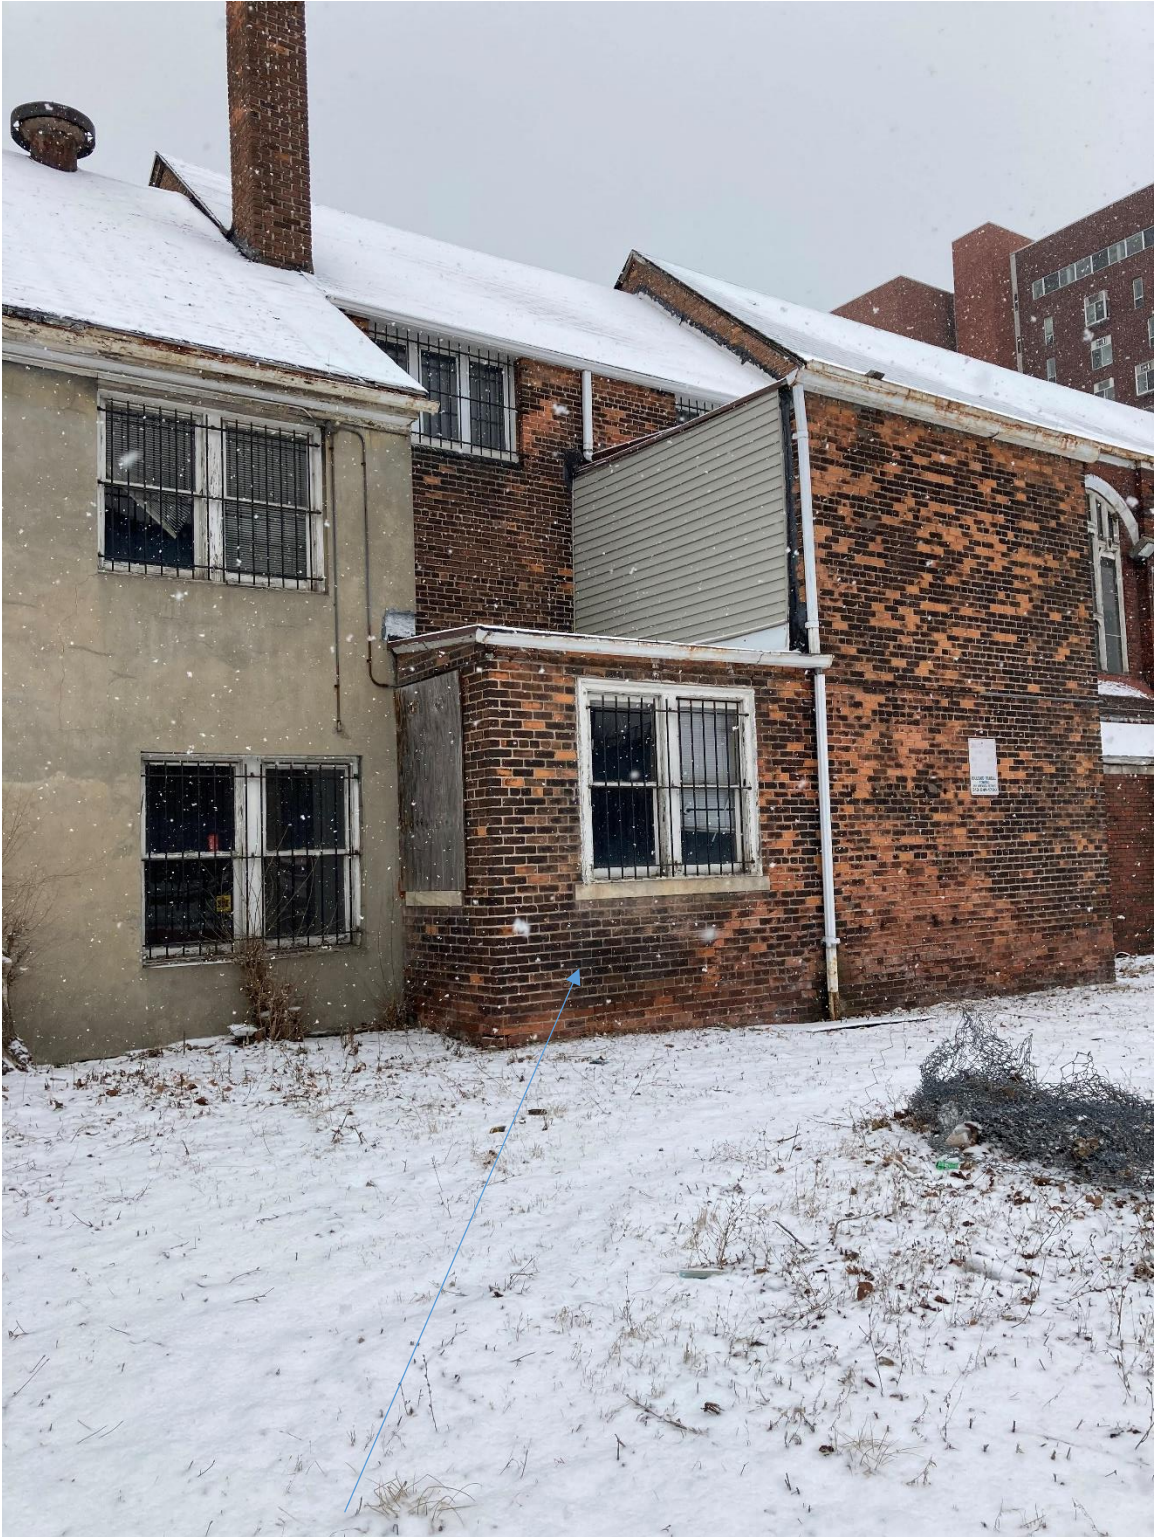
This wing will be demolished, with new wing to be built within the same footprint. The second-story portion of the new wing will be higher than the current. The existing brick will be reused to clad the new wing.

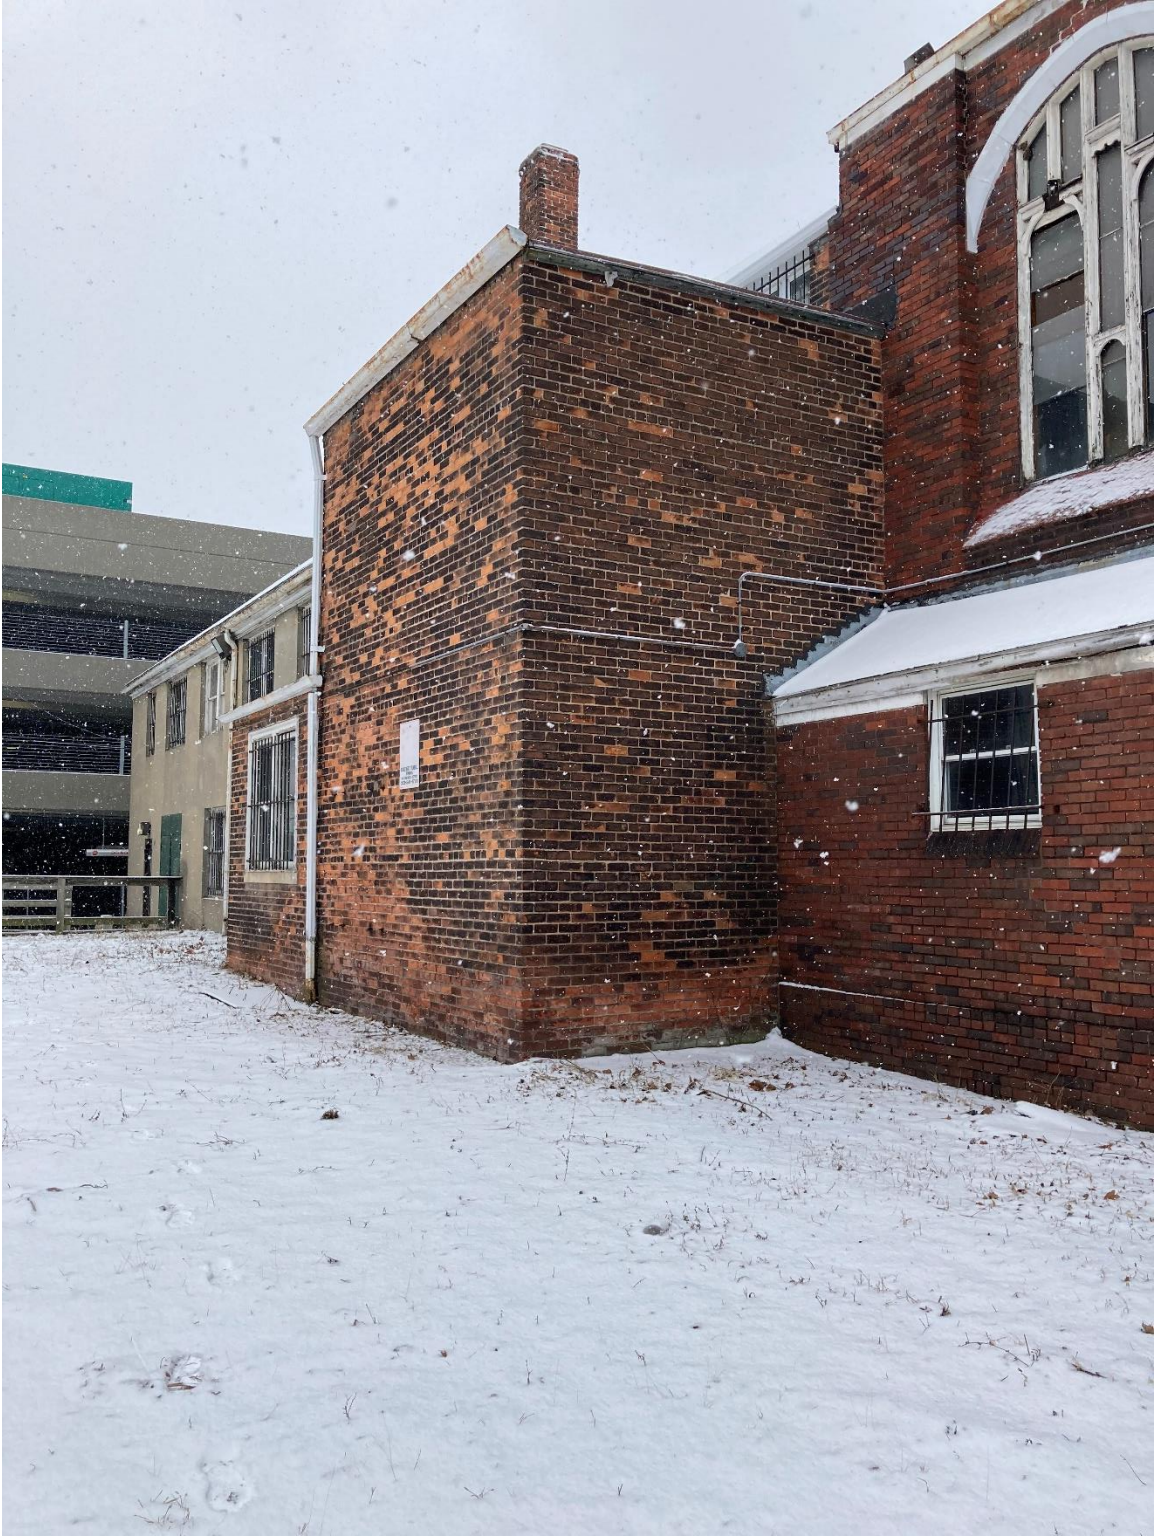
This wing will be demolished, with new wing to be built within the same footprint. The second-story portion of the new wing will be higher than the current. The existing brick will be reused to clad the new wing.
