**STAFF REPORT 04-13-2021 REGULAR MEETING**

**APPLICATION NUMBER: 21-7744**

**ADDRESS: 603 E MILWAUKEE (AKA PEERLESS BUILDING)**

**SCOPE: REPLACE WINDOWS**

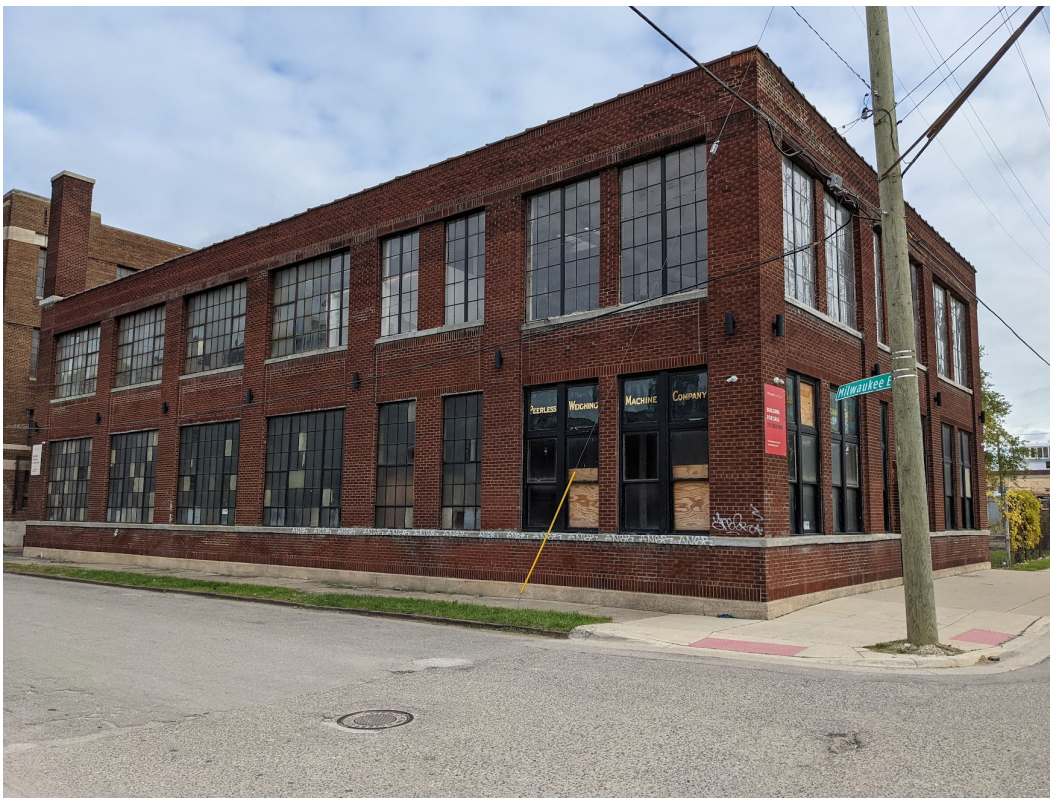
The subject property is a historically distinctive corner property with steel sash factory windows and transomed single-hung (essentially, triple sash) wood windows at the first-floor corner and extending across the first-floor East Milwaukee facade. Erected in 1925, the building is of brick and steel frame construction, exhibiting dark red brick competently deployed in modest ornamental patterns; juxtaposed with modern concrete sills and a water table below the first floor window line. Window groupings are divided by brick piers, and the main entry on Milwaukee has a brick portal slightly relieved from the main building façade. The top sashes in the wood windows show painted gold lettering from a previous manufacturing tenant.

*View of existing conditions at 603 E Milwaukee, corner of St. Antoine and E. Milwaukee. Staff photo, November 2, 2021.*

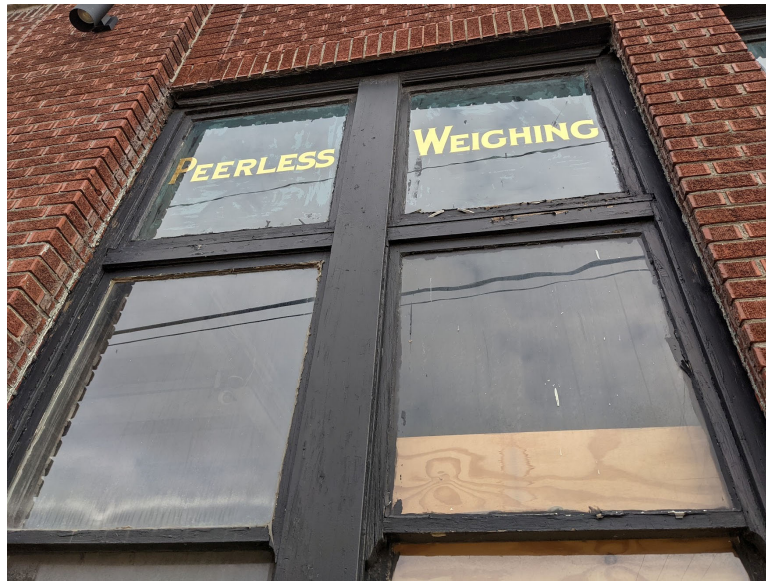
*Detail view of large wood windows at first floor. Staff photo, November 2, 2021.*

- It is evident to professional staff, given our own expertise and experience in the field, that these wood windows are not deteriorated beyond repair, and can “reasonably be repaired” per NPS Guidance. Destroying them, instead of somehow protecting the future “architectural heritage and design” of the building, will instead have the unfortunate result of substantially and irreversibly damaging such character. These are important and distinct windows, and should be preserved.

- Concerns about heating or energy efficiency can and should be addressed by the selection and installation of appropriate storm windows, similar to thousands of such installations protecting historic wood windows in historic districts in northern cities.
- As noted in the previous November 2021 staff report, the proper rebuilding and restoration of wood windows is a common activity for property owners and woodworkers throughout Detroit’s historic districts. Staff not only sees relatively minor deterioration in these particular windows, but is confident that any required repair (i.e., for the sills as mentioned in the report) is both feasible and technically reasonable.

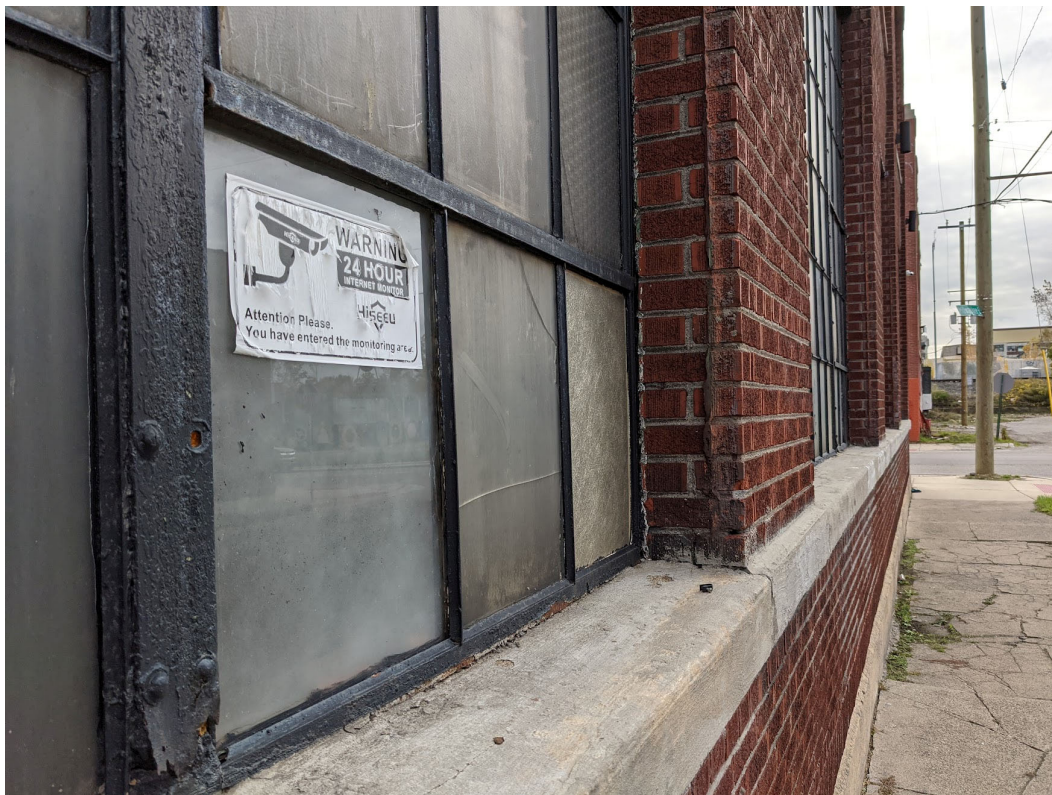
*Detail view of steel sash windows and concrete sill/brick at first floor. Staff photo, November 2, 2021*

- **Steel sash windows:**
- We have now received, via this new application, a quote for repair of the windows.
- The report characterizes the windows as being in “very poor” condition. Staff disagrees and would characterize them as poor to fair. These are industrial windows built for an industrial use, and should not be held to an appearance or performance standard for windows that may be desirable for a modern luxury residences. There are areas of substantial decay, but repair is feasible.

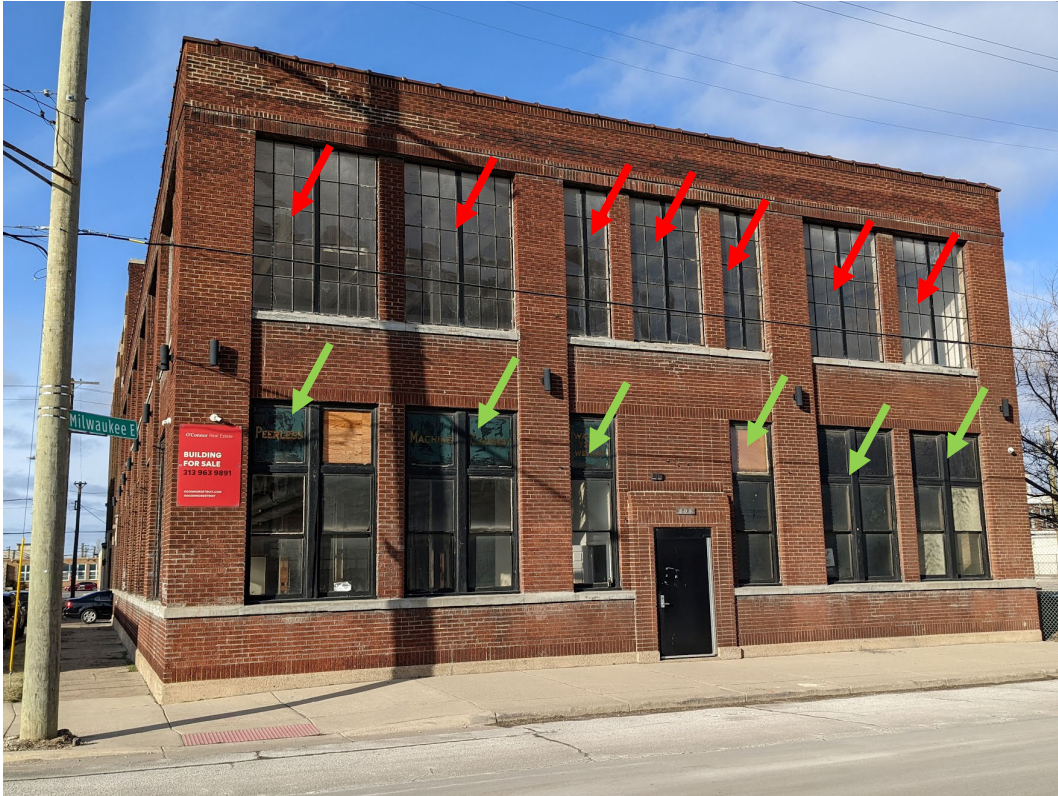
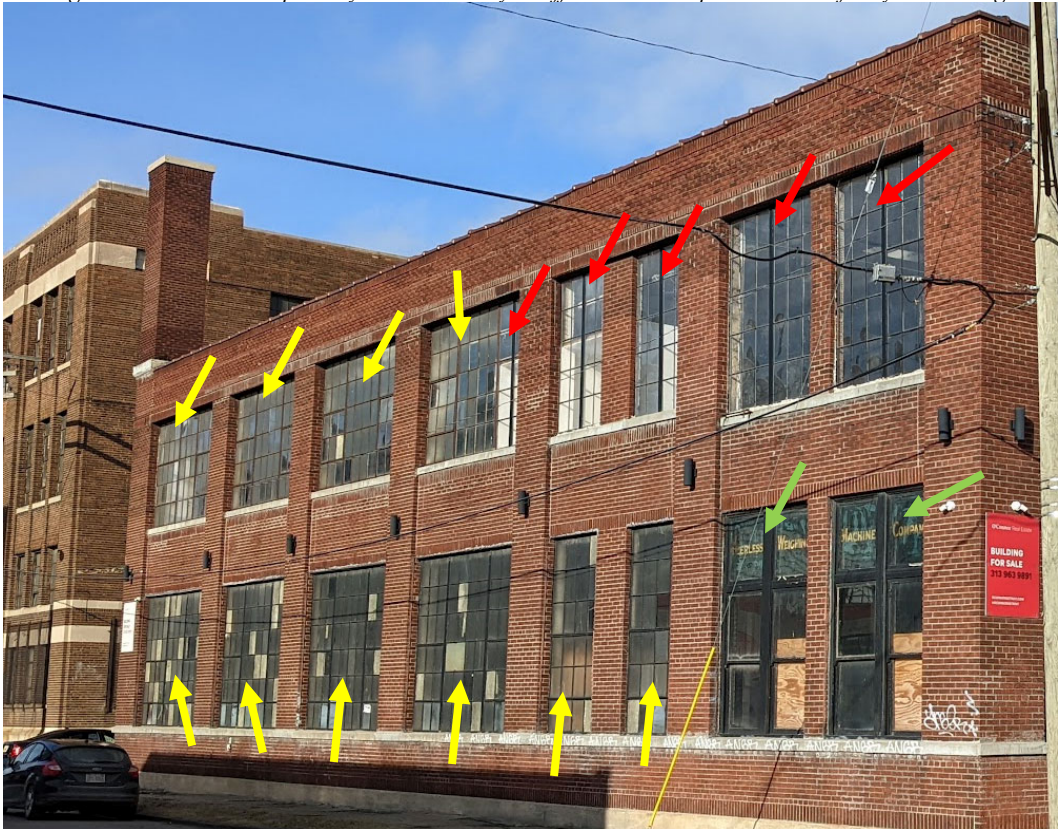
*Above and below images: Non-historic steel sash windows indicated with red, historic steel sash windows in yellow, wood windows in green. Front and side primary elevations only. Staff recommends preservation of all yellow and green locations.*

- The remaining steel windows at the primary elevation on St. Antoine (staff counts ten, including one opening partially replaced with new) are distinctive character-defining features that define and establish the historic character of this property.

- The Quaker H450 Series replacement windows proposed are appropriate and compatible for locations where no historic windows remain (red arrow locations on the diagram, and alley side/east side), or, should the Commission decide that the original steel windows are beyond feasible repair, in all steel window locations.

Staff finds that the proposed replacement of windows at *non-primary* elevations (alley and east elevations), and the replacement of *non-historic* steel windows at the primary elevations (St. Antoine/East Milwaukee), to be appropriate per the Secretary of the Interior's Standards and the defined elements of design for the historic district. Staff therefore recommends that the Commission issue a Certificate of Appropriateness for this work.

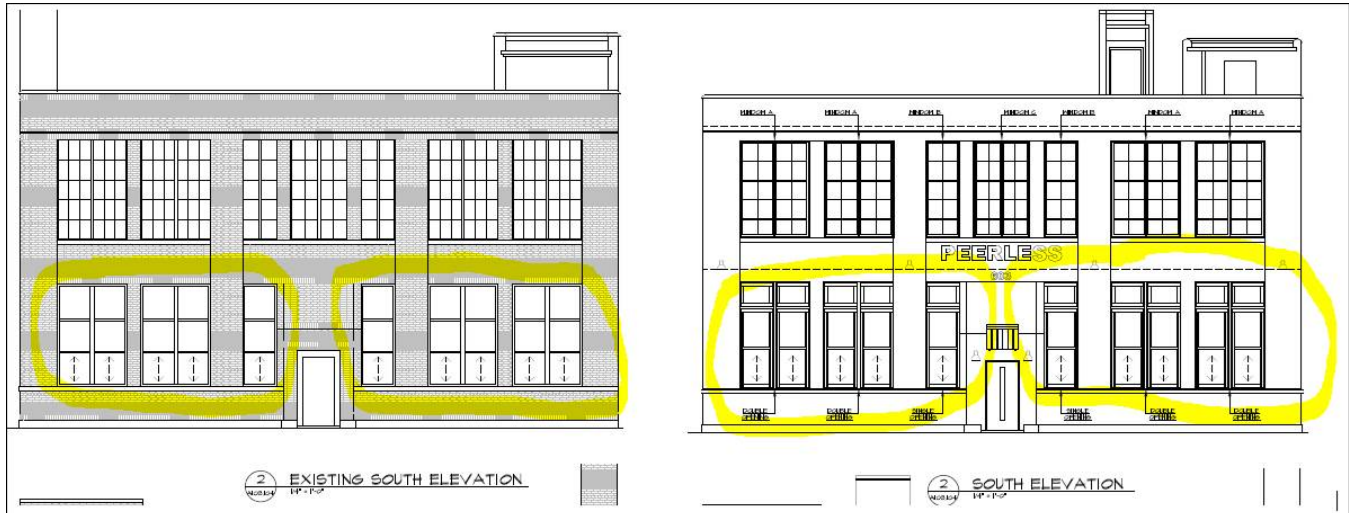
- Although replacements should only be considered if the originals are determined beyond repair under Standard 6, staff does note that the proposed replacements, per the elevations below, are poorly matched and do not convincingly replicate the original historic expression. Defining features of the historic window, in addition to its authentic detailing, include their original materiality, historically lettered glazing, and hand-crafted details.

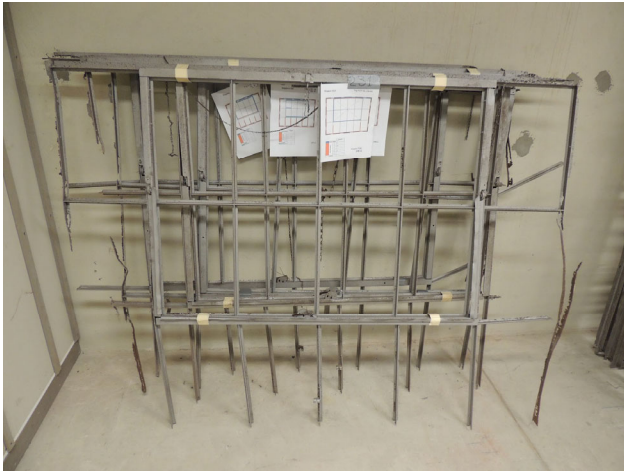
- Staff has included in this report photographs from an unrelated project, with your staff writer as the consulting historic architect, for a historic rehabilitation project for a National Park Service property on the east coast, which featured steel industrial windows in very poor condition. The windows were restored and reinstalled.

Before restoration (treated and primed)
