STAFF REPORT: APRIL 13, 2022 MEETING PREPARED BY: A. DYE

APPLICATION NUMBER: 22-7752

ADDRESS: 15004 WARWICK

SCOPE: REPLACE WOOD WINDOWS WITH VINYL WINDOWS

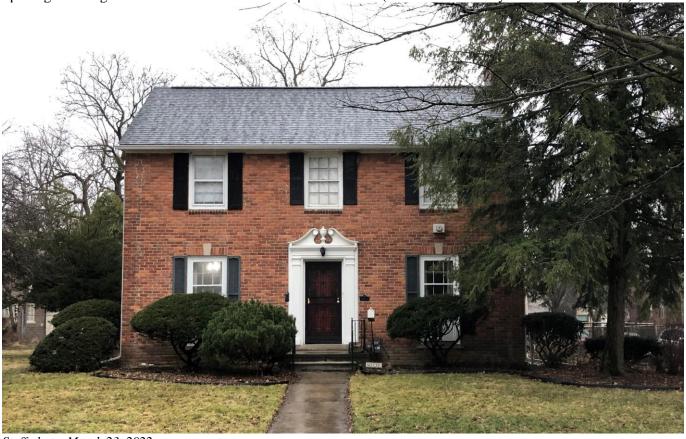
Staff photo, March 23, 2022

Erected circa 1935, this two-story house was designed with minimal, yet prominently placed colonial revival details, including a symmetrical placement of window and door openings, keystones above the first-floor window openings, and a front entry flanked by pilasters and topped with a highly sculpted broken pediment. The windows on each elevation are double-hung units with a six-over-six glass pattern; the front elevation first floor window openings are larger than the others due to wood panels below (which are currently obscured by shrubs).

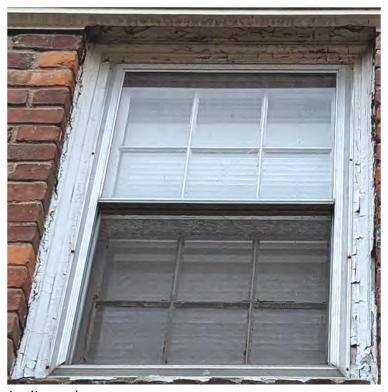
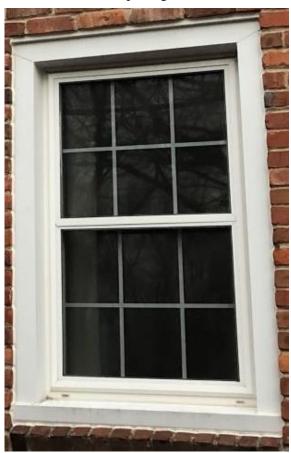
Applicant photos

- The applicant states the original windows are suffering from condensation that is trapped between the storm and wood sash, and that he has attempted to maintain the windows. The windows do not appear to be highly deteriorated, likely in part to the owner's proactive care. The condensation may be caused by storm windows that do not have weep holes (or that the weep holes have been covered with caulk), whose purpose is to prevent/minimize moisture from being trapped against the window sash.

- Vinyl windows are not appropriate for historic houses, as the level of detail of a true-divided light window can not be matched by current vinyl production methods. Even though the storm window on the wood unit partially obscures the dimensionality of muntins when looking at the window from a distance, once up close, the dimensionality is noticeable and retains equal dominance with the profile of the wood brickmold. The vinyl window frame is boxy and flat, and makes the window sash look even more recessed. Additionally, the muntins of the vinyl unit are flat and in shadow, as they are recessed behind the glass. They add very little to the definition of the window unit and window opening.

- o It is possible the wood windows can be repaired by an experienced window repair company, and the installation of better fitting storms that offer weep holes may not only take care of the existing problems, but may offer greater thermal insulation than new plastic window framed units.

The Wallside window contract states each new window will cost \$1669. Staff believes the professional repair/restoration of a 34" x 53" double-hung window with wood muntins, and the installation of a new storm window would likely be less than the price of the vinyl window. The repaired units will offer a much longer lifespan through continued maintenance and repair. Repair is not an option for vinyl windows due to the totality of their fabrication, therefore they will need to be replaced, and then replaced again.

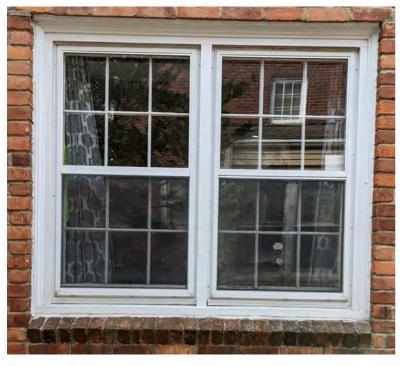
6. Bathroom Window
Has major chipping of
paint. Caulking pulling
away from brick exterior.
single pane glass with bad
glazing. No glass storm for
lower 1/2. Condensation
that pools on interior as
seen in the detail picture to
the right.

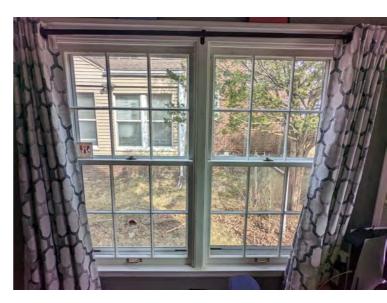
Windows 9 and 10 I refinished the exterior During the Covid shutdown period in 2020. The grills glazing is chipping and lifting. The storm is a white aluminum. One of the many styles of storm mix matched across the

Interior view of 9 and 10 although may look ok in this photo they also suffer from moisture pooling on sills and has mold growth. Windows 8, 9, and 10 all have a screen insert as well as glass storm system which is the white aluminum and have faired the best in the existing wood windows because of it.

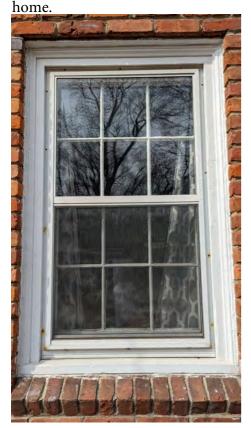
8. exterior view rusting frame and fasteners

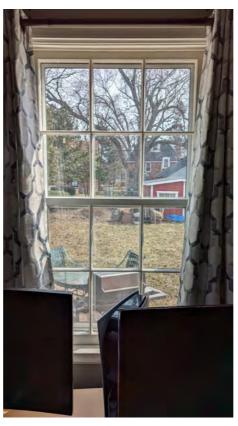
8. interior view also pools moisture

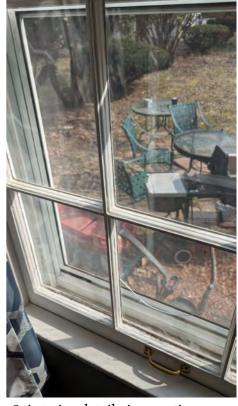
8. interior detail view. notice cracked pane and moisture

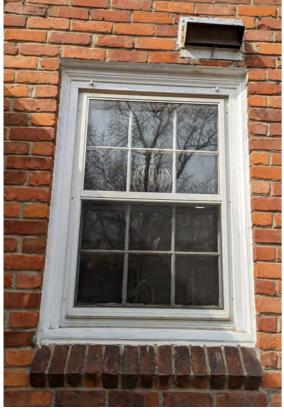
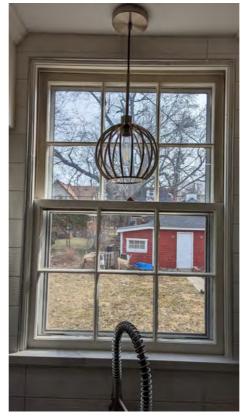
11. Kitchen Sink window This is another window I have attempted to repair. This lower glass portion of this storm is missing and therefore deals with a lot of moisture pooling. The interior of this window was painted in 2021 with a high quality latex paint and it still has visible mold on the lower sill when you zoom into the photo. The sound of the wind is pronounced at this window and we fear is a major point of escaping heat and energy loss.

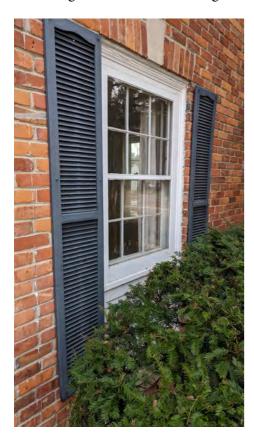
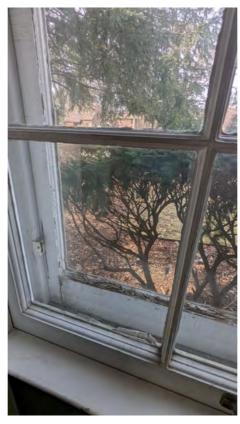
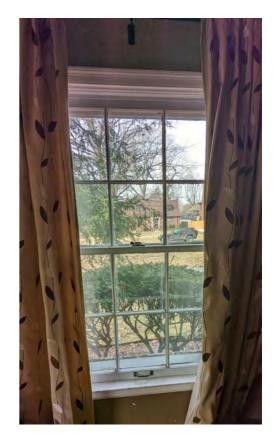
2. Dining Area Exterior, Dining Area Interior, and Dining Area Interior Detail (L to R)

In this set of 2. Dining Area Window photos to the left you will notice the third style of storm window. There is only 2 of this style of storm in the home, here and found in the Living Room. These windows have shown very little moisture on the interior sills. I would attribute this in all most likely hood to have had caulked the storm shut when I repainted the exterior.

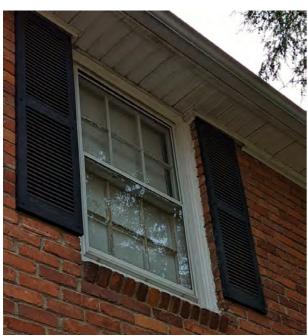
4. Upstairs Bedroom 1 Exterior, Interior, and Interior Detail.

*Note Storm is missing completely from this window and lets in a massive draft. In the exterior photo you can notice fresh window glazing that is unpainted due to weather temp dropping last year before we could complete the restoration of the panes. Major mold growth this year discovered at time of taking these photos.
