**STAFF REPORT: MAY 11, 2022 MEETING**

**APPLICATION NUMBER: #22-7808**

**ADDRESS: 647 ARDEN PARK**

**SCOPE OF WORK: REPLACE GLASS BLOCK WINDOWS WITH VINYL WINDOWS**

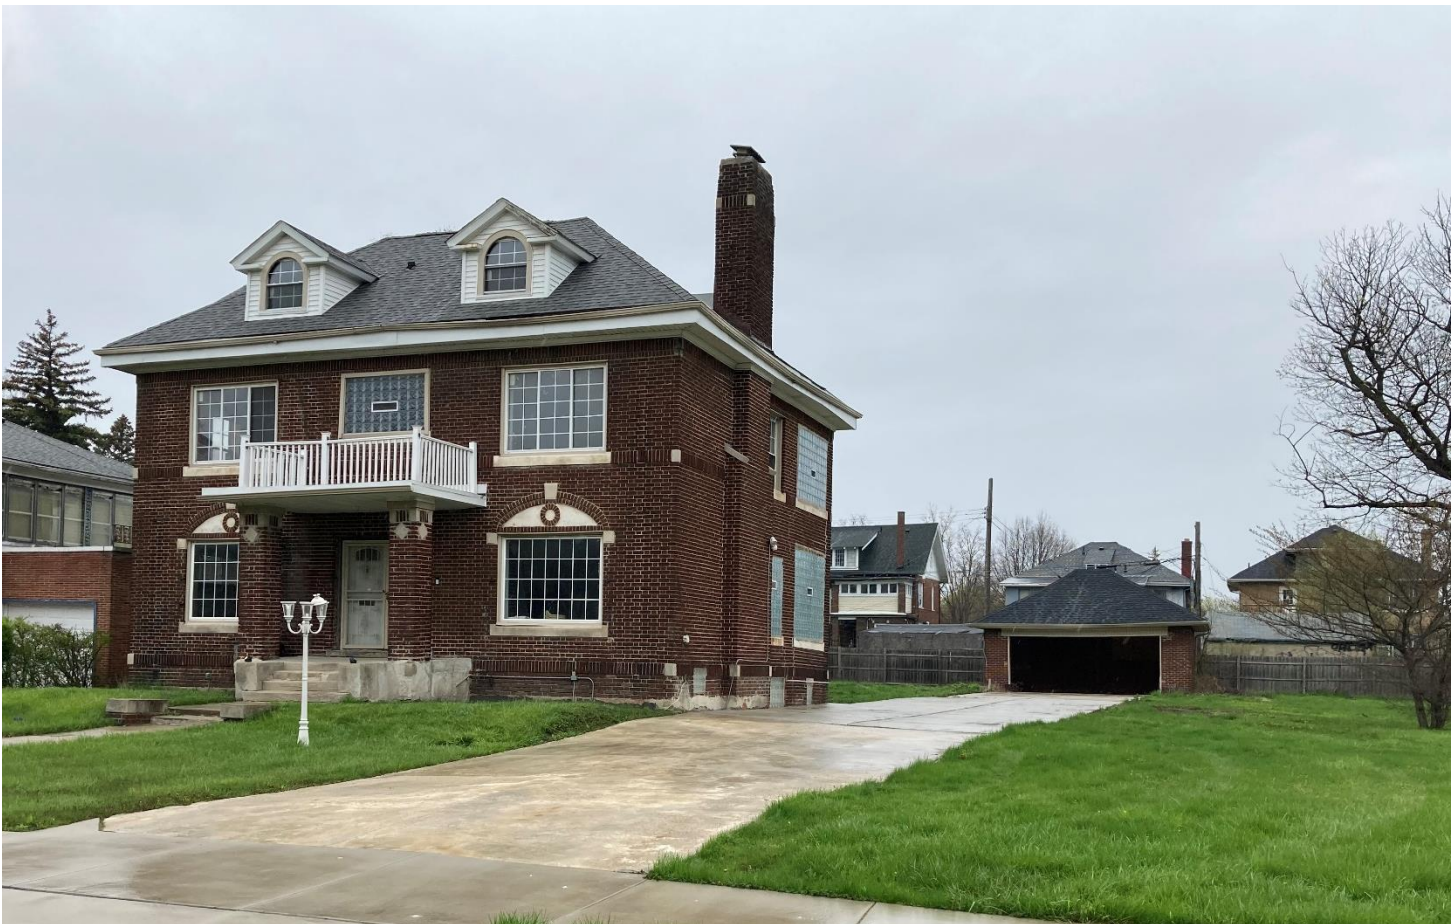
**647 Arden Park, current appearance**
