STAFF REPORT: 9/14/22 REGULAR MEETING

APPLICATION NUMBER: 22-8016

ADDRESS: 1773 PARKER

SCOPE: REPLACE WINDOWS ON ATTIC DORMERS, SOUTH ELEVATION BAY WINDOW, AND REAR PORCH

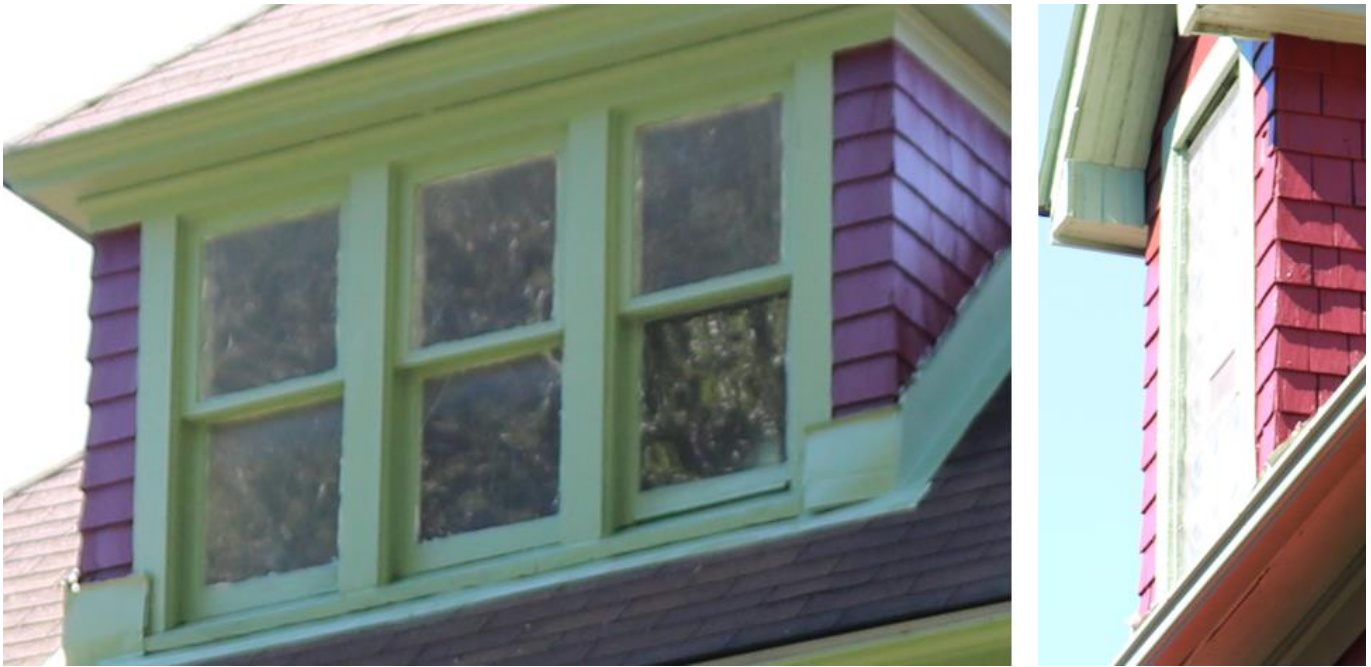
Attic fenestration consists of two dormers. A front-facing (east) dormer features three, apparently original, wood one-over-one sash windows; a south-facing dormer features a single, non-historic glass-block window.

Left: front-facing (east) dormer. Right: South-facing dormer. Photo by staff.

- Appropriate windows for the south-facing dormer would match those on the north-facing dormer in materials and profile (though not necessarily in operation).

- The Secretary of the Interior's Standards for Rehabilitation, specifically Standard #6, requires that "replacement of missing features shall be substantiated by documentary, physical, or pictorial evidence." Appropriate windows for the south-facing dormer would match those on the north-facing dormer in materials and profile (though not necessarily in operation). Similarly, appropriate windows for the side lights on the projecting bay window, and the rear porch windows, would be double-hung wood sash windows comparable to those found elsewhere on the house and on similar houses within the historic district.
- Standard #2 directs that "the removal of historic materials ... shall be avoided." Thus, the replacement of wood sash windows on the front-facing (east) dormer is not appropriate.

- The replacement window on the south-facing dormer be identical in materials and profile to the windows on the front-facing (east) dormer, subject to approval by staff;
- The dimensions of the projecting bay's "picture window" will be subject to approval by staff; and
- The dimensions of the projecting bay's "custom opening wood casements" or "fixed windows" will replicate the appearance of sash windows elsewhere on the building, subject to approval by staff.

- Replacement of front-facing (east) dormer windows with fixed or hopper windows
- Replacement of rear porch windows with casement windows

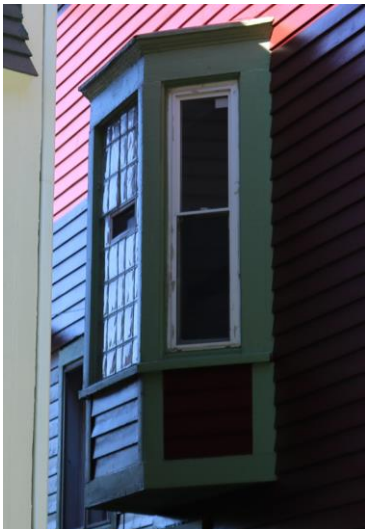
A projecting bay window on the south elevation of the house currently contains a larger, central, non-historic glass block window flanked by narrower, non-historic, vinyl sash windows.

South elevation bay window. Photo by staff.

- No known evidence exists regarding the original appearance of the central glass block window on the south elevation projecting bay. Staff suggests that replacing this window a fixed, wood, single-pane window would be appropriate given the diversity in architecture and the broad Period of Significance of the district.

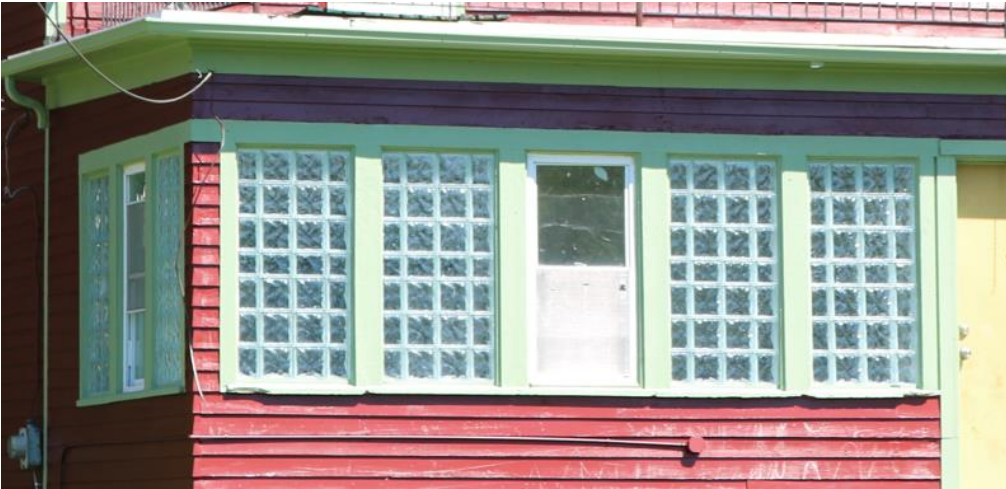
The rear porch currently contains six glass block windows and two vinyl windows.

Rear (west) porch viewed from alley. Photo by staff.

- Glass block windows are an anachronistic addition to the building. Where glass block windows exist, original windows are missing. Double-hung, wood sash windows would have been used at the time of the porch’s construction. Such windows are nearly ubiquitous on comparable houses in the vicinity, as observed by staff during a site visit.

- On November 18, 2020, the applicant received a Certificate of Appropriateness to replace six glass block windows and two vinyl windows on the building’s rear (west) porch with appropriate new windows (specifically, Pella Architect Series, aluminum-clad, double hung one-over-one wood sash windows with a white finish). Appropriate replacement windows in this location may also be approved by staff. The windows proposed for this location in this application, however, are not appropriate (see “Issues,” below).
