STAFF REPORT: 9/14/22 REGULAR MEETING

APPLICATION NUMBER: 22-8018

ADDRESS: 2523 ATKINSON

SCOPE: REPLACE TEN (10) WOOD WINDOWS WITH EIGHT (8) VINYL WINDOWS

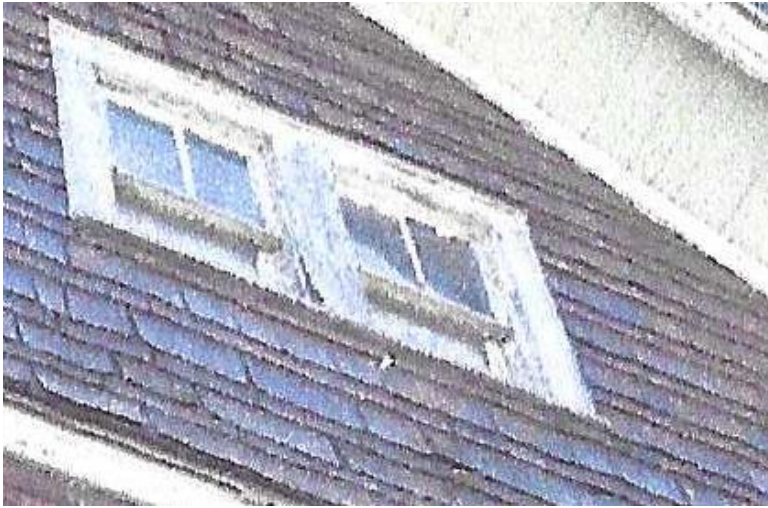
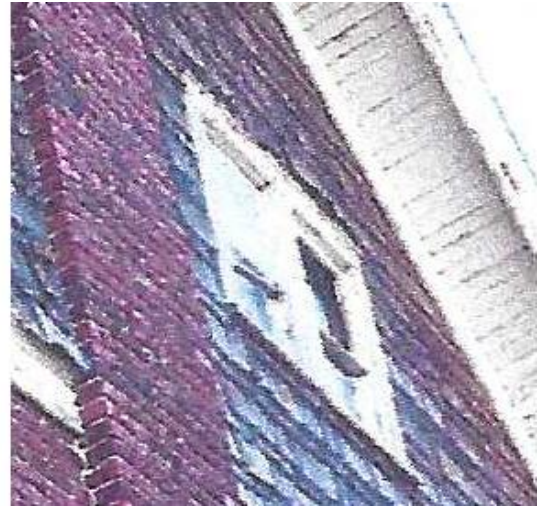
Attic windows proposed for replacement. Left: west elevation; Right: east elevation. Photos from application.

- The attic windows, based on architectural style, appear to be original to the building.
- The first floor and second floor windows are located on a rear ell that, based on materials and style, appear to be original to the building, or an addition built early in the building’s history. The south and west faces of the ell subject to this application are not visible from the public right-of-way, but are visible from the alley.

- The application states that the windows are “drafty,” dry-rotted,” and that the “attic windows are falling out.”
- Staff was not able to locate a Certificate of Appropriateness or a Notice to Proceed for the windows on the building that have already been replaced. The applicant states that the windows were replaced prior to the creation of the historic district.

Staff recommends that the Commission issue a Denial of the proposed work as it does not meet the Secretary of the Interior’s Standards for Rehabilitation, in particular:

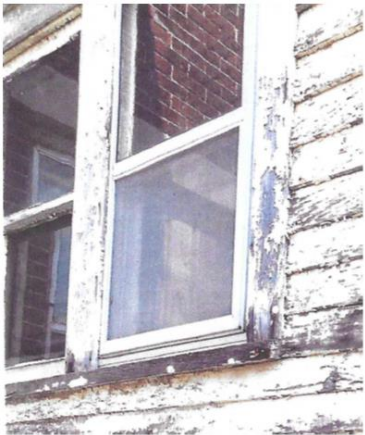
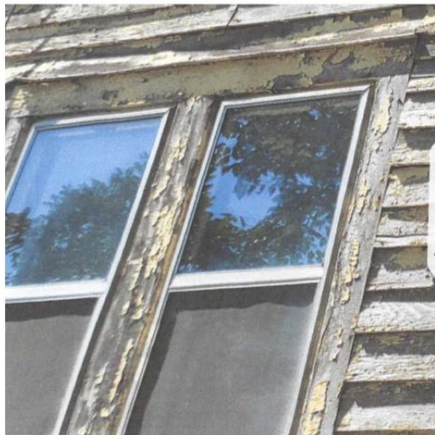
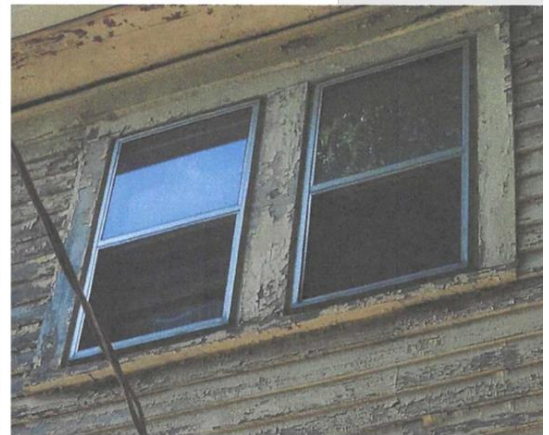
Left west elevation windows; Center: first floor windows; Right: second floor windows. Photos from application.

- The existing first- and second-floor windows are not visible from the public-right-of-way, and in photos included in the application, they are covered by storm windows and not clearly visible. Staff is therefore unable to provide additional information on the condition or other qualities of the windows. The applicant states that they are wood windows.

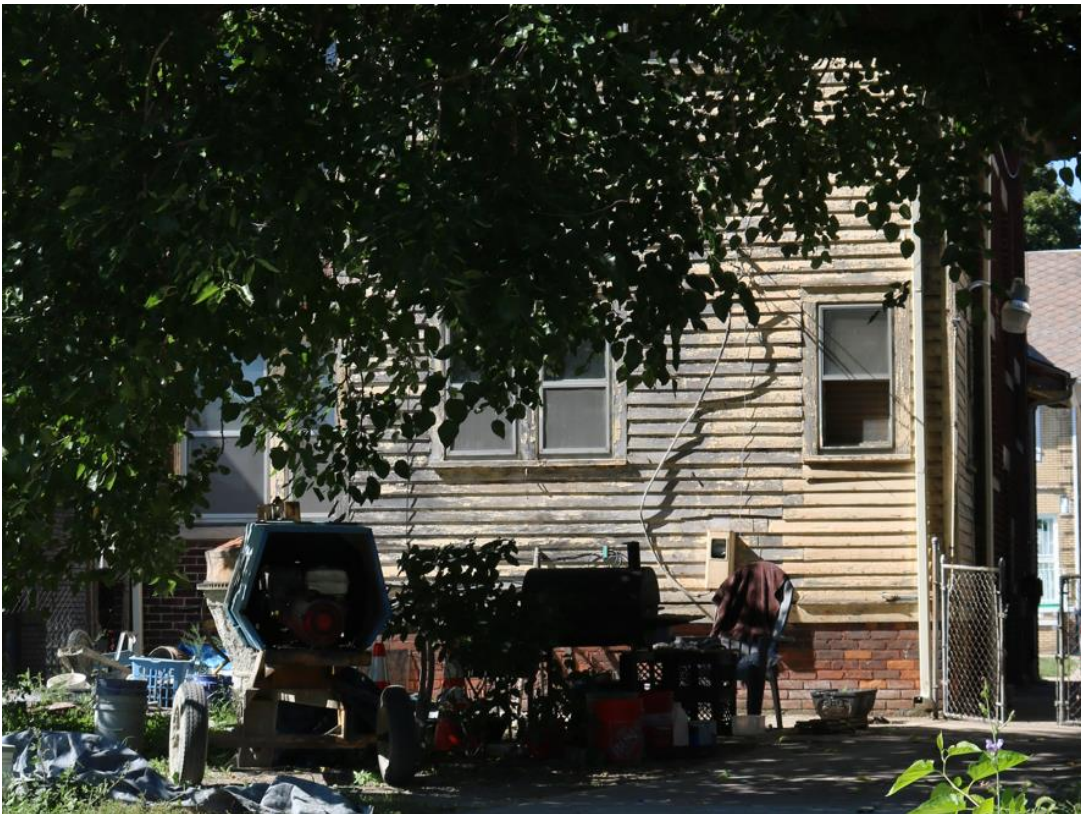
Rear (south elevation) of building. September 2022 photo by staff.
