STAFF REPORT: 10/12/2022 REGULAR MEETING

APPLICATION NUMBER: #22-8066

ADDRESS: 2011 LONGFELLOW

SCOPE: REPLACE WOOD WINDOWS WITH WOOD AND FIBERGLASS UNITS ALTER PORCH
(WORK COMPLETE WITHOUT APPROVAL)

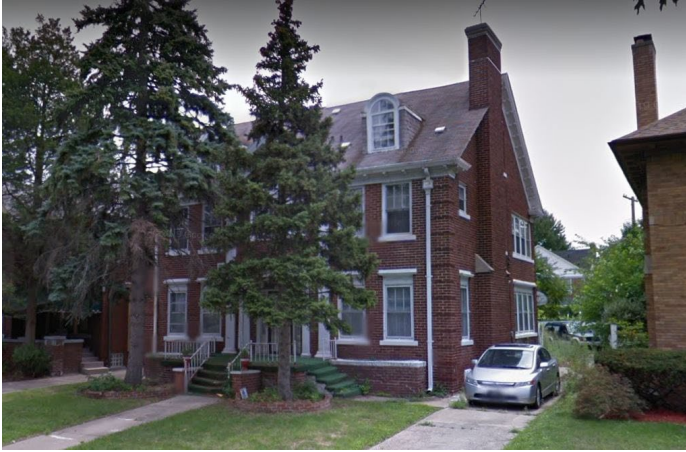
Site Photo 3, Google Streetview Aug. 2011: (Northwest) front/side elevation showing front porch alterations made with added wingwalls to front steps. Planter boxes on either side are still in place.

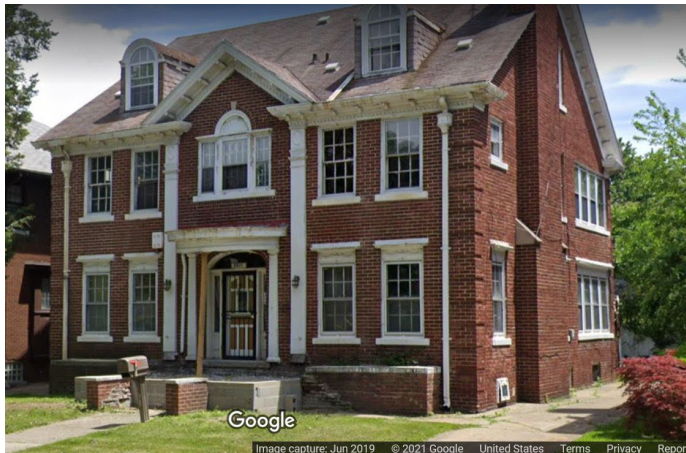
Site Photo 4, Google Streetview June 2019: (Northwest) front/side elevation showing front porch alterations. Planter boxes on either side are still in place, most original windows are still in place, security lights are installed on pilasters.

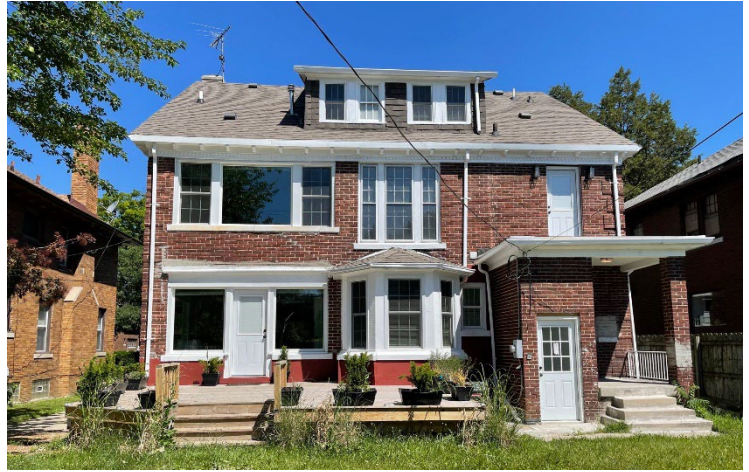
Site Photo 6, by Applicant: (South) rear side elevation showing replaced fiberglass windows on first and second floors and original wood windows on second (middle) and third floors.

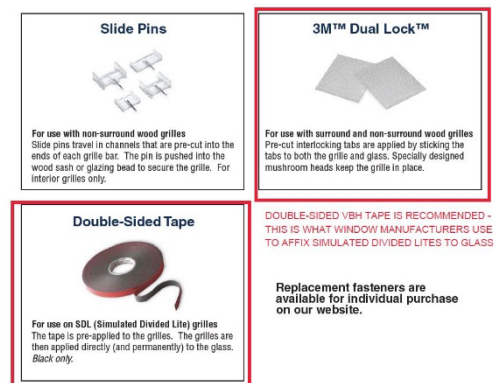
Fig 1, by Applicant: Proposed adhesives for applying wood grid to existing fiberglass window installation.

- It is staff’s opinion that the application of wood muntins on fiberglass windows is not an appropriate application of materials as it attempts to disguise rather than restore historic character-defining features, especially the operation and design of the original ribbon of wood, double-hung windows that were replaced by picture windows. However, staff observed that the application of these muntins occurs in locations of the house that are not as publicly visible, with the exception of windows 23 and 18, which staff noted earlier, is publicly visible.

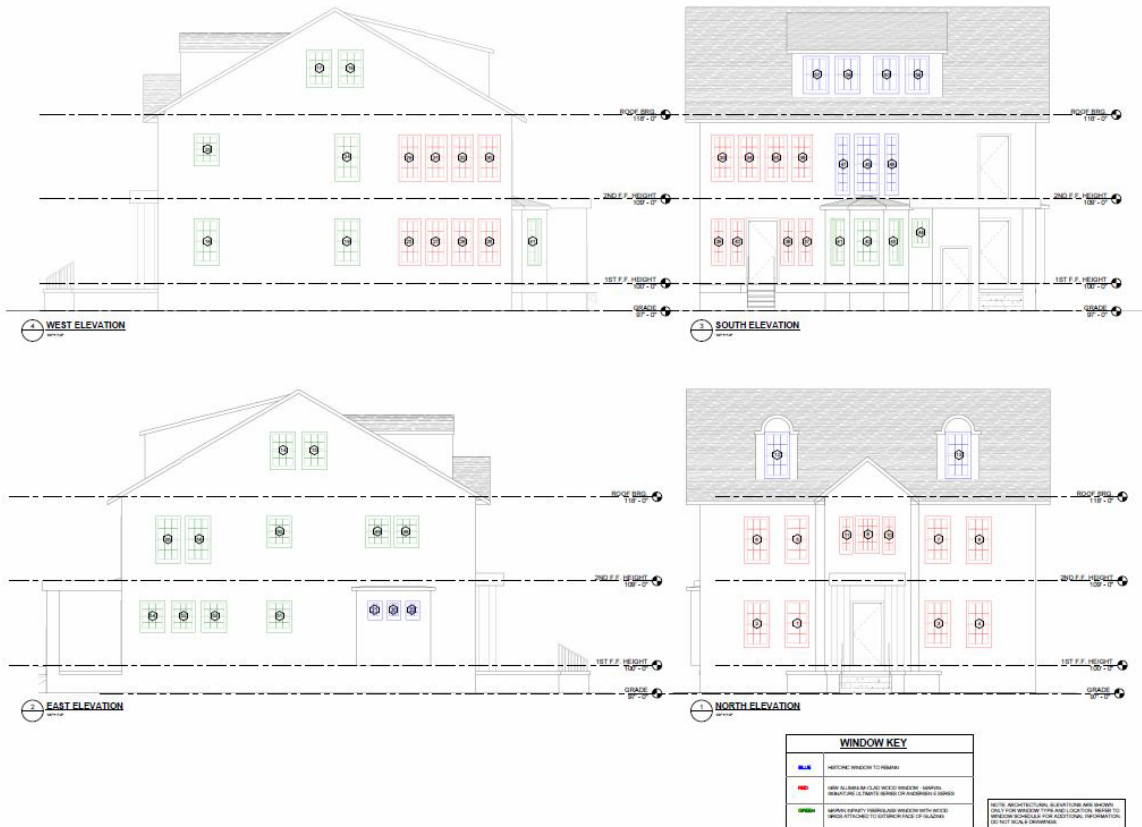
Fig 2, by Applicant: Proposed window schedule, showing the reverting of large picture windows back to the double hung windows at the rear and side (west) elevations and retention of historic windows (blue), replace fiberglass with aluminum clad wood (red), and retaining fiberglass windows (green).

- Retain twenty-one (21) of the replaced forty-eight (48) windows with Marvin fiberglass “Infinity” windows; Adhere external wood grids on all installed fiberglass windows with double-sided tape to mimic the configuration of the original wood window muntins. Painted white. (See attached window schedule, fig 2, “green” windows 14-19, 23-24, 41-44, 48-56)

- Replace five (5) fiberglass area picture windows and all eleven (11) front elevation fiberglass double-hung windows with aluminum clad wood, double-hung windows with SDL to match historic configuration, painted white. (See attached window schedule, fig 2, “red” windows 1-11, 25-40)

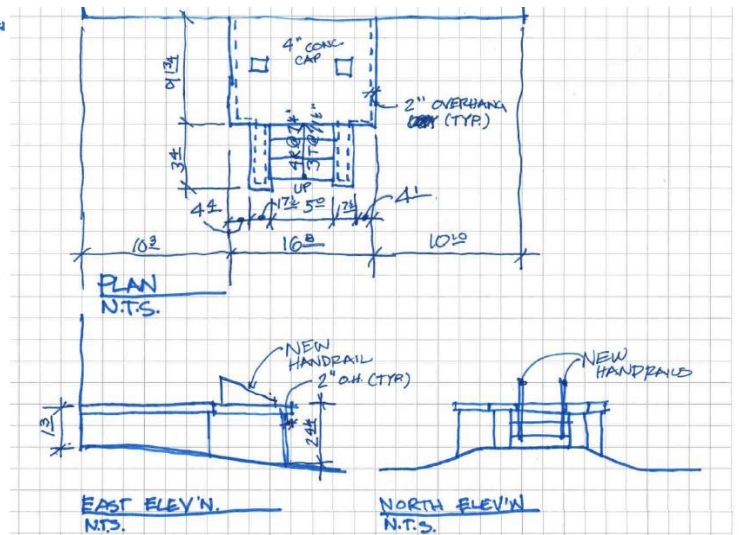
Fig 4, by Applicant: (North) front side plan showing current built conditions and installed handrail elevations for the front steps, work complete.

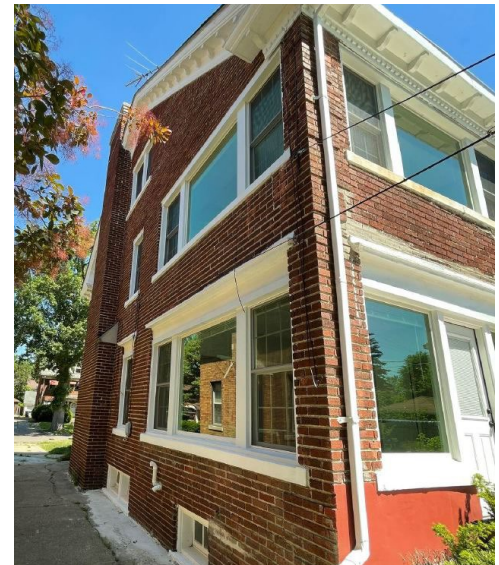
- It is staff's opinion that replacement of picture windows (that had previously replaced original double-hung windows) with double-hung windows on the rear and west elevations is appropriate in type and scale as it mimics the original historic, character-defining features of this ribbon formation that was lost when the original windows were removed.

Site Photo 8 by Applicant: (West) side elevation showing fiberglass picture and double hung windows that replaced the original ribbon of wood, double-hung windows on the first and second floors.

- While the original window material has been removed without approval and the material is considered a character-defining feature, it is staff's opinion that the replacement of the fiberglass picture windows to restore the ribbon of double-hung windows with simulated divided light at the side and rear elevations and the replacement of fiberglass windows at the front elevation with double-hung with aluminum clad wood windows with simulated divided light and the restoration of the brick molds, is a reasonable and feasible solution in an effort to retain the dimensions, operations, and configuration of these windows, thus not greatly altering the features and spaces that characterize the property, given that the original material is lost and a true replacement may not be feasible.

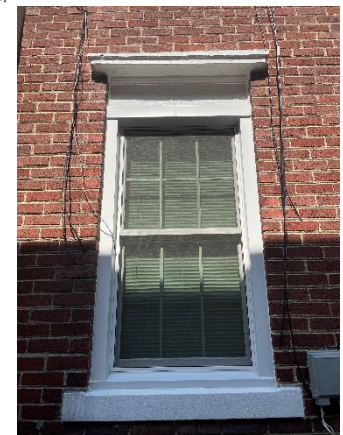
- Staff observed that the installed fiberglass windows have several features that are not appropriate. These larger changes to the original wood windows greatly outweigh the changes in the proposed attempt to add attached grids to the exterior of the windows:

- the surrounding coil covering the brickmold is large and gives the windows a chunky appearance and with the picture windows, larger seems are found around the perimeter,

Site Photo 7, by Staff: (West) side elevation showing thick, aluminum coil stock around brick mold and seam, and aqua tinted double-hung window (#18), proposed to remain.
