STAFF REPORT: 10/12/22 REGULAR MEETING

APPLICATION NUMBER: 22-8046

ADDRESS: 1531 PARKER

SCOPE: DEMOLISH EXISTING FRONT PORCH, CONSTRUCT NEW FRONT PORCH

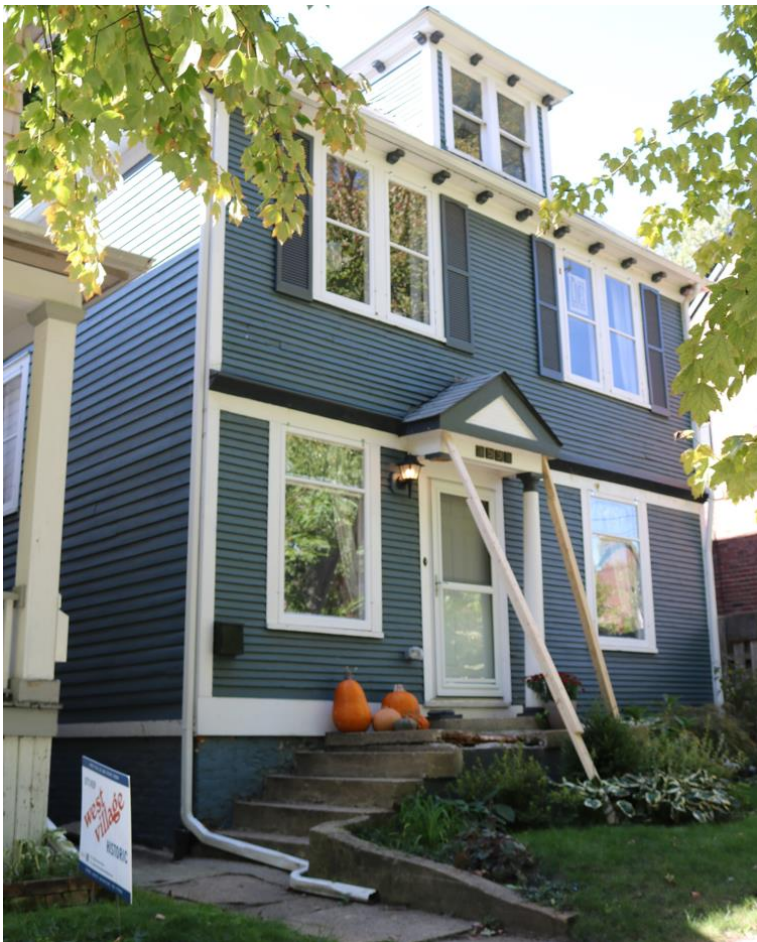
October 2022 site visit photo by staff.

The applicant proposes to demolish the existing reinforced concrete porch deck and steps, which is currently cracking and sagging. The proposal is to retain the portico and build a new wood porch with handrail and guardrail. The proposed porch is to have the same height and depth as the existing porch and occupy the footprint of the existing porch. However, it will be oriented such that the front steps lead directly from the front door, rather than oriented perpendicular as in the current configuration.

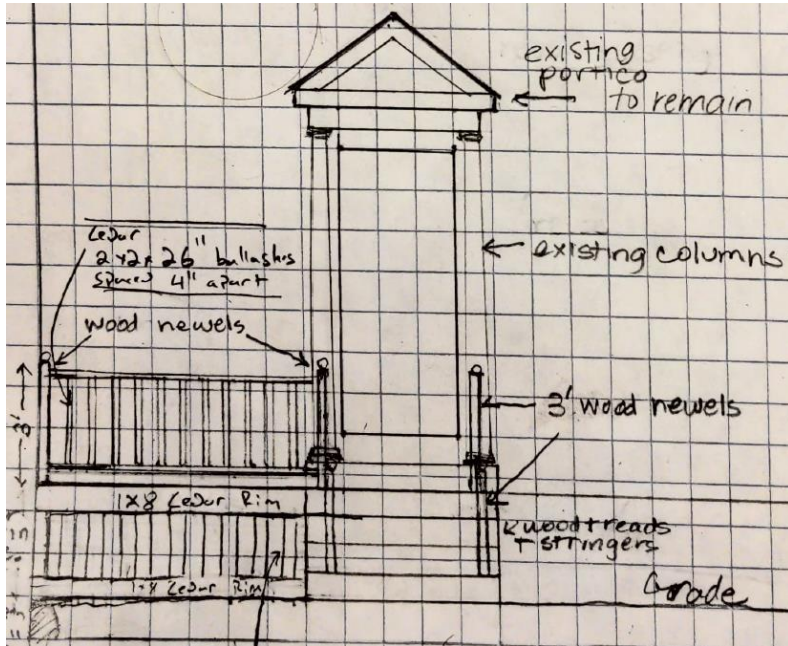
Front elevation of proposed porch. Sketch by applicant. Additional images are found in the application.

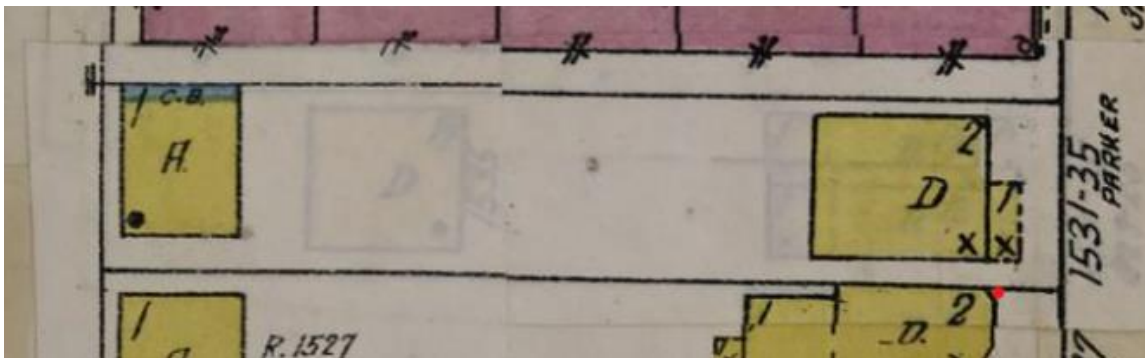
- Staff researched Sanborn maps and building permits, and visited the site, to determine if the existing porch proposed for demolition is an original, historic, or character-defining feature. Staff determined that it is not. The materials used, workmanship, the degree of weathering, and other observations suggest that it dates from the mid- to late twentieth century. As the applicant has also observed, a Sanborn map from 1950 shows a wood porch.

Subject property in 1950. Dotted line and yellow field indicate open wood porch. Image: Sanborn Map Company.

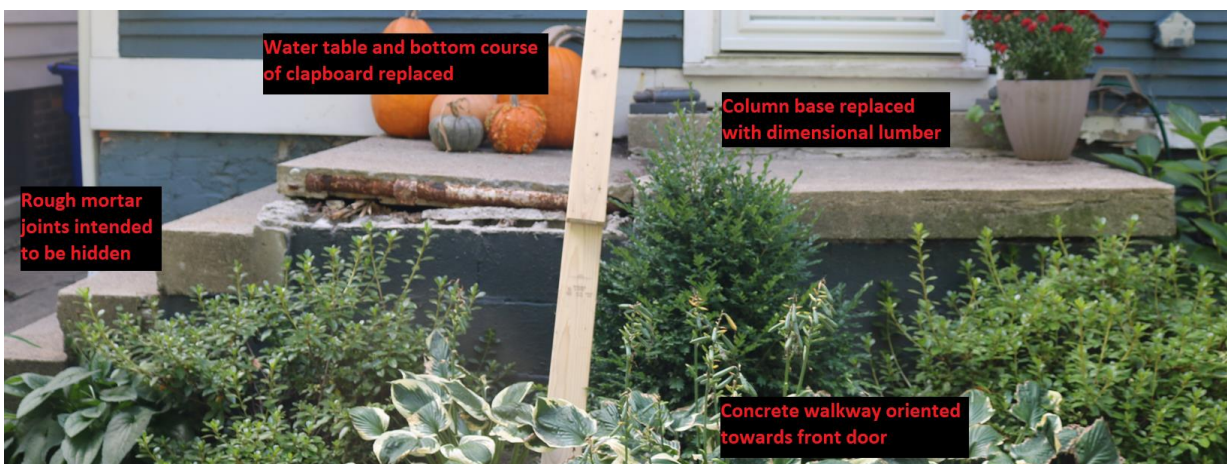
- Further, staff was able to determine, with a reasonable degree of certainty, the configuration of the original or historic porch. Several clues, including the use of rougher brick on the left (south) end of the foundation contrasted with textured brick on the right (north) end, the use of newer dimensional lumber to infill areas where original porch elements formerly existed, and the orientation of a concrete walkway with respect to the front entrance, suggest that the building once possessed a wood porch very close to what the applicant has proposed.

Illustration by staff.

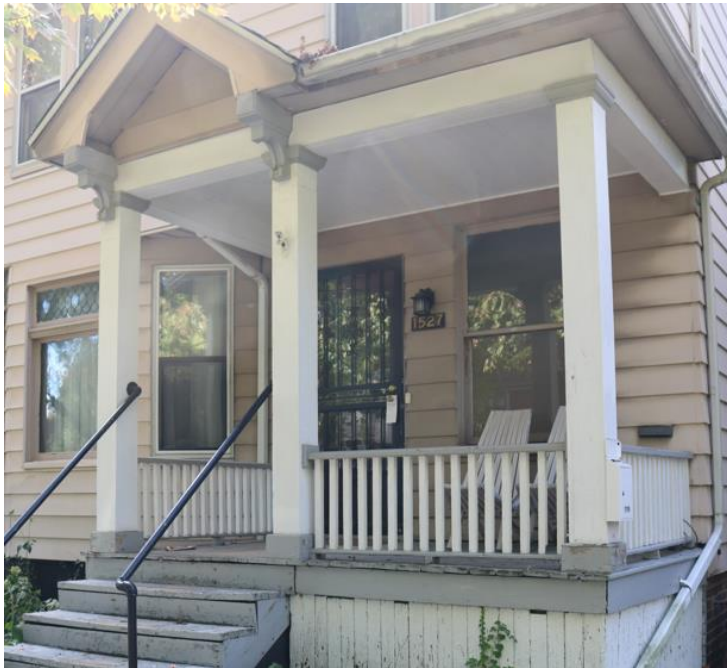
Neighboring porch at 1527 Parker. Photo by staff.

consider replication of the full, covered porch. Such a porch would appropriately be modeled after porches found on comparable buildings in the West Village Historic District, including 1527 Parker, extending the existing historic pediment and columns forward toward the street, and covering the remainder of the porch with a hip or flat roof section supported by a third column. Alternatively, a contemporary, “clearly differentiated” design in a complementary and compatible style would also be appropriate (Standard #9), as long as it incorporated a roof. Such a design should nonetheless retain the existing historic pediment and columns (Standard #2).
