**STAFF REPORT:** 10/12/2022 REGULAR MEETING

**ADDRESS:** 4001 14<sup>TH</sup> STREET

**APPLICATION NO:** #2022-8052

**SCOPE:** DEMOLISH EXISTING FRONT STEPS, CONSTRUCT NEW FRONT STEPS

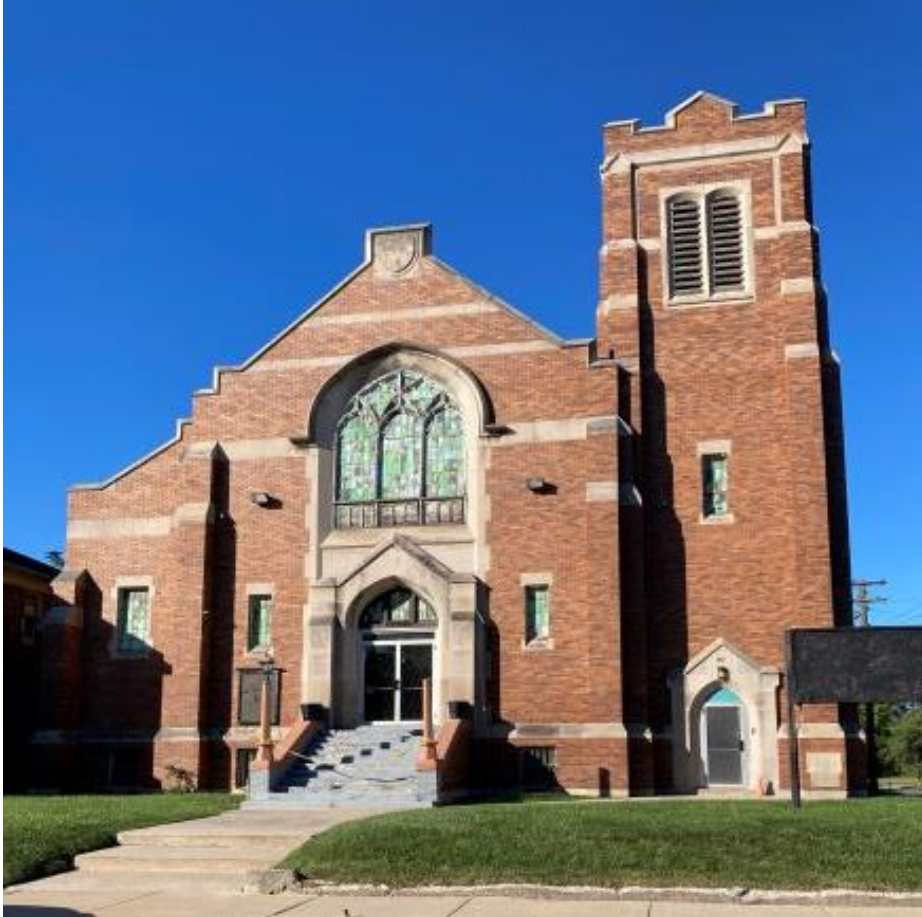
**Current conditions (staff photo taken on 10/1/2022)**

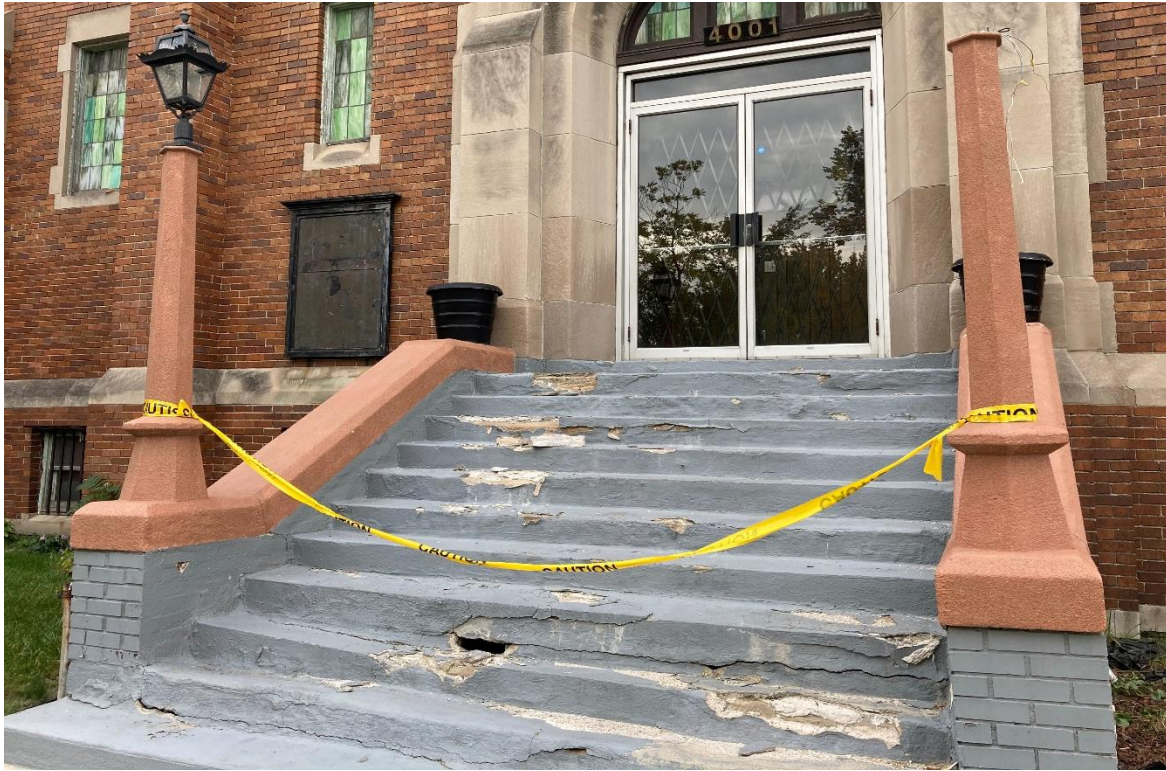
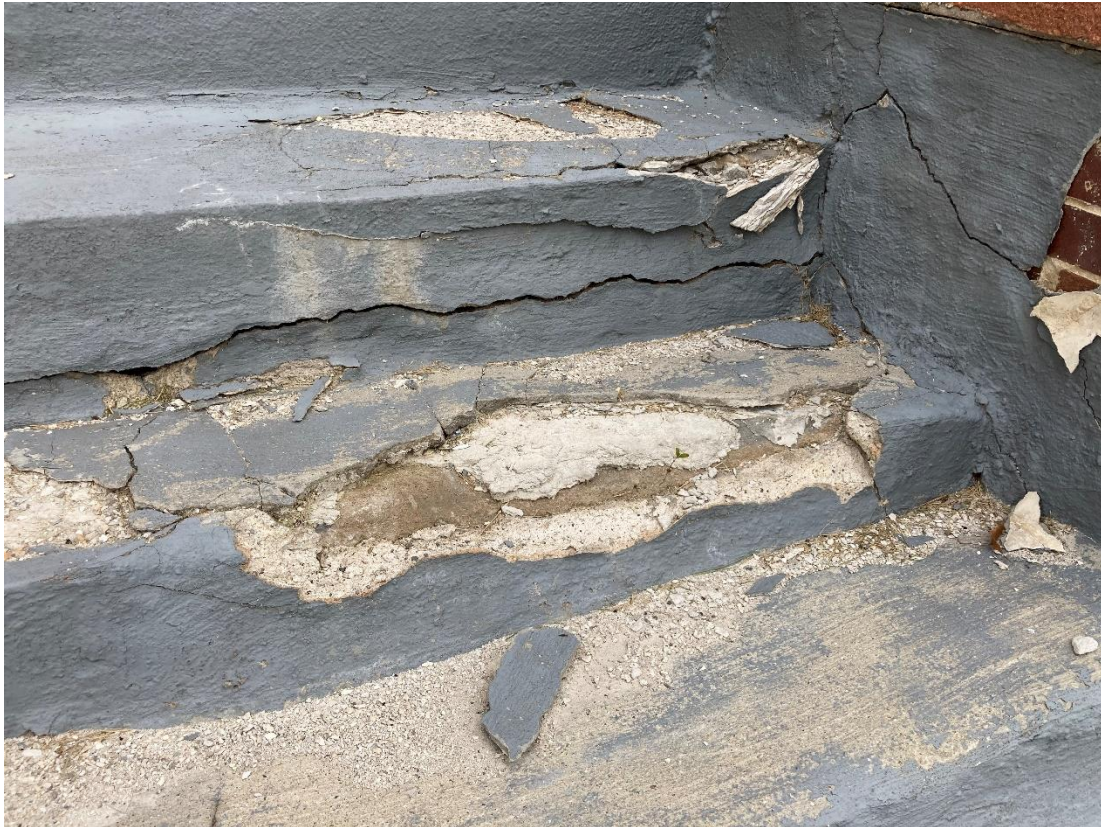
The building's primary entrance is accessed by masonry steps. The steps are composed of sandstone treads that are tied to brick and stone wingwalls. The steps and wingwalls have been covered with a cementitious material and then painted. Please note that the application materials state that the historic steps/treads are limestone. However, staff did speak with the contractor and he indicated that he felt that the historic steps/treads are sandstone.

**Current conditions at steps. Note thick layer of cement which covers the steps (staff photo taken 10/6/2022)**

- As previously noted, the stone steps were covered with the current cementitious coating and paint at the time of the district's designation. It is also staff's opinion that the stone steps appear to be in an advanced state of deterioration and the cost of any possible repair would not be financially feasible. As such, it is staff's opinion that the submitted proposal is a compatible, financially- feasible option and does meet the SOI Standards as an appropriately stained concrete would adequately match an historic stone step.

With the current submission, the applicant is seeking the Commission's approval to replace the existing steps with concrete. A metal handrail will be installed (location, height, and style not specified) and the existing wingwalls will be retained and restored per the submitted scope.

- HDC staff shall be afforded the opportunity to review and approve the style, location, and height of the porch handrail prior to the issuance of the project's permit
- The new concrete cannot be "bright white". Rather, it shall be tinted a color which matches the stone trim/detailing found at the building's exterior walls. HDC staff shall be afforded the opportunity to review and approve the color of the tint prior to the issuance of the project's permit.

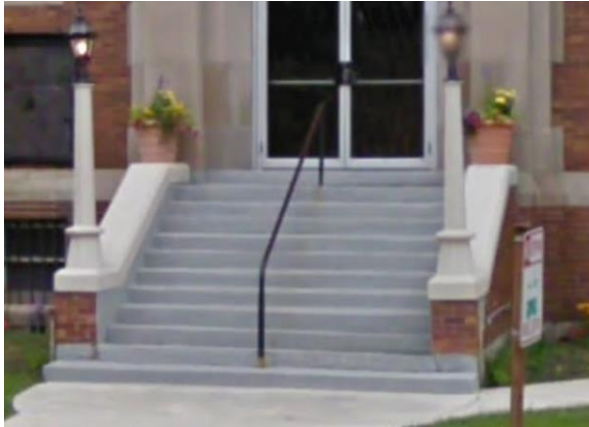
2009 appearance

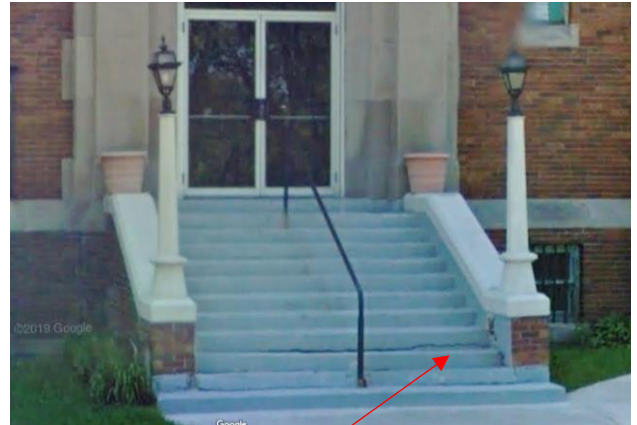
2011 appearance, note cracked step

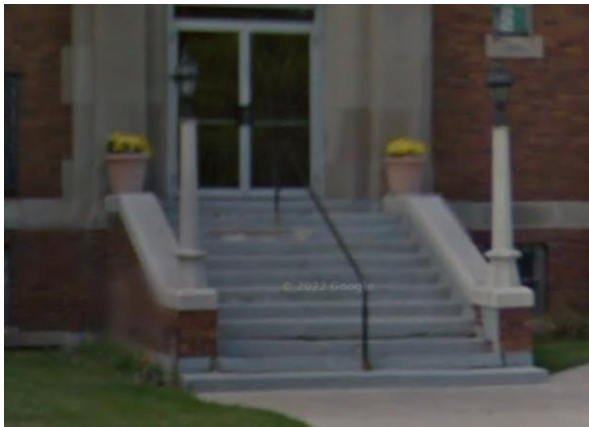
2013 appearance, note extensive/advancing deterioration

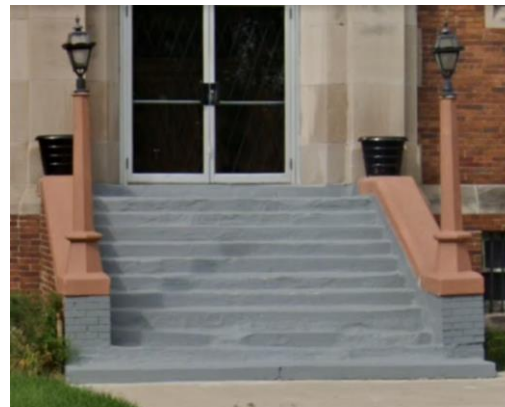
- The current cementitious coating was present at the time of the district’s designation in 2020.
- A review of Google Streetview images revealed that the cementitious coating was applied as a means to patch cracks/deterioration at the steps between 2007 and 2009. It appears that the coating was routinely added/added to over the over the years in order to temporarily address deterioration/patch holes and cracks as they materialized.

2018 appearance, note cementitious coating has been added to repair deterioration
