STAFF REPORT: 12/14/2022 REGULAR MEETING

APPLICATION NUMBER: 22-8151

ADDRESS: 3385 CAMBRIDGE

SCOPE: REPLACE WOOD SHAKE ROOF WITH ASPHALT SHINGLES

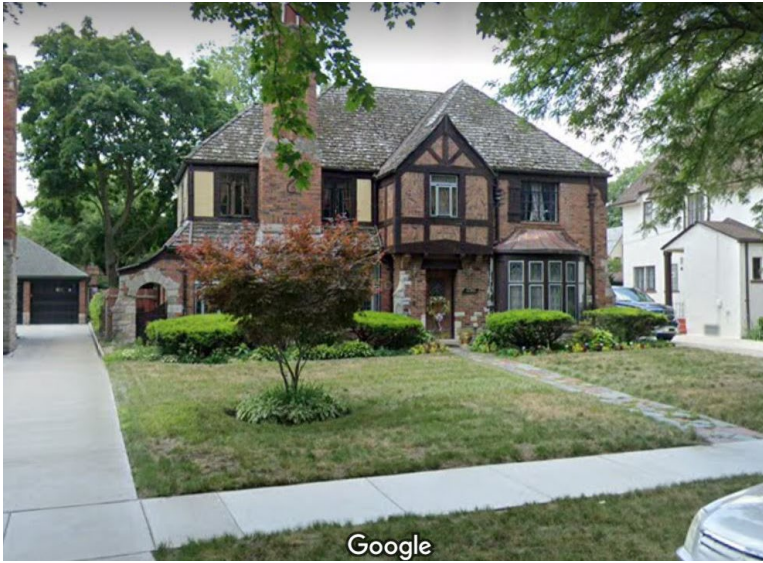
Site photo 2, by Google Street, July 2018: (North) front showing original cedar shake roof.

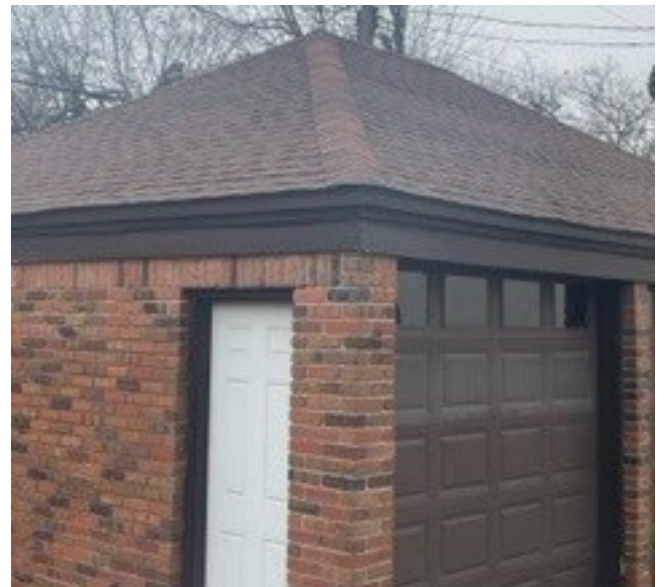
Site Photo 2, by applicant: (northwest) Front and side of garage roof, showing current conditions.

Recommendation 2: Removal of asphalt roof and installation of asphalt roofing at garage

It is staff's opinion the installation of the asphalt roof for the garage is appropriate. Staff therefore recommends the Commission issue a Certificate of Appropriateness for the work as proposed because it meets the Secretary of the Interior Standards for Rehabilitation.

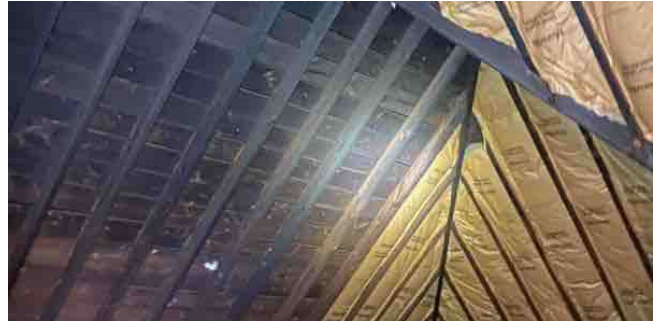
- The Schaufele inspection notes that the roof is of an approximate age dating to 1980, and typically has a life cycle of 20-25 years. It states that the wood shake roof needs immediate replacement or extensive repairs, damaged/rotted shakes are noted throughout the roof, and recommends a wood shake specialist for repairs. Interior roof structure shows evidence of previous fire damage, as some charred structural members are still visible. This report also recommends adequate air ventilation in the attic to reduce moisture damage. The garage asphalt shingle roof dates to approximately 2015.

Roof Detail 1, by Schaufele inspection: Interior roof conditions.

- While staff agrees that these inspections and assessments demonstrate the house's roof need for immediate repair, it is staff's opinion that the house roof's repair could be performed by removing the old shake, repairing the roof where needed, and installing new shake to repair in-kind this distinctive, character-defining feature.

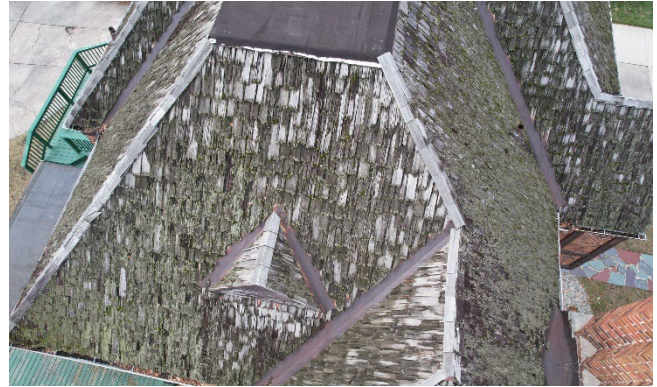
- The MGS roof inspection was performed by the applicant and shows drone shots of the exterior roof, which is only directed to the conditions of the cedar shakes and the metal valleys on the roof's exterior but no notes on the interior roof conditions. This assessment states that the metal valleys are rusted thru, and that more than half of the shakes are rotted throughout the roof (*see report*).

Roof Detail 2, by MGS inspection: Exterior roof conditions.
