STAFF REPORT: DECEMBER 14, 2022 MEETING

APPLICATION NUMBER: 22-8161

ADDRESS: 1001 E. JEFFERSON AVENUE

SCOPE: REHABILITATE EXTERIOR, REPLACE WINDOWS AND DOORS

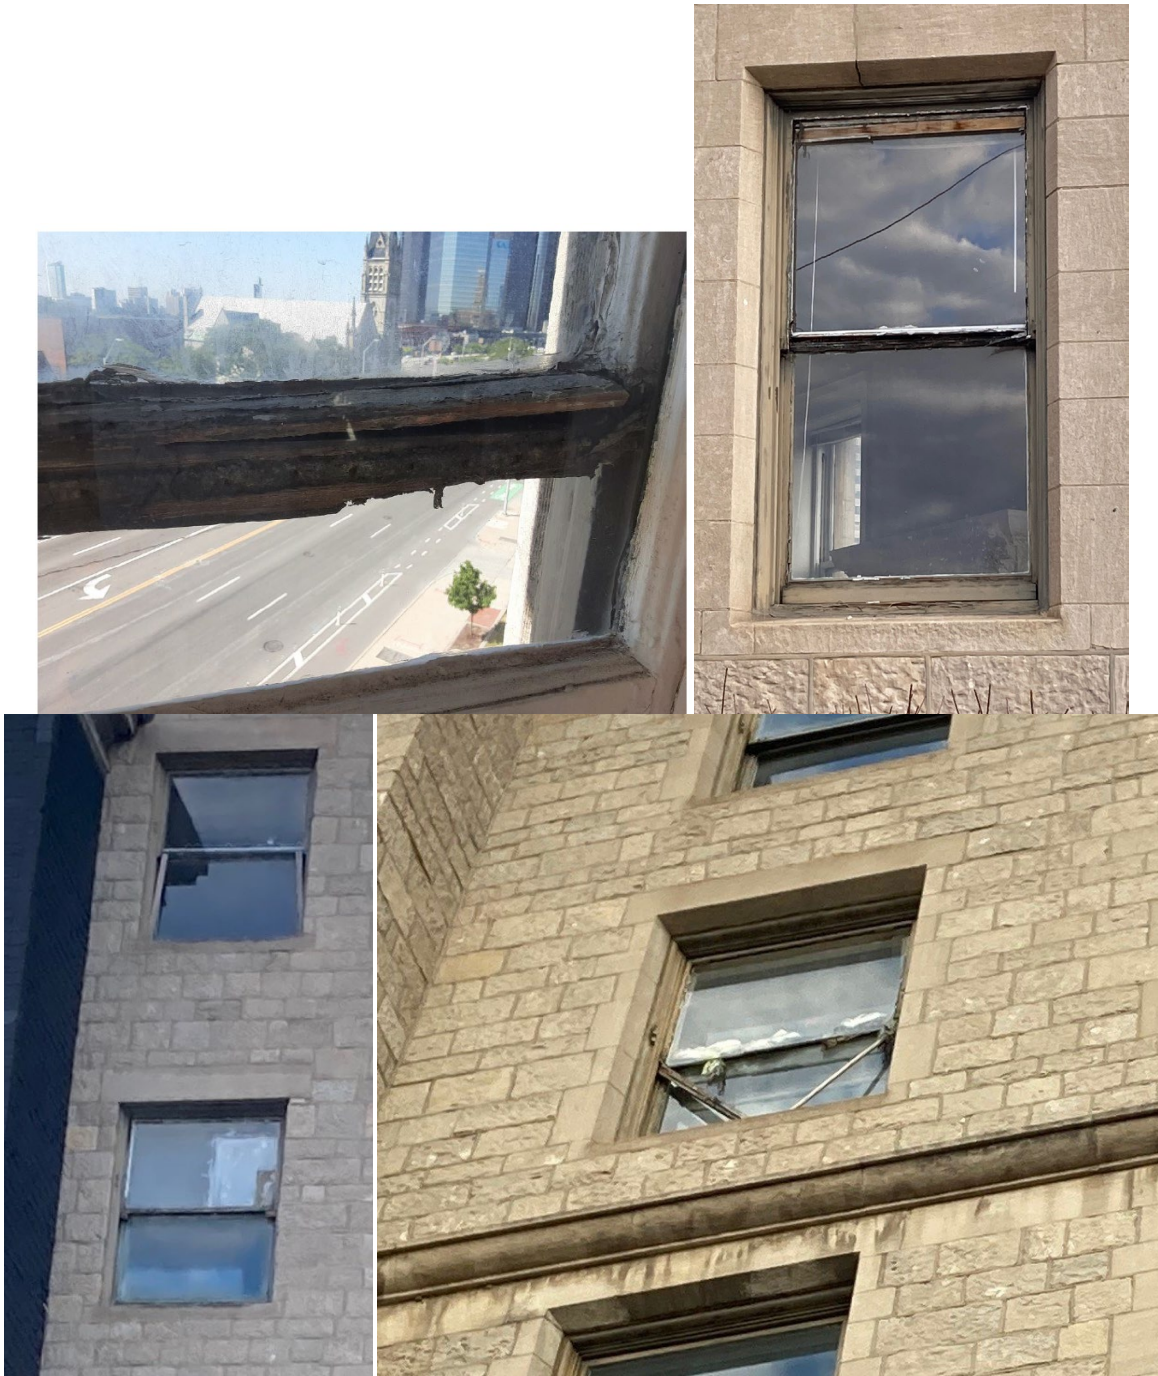
- Photographs from the applicant and from the staff site visit indicate that numerous wood window sashes are decayed beyond repair. Staff was able to observe failing meeting rails, jambs, and sills from the public right-of-way. The applicant submitted quotes for both replacing the existing windows and rehabilitating the existing windows and adding interior storm windows. The applicant provided a quote from BlackBerry Systems for the restoration of the wood windows on the building for approximately 1.66 million dollars. This estimate did not include the replication of any windows deemed beyond repair. The cost estimate from Quaker Windows to furnish new aluminum single-hung windows was approximately 755,000 dollars.

Figure 3. Examples of existing conditions of the wood double-hung windows

- The replacement of a portion of the glass block windows with single-hung aluminum windows will have a positive effect on the building's integrity.
- The double-hung wood windows proposed for replacement are early or original units. However, evidence suggests that a significant number of the windows have deteriorated to a state where repair is not feasible, and replacement is required. The quotes provided by the applicant further suggest that retaining and restoring the original windows is not reasonably financially feasible. It is staff's opinion that appropriate replacement windows should be considered, and the proposed single-hung aluminum window units are *not an inappropriate* solution. The new windows will have the same overall dimensions as the originals, and the meeting rails, muntins, and mullions will have the same configuration. The windows' material differences and relatively minor differences found in the details of the trim and brick molds should not have a substantial visual effect on the building.

1. The double doors at the Rivard Street entrance be retained.
2. The HDC is supplied with detailed window drawings that provide a clear comparison between the existing windows and proposed windows as they will be installed in the existing openings. The drawings will provide details for comparison of the overall dimensional changes in the sash, as well as exterior trim and brick mold configurations. If the details do not illustrate an acceptable match that can be approved at the staff level, the windows will be returned to the Commission for review.

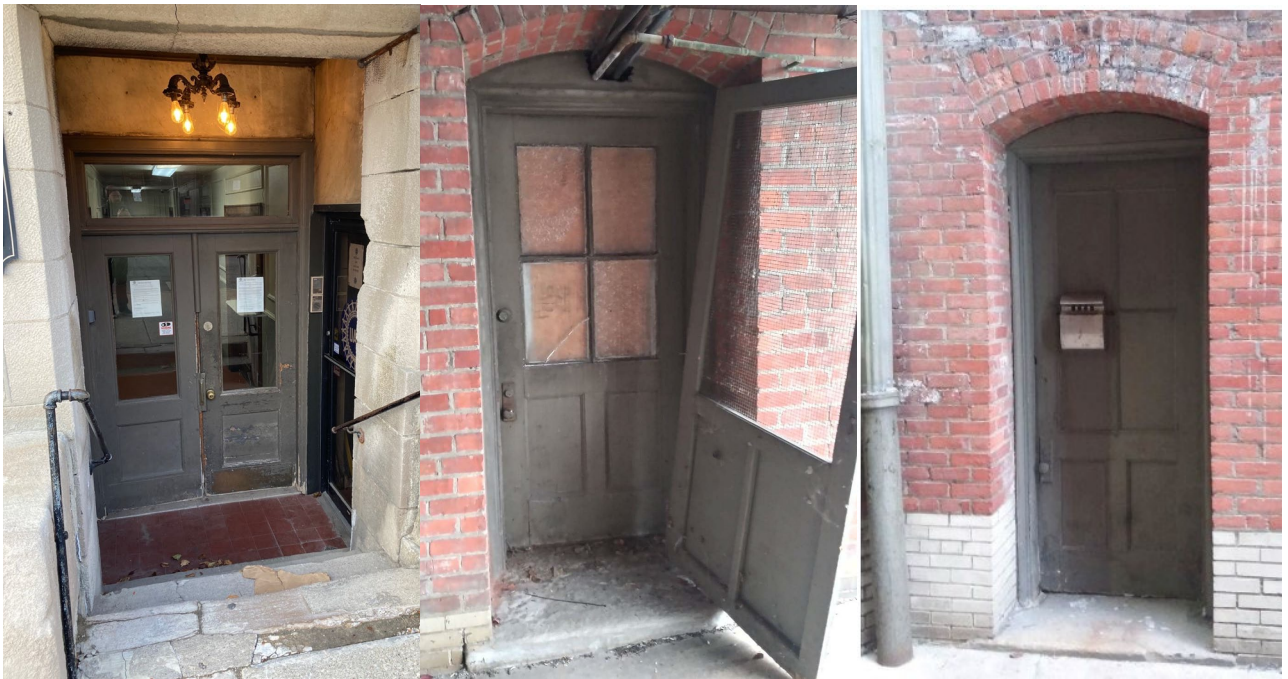
- The storefront entry door, courtyard doors, and north elevation service door that are proposed for replacement with metal doors appear to be early or original units. The applicant noted the current pair of doors at the Rivard Street entrance do not meet modern egress code.

Figure 5. L-R: Storefront door, typical fire escape door, courtyard door.

- The wood panel doors proposed for replacement are early or original units. However, the doors in the courtyard area and fire escape are located on secondary elevations and generally not observable from the public right-of-way. The proposed replacement doors will be painted to match the new windows, and the fire escape doors will

feature windows in approximately the same location as originals. It is staff's opinion that the replacement of these doors with hollow core insulated metal doors is *not inappropriate*.

- An entry consisting of a pair of doors with a transom lite are located along Rivard Street. These early or original doors are visible from the public-right-of-way and were historically associated with the tea room (illuminated by the extant stained glass windows) in the basement level of the building. The applicant proposes to replace these doors with a single aluminum door. This entry is historically a publicly accessible area, and is a character defining feature of the building. Replacing these doors with the proposed modern metal door would have a detrimental effect on the integrity of building.
