STAFF REPORT: MARCH 8, 2023 MEETING

APPLICATION NUMBER: 22-8197

ADDRESS: 15083 MINOCK

SCOPE: DEMOLISH GARAGE*, ERECT GARAGE, DEMOLISH ADDITION, ERECT ADDITION AND DECK, INSTALL VINYL WINDOWS

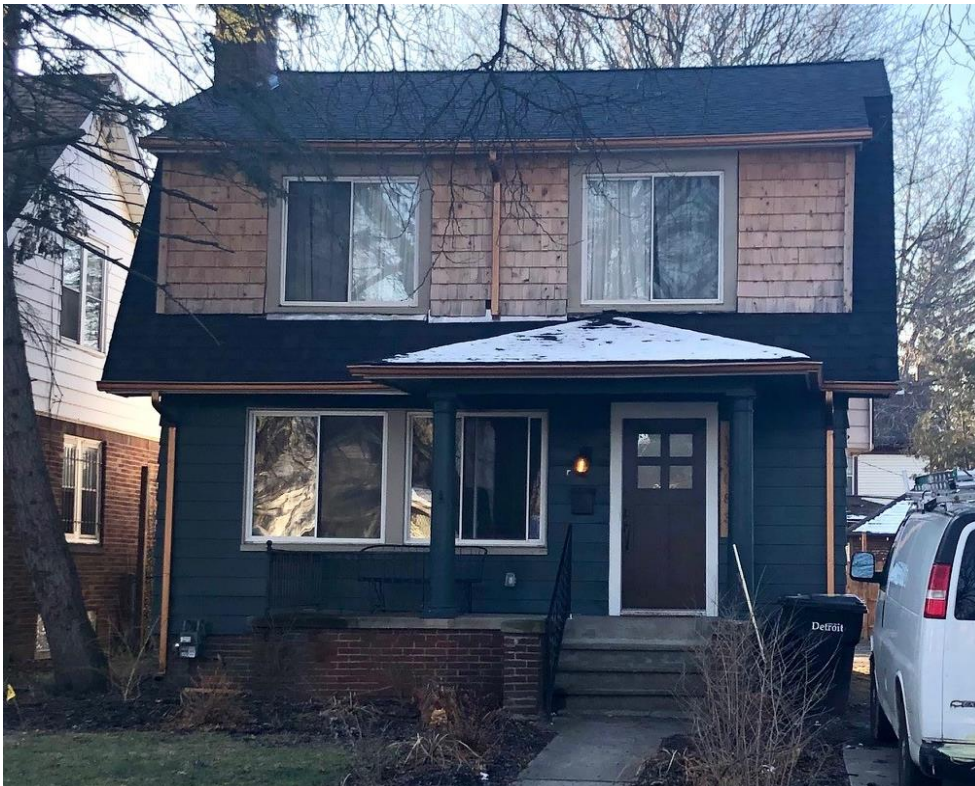
Staff photo, January 24, 2023

The two-story dwelling at 15083 Minock was erected in 1926. Wide shed dormers extend from the gambrel roof on the front and rear elevations; the large front elevation window openings have vinyl sliding units. Black asphalt shingles cover the roof, while the walls are faced with wood, aluminum, vinyl, and asphalt siding.

Most of the front porch is covered by a shallow-pitched hip roof that is supported by round wood columns. The house sits high above grade; the raised porch is accessed by stairs that are enclosed with masonry wing walls. A low iron railing (likely original to the house) runs along the majority of the porch perimeter and a contemporary aluminum railing has been installed on one side of the front steps.

The color palette on the sides and rear of the house are brown (asphalt siding) and white (aluminum/vinyl siding, window sash), while the front elevation is faced with unstained wood shingles and aluminum siding painted a dark blue-green. A new front door (black with square lights in the top half) and copper gutters and downspouts complete the front elevation.

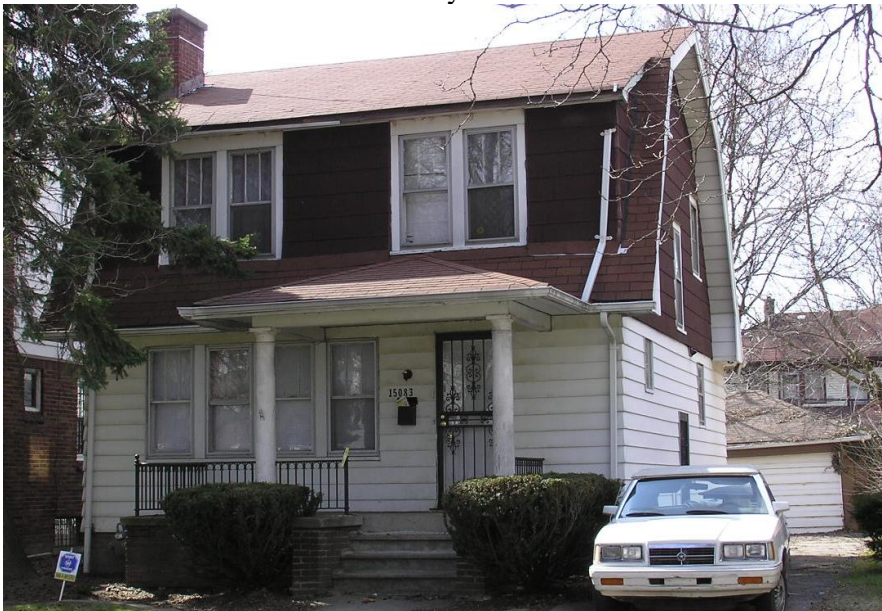
*Left: HDAB
designation photo,
2006*

- The Rosedale Park Historic District was established in 2006.
- Minock Avenue was likely named after Edward J. Minock, who in 1913 recorded a plat of land in Redford Township, which ultimately was developed as part of the Rosedale Park subdivision.
- Below is the district designation photo that shows original/historic wood windows in place on the front elevation, as well as asphalt (second floor) and aluminum siding. The front porch railing extended to the steps (portion between column and steps is now missing), and a two-car garage was present at the northwest corner of the rear yard.

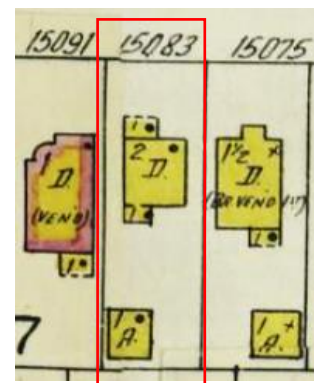
*Below: Sanborn Map,
Vol. 26, 1938-1950*

- The 1950 and 1971 Sanborn maps show a one-car wood frame garage at the rear corner of the lot. Per HDAB’s Final Report that discussed the erection of garages, *“The majority of builders and homeowners tended to select modest, utilitarian designs, settling for the simple box garage with a gable or hipped roof, double doors, and perhaps a stock window or two.”*

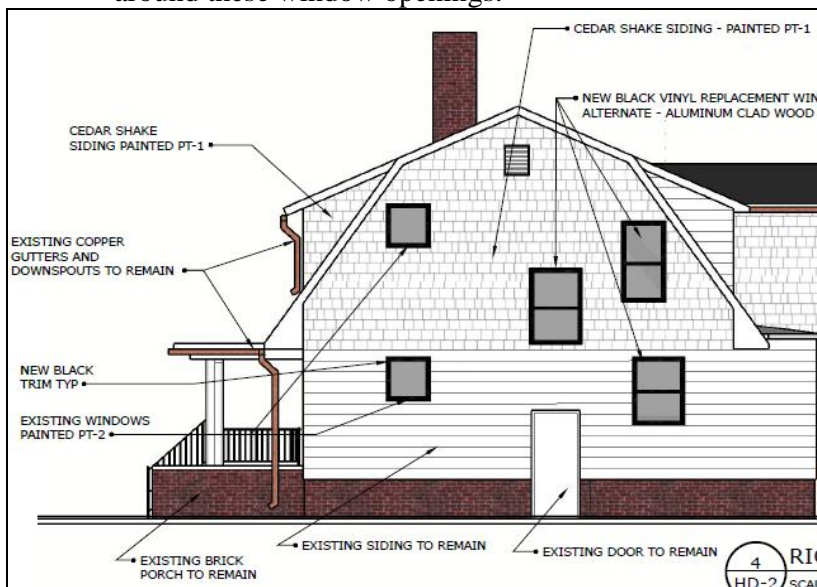
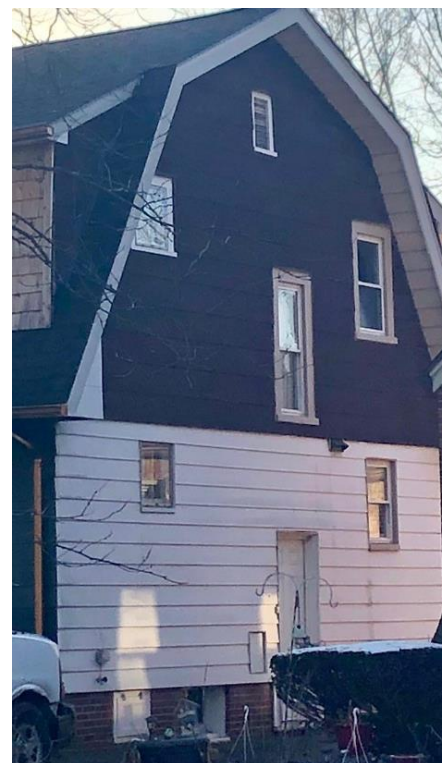
Applicant drawing – side/north elevation

- The applicant proposes to retain the remaining wood awning window units on the dwelling, located on both side elevations (first and second floor). The existing aluminum siding installation “jumped the casings” so the windows appear as small holes in the exterior walls. Vinyl trim is proposed to be installed around these window openings.

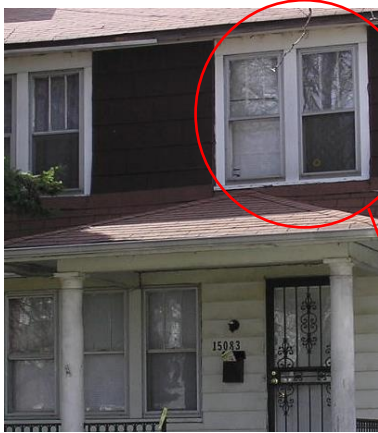
2006 designation photo

The designation photo shows what is likely the original casings/framing around the windows. The wood had a flat profile; the horizontal header is wider than the vertical members, and the bottom sill was very thin in height and extended outward from the vertical framing.

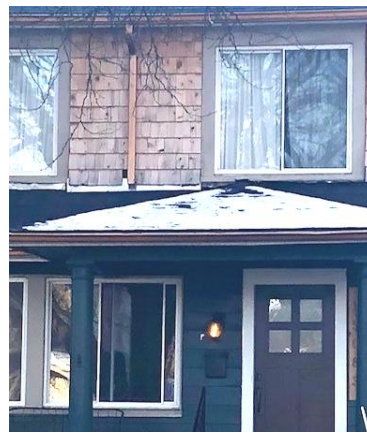
2023 staff photo

The clarity of the historic and current images isn't ideal; however, it still appears to staff that the existing framing is very similar in dimension to what is shown in the designation image, and a narrow, protruding sill is evident. Therefore, staff believes the historic wood casings remain in place and should be retained for the upper and lower window openings, including the mullion remaining within the first floor opening (visible in top right photo). The trim choices offered by Anderson: flat and profiled casings, brick mould casings and sill nose (metal and wood) should not be selected as none of these options match the historic/existing conditions.

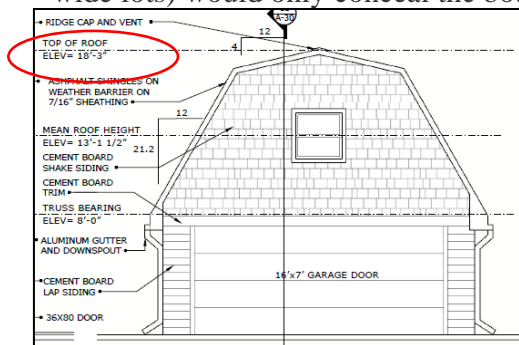
Drawing from February 2023 application

- Staff reviewed the new construction against the district’s elements of design. Elements that relate to the proposal are listed below:
 - Height** The height of the single-family residential structures in the Rosedale Park Historic District range from one-story to 2½ stories tall... Additions to existing buildings shall be related to the existing structure. Garages are generally one-story tall.
 - The garage has a standard footprint of 20’ wide x 20’ deep, however the steep pitch of the gambrel roof creates a ridge height of 18’-3”. The garage’s design is in context with the house’s gambrel roof; however, the exceptionally tall height of this garage will be out of proportion for the neighborhood. Additionally, the standard six-foot privacy fence, only five feet way (on 40’ wide lots) would only conceal the bottom third of the structure from the neighboring property.

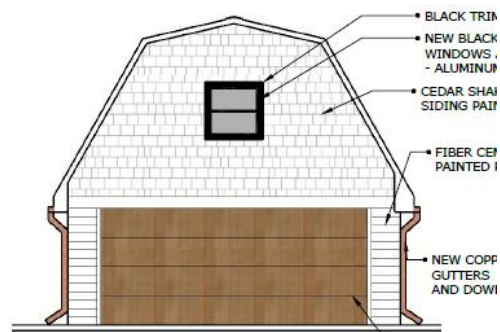
Drawing from current March 2023 application

- The applicant removed the notation of a second floor on the garage plans; however, the sizing/height of the garage was not reduced.

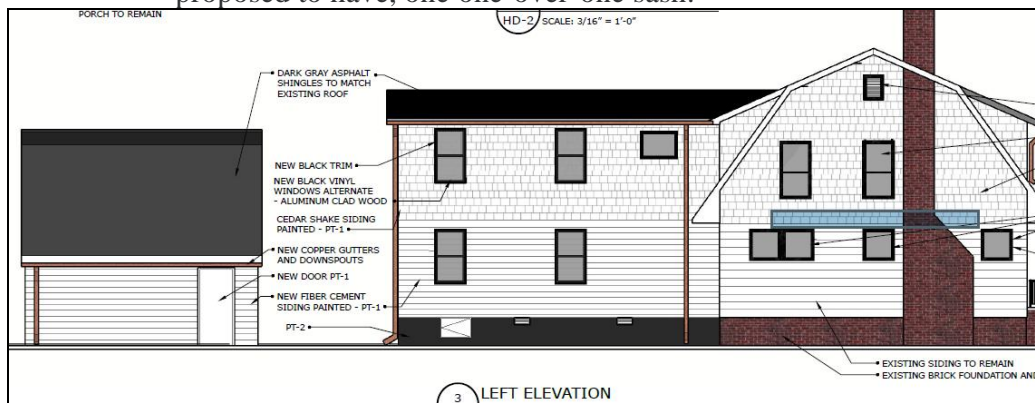
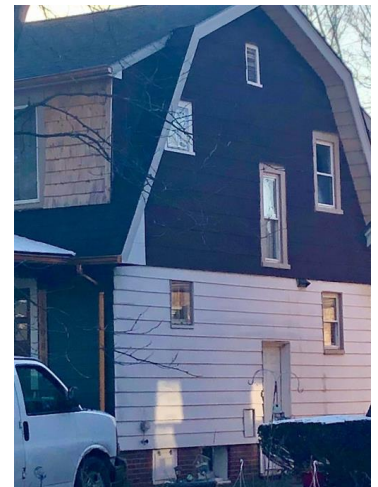
- The addition's southern elevation (shown below) has mostly double-hung windows, but one smaller horizontal window remains. The existing small windows on the house (which the applicant will retain) are located on both sides of the house; the north elevation has one small window at the second floor. All of the double-hung windows on the sides and rear have, and are proposed to have, one one-over-one sash.

Above, top, and bottom right: applicant drawings and photo; middle right: staff photo

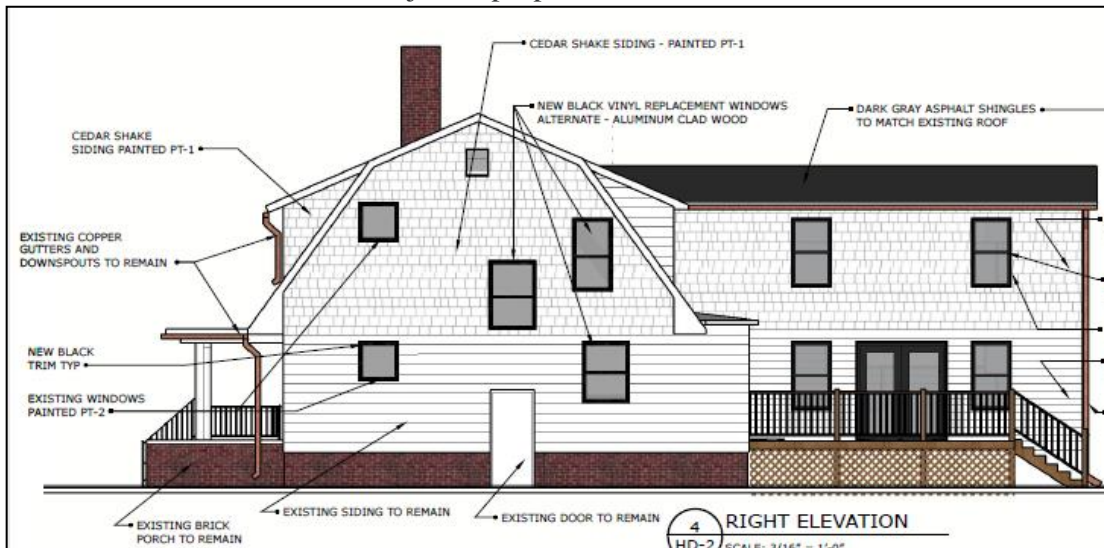
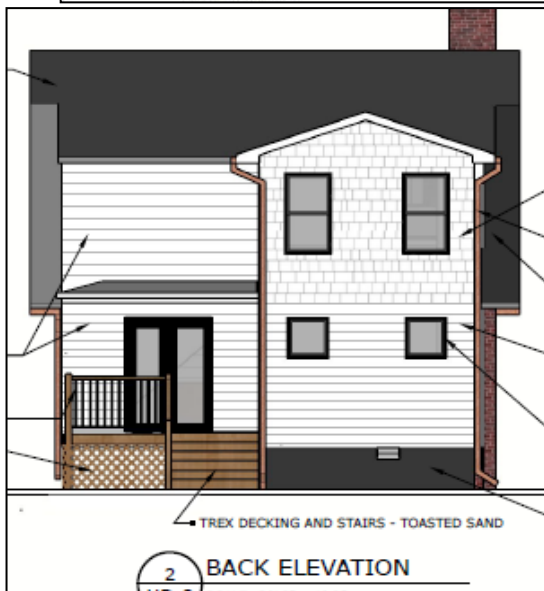
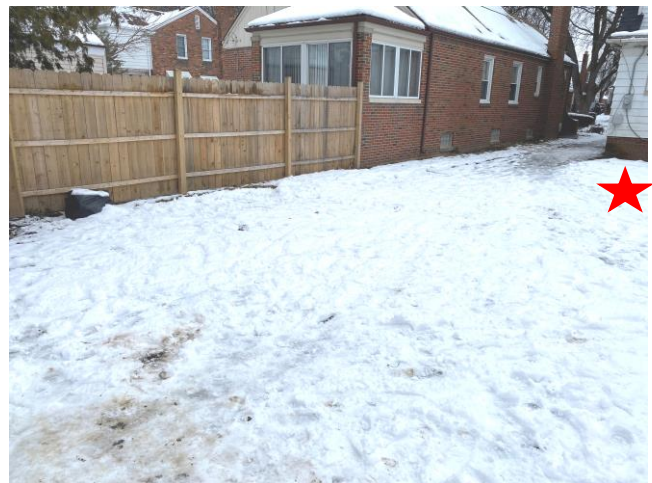
- The term “moderately scaled dwellings” is referenced in multiple elements of design. As staff mentioned with the garage, a two-story addition extending almost 29’ back from the house will create a large impact on the neighboring lots.

- Staff isn’t opposed to the erection of an addition or a 20’ x 20’ garage, rather the main opposition is over the scale of each structure. Additions extending from the rear elevation are very common, however they often have flat or low slope shed roofs starting at/near the house’s eave. An addition should also not have a larger footprint than the house (whether in direct length or overall square footage). Just as the width of the proposed addition is about half the width of the house, the addition’s length should be at most half of the existing house’s length. Therefore, all elevations would be more proportional to the house, lot, and adjacent properties.

Applicant drawings and photographs. The applicant’s photo is taken from the location of the proposed garage. A star denotes the location of the proposed deck.
