STAFF REPORT: MARCH 8, 2023 MEETING

APPLICATION NUMBER: 23-8237

ADDRESS: 2905 GARLAND (AKA THE OSSIAN SWEET HOUSE)

SCOPE: REPLACE REAR SECOND STORY PORCH* (WORK STARTED WITHOUT APPROVAL), INSTALL GLASS BLOCK WINDOWS

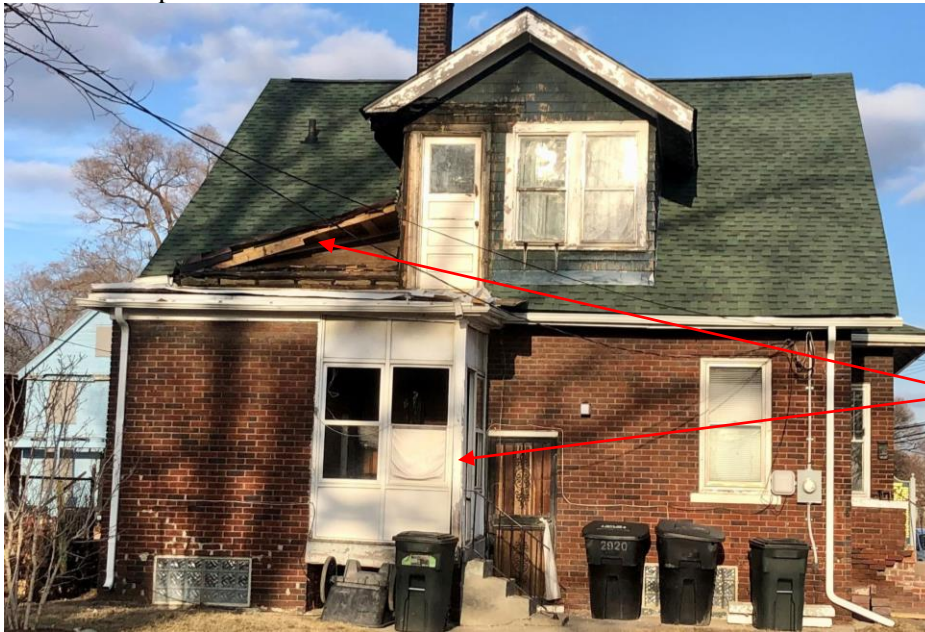
All brick areas seen here are original construction. The sloped roof and first story aluminum enclosure are later additions. The area enclosed by aluminum was once an open porch and retains its wood floor and beadboard ceiling.

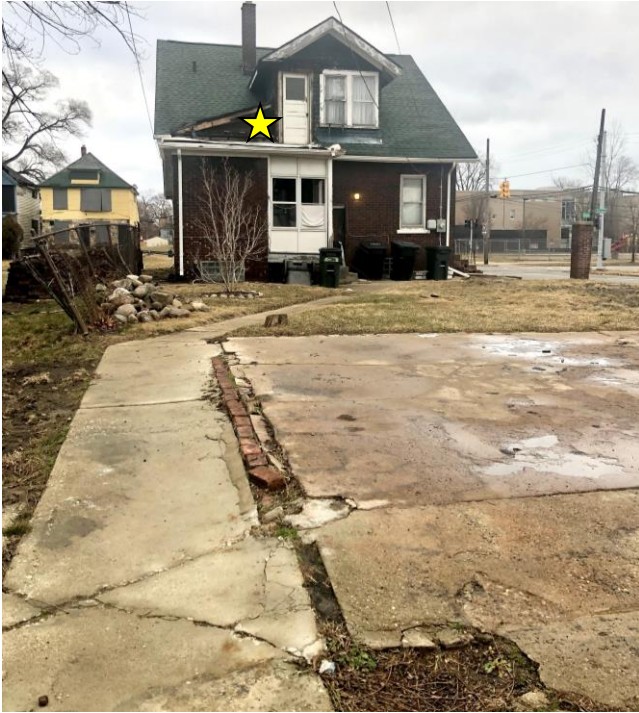
Left: Staff photo, February 21, 2023; entire upper porch removed.

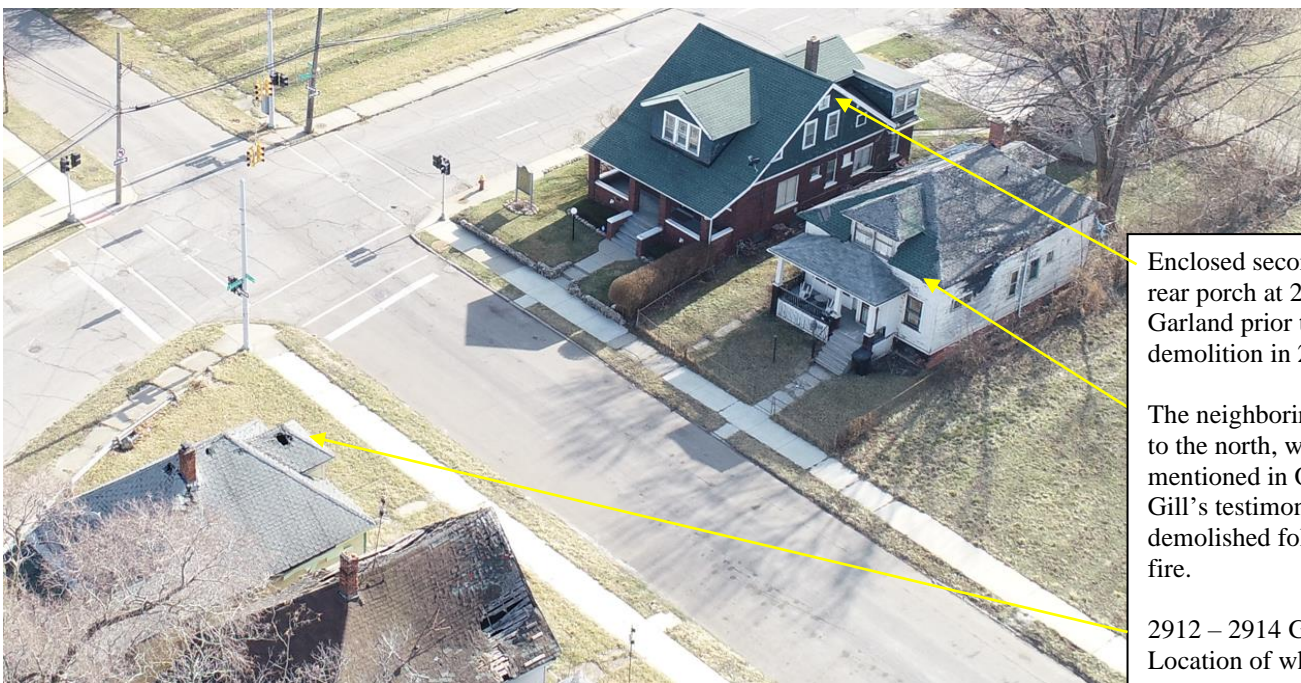
Enclosed second story rear porch at 2905 Garland prior to its demolition in 2023.

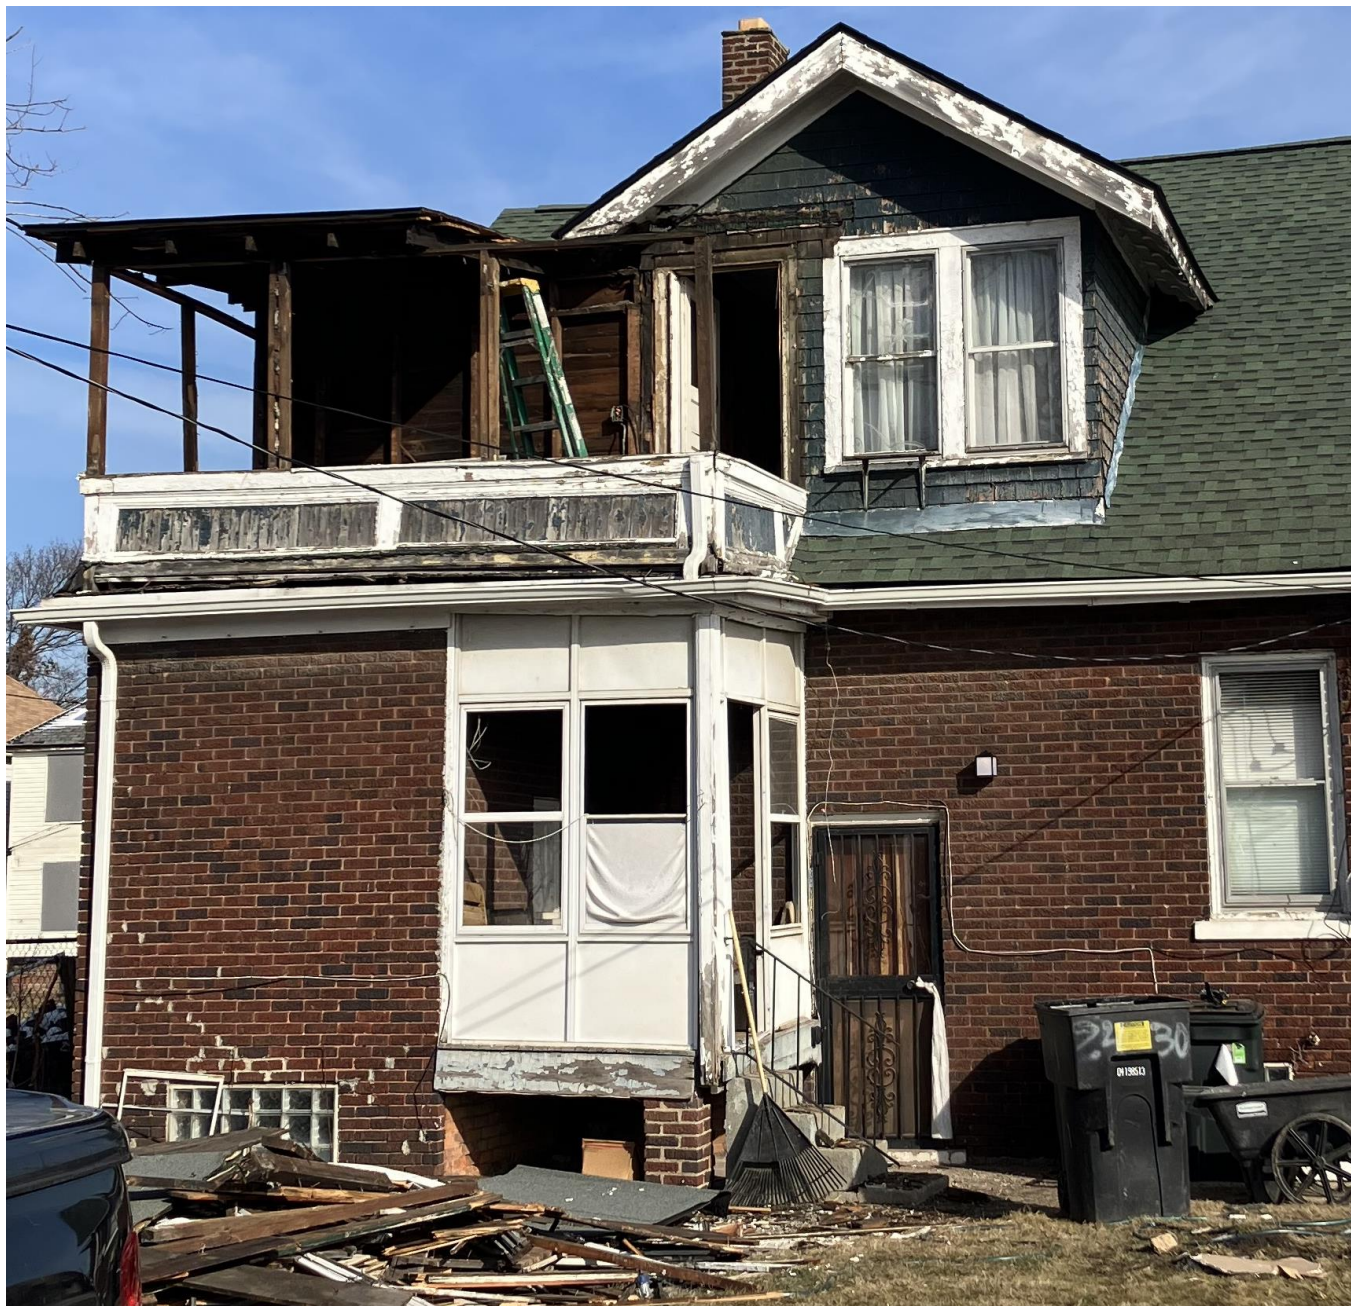
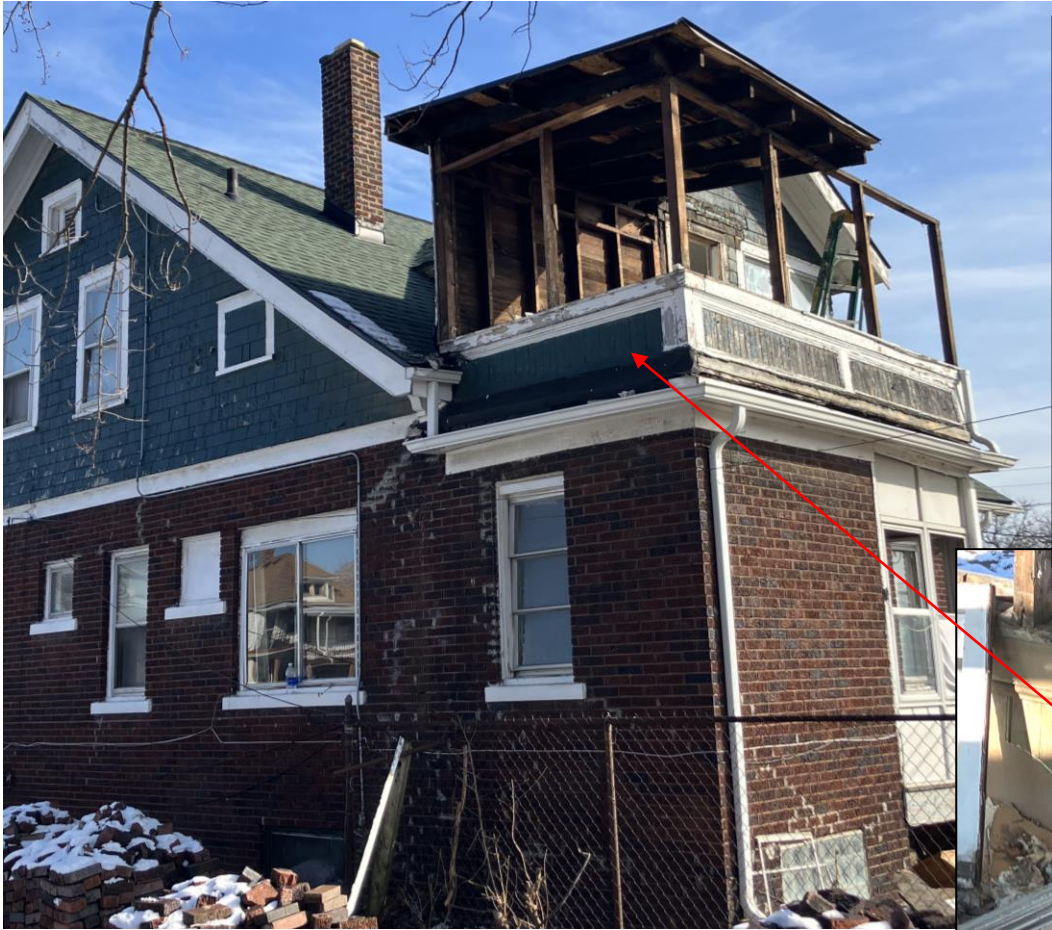
The inside walls were faced with beadboard that matched the exterior wall condition, offering evidence that this knee-wall was originally an exterior component of the porch.

Photo at left and the below close-up are the exterior and interior walls at the north elevation.

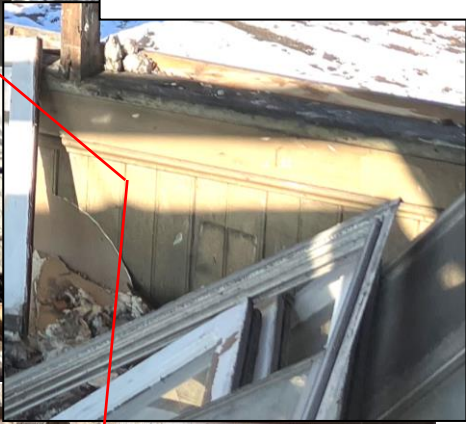
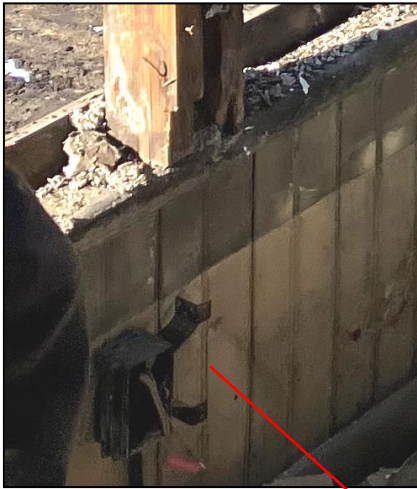
The electrical box installed on the outer wall confirms that electricity was not originally supplied to the porch; this box was likely added when the upper walls and windows were constructed.

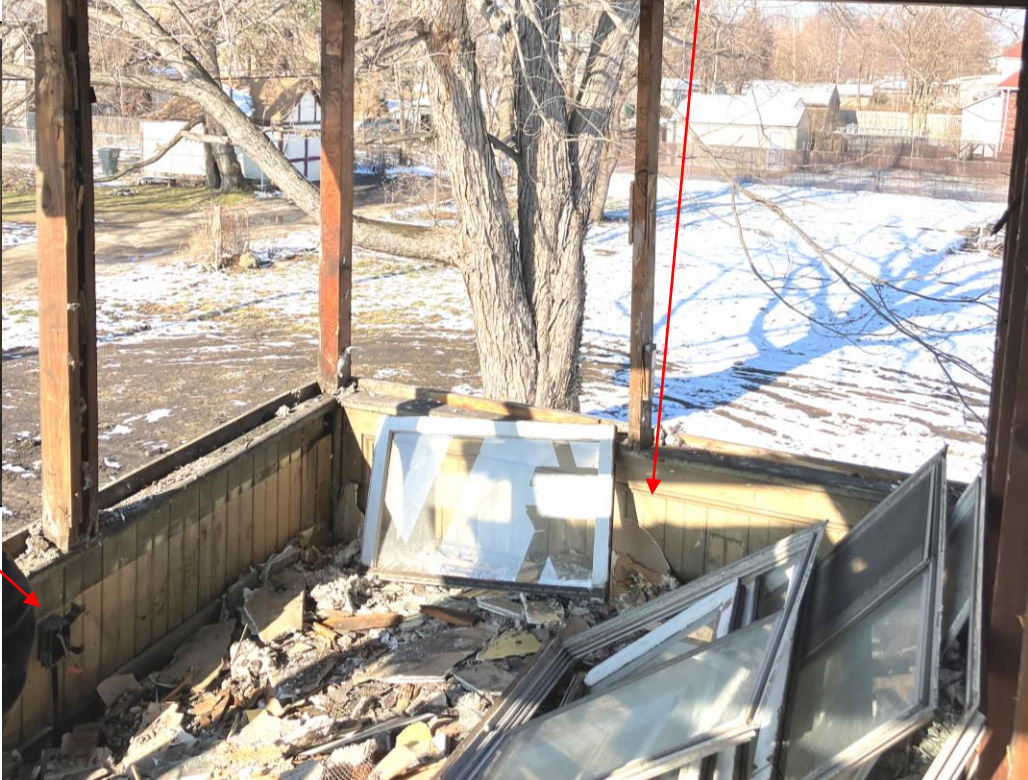
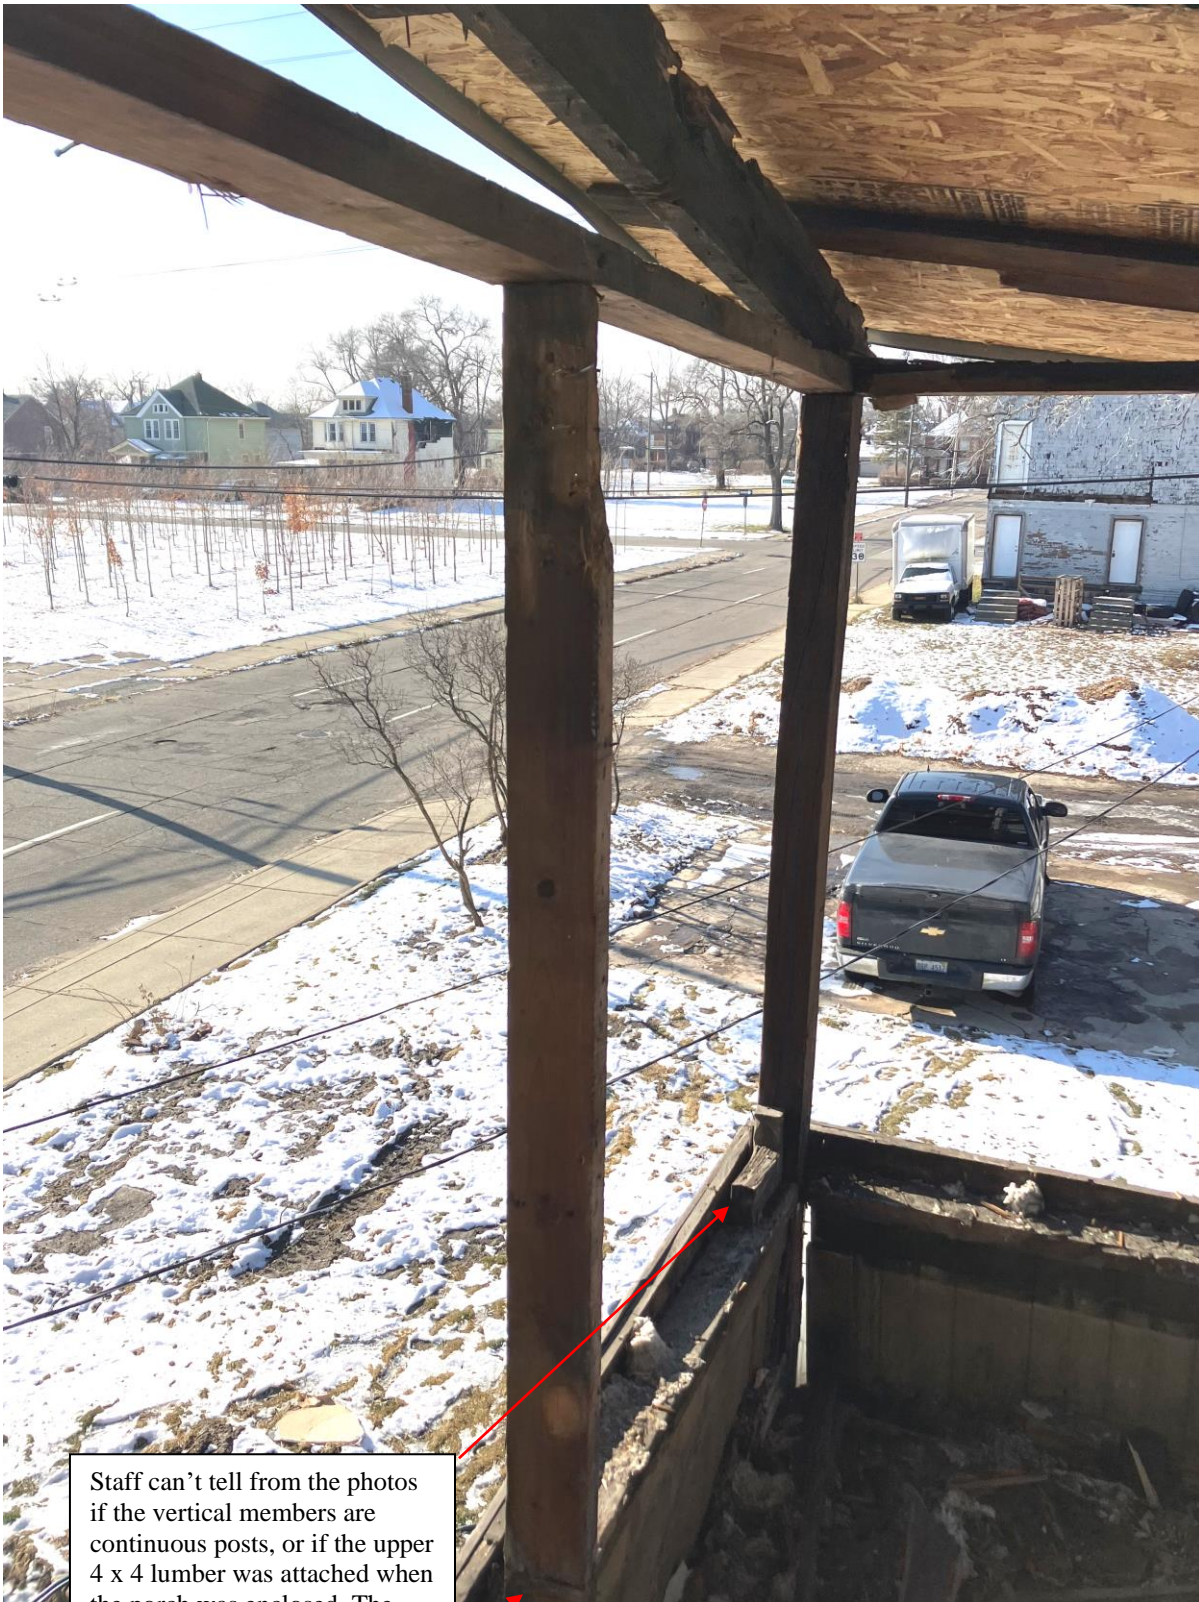
Staff can't tell from the photos if the vertical members are continuous posts, or if the upper 4 x 4 lumber was attached when the porch was enclosed. The additional framing at the corner post and possible cut line at the interior post may suggest the latter.

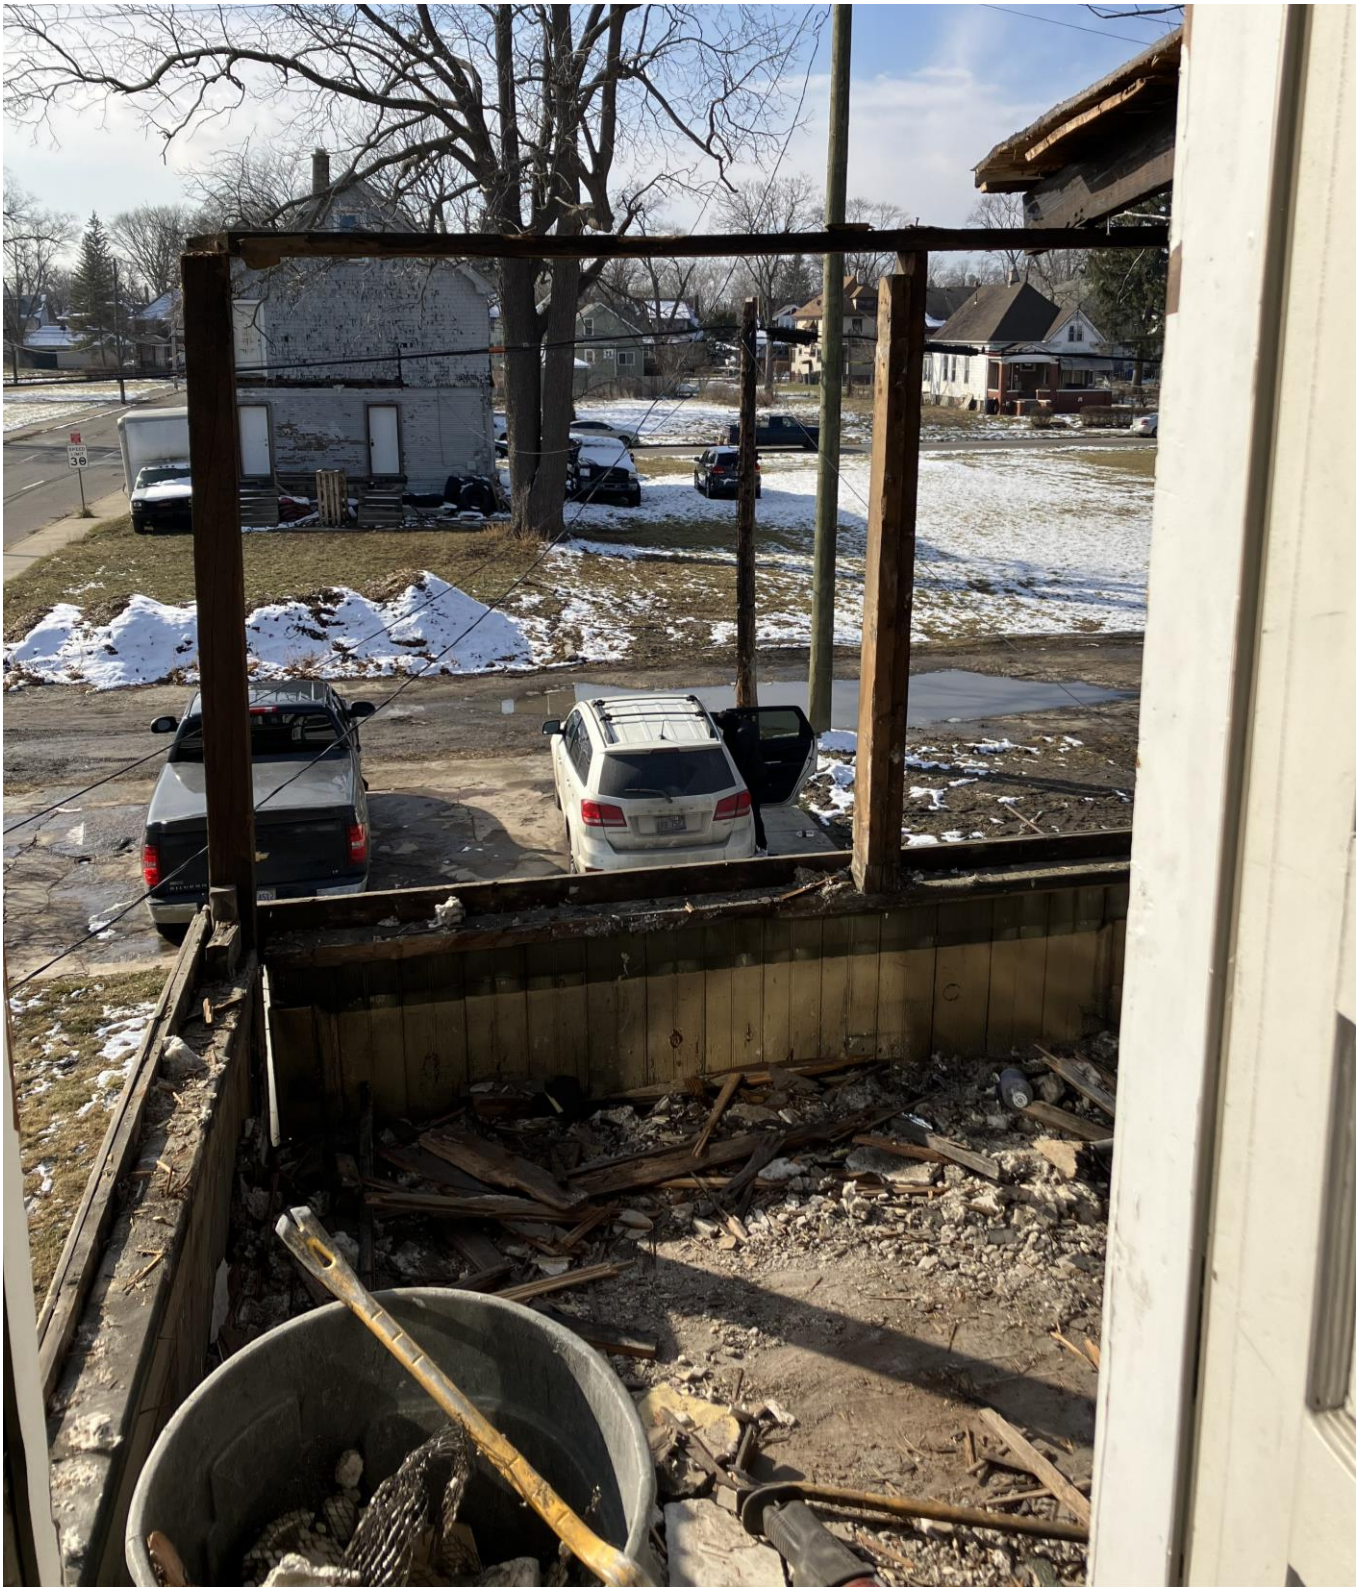
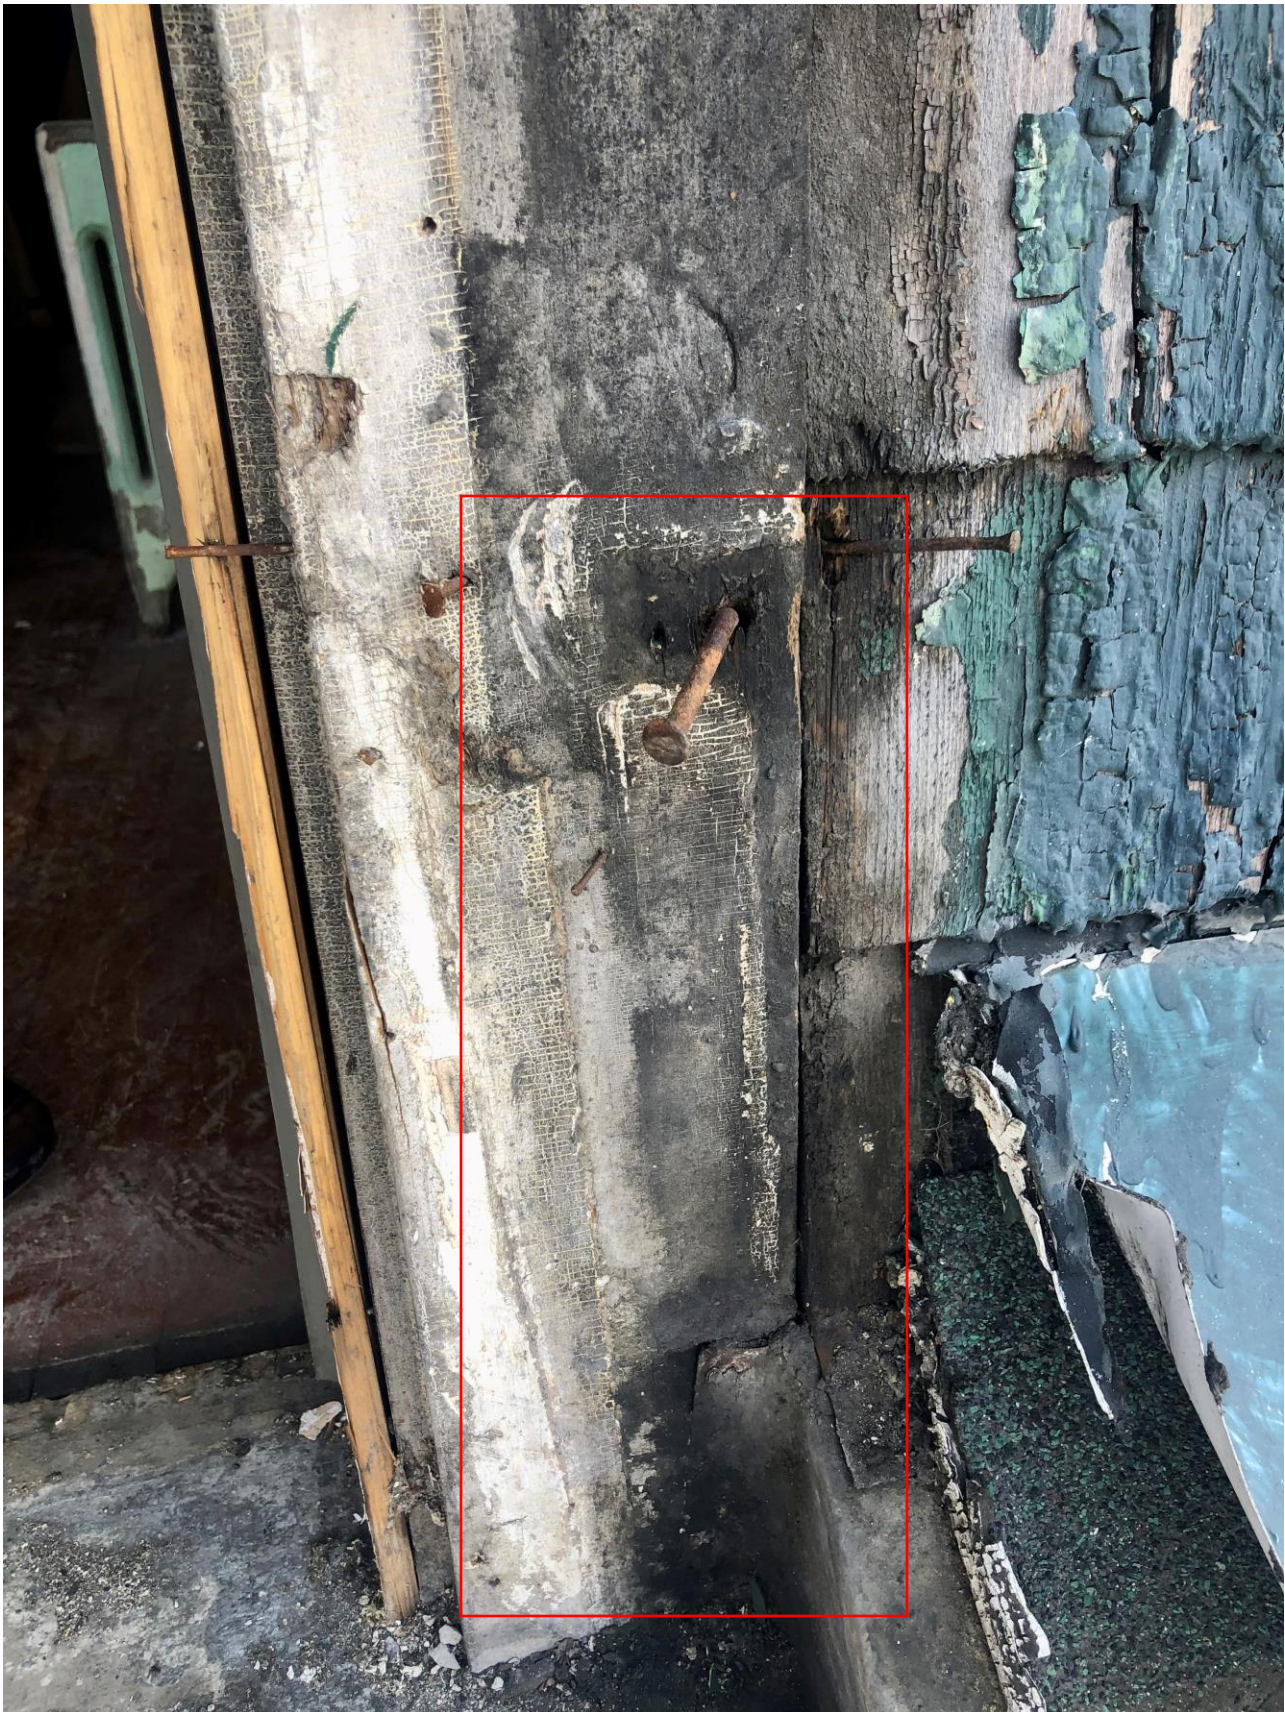
Staff photo, March 6, 2023. Some visual evidence of the upper porch railing is evident.

- The applicant will propose a period and architecturally appropriate painted wood railing for the upper porch as well as the lower porch and stairs. An alternate option for the upper porch would be to rebuild the knee-wall that is heavily documented in pre-demolition photographs.
- The applicant will modify the previously submitted rear elevation drawings to show the location, dimensions, design, materials, and finish of the porch railings and concrete steps; the drawings will be submitted for staff review. Painted wood steps, in lieu of concrete, shall also be appropriate.
- ~~The retention and repair of the existing basement windows on the north and south elevations, the removal of glass block and installation of wood hopper windows (matching existing) at the west elevation, with paint color for sash listed, will be noted on the architectural drawings submitted for permit.~~

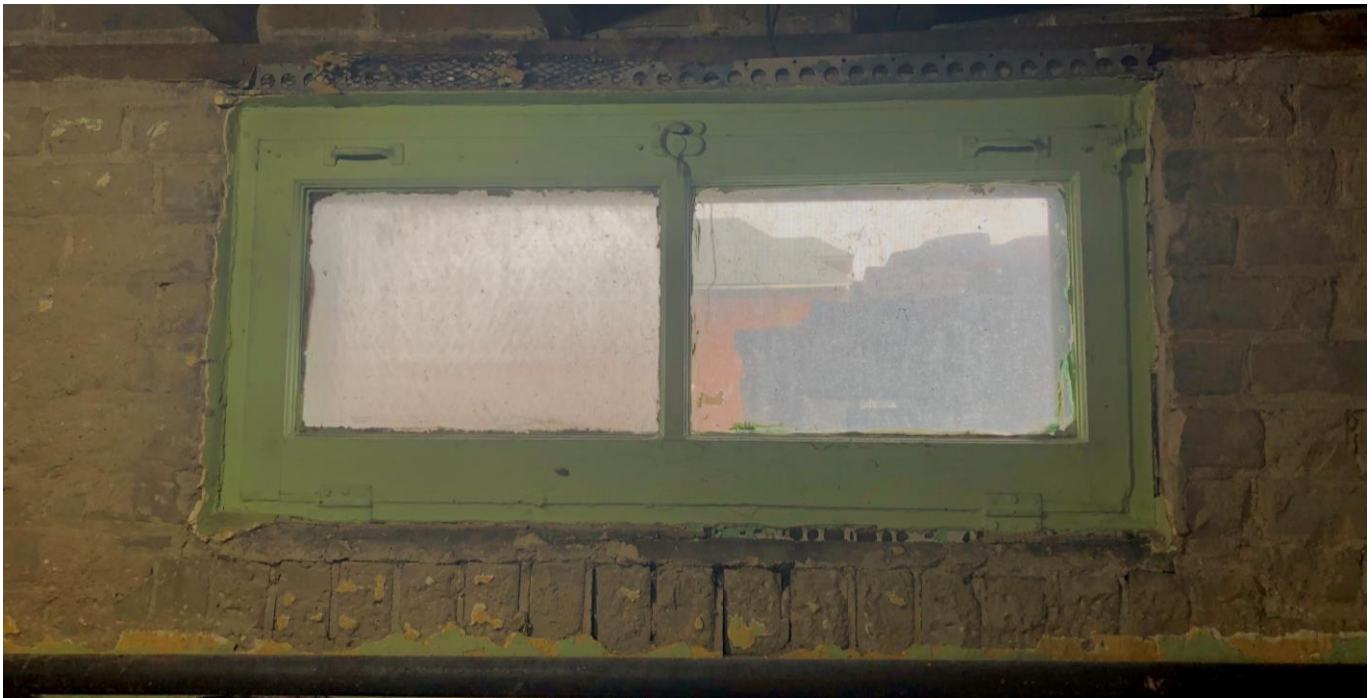
Example of intact wood frame hopper units at north and south elevations.

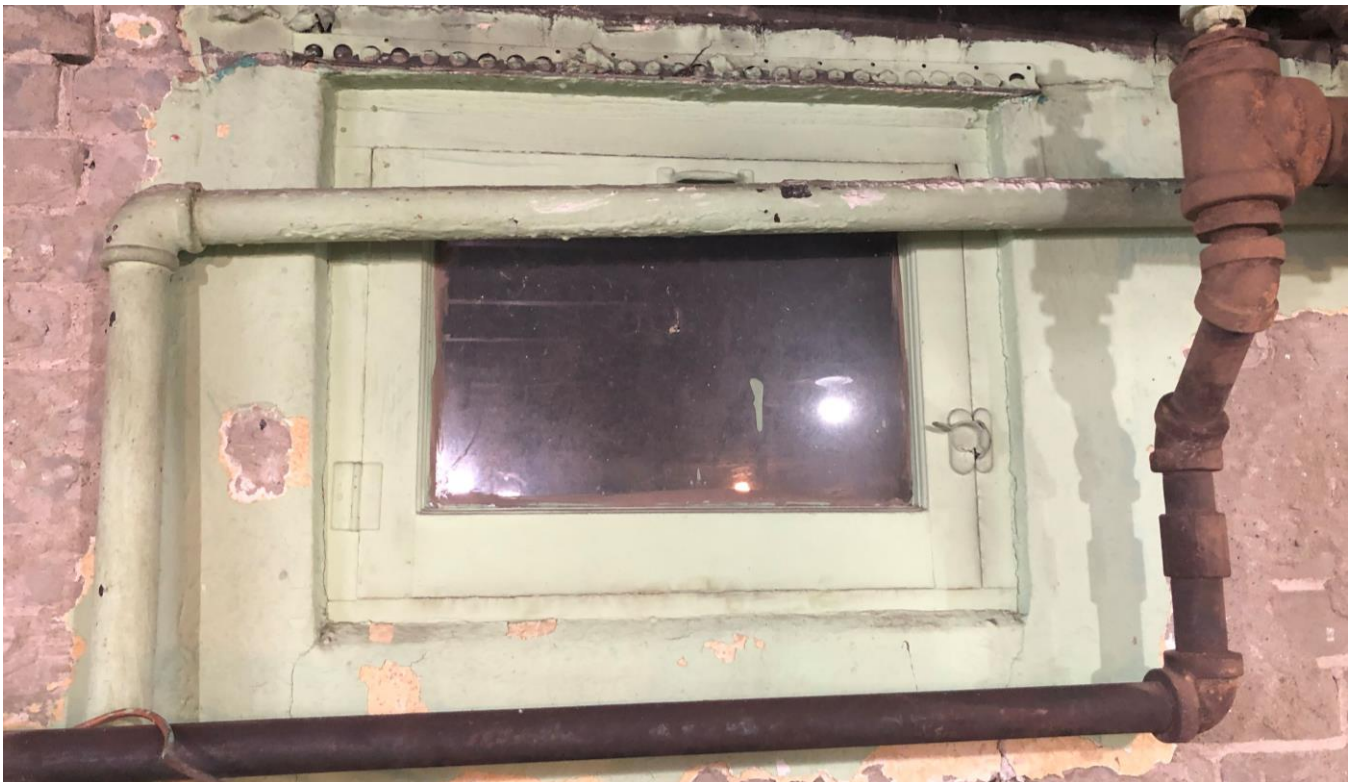
Example of window (one of two) at the front elevation (below front porch). These openings and sash will be retained.
