STAFF REPORT: MARCH 8, 2023 REGULAR MEETING

APPLICATION NUMBER: 23-8423

ADDRESS: 1411 AND 1425 CHICAGO

SCOPE: ERECT FENCE

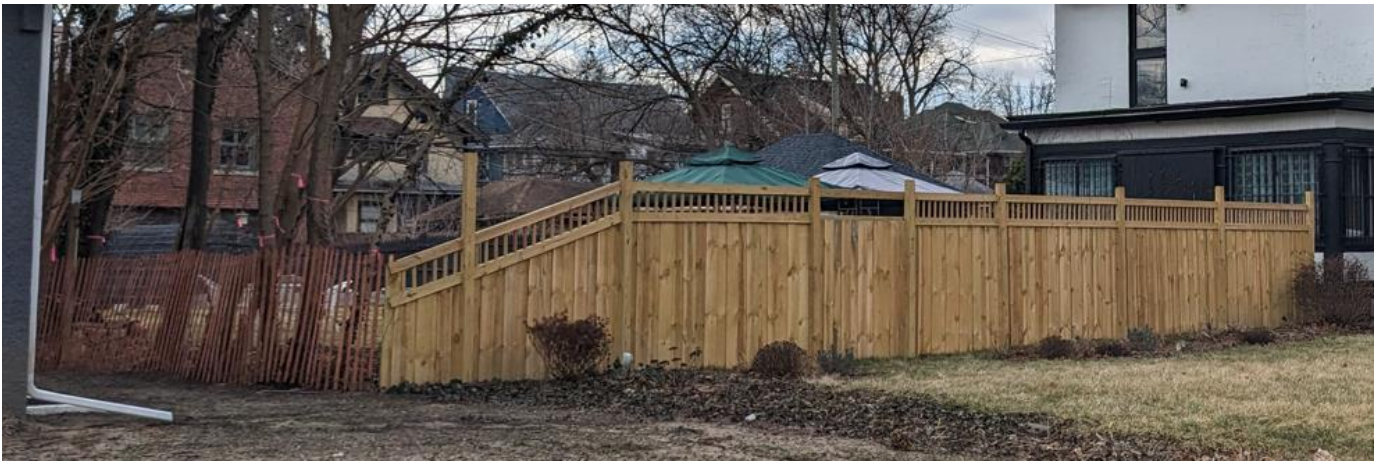
The applicant explained in an email to staff that the eastern edge (left side, when viewed from the street) is not in its final configuration, as the applicant is in the process of discussing a shared side fence with the neighbor. According to the applicant, the side fence was removed by a previous neighbor. Staff observes an apparently temporary, 4' snow fence now running along the eastern edge of the property.

Eastern termination of the fence. February 2023 site visit photo by staff.

- Unfinished treated wood is a contemporary material that is not appropriate for the Boston-Edison Historic District. The fence should be painted or stained.
- Historic fences in the Boston-Edison Historic District generally run parallel to the plane of the ground and have a uniform height. The sharp downward slope of the east end of the new fence is not appropriate.

- The fence shall be painted a color as deemed appropriate by staff.
- The fence height shall be standardized to six feet along its entire length.

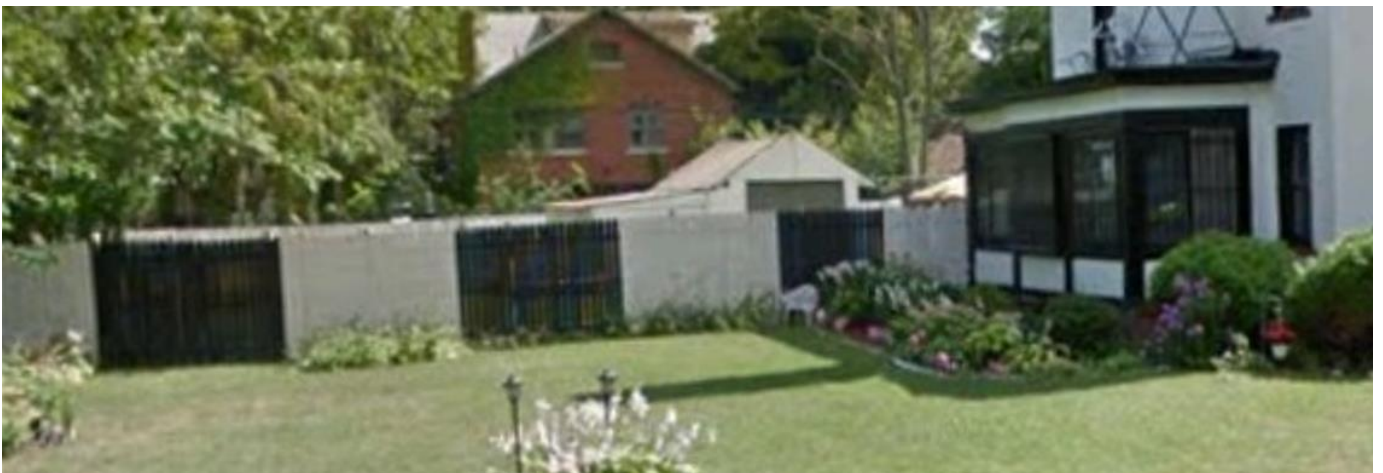
The old fence is a 6' wood stockade fence. Only the rear section remains, as the front and east side sections have been removed, as described above, and the west side is served by the adjacent property fence.

Undated image of old fence, provided by applicant.

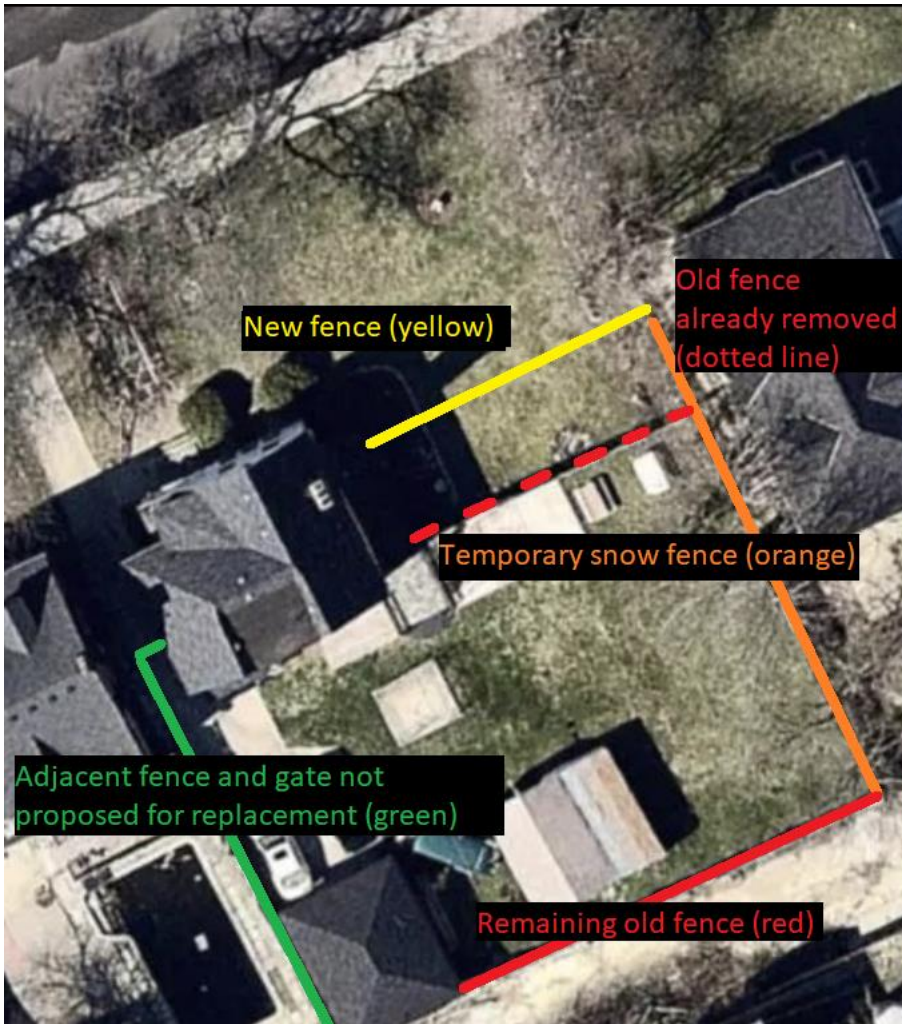
The new fence is in a different location than the previous fence, as shown in the illustration below. The removed fence sat at the rear (south elevation) plane of the projecting sun porch, while the new fence sits at the front (north

elevation) plan of the sun porch.

Aerial photo depicting old and new fence sections. Image from Gaia GPS, illustration by staff.

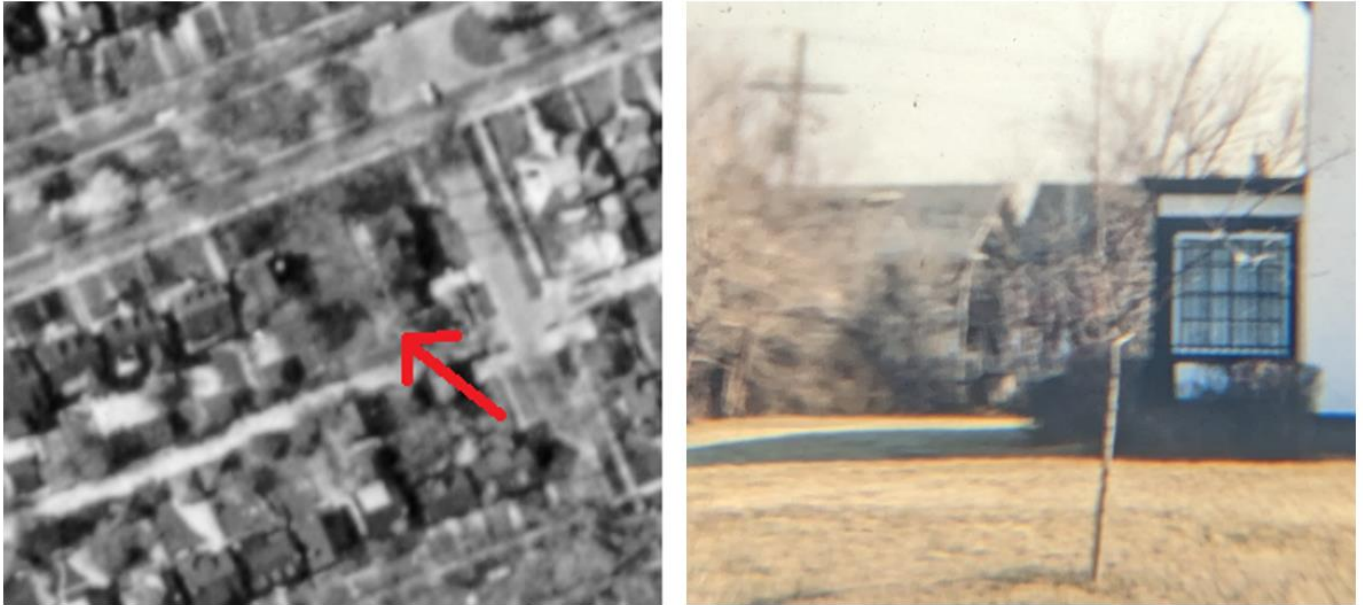
- Staff opines that the side lot is a historic, character-defining open space. Building permits show no record of a building having existed at that location, and the lot is seen as open in a 1949 aerial photograph. The orientation of the sun porch appears to be intentional with respect to this open space. Additional photographs from the 1960s and 1970s show that it has remained open. The fence was added sometime

after the historic district was established in 1974. Staff finds no record of a Certificate of Appropriateness for the fence.

Left: Arrow indicating location on 1949 DTE photograph. Right: 1974 photo by the Historic Designation Advisory Board.
