**STAFF REPORT:** 4/12/23 REGULAR MEETING

**APPLICATION NUMBER:** 23-8232

**ADDRESS:** 4440 E. CANFIELD/4444 RUSSELL

**SCOPE:** ALTER FRONT PORCH OF RECTORY BUILDING

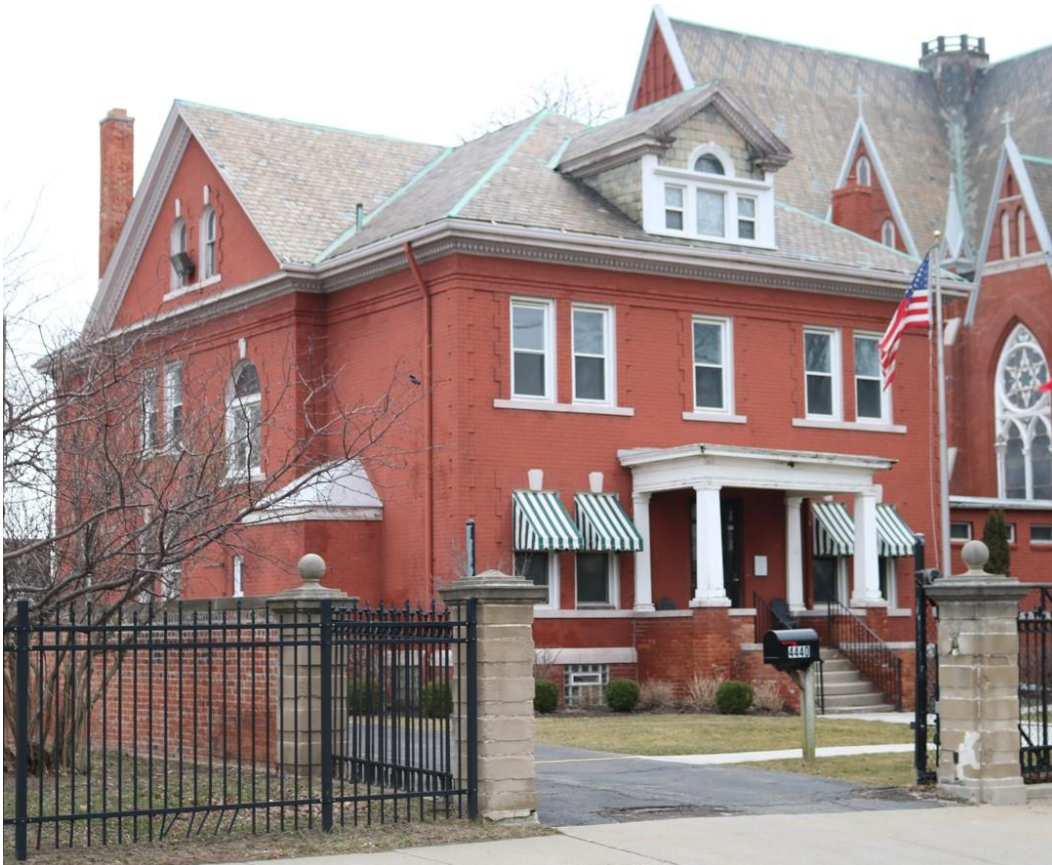
*March 2023 photo by staff*

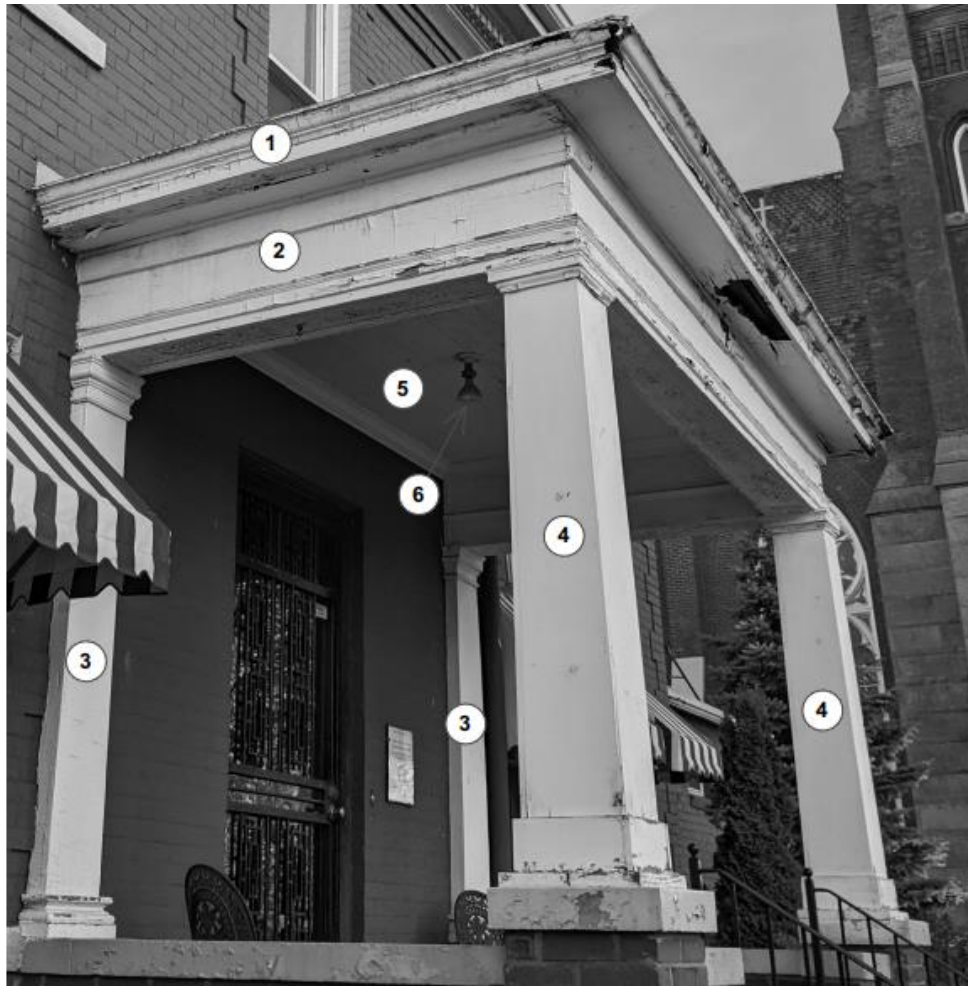
*Existing porch proposed for demolition. Image from application.*

- ① DEMOLISH ROOF AND ROOF FRAMING
- ② DEMOLISH ROOF SUPPORT STRUCTURE
- ③ DEMOLISH PILASTERS
- ④ DEMOLISH COLUMNS
- ⑤ DEMOLISH PORCH CEILING
- ⑥ REMOVE PORCH LIGHT BUT MAINTAIN BRANCH CIRCUIT FOR CONNECTION TO NEW LIGHT

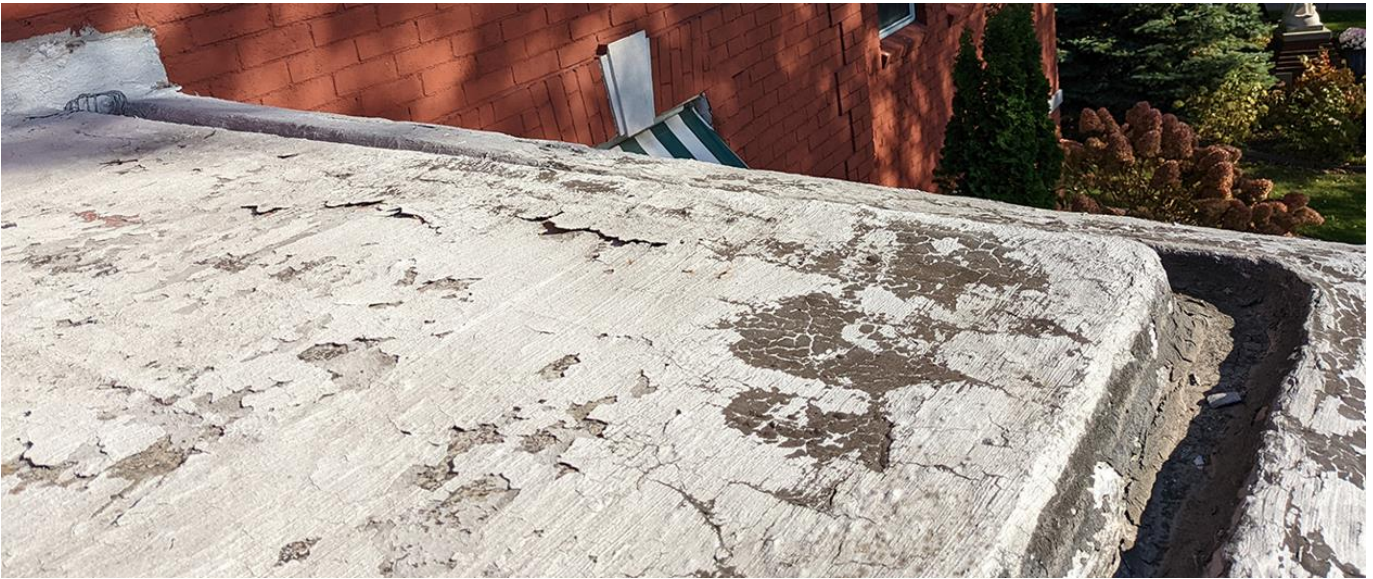
The existing flat roof slopes downward slightly away from the rectory building and contains a shallow integral gutter that is supposed to drain to a downspout mounted on the rectory front façade adjacent to the south pilaster. The existing downspout is a 3" diameter painted PVC sewer pipe. It is unclear whether the roof slope was an original design feature or if it was created by decay of the original support columns and replacement of those columns with temporary columns that were too short. The current counteracting roof slope prevents water flow toward the

downspout drain resulting in it spilling over roof edges. The poor condition of the integral gutter inverts allows water in the gutter to soak into the roof structure. The seepage of water into the roof structure and edge spillover has contributed to decay of the wood soffits, fascia and roof joist ends and it likely contributed to decay of the original columns that ultimately necessitated their removal. Professional roofing contractors have indicated that redesign of the roof drainage strategy is necessary for successful installation of a new roof on the porch.

*Existing condition of porch roof. Photo provided by applicant.*

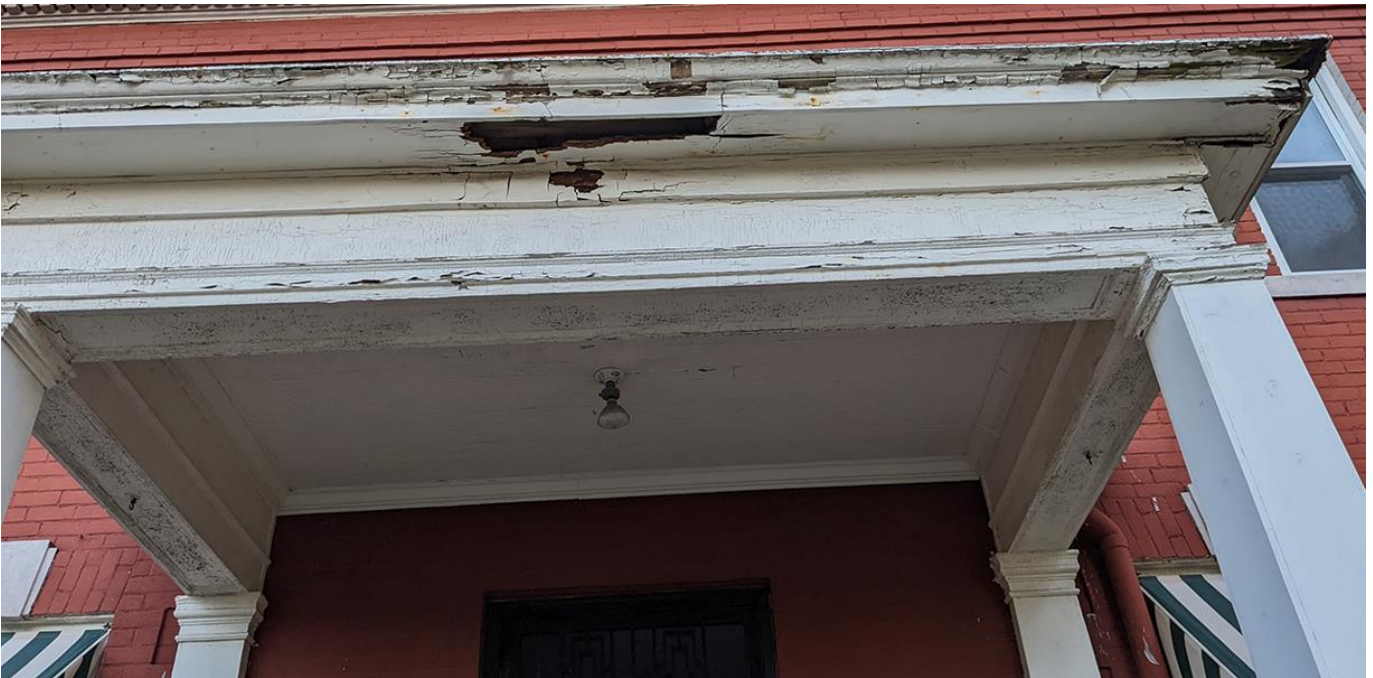
*Existing condition of porch. Photo provided by applicant.*

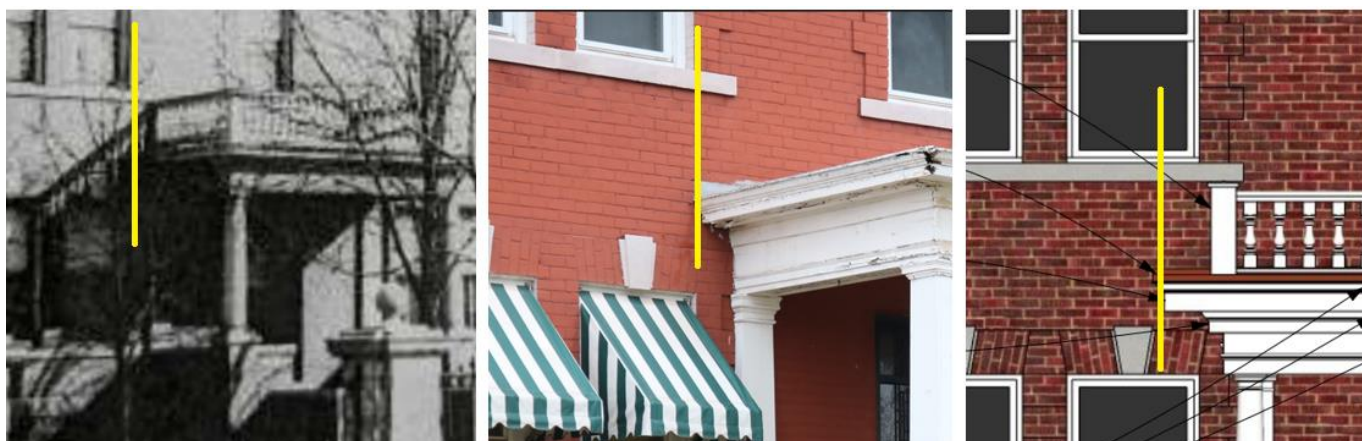
- The proportions of the proposed porch are clearly different from those of the historic porch. For example, the upper cornice of the proposed porch appears to be about two feet wider than the same element of the historic porch. The dimensions of the proposed porch would thus alter the visual relationship of the porch to the core facade. The proportions of the proposed porch entablature also appear to be changed from the current porch.

*Left to right: Historic (from application), current (staff photo), and proposed (from application) porch; yellow line added by staff to indicate approximate western extent of porch cornice. Image is typical of both sides of porch as porch is symmetrical.*

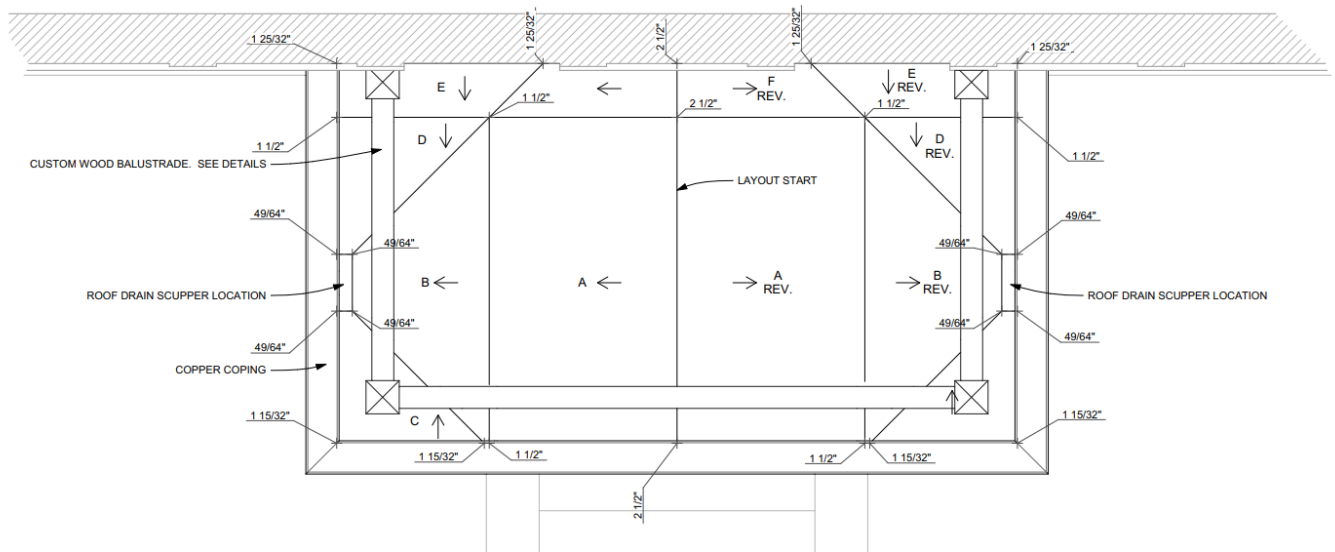
- It appears that the proposed wider porch roof is intended to provide clearance for drain scuppers located on the sides (north and south elevations) of the proposed new porch. Staff suggests that other mechanisms for drainage could be explored that would not require changing the dimensions of the historic porch.

*Roof plan showing drainage system. Image from application; see application documents for additional images and detail.*
