STAFF REPORT: APRIL 12, 2023 MEETING

APPLICATION NUMBER: 23-8284

ADDRESS: 10321 OUTER DRIVE WEST

SCOPE: REPLACE WOOD WINDOWS

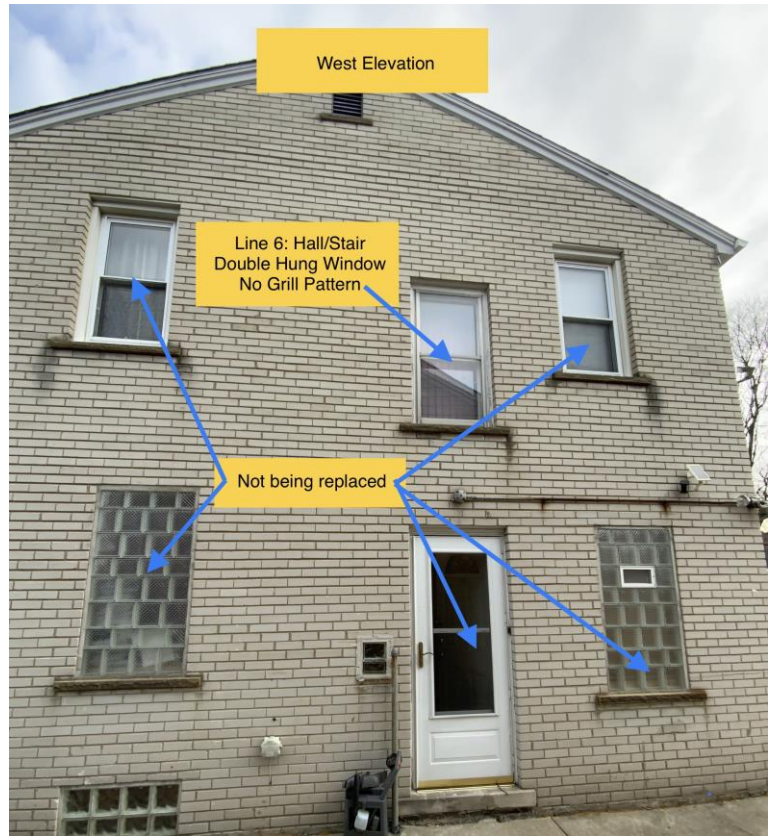
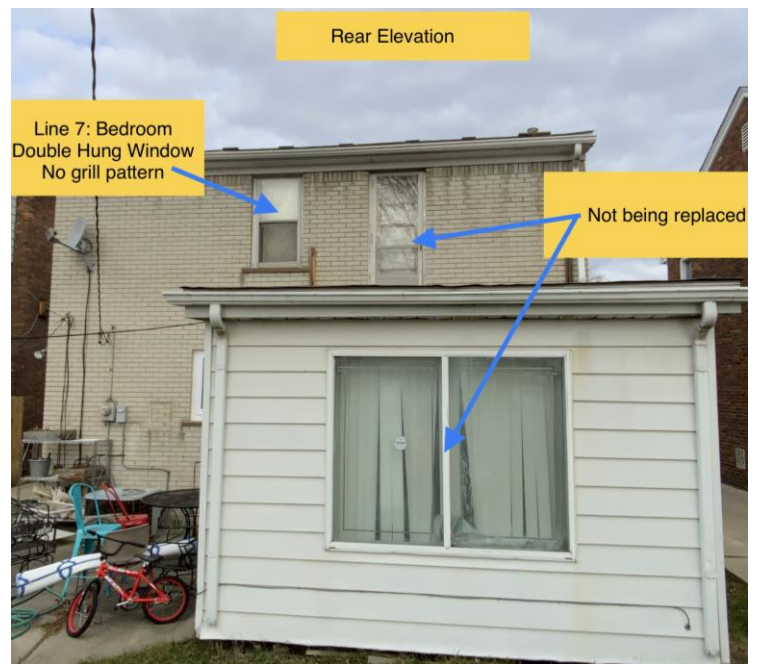
Applicant photos

- The applicant stated, “*We are replacing the current windows because they are old, the wood around each window is rotted, and they are loose and falling apart.*” However, it is staff’s opinion, based on the interior photos submitted by the applicant, the sash is intact within each window opening and the wood frames don’t show visible evidence of significant deterioration.

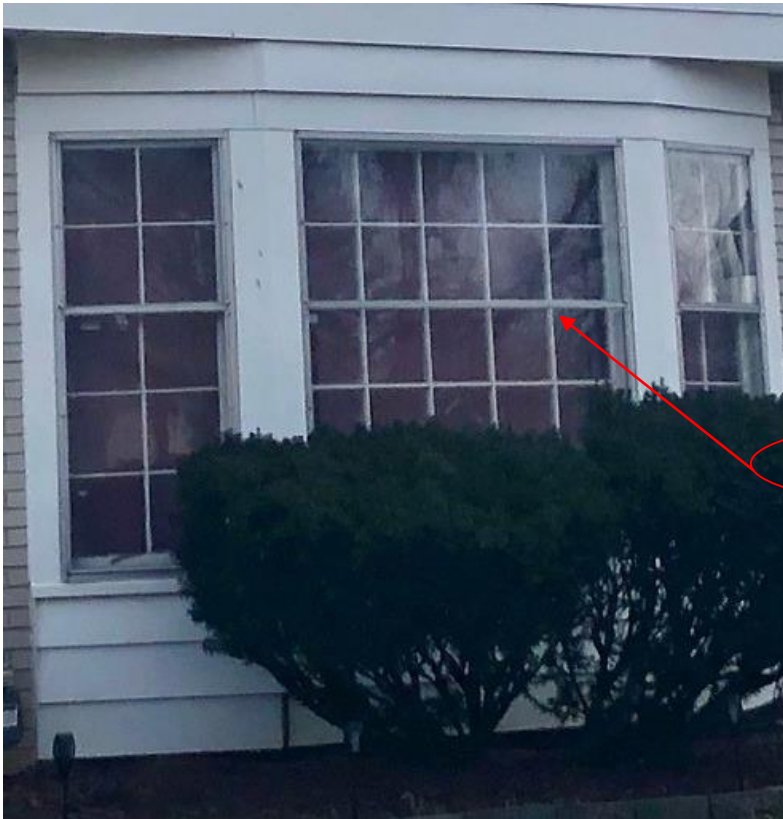
Staff photo, March 28, 2023.

- While Anderson markets Fibrex sash as a wood window, the majority of the material within the frames is plastic.
- The front elevation bay window is a distinctive character defining feature of the house. The existing wood windows contribute to this feature for the following reasons:

- True divided-light muntin bars offer a dimensionality to the window openings and is the dominant architectural detail on the structure.
 - The cottage-style flanking units are not ubiquitous on houses, and adds a unique proportion to the front elevation.

- The central fixed wood window has a custom feature in which the second horizontal bar is thicker, emphasizing its alignment with the meeting rails of the side windows. This difference in width is further evident in the interior picture provided by the applicant. While this different width is a small detail, it is staff's opinion it is these small details that contribute to the uniqueness of historic structures.

It is staff’s opinion that the existing wood windows are not deteriorated beyond repair and the wood sash at the front elevation retains a level of materiality and dimensionality that offers architectural detail to the structure. Therefore, staff recommends the Commission deny a Certificate of Appropriateness for the work as proposed because it does not meet the Secretary of the Interior Standards for Rehabilitation and the Elements of Design for the district, specifically Standards:

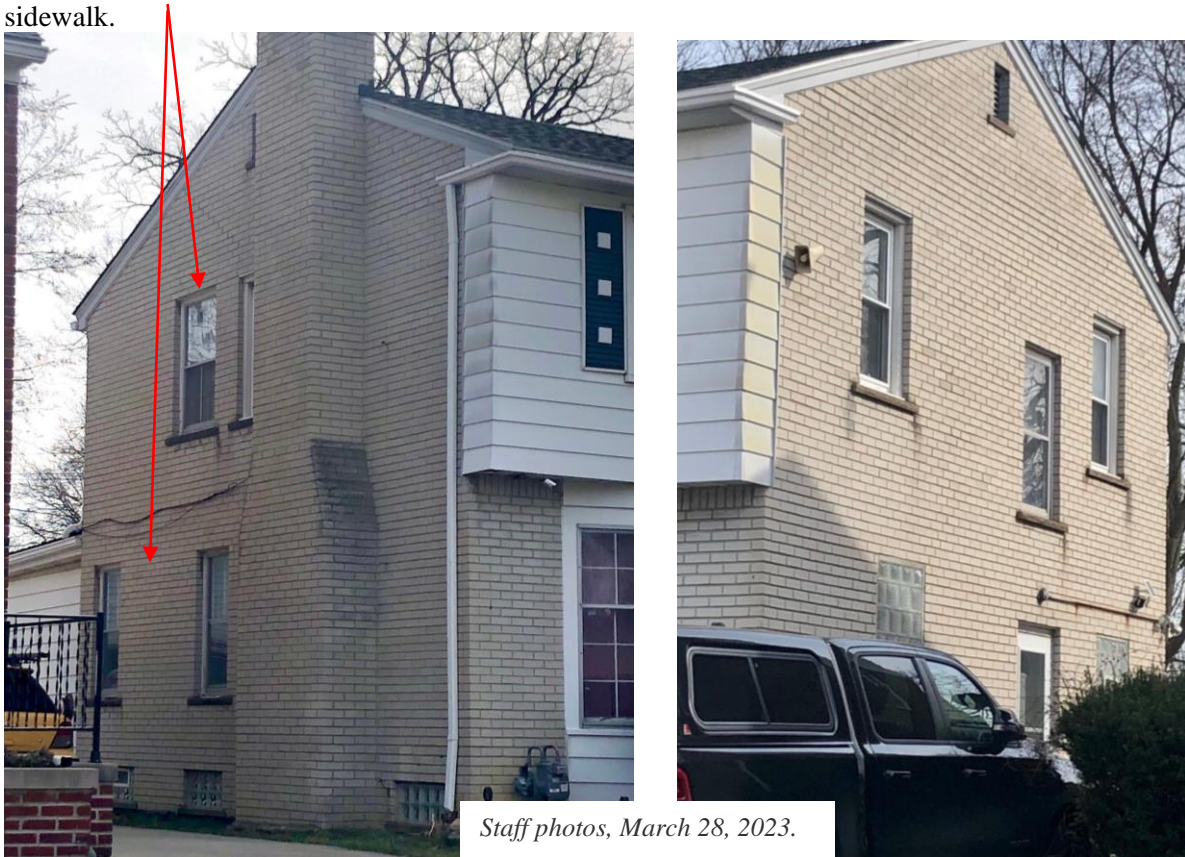
- The window openings at the side and rear elevations have stone or cast concrete sills with a rough, cut surface. The protruding sills are character-defining features, however the window sash at the side walls are minimally visible from the public right-of-way. The divided-light double-hung windows on the east wall (#1, 2, 8) are further obscured from view by the chimney and the muntin patterns are not visible from the sidewalk.

It is staff’s opinion the remaining work will not alter the features and spaces that characterize the property, and therefore recommends the Commission issue a Certificate of Appropriateness for the work as proposed because it meets the Secretary of the Interior Standards for Rehabilitation and the Elements of Design for the district.

- Window units at the east elevation (#1, 2 and 8) can be one-over-one double-hung units, thereby matching the adjacent vinyl one-over-one double-hung window.
