STAFF REPORT: APRIL 12, 2023 MEETING

APPLICATION NUMBER: 23-8285

ADDRESS: 1444 EDISON

HISTORIC DISTRICT: BOSTON-EDISON

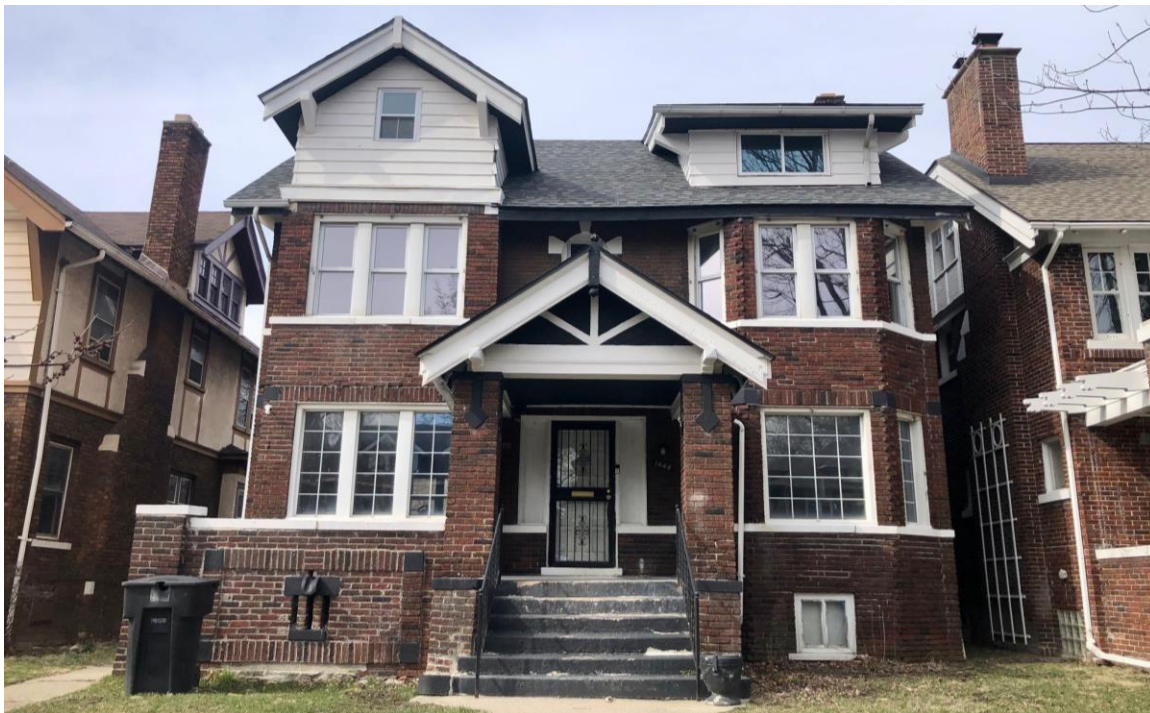
Staff photo, March 28, 2023.

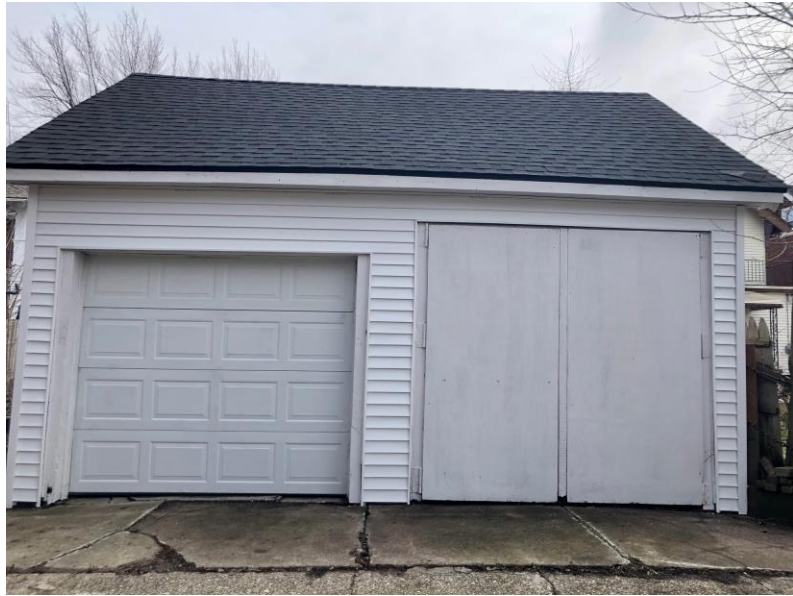
Garage from alley. Staff photo, 04-04-2023

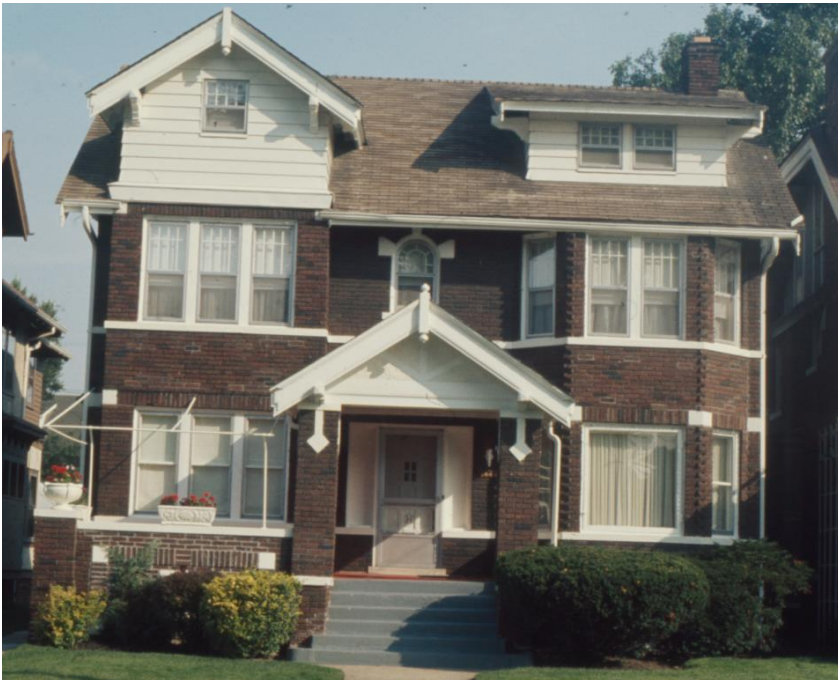
- The Boston-Edison Historic District was established in 1974.
- Due to the mismatching vinyl windows at the front elevation, staff researched the history of the house. Starting with the designation photo, mismatching windows were already present at the first floor. The symmetrical design of the front elevation suggests the first floor windows would have originally been identical, in design and operation, to the windows present at the second floor; the one-over-one double-hung and large plate glass windows suggest replacement window sash. Note the unique muntin pattern in the upper sash of the double-hung windows at the second floor, as well as the arched window above the front entrance. As the first floor windows were in place at time of designation, those window units would not be considered a violation.

Designation photo, 1974, HDAB

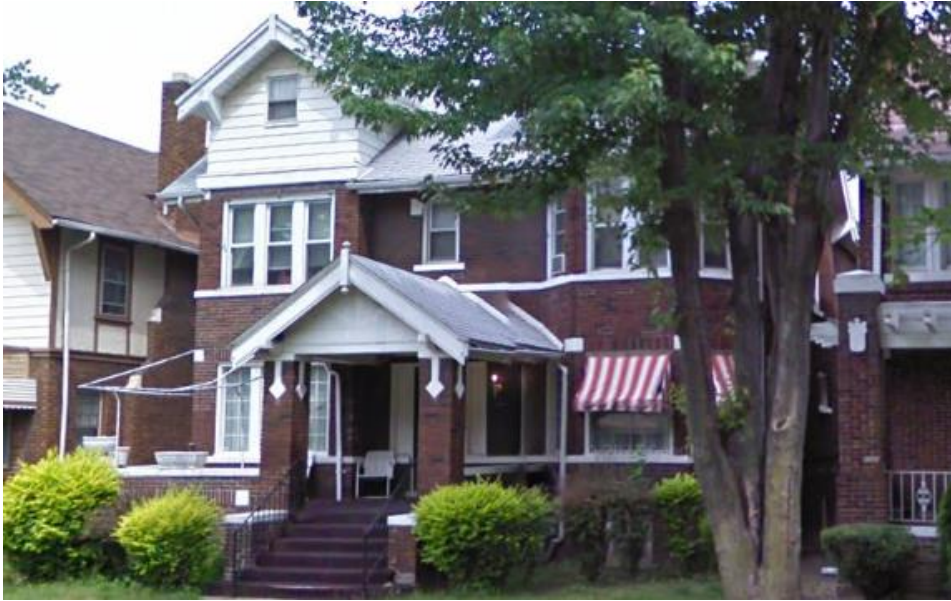
- The 2009 Google image shows the first floor clear glass units have been replaced with between-the-glass muntin-patterned sash; the operation of the double-hung windows changed to casements. The historic windows at the second floor are gone; one-over-one double-hung units fill the openings. Therefore, between 2000 and 2009 all of the first and second floor windows were replaced (some, or all, of which were included in the 2000 violation). These windows are not included in this application.

Google street view, July 2009

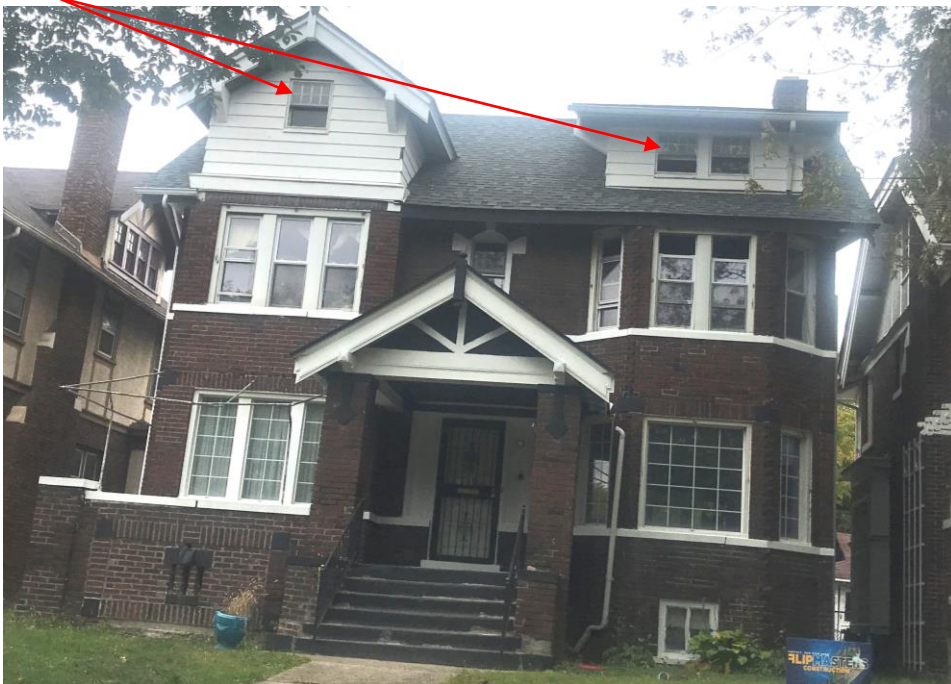
- In October 2020, HDC staff was notified of work occurring without Commission approval, namely the painting black of decorative elements (specifically, the corner stones on the porch walls and first floor window headers, the tops at the porch's cheek walls and decorative trim on the masonry columns, the concrete stairs, and the eaves of the attic gables). The original window sash in the dormers were still present.

Staff photo, October 15, 2020.

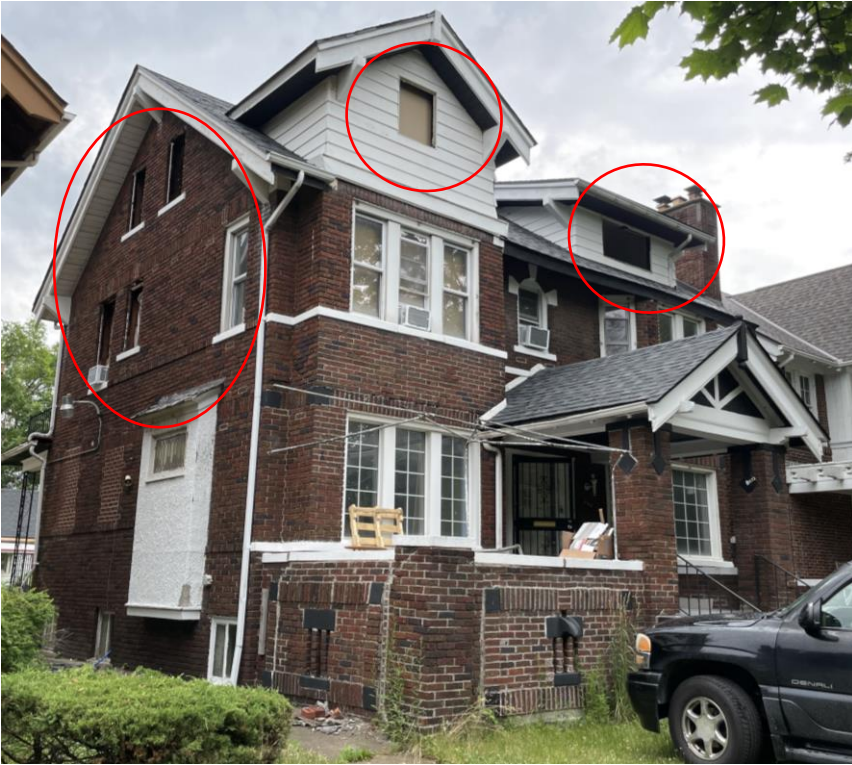
- In 2021, staff was notified that windows were being removed (*circled below*). Violation notices were sent to the owner (November 2020 for the painting; June and November 2021 for the painting and windows), but no response was received; these remain active violations. At the time of the staff report, this scope of work has not been added to the application.

Staff photo, June 25, 2021

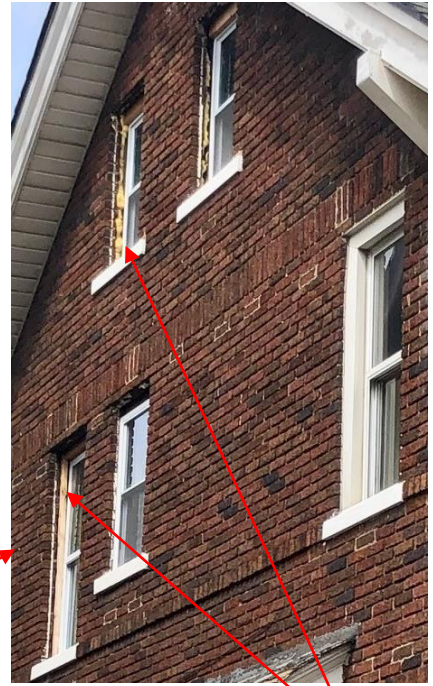
West Elevation

The close-up photo, above, shows unfinished work at the window openings. Wood framing at the second floor and insulation at the third floor are visible due to the original brick mould being removed and new brickmould (or coil stock as shown in the far-right window at the second floor) hasn't been installed.

One historic window sash remains intact, the leaded glass unit in the stucco covered extension.

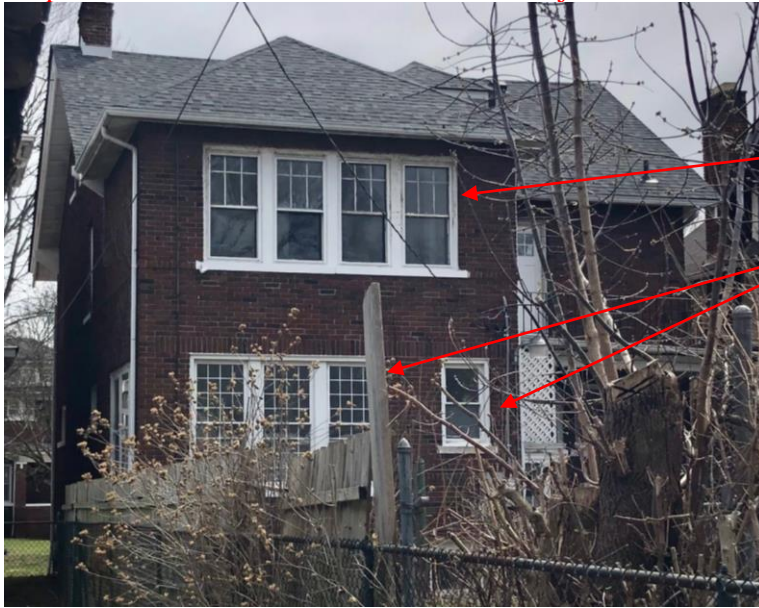
- During 2023 site visits for this application, Staff has confirmed that historic window units remain in place at the basement openings on each elevation, and at the second story on the rear elevation, and east side elevation at the first floor. Similar to the front elevation second and third floors, staff didn't find record of Commission approval for the existing vinyl windows at the first floor at the rear elevation, which encompasses the 16-over-16 sash as well as the adjacent one-over-one unit.

Staff photo, April 4, 2023

West Elevation
 Historic sash at second floor
 Vinyl replacement windows at first floor

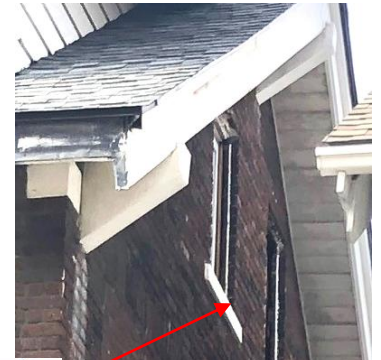
East Elevation
 Historic window units remain at the first floor which include two single opening, fixed windows and a mulled triple double-hung window opening near the rear elevation.
 Vinyl replacement windows are at the second and third/attic floors.

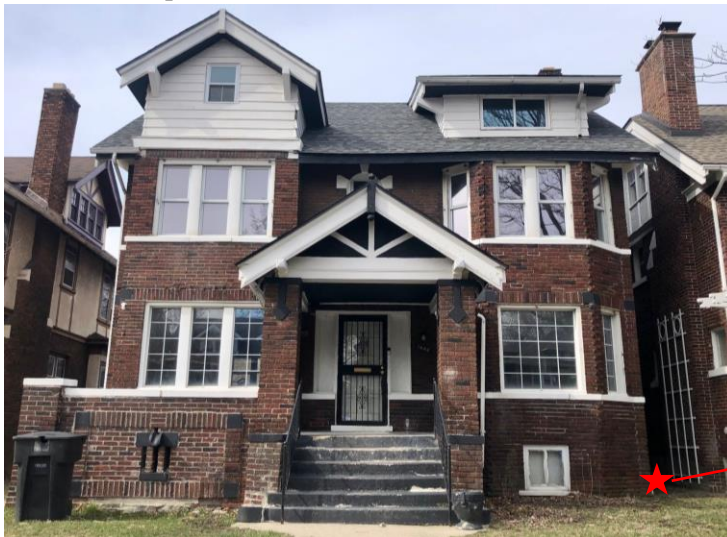
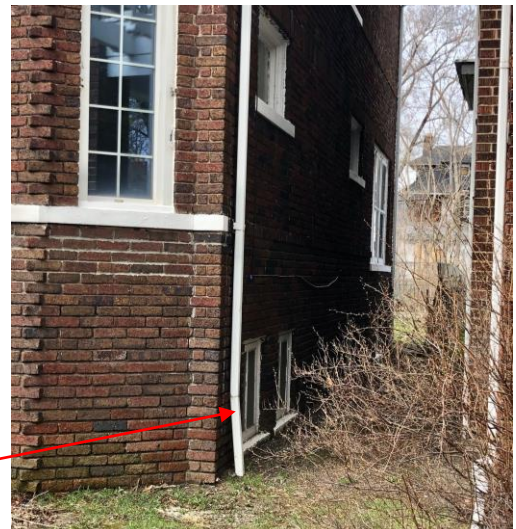
- The front-facing basement window with vertical mullion echoes the verticality and size of the porch’s decorative ventilation openings.

There is a symmetry to the four levels of openings at the front of the house which would be altered by the removal of the basement window. The installation of vents on a primary façade would be an additional visual intrusion.

Staff questions the possibility of bricking in one of the basement windows on the east elevation. The side windows are very close to the applicant’s proposed location, but the east wall openings are partially obscured from public view due to the close adjacency of the neighboring house. As this wall is likely always in shadow, the visual impact of the vents could be lessened further.

- *An east elevation basement window will be selected for the HVAC vent installation. The brick and vents will be recessed one inch from the exterior house wall. Dimensions of the existing and new brick will be submitted to staff, along with a photo of the selected brick sitting next to the wall of the house for confirmation of color match.*
- *A bulleted scope of work for the masonry repair will be submitted for staff review and will list the defined boundary for the work and mortar specifications (matching the strength, composition, color, and profile of the historic mortar). Should it be determined that some replacement brick is needed, new brick samples will be submitted for staff review to confirm the size, pattern, color, and surface texture will closely match the historic brick.*

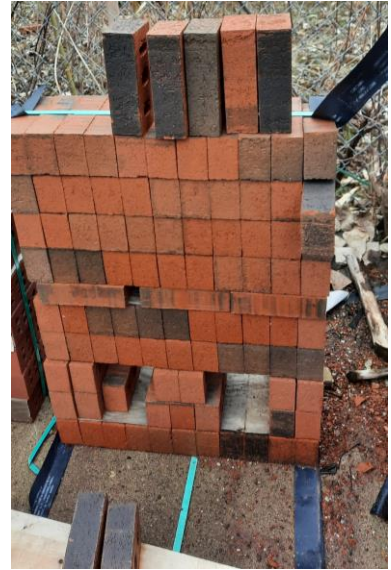
- A photo of new brick was submitted, which staff assumes was selected for the bricking-in of the basement window. Color-wise, some of the darker bricks appear to be close to the color of existing bricks, but the light colored bricks are too bright and too orange. If only used to brick-in one window opening, it might be possible to find enough darker bricks within this collection to offer a suitable match as the enclosure is small. In addition to the low visibility of an east elevation basement opening, the new brick should be recessed from the outer walls, so the window opening remains clearly visible. A recessed placement would further obscure these items from public view. The dimensions of the existing and proposed brick were not submitted, so staff can't offer additional comment on appropriateness of the new bricks beyond the color.

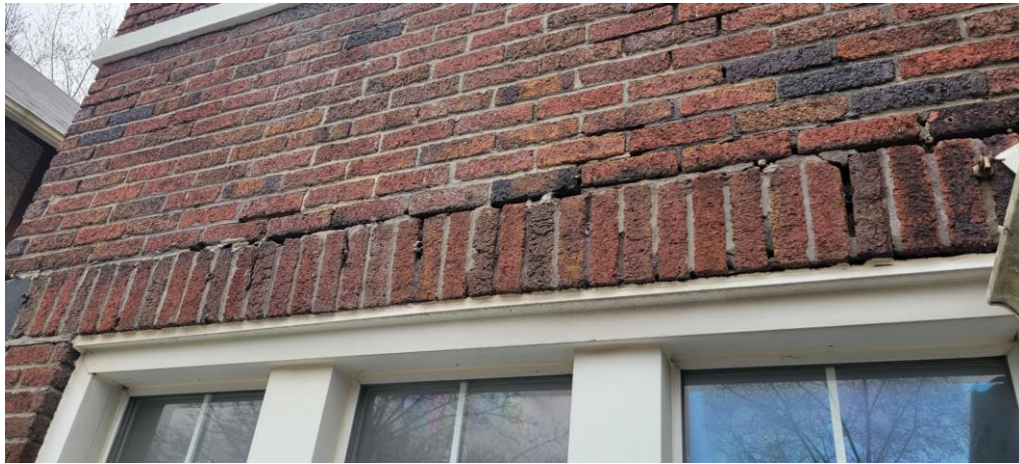
- The applicant submitted the below photo of the general area where the repair will take place. The applicant confirmed in an email that only tuck-pointing will occur.
- A written scope of work that specifies the mortar composition and mortar joint is still required. Should any new bricks be needed in this area, the purchased bricks discussed above are not appropriate for use at this primary façade location.

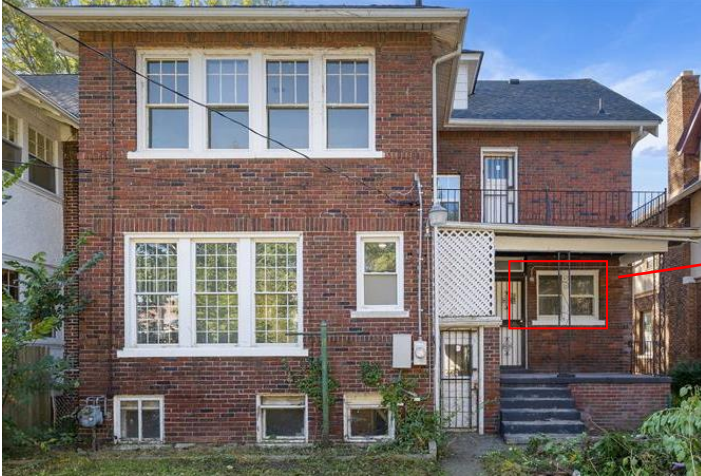
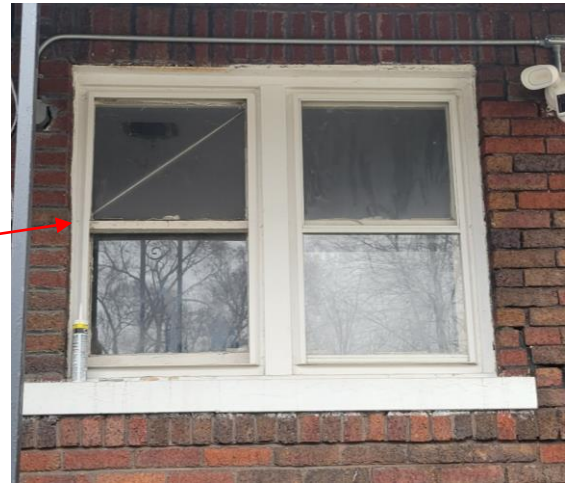
- The applicant is requesting to replace two wood windows at the rear of the house with vinyl framed single-hung units. Staff doesn't consider this window opening a character-defining feature, so replacement of the existing window sash will not remove distinctive features. However, the operation and general appearance of the new windows should remain historically appropriate. Single-hung windows have an upper sash that is welded to the outer frame which would change the dimensionality of the windows and opening. Wood sash double-hung units are more likely to match the existing windows in operation and sash dimensions, as well as exterior finish colors. Most white vinyl windows, including the selected JELD-WEN unit, are brilliant white and are not compatible with historic color palettes.

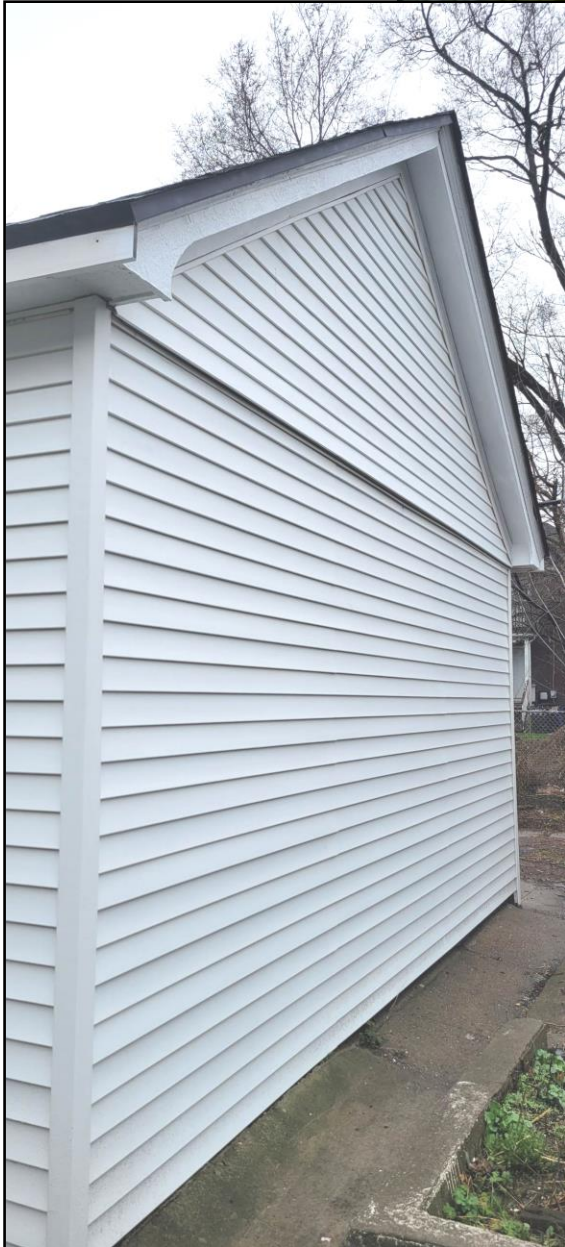
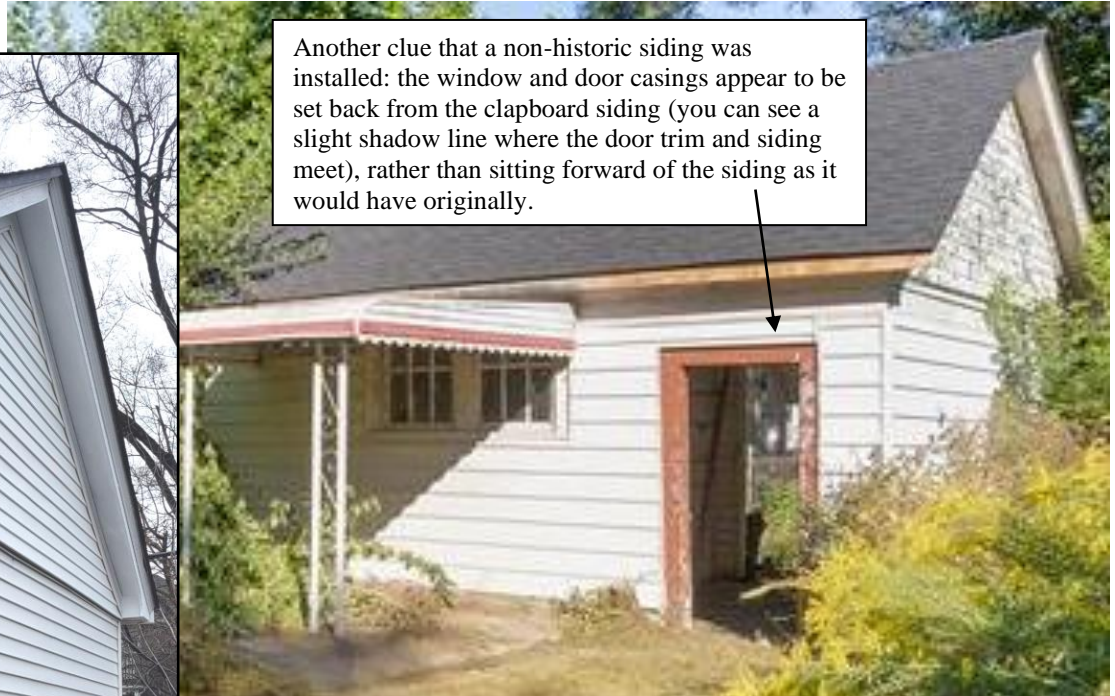
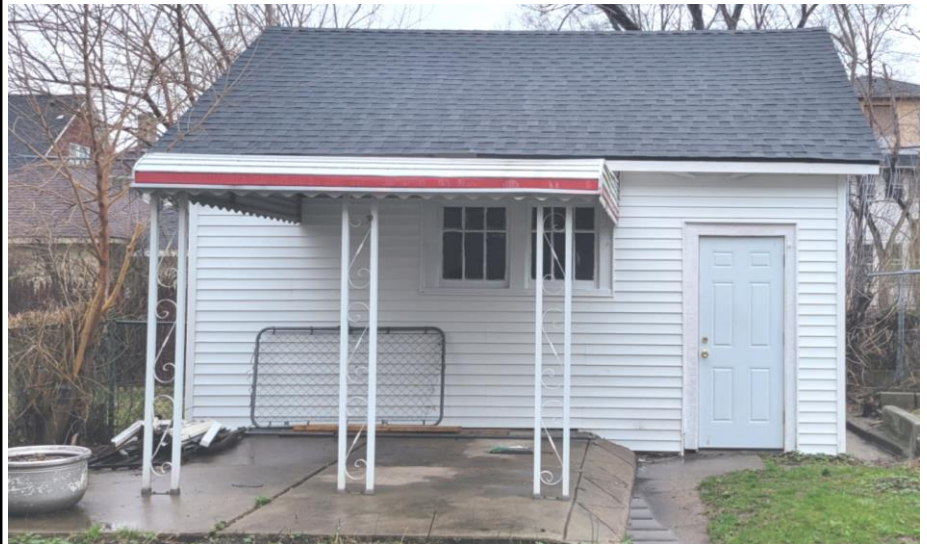
- The garage picture submitted with the initial application shows wide clapboard aluminum siding that closely matched the siding present at the front elevation gables. The photo is not very clear, but staff believes a different siding, probably shake shingles, was installed within the gable ends. The historic windows have an uneven muntin pattern, as seen on the upper sash of the historic windows that remain on the rear elevation of the house. It is staff's opinion that the garage, as displayed in the "before" photo, had an architectural compatibility with the house through the use of similar materials and architectural components (i.e., the windows).

Applicant photos. Photos at left and below show current garage conditions.

- Staff inquired on whether wood siding was revealed when the aluminum siding was removed. The applicant told staff no; however, staff isn't sure why the vinyl siding (and the aluminum before that) sits forward from the window and door trim. The 4-inch vinyl clapboard siding (*above left*) was installed on the entire side wall surfaces and created a monolithic and contemporary appearance at these elevations.

The installation of vinyl siding, vinyl windows, **steel entry door and painted red porch ceiling**, are not compatible with the architectural style and age of the garage and house. The installed synthetic siding does not adequately reproduce a historic wall surface, and the proposed replacement window does not match the historic sash in operation, dimensionality, and color. **A physical assessment and detailed photos confirming the current condition of the front door was not submitted, and the steel/composite replacement door does not mimic the dimensions, pattern and materiality of the existing door. The brick red paint color selected for the porch roof is not an appropriate color at this location as the wood ceiling should be painted to match the existing wood trim (off-white).** It is staff's opinion the installation of the vinyl siding and proposed vinyl windows alter features and spaces that characterize the property, and therefore recommends the Commission issue a denial for the work as proposed because it does not meet the Secretary of the Interior Standards for Rehabilitation and the Elements of Design for the district, specifically Standards:
