**STAFF REPORT: MAY 10, 2023 REGULAR MEETING**

**APPLICATION NUMBER: 23-8336**

**ADDRESS: 1453 W BOSTON**

**SCOPE: REPLACE SLATE ROOF WITH ASPHALT SHINGLE ROOF, REHABILITATE AND EXPAND DRIVEWAY AND PATIO, REMOVE TREE**

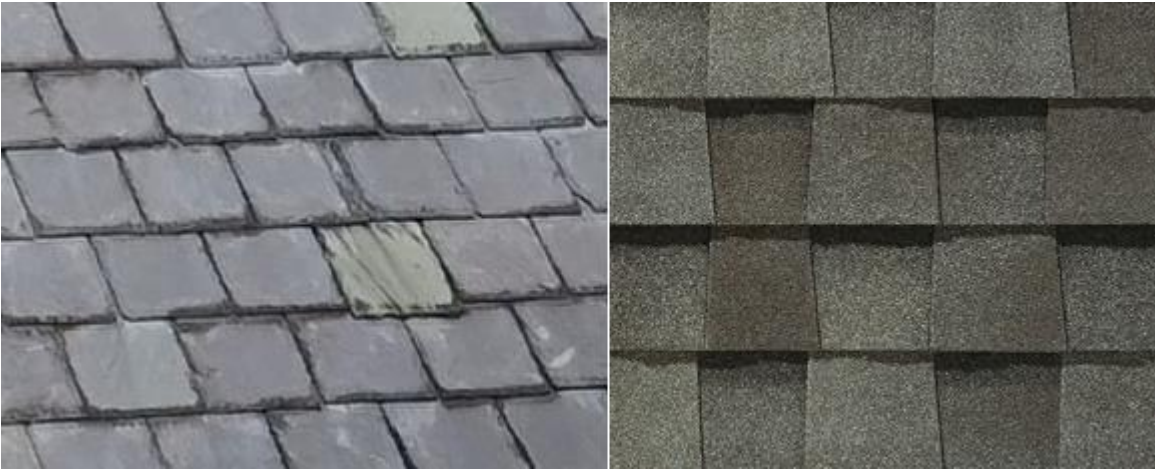
Left: Existing roof. Right: Proposed replacement product. Image from submitted application materials.

- A slate roof is almost invariably a distinctive, character-defining feature of a building, as is the case with the house and garage on this property. The slate roof appears to be original to the house and garage.

- The applicant has submitted photos showing missing and cracked roof tiles, damage to flashing, and interior water damage (see application materials for photos).

- The deterioration on the garage roof is clearly more severe than on the house, with missing tiles on all planes and visible damage to the decking below.

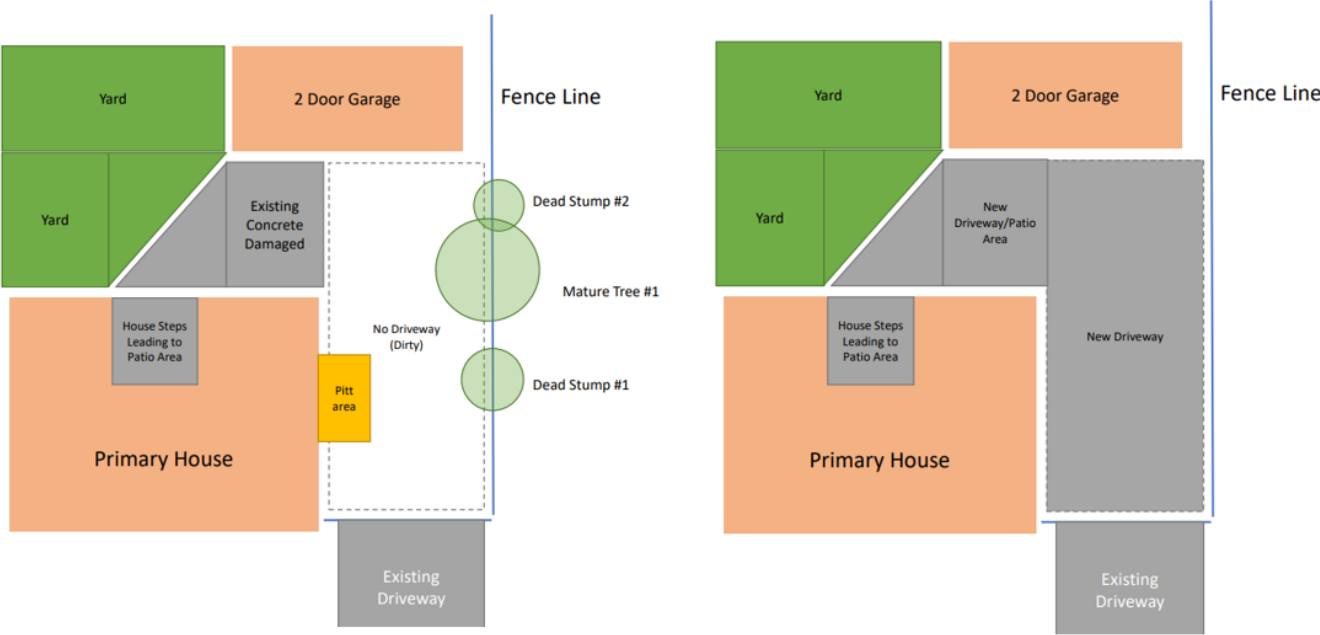
Left: Sketch of existing conditions. Right: Sketch of proposed work. Images by applicant. Images are not to scale.

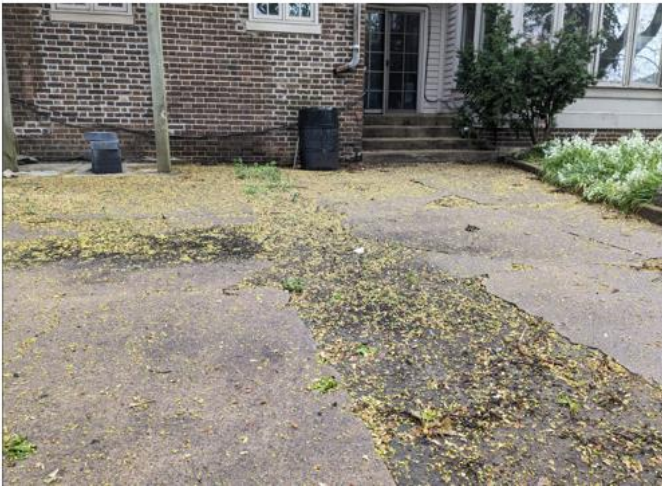
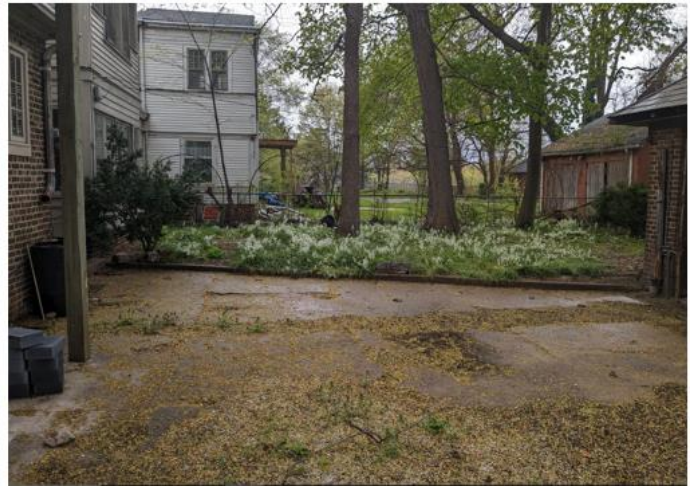
- The applicant invited staff to view the back yard on May 3, 2023. The existing paved area is cracked and broken and covered with soil and plant matter such that staff cannot determine its full extent. There is clearly a newer front driveway in good condition which ends at the front plane of the house where a gate is located. Beyond the gate, the driveway is either missing or entirely covered in dirt. In the rear yard, an expanse of broken concrete transitions into a poured concrete patio area. The garage slab is also cracked and broken.

- Due to its apparent age of the patio and the coarse aggregate used, staff suggests that the patio is historic or original to the house.
- Due to the location and orientation of the garage, staff suggests that it almost certain that a continuous side driveway originally ran from the front curb cut to the rear garage. Upon reaching the back yard, the driveway would likely have widened to access both doors of the garage and connect with the patio.

*Staff photos of rear patio area.*

- The driveway width in the side yard area shall continue the line created by the existing front yard portion of the driveway (upon reaching the back yard, it may expand as shown in the application sketch to connect the garage and patio).
- The concrete curb separating the patio from the grassy portion of the back yard shall be retained. If damaged, it may be replaced in-kind.

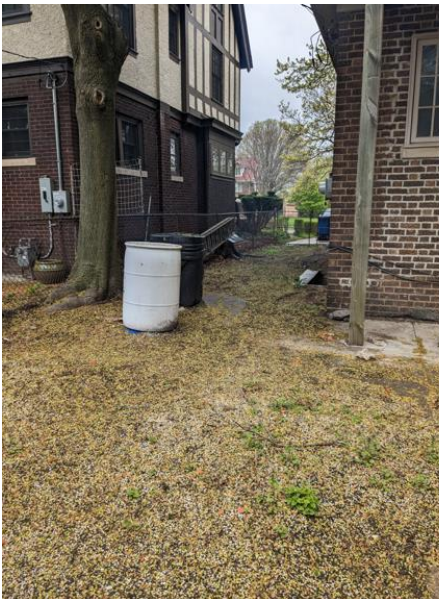
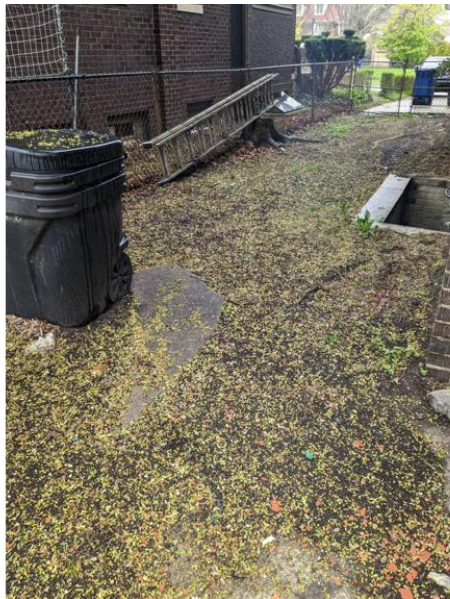
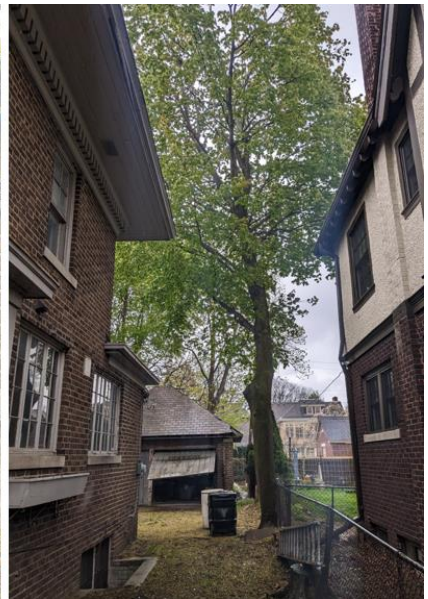
*Staff photos of driveway area.*

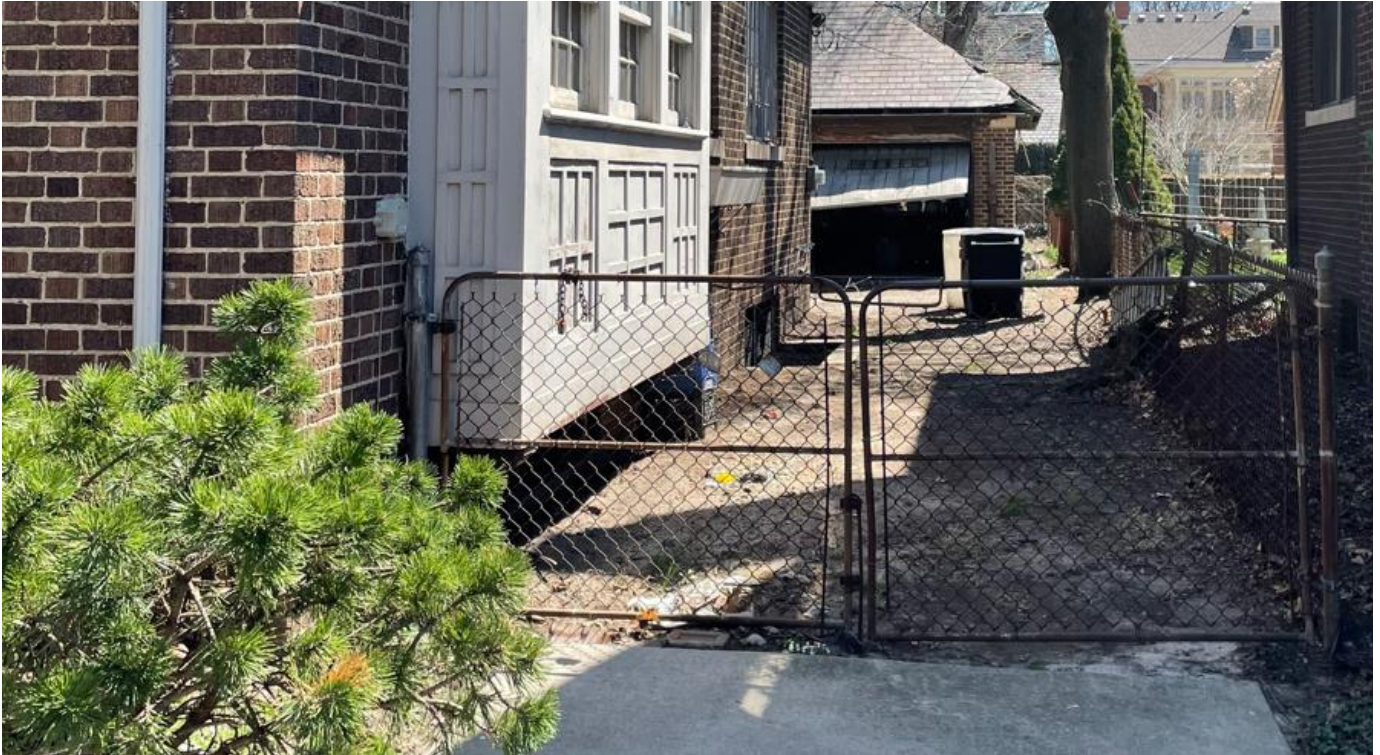
*Application photo of driveway area.*

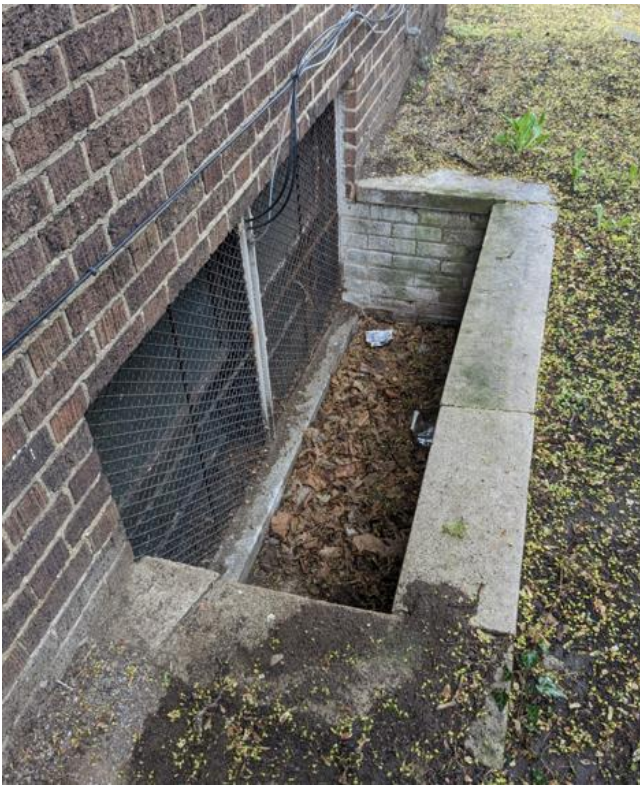
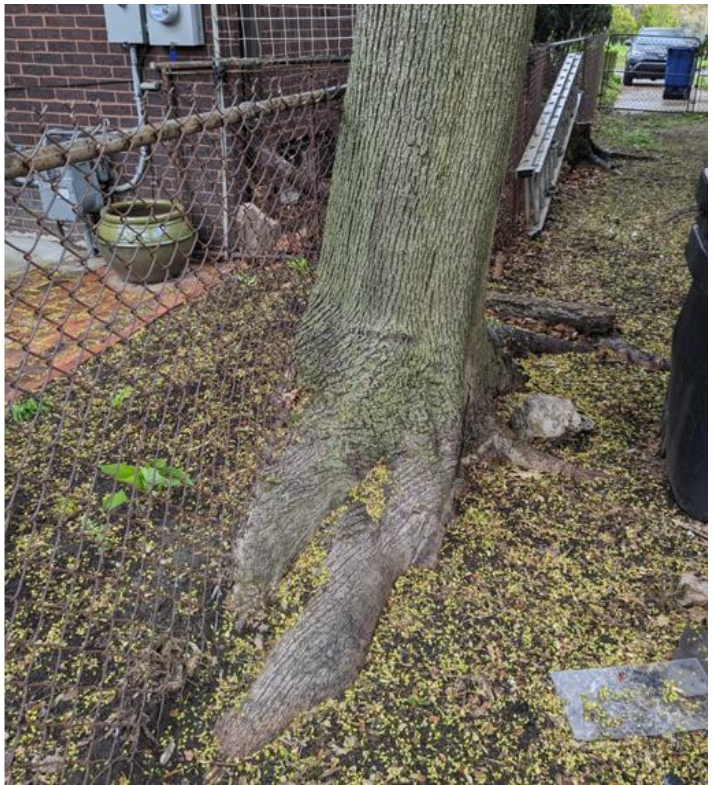
*Staff photos of window well and tree proposed for removal.*

- Staff notes that the tree proposed for removal has grown to create a root system that impedes completion of a driveway that likely existed historically, as noted above. The roots also seem to be expanding and continuing to crack the remaining driveway and patio concrete.

- The tree proposed for removal is a Norway maple, a non-native tree introduced in the eighteenth century as a shade tree. It is one of ten mature Norway maples that currently occupy the property (six in the back yard and four in the front yard). Due to the ability of the tree to spread on its own, and the random placement of the trees, it is likely that these trees grew naturally and were not planted.

- The above-grade portion of the window well shall be enclosed as specified in the Historic District Commission Glass Block Guidelines (the window well may be filled to grade level).
