STAFF REPORT: 06/14/2023 MEETING

APPLICATION NUMBER: 23-8400

ADDRESS: 535 ARDEN PARK

SCOPE: *INSTALL ALUMINUM CLAD WOOD WINDOWS*, APPLY WINDOW TRIM

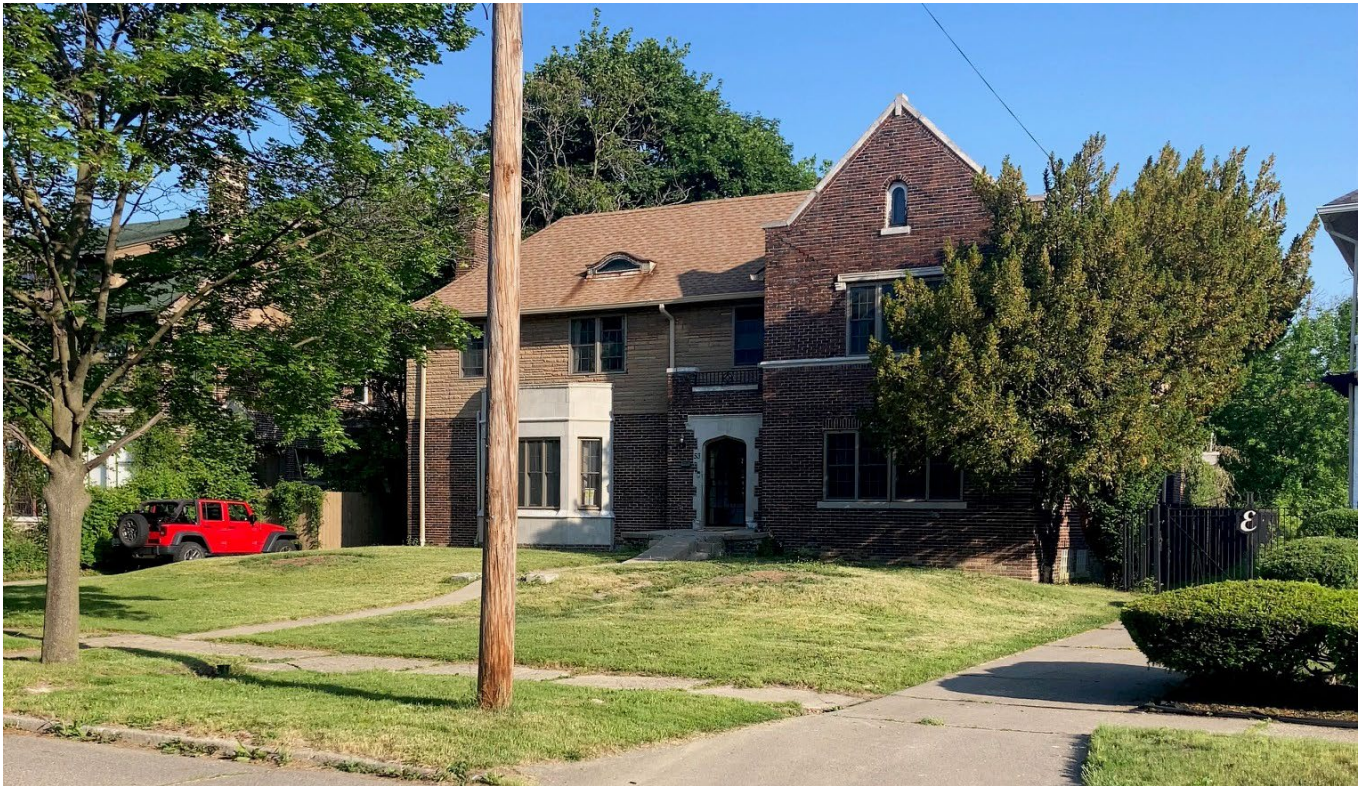
Figure 1: Current view of 535 Arden Park

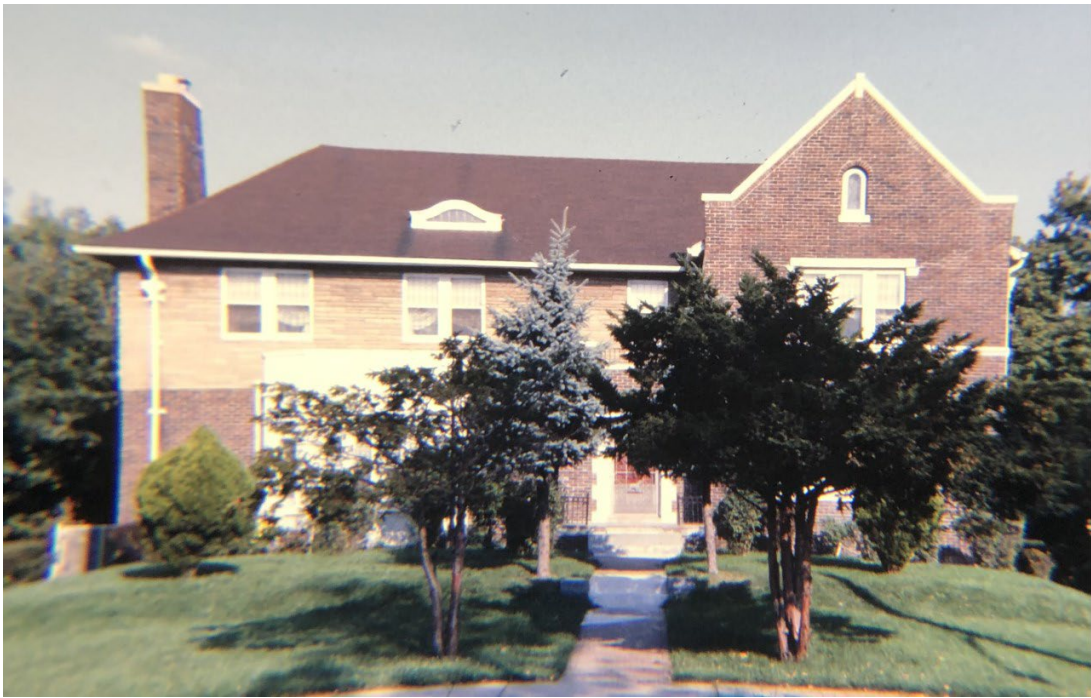
Figure 2: View of 535 Arden Park ca. 1981. HDAB

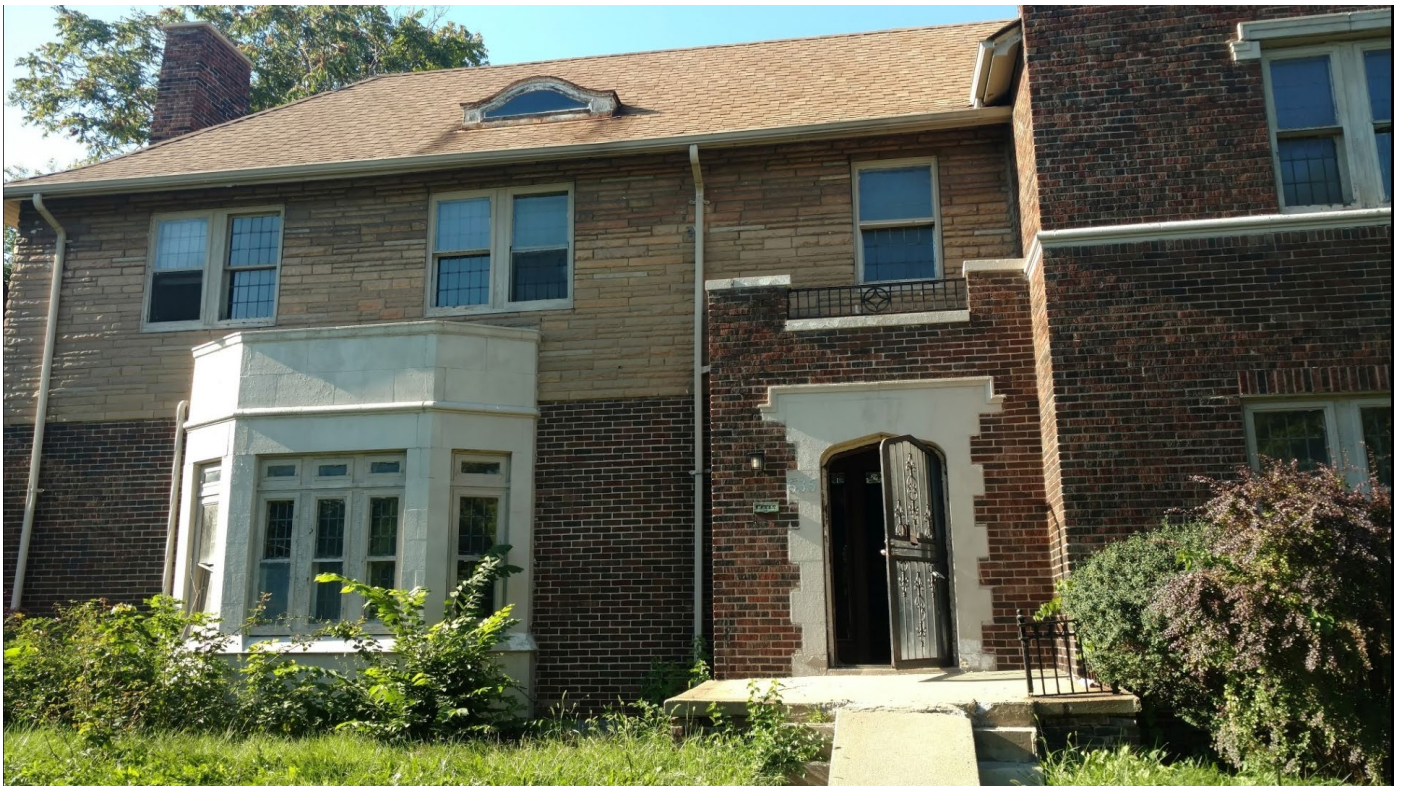
Figure 3: View of the façade windows prior to replacement.

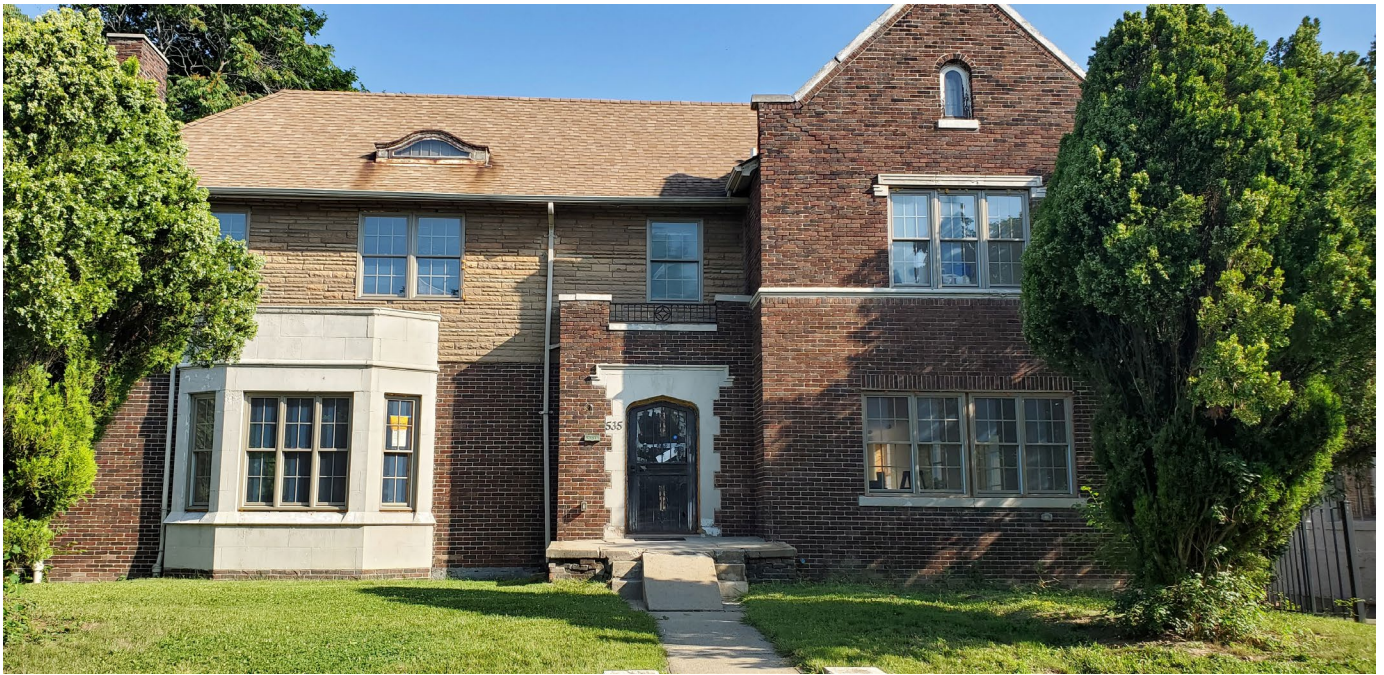
Figure 3: View of the façade windows after replacement.

- The current windows were produced by Pella and are in their Lifestyle series. They are double-hung, aluminum-clad wood units. The window grills consist of wood muntins applied to the exterior of the glass panes and are removable according to the information provided by the applicant. The extant grill pattern does not match the pattern of the original leaded comes.

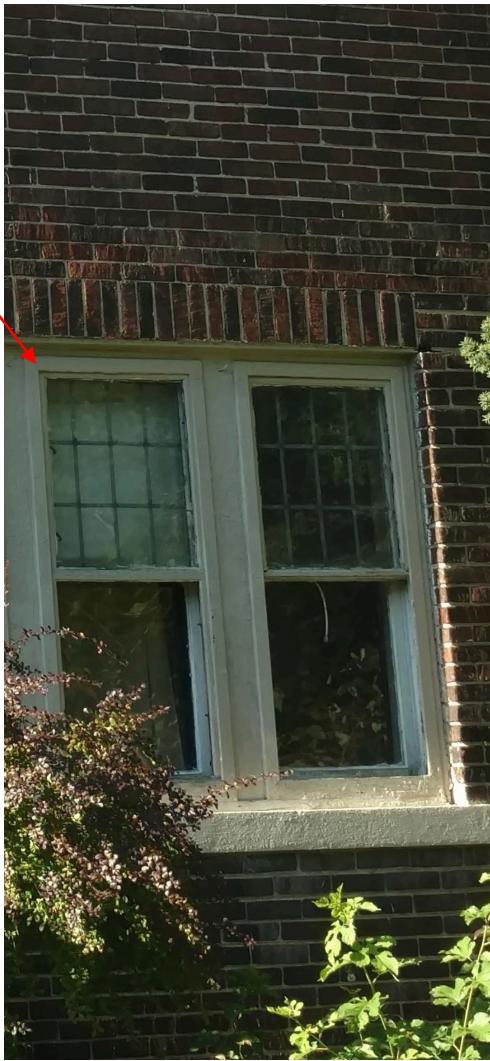
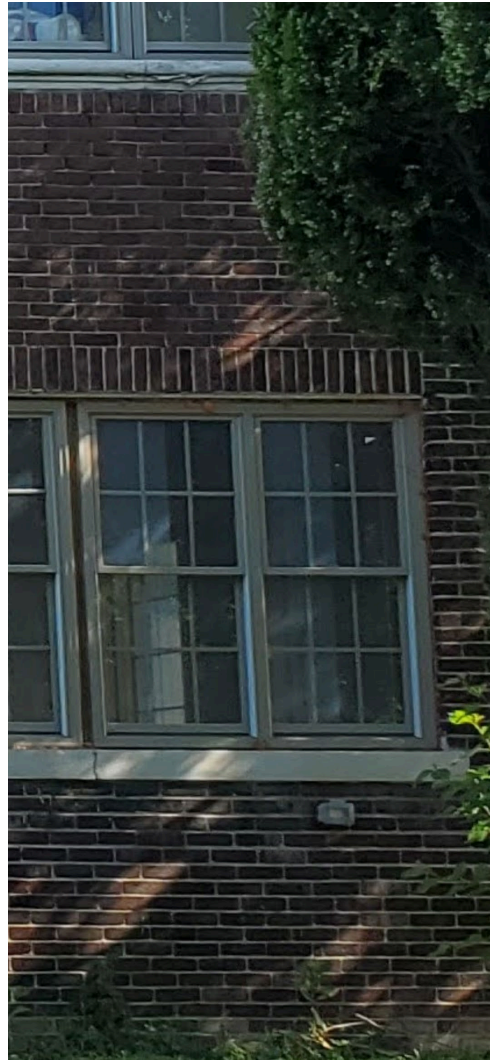
Figures 3,4: Photographs of the original windows (left), and extant replacement windows (right) on the side elevation of 535 Arden Park. The red arrow indicates the wood pieces the proposed project aims to replicate.

- The wood “trim” pieces visible in the pictures prior to the window replacement appear to be associated with a former storm window system and were not an integral part of the original windows.
- The gaps visible between the windows at the window banks are due not to a lack of window trim, but instead to the fact that the replacement windows are paired units, while the original configuration consisted of four individual units divided by mullions.

- It is staff’s opinion that the limestone windowsills were likely originally unpainted. Generally speaking, applying common house paint to stone is an inappropriate treatment that can lead to accelerated deterioration.
- The proposed applied trim does not remediate the window replacement previously deemed inappropriate by the Commission. The wood trim seen in the “before” photographs was part of a storm window installation, and not integral to the original windows.

The proposed applied trim and painting of the window sills does not mitigate the inappropriate nature of the replacement windows.

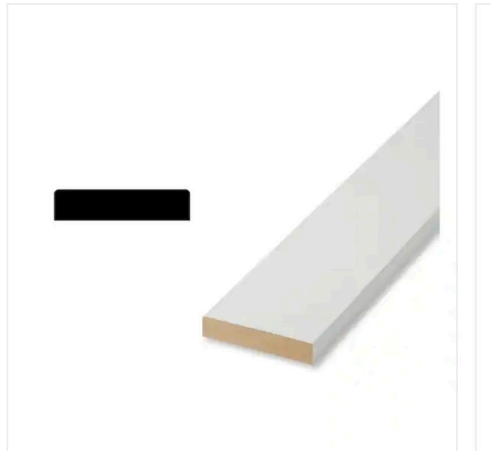
Figures 5: Example of the proposed trim material.
