STAFF REPORT: JULY 12, 2023 MEETING

APPLICATION NUMBER: 23-8404

ADDRESS: 8022 KERCHEVAL

SCOPE: MASONRY REPLACEMENT, WINDOW REPLACEMENT

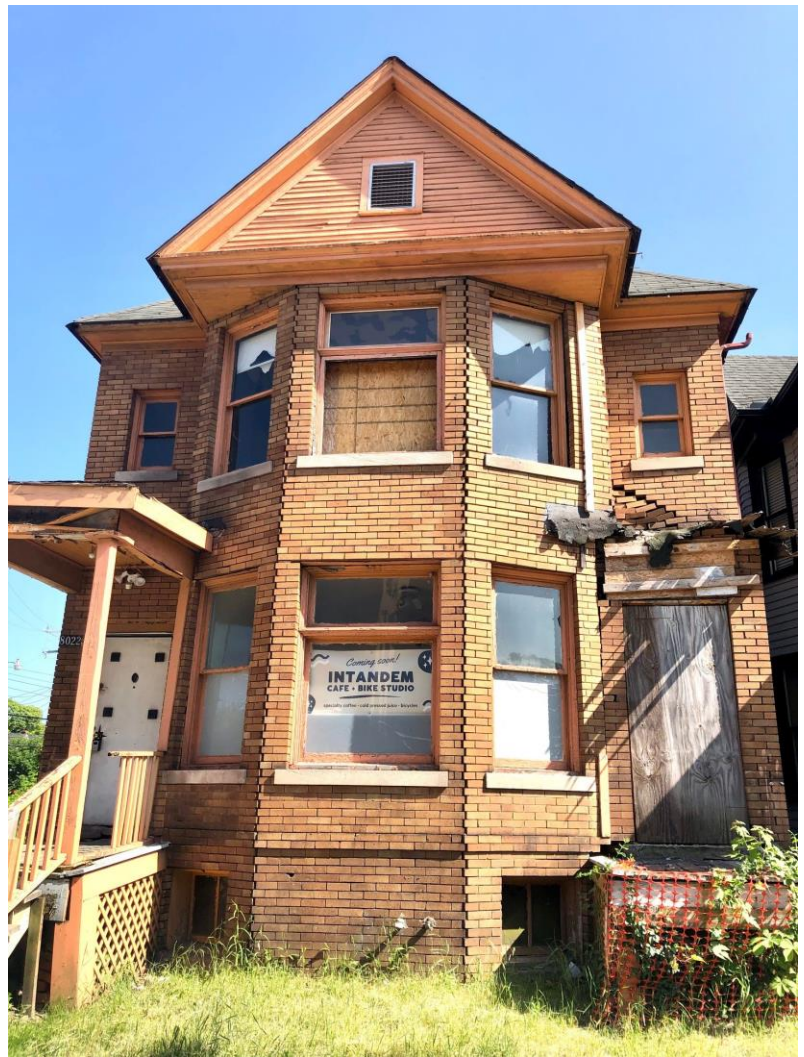
Staff photos, May 30, 2023.

The west front entrance porch is partially intact; mismatching grout joints at the wall shows where a porch rail once met the house. The east porch is missing and while the brick adjacent the front door appears intact, damage to the brick above the missing porch is visible.

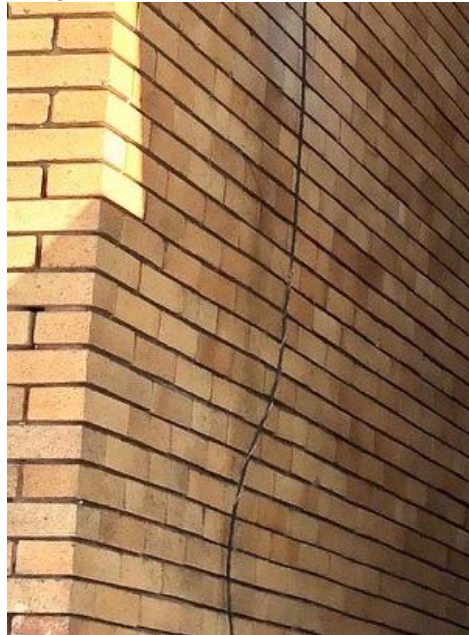
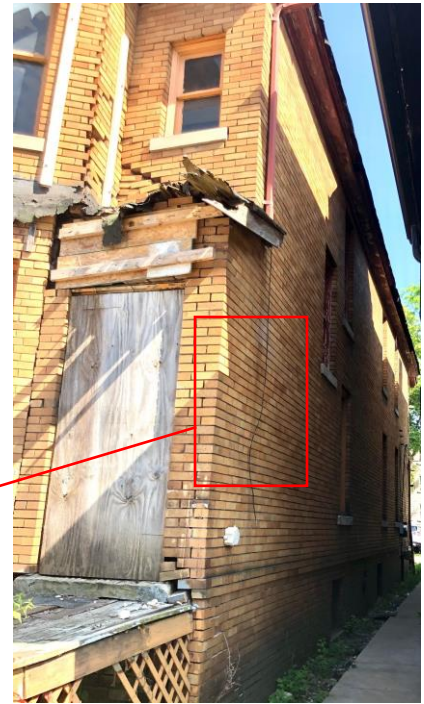
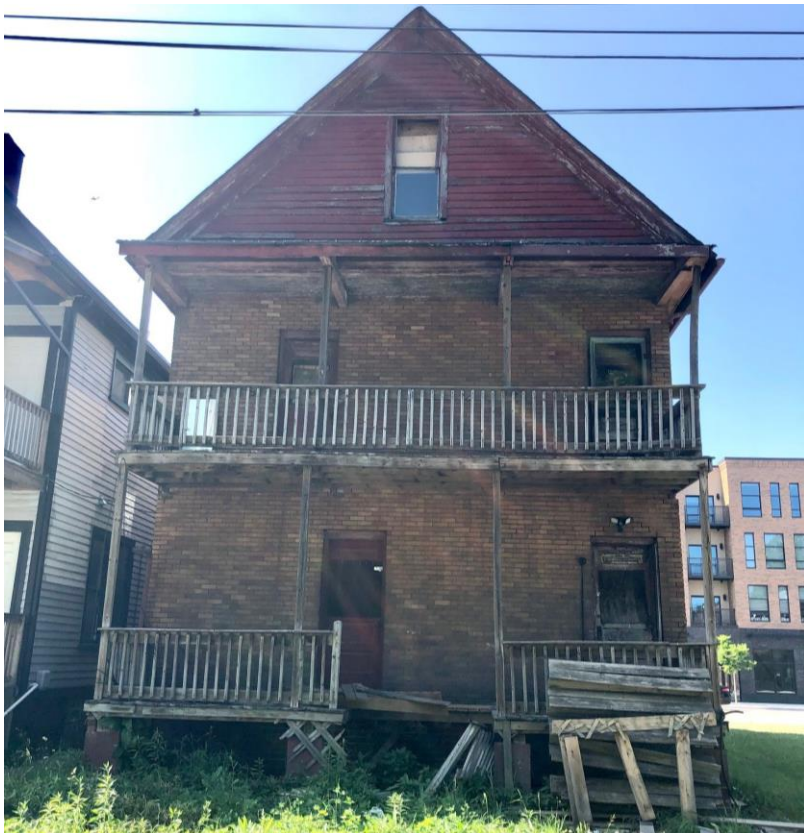
Staff photos, May 30, 2023

Upon close inspection of the site visit photographs, staff noticed that the vertical mortar joints are flush with the brick, while the horizontal mortar joint have a raked/recessed joint. This creates the effect of a traditional brick pattern when looking at a façade straight on and offering strong horizontal lines when looking at a wall from an angle.

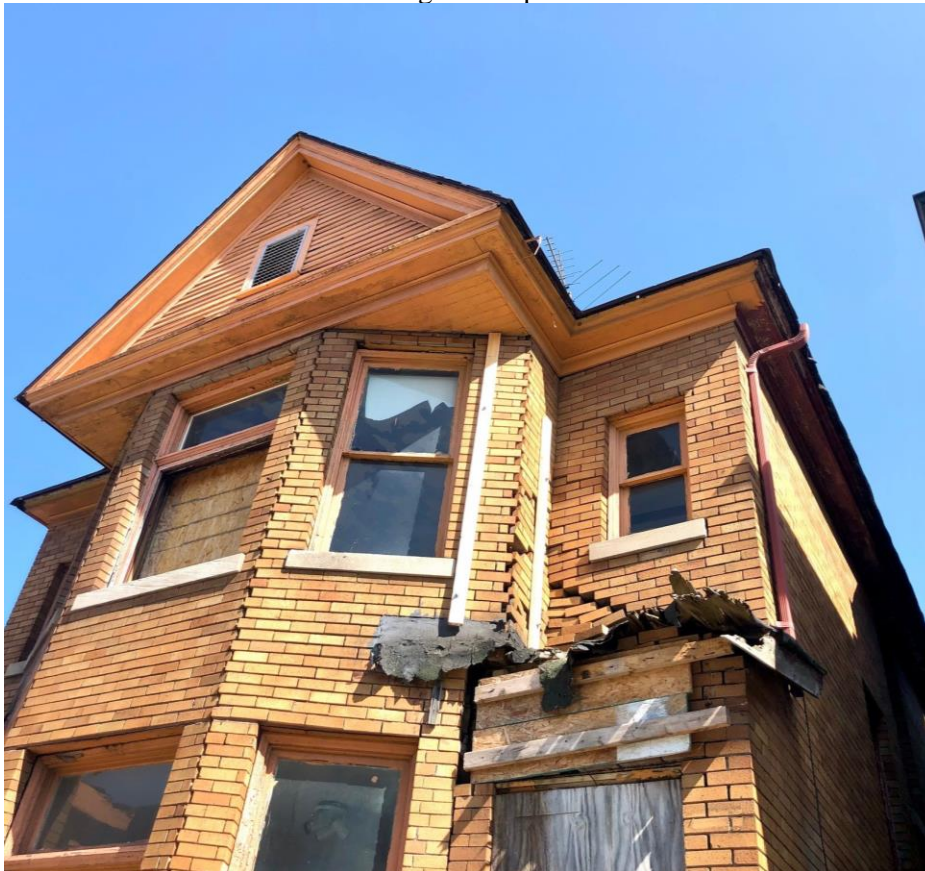
Staff photo, June 30, 2023.

- Staff notes that some exterior bracing was in place at the time of the June site visit.

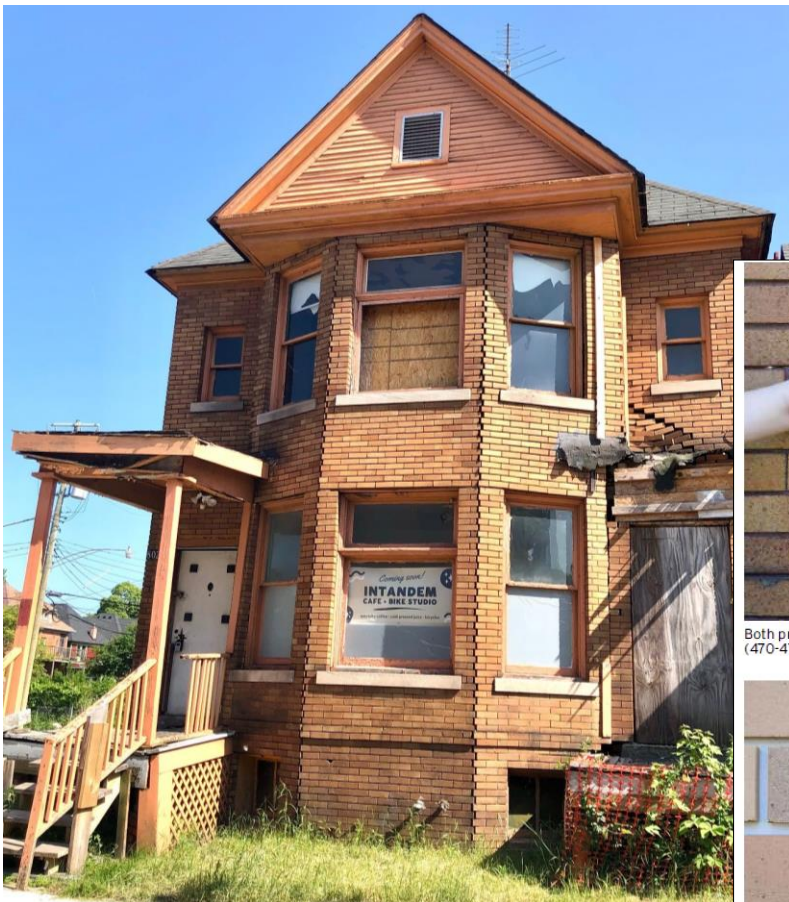
Staff photo, May 30, 2023. Applicant photo of brick samples.

- Staff believes the applicant provided sufficient documentation on why the front façade must be fully removed and that some new brick will be needed at the front elevation. Staff viewed both brick samples on site and agrees with the applicant that the Madrid brick is the closest match to the historic brick.

- It is not reasonable to require the applicant to have a special run of brick fabricated to match the historic brick size when only 1/3 of the run (3,000 of the required 10,000 minimum order) would be needed.

- Blending a different-sized brick in with the historic brick is not a feasible solution.
 - Therefore, staff agrees that areas of new brick will be needed.

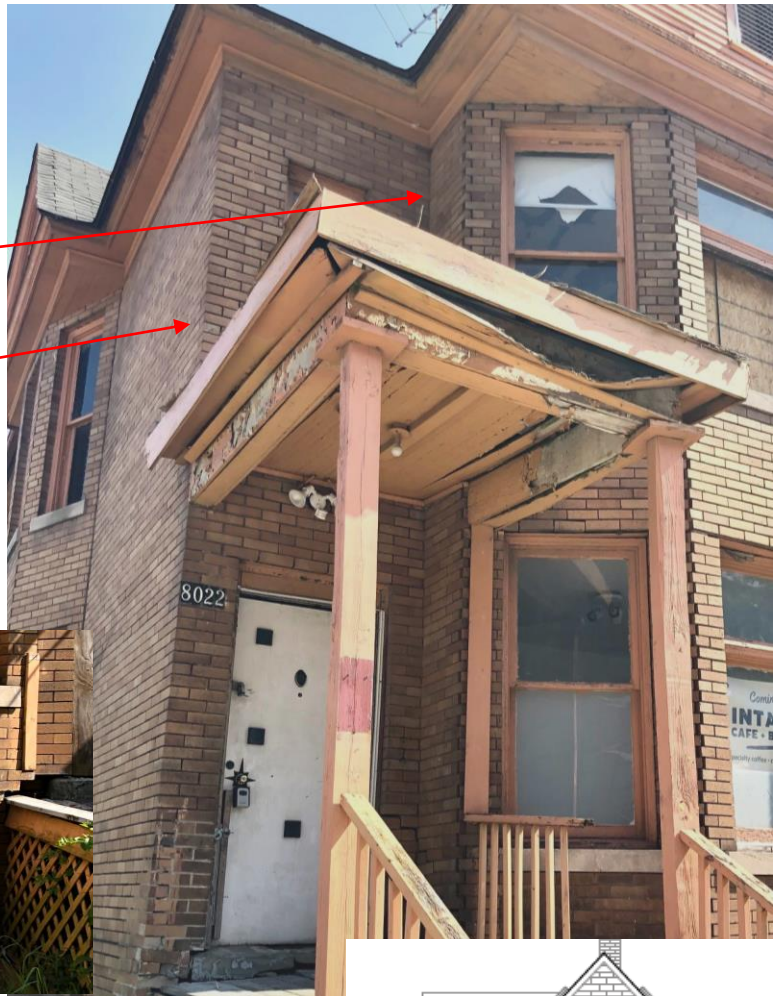
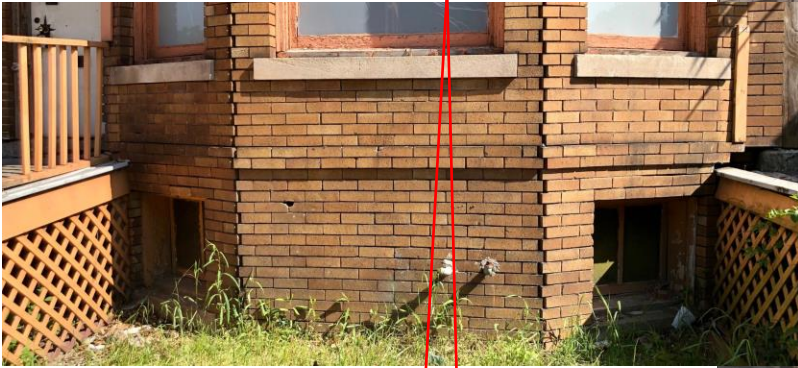
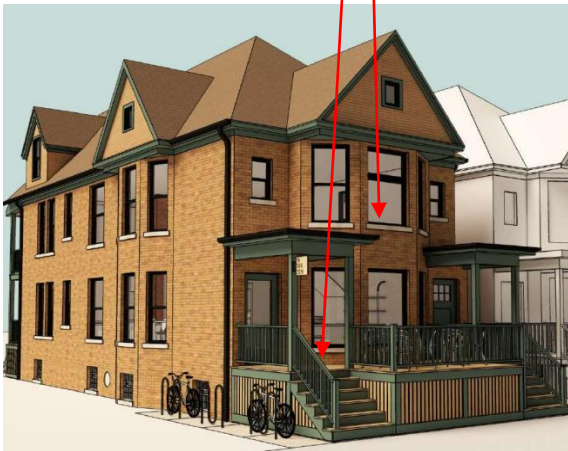
Staff photos, applicant renderings.

- Should replacement brick be considered, it is important to look closely at the historic design of the front elevation to determine where the new brick could be used in the least intrusive way.
 - The two-story bay extends forward from the front wall with uniform vertical joints. This clean break of plane would allow for the insertion of new brick at the bay.
 - The historic brick should remain at the front walls and wrap the sides of the building, retaining a distinctive character-defining feature.
 - The wall below the water table is proposed to be faced with new brick. The existing raised porches and future connecting deck will cover this area of the elevation.

- The adjacent colored rendering says there is a potential availability of salvaged brick for the right front wall. It is staff's position that the success of integrating new brick with historic brick can only be achieved within the two-story bay. Historic brick must be used at the two flanking front walls.

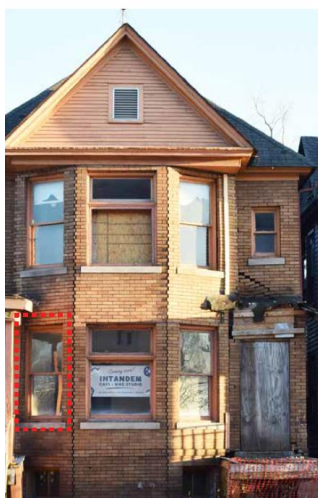
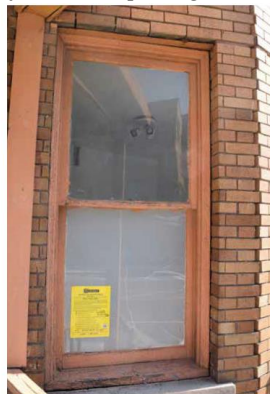
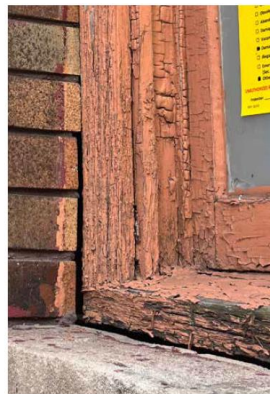
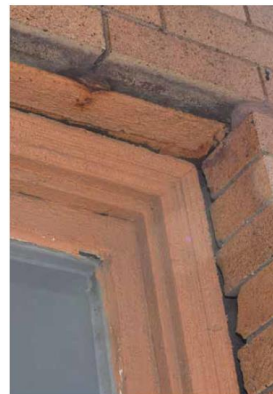
Applicant window schedule and photos of window opening 1.3.

- The submitted window schedule states that repair to differing levels is needed, but the applicant hasn’t provided written repair estimates and/or written testimonials from window repair companies stating that the windows are beyond repair. Therefore, staff determines that the replacement proposal doesn’t meet Secretary of the Interior Standard 6. The Commission, however, may take additional circumstances under consideration when making its decision.

1.2A	4'-3"	1'-11 1/2"	FIXED/TRANSOM						N/A	FILM ON GLASS
1.2B	4'-3"	3'-11 1/2"	FIXED						N/A	MISSING ROPE/WEIGHTS/PULEYS
1.3	2'-10"	6'-0"	DOUBLE-HUNG							FRAME DISTORTED, SASH ROT, MISSING STOPS AND HARDWARE, MISSING ROPE/WEIGHTS/PULEYS

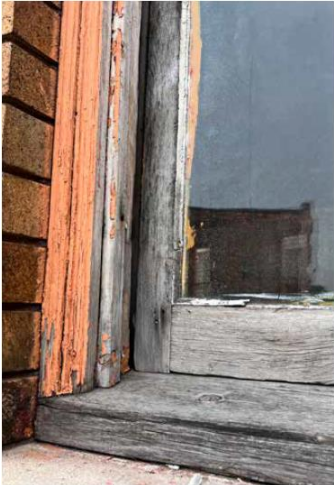
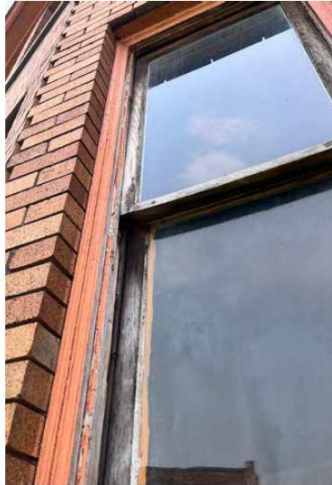
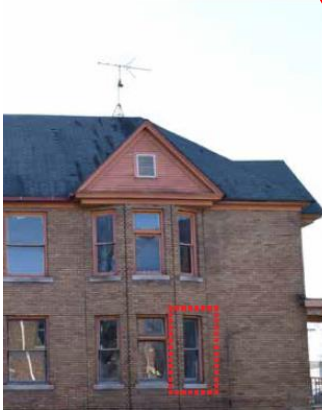
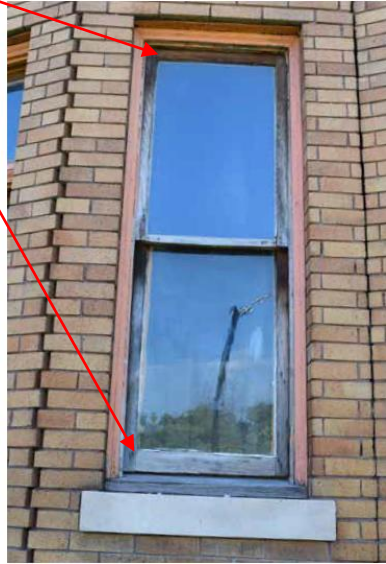
Applicant photos

- A small number of openings do not contain historic sash and new window units are needed. Understanding that it is likely that no replacement window can identically match the dimensions of a historic window, the Commission needs to determine how impactful the proposed replacement window will be on the elevations, either in individual openings (where no historic windows exist) or collectively within all the window openings.
- Reviewing the comparison window chart, the new windows will have an almost height for the top and bottom rails, unlike the differential (3" bottom rail and 1-3/4" top rail) of the existing units. The height of the meeting rail for the replacement window matches the height of the historic window (2").
