STAFF REPORT: JULY 12, 2023 MEETING

APPLICATION NUMBER: 23-8442

ADDRESS: 1419 SEYBURN

SCOPE: REHABILITATE DWELLING, REPLACE WINDOWS

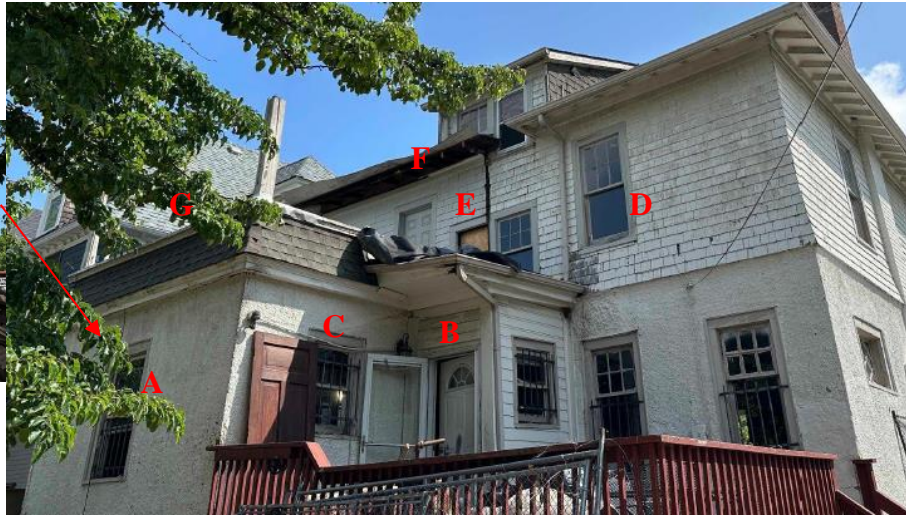
- A. 53" h x 32" w window to be changed to 53" h x 60" w window.
- B. Replace door with new window, header height, size, and operation to match adjacent window.
- C. Replace small window opening with French Door – JELD-WEN 60-in x 80-in Tempered External Grilles Primed Steel Left-Hand Inswing French Patio Door.
- D. Install fiberglass double-hung (six-over-six) window due to new shower location. Marvin Infinity, Cottage 1-High Casement specified.
- E. Install new window where previous was removed.
- F. Remove eave and reopen full window opening (to match adjacent existing condition).
- G. Erect perimeter railing at second floor deck. Design to match front porch railing. install 12" railing at top of 24" knee wall.

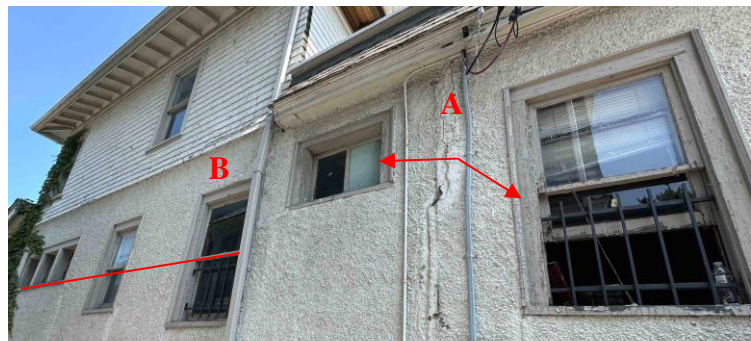
North-Side Elevation

- A. Remove small sliding and double-hung windows. Enclose openings and apply stucco finish.
- B. Remove window and enclose bottom half of opening. Apply stucco finish. Sill height to match adjacent windows near front of house.

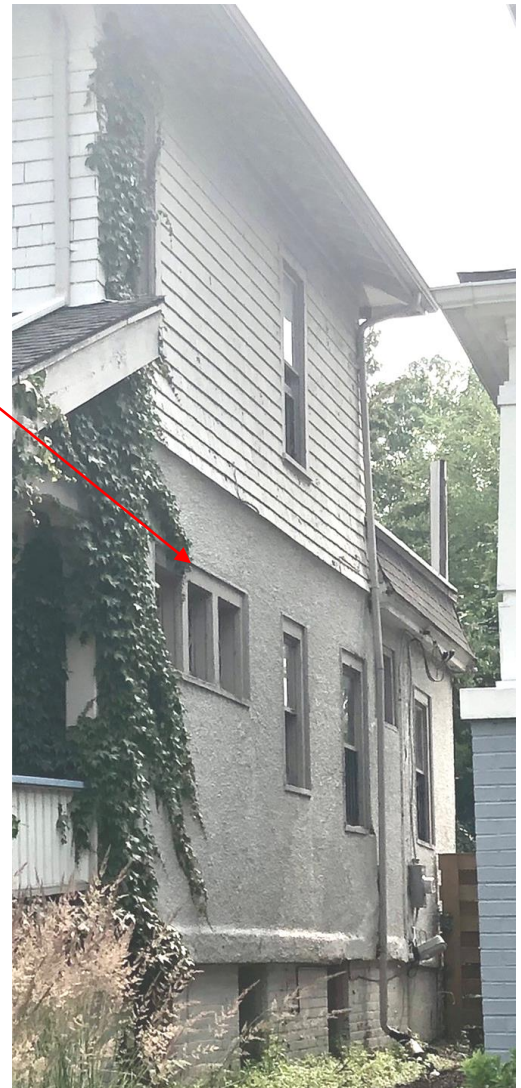
- As staff illustrated in a previous report for 7908 St. Paul (03/08/23 meeting), between 1910 and 1915, a large number of houses within West Village underwent renovation. Changes documented on Sanborn maps included buildings and/or porches being enlarged, and bay windows added.
 - The historical study at 1419 Seyburn shows it was enlarged at the rear, which remains its current footprint.
 - The yellow color denotes a wood frame/wood sided structure. By 1915, the note “Plastered 1st” was added to indicate stucco had been applied to the first floor exterior walls. Staff assumes the stucco was applied over the wood siding, as the first floor window openings have wood casings which are now recessed within the stucco walls.

Staff photo, June 30, 2023.

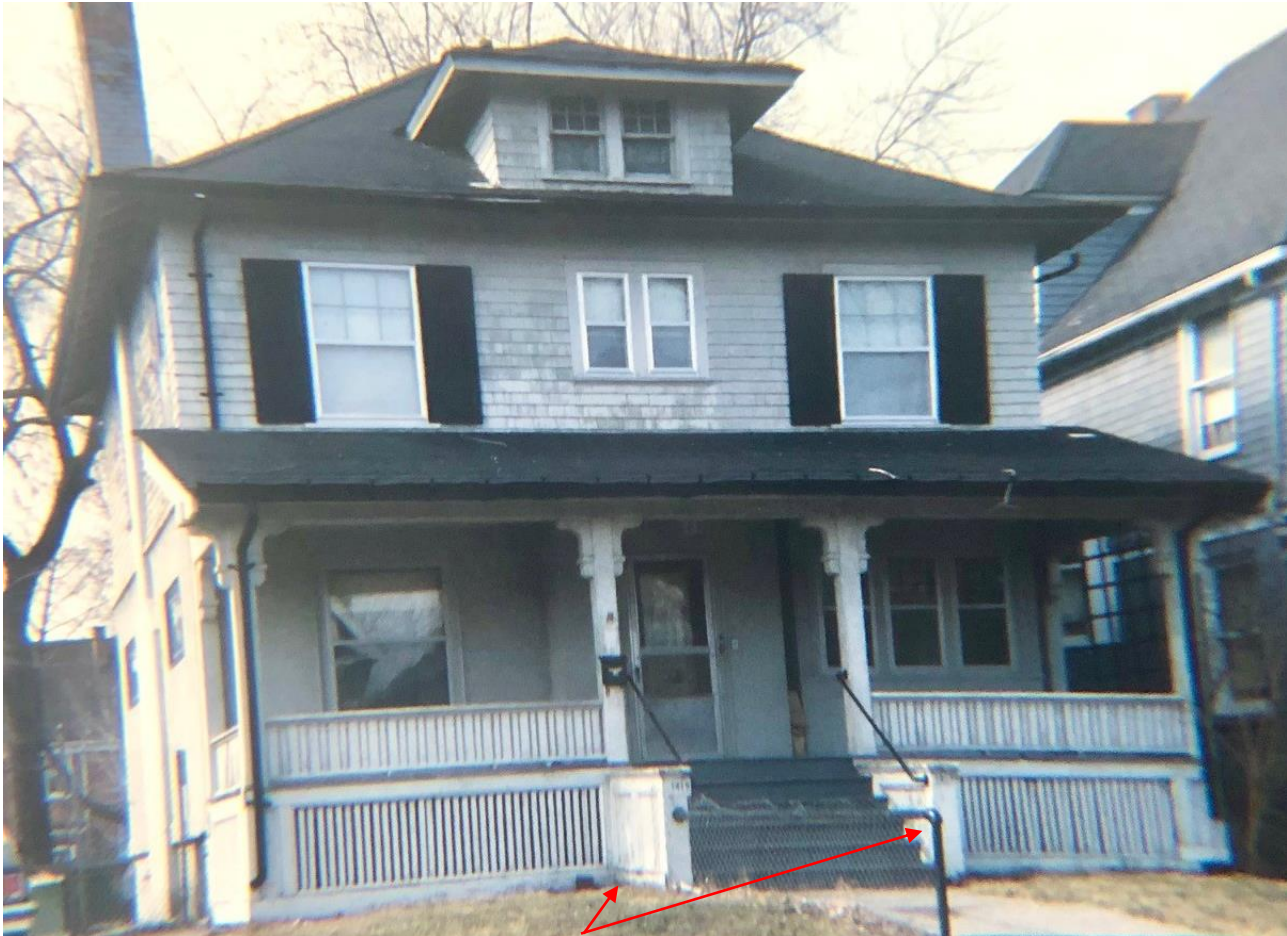
- Comparing existing conditions of the front porch to that captured in the designation photo, confirms much of the existing porch structure and detailing is original and/or historic. However, some changes have occurred without Commission approval, including a replacement porch railing and the removal of the front steps wing walls, both of which are distinctive character-defining features. A 2000 violation notice was found in the property file, but no documentation on further enforcement was located.

- The wing walls were an effective way to enclose the stairs in lieu of a railing. Prior to designation, pipe railings at the stairs and front walk were installed. It is staff's opinion the pipe railings are not historic nor appropriate for the property. As the wing walls were removed decades ago, this is not a current violation and is not addressed within this application.

- The existing railing is sympathetic in styling, height (taller than the historic railing, but likely lower than a contemporary 36-inch railing), material and finish, but doesn't meet Secretary of the Interior Standard 6, which requires exact replacement of deteriorated character-defining features.

1983 Designation photo, HDAB. Wing walls that were removed without Commission approval.

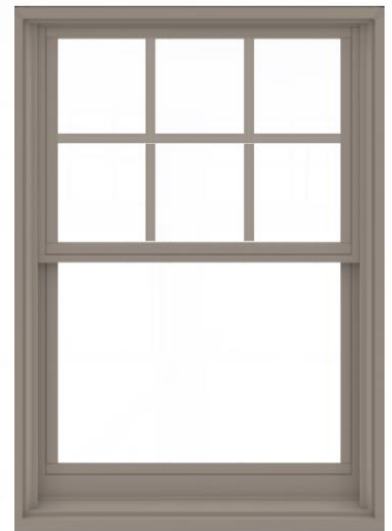
Left: Rear, second story window, new bathroom location. Right: Jeld-Wen catalog.

- For the window at the rear elevation shower location, it appears the Marvin Infinity line offers a custom simulated divided-light six-over-one pattern, as well as a "simulated check rail to give the look of a double-hung on a casement window". The applicant specified white opaque glass. Staff assumes this glass would create an opposing contrast of the divided light/check rail pattern than is typical of historic window openings. Should the Commission consider the fiberglass unit at this location, Marvin offers obscure glass. This would retain the typical relationship of darker glass and lighter colored frame while offering privacy at this second story rear elevation location. A dimensioned rendering of the custom window should be submitted before a

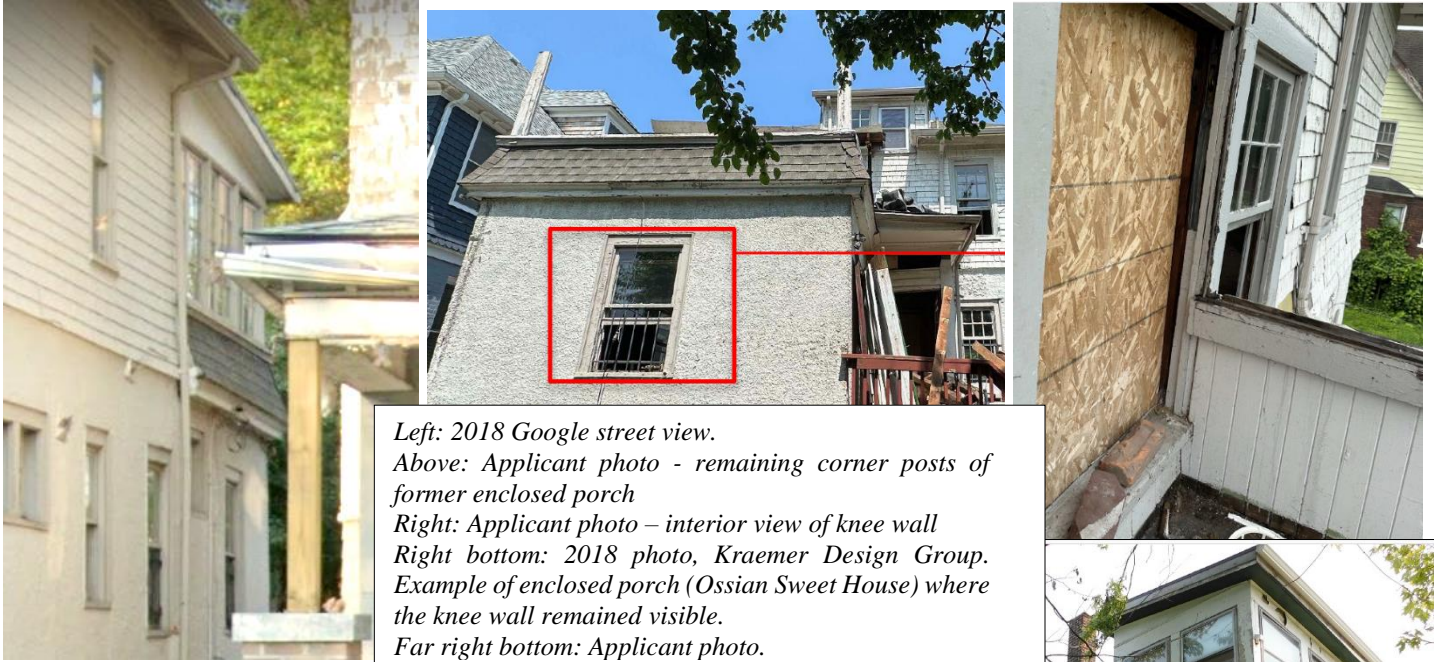
- The 2018 Google street view shows the upper porch was enclosed prior to its removal. Remnants of this construction are evident in the remaining corner posts and the cutaway area of the eave. This leads staff to believe the enclosed upper porch was not part of the original circa 1915 design, due to the conflicting way the shed roof meets the house, and that open air porches were a ubiquitous element of early 20th century, pre-airconditioned houses.

*Left: 2018 Google street view.
 Above: Applicant photo - remaining corner posts of former enclosed porch
 Right: Applicant photo – interior view of knee wall
 Right bottom: 2018 photo, Kraemer Design Group. Example of enclosed porch (Ossian Sweet House) where the knee wall remained visible.
 Far right bottom: Applicant photo.*

- It is not clear to staff whether the sloping exterior element, which is covered in asphalt shingles, is original to the 1915 construction of this extension. It is possible that the outer walls could be vertical panels, matching what is seen on the exposed interior walls. A similar condition occurred at the Ossian Sweet House.
- The existing design at 1419 Seyburn effectively masks the appearance of the knee wall. Therefore, it is staff’s opinion, that the proposed 12” wood railing to run at the top of the wall/roof is not demonstrably inappropriate for this area. However, staff suggests thin boards be used so that the railing is more transparent against the supporting structure. However, it might be possible for the retention of the knee wall without a railing, should the rehabilitation code be used to review this proposal.

- Dimensioned drawing of rear upper porch railing, using narrow balusters and corner posts will be submitted for staff review. The railing will be painted light olive gray.

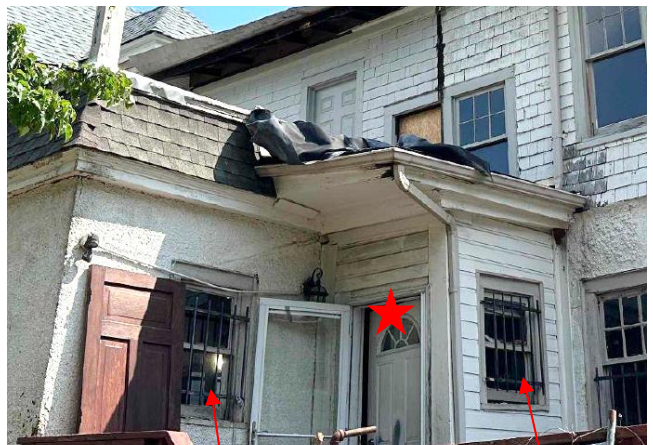
- The applicant proposes to place a window where the door is to be removed. Applicant confirmed the new window would match the size and operation of the adjacent window and would have the same head height.
 - It appears that the window proposed for removal (where the French door is to be placed) may be identical, or close, to the dimension of the window to remain in place. As these openings will be adjacent each other, the most appropriate solution is for the two window units to match in material and finish. As staff suggests the original wood windows should be repaired, relocation of the existing window may be a viable solution.

Window to be removed; French door to be installed. New window location. Window to remain.
