STAFF REPORT: AUGUST 9, 2023 REGULAR MEETING

APPLICATION NUMBER: 23-8483

ADDRESS: 2432 W BOSTON

SCOPE: REHABILITATE DWELLING AND GARAGE

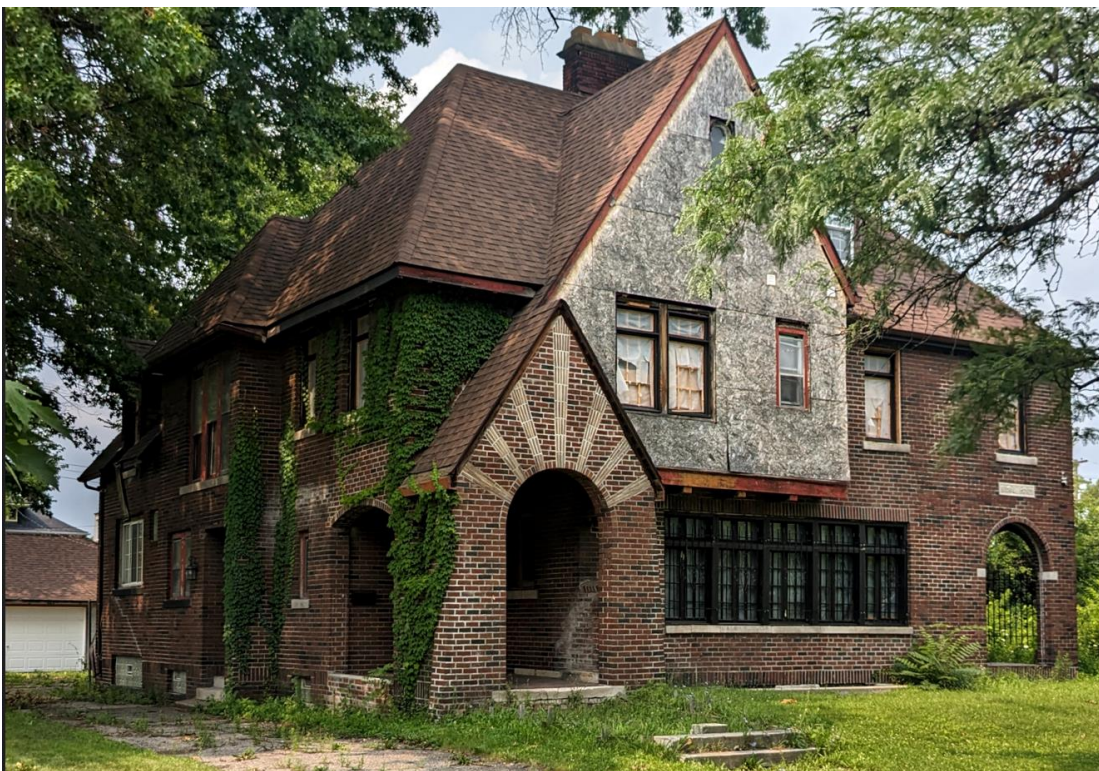
August 2023 photo by staff.

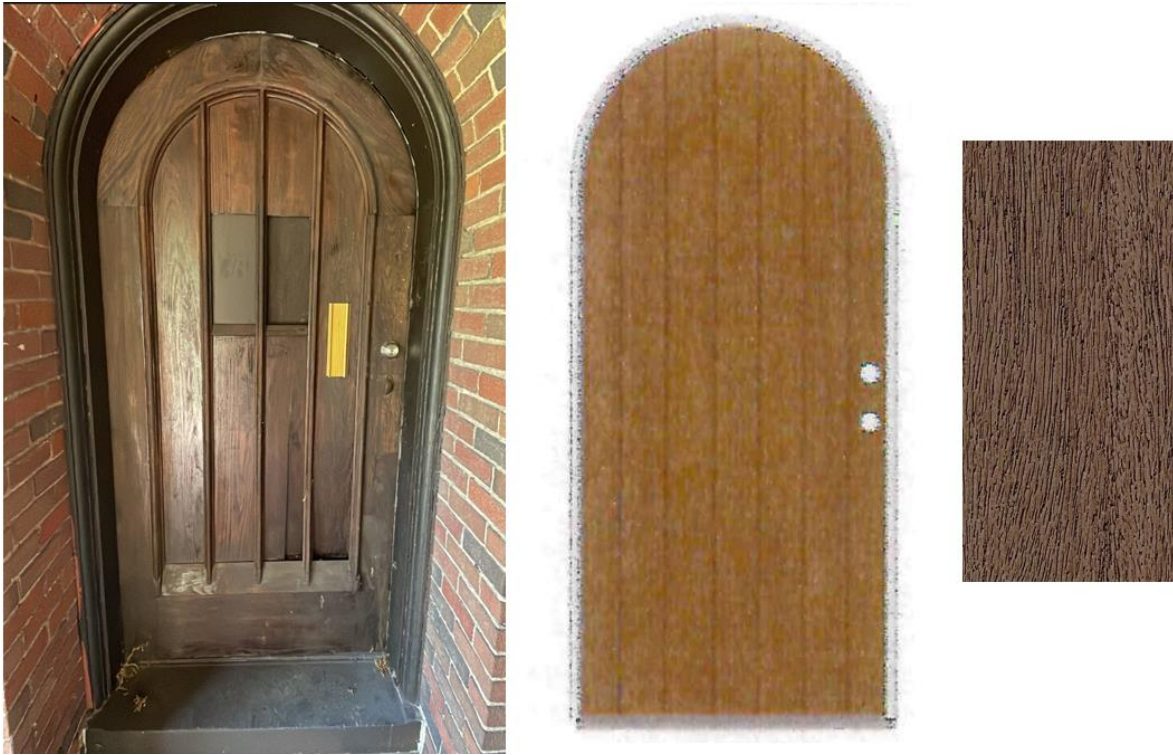
Left: Application photo of existing front door. Center: Sketch of proposed door from application materials. Right: Mahogany wood grain pattern from product website.

- The proposed brown window color is appropriate, as noted in the Elements of Design.
- The applicant has submitted photographs of the front entrance door showing damage including warped wood components (possibly a veneer) on the exterior and extensive use of wood filler on the interior.

- Photographs of the front entrance door show a large degree of deterioration, but staff is not convinced that it is beyond feasible repair. Standard #2 requires that “the removal of historic features ... shall be avoided.” This is particularly true of a “distinctive feature,” such as a unique front door (Standard #5).

- A front entrance door is typically a distinctive, character-defining feature worthy of preservation. This is especially so in Tudor Revival architecture, where doors tend to be heavy, solid wood panel doors, with unique detail and complexity. The proposed new door is much simpler than the historic door in that it lacks the depth, depth, battens, glazing, and curved wood panels of the historic door. Replacing the historic door with a simpler new door is contrary to Standard #6: “the new feature shall match the old in design, color, texture, and other visual qualities, and where possible, materials.”

Staff concludes that the proposed front door replacement does not meet the Secretary of the Interior’s Standards for the following reasons:

- The existing front door is a distinctive feature that has not been shown to be beyond feasible repair.
- The proposed replacement, lacking the battens, recessed panels, and square window of the historic door, lacks the necessary texture and depth to serve as an appropriate replacement.

Therefore, staff recommends that the Commission issue a Denial for the proposed replacement of windows 1, 2, 47, 53–56, and both garage windows, the proposed replacement of stucco and wood with fiber-cement panels and siding, and the proposed front door replacement as the proposed work fails to meet the Secretary of the Interior’s Standards for Rehabilitation, in particular:

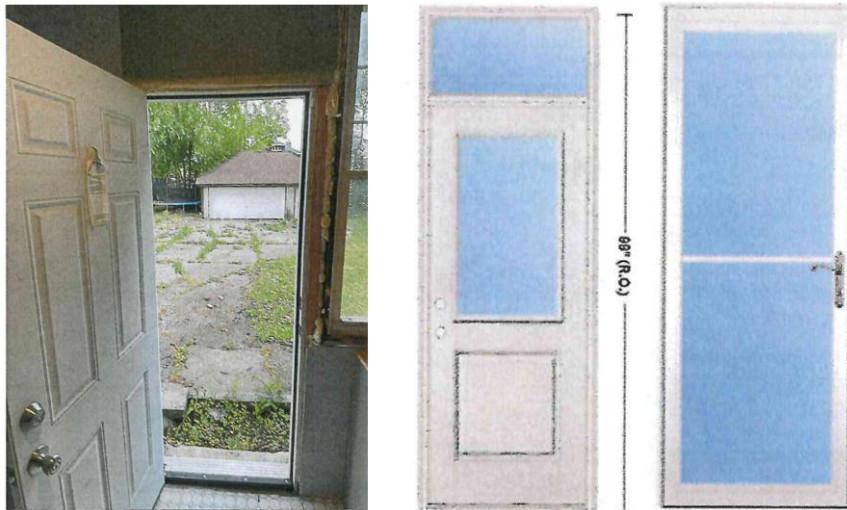
Left: Existing door. Photo from applicant. Center and right: Proposed door and storm door. Images from application materials.

- The proposed rear (south) door and storm door replaces a non-historic door with a compatible new door.
- The existing porch doors do not appear to be intended for exterior use and may date from the era when the porch was enclosed. Due to their recessed, west-facing location, they are minimally visible. Staff suggests that their replacement is appropriate.

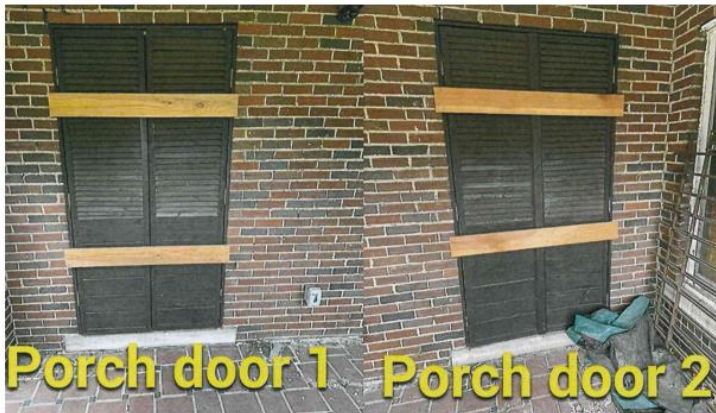
Left: Existing porch doors, photos from application. Right: Pella Reserve Traditional door (shown without simulated divided lights), image from product website.

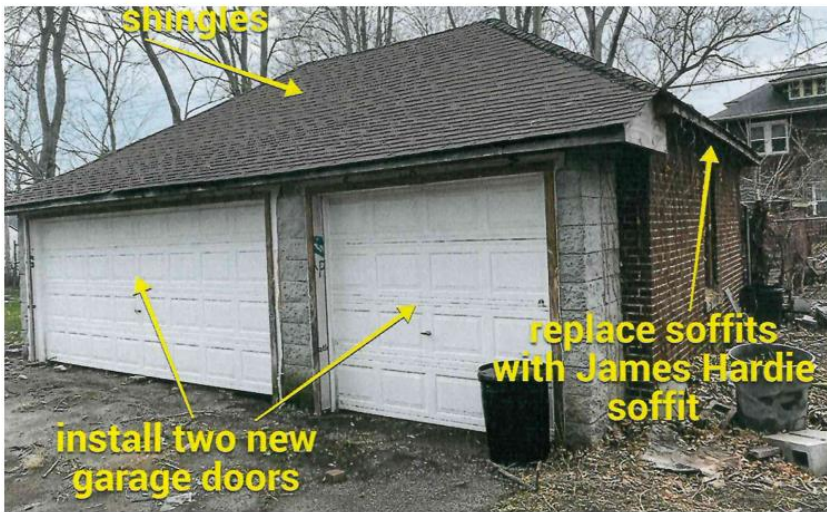
Left: photo of garage from application. Right: Timberline hickory shingles. Image from product website.

- The proposed garage shingle work replaces a worn, historically appropriate material with matching material.
- The garage doors are not a historic feature; the Secretary of the Interior's Standards do not require that they be retained. However, the new doors must be compatible in materials and visual qualities.

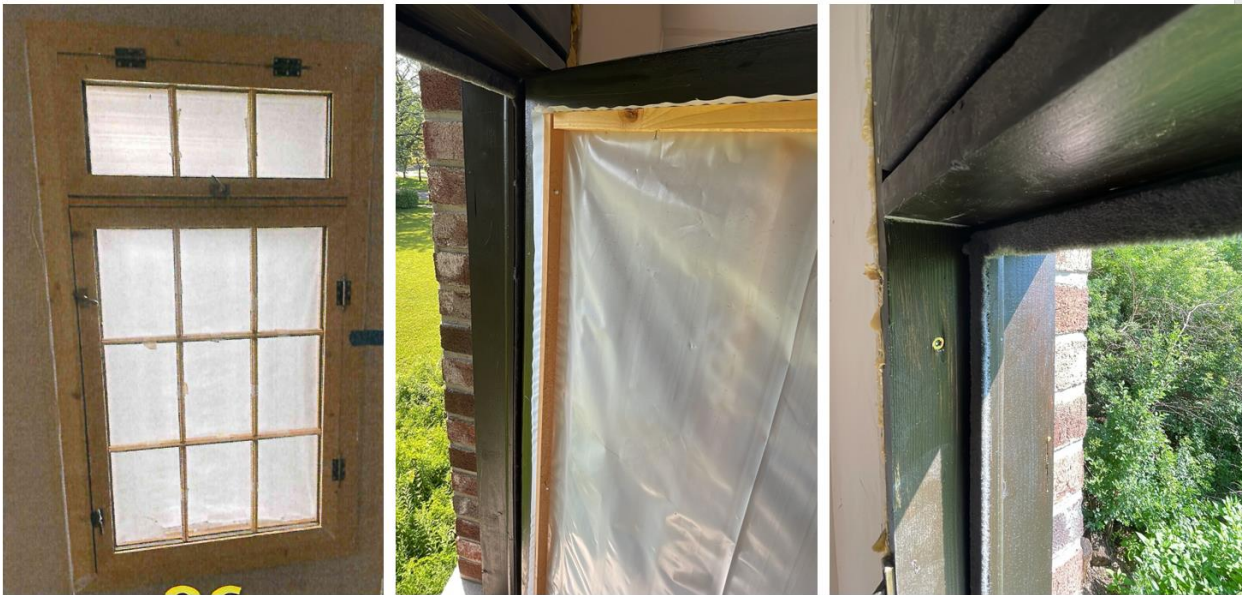
- Windows 27–30, 36–43, 45, and 46 have a casement lower portion and an awning upper portion, and appear to be either non-historic windows or historic windows that have been modified to the point that they can no longer be considered original or historic features. They appear to date from 2018–2022, as noted above. The windows appear to be the result of prior fabrication work that was never completed. They have muntins that appear to be made of unpainted pine and glass is not present. With the original windows missing, the guidance cited in the previous point also applies here; staff suggests the proposed windows are appropriate.

Details of non-historic windows proposed for replacement. Images by applicant, cropped by staff.

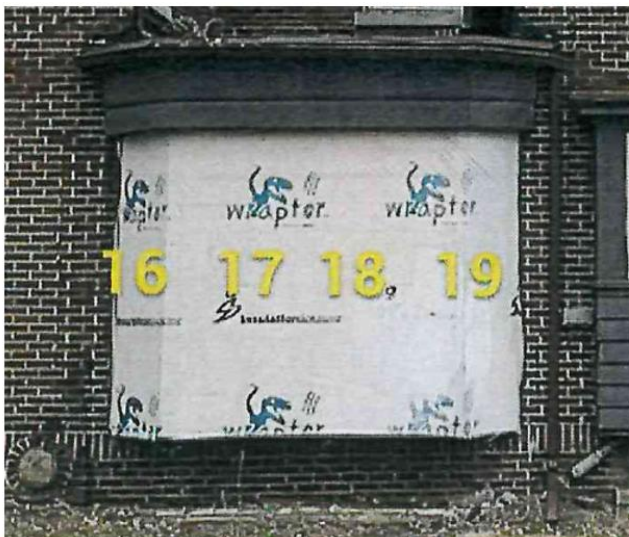
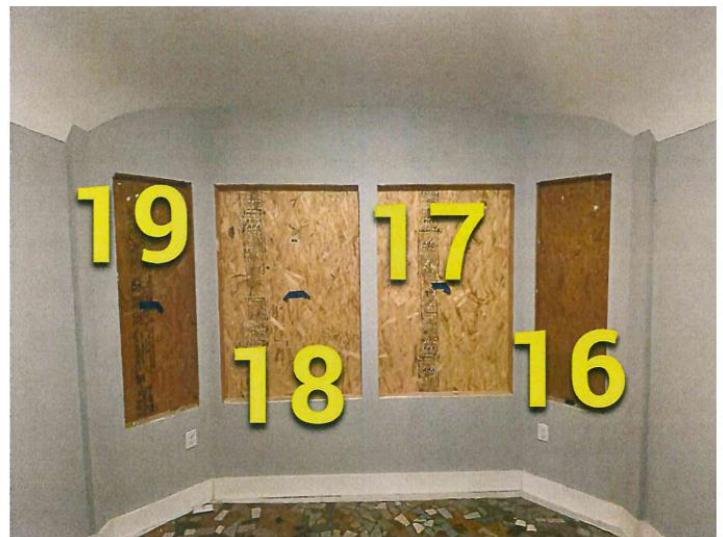
- Windows 17 and 18, located within a larger bay window on the south (rear) elevation, are proposed to be replaced with a larger, sliding door. This would necessarily require enlarging the opening. Staff suggests that while the bay window itself is a character-defining feature, the placement of individual units within the bay window is not. Also, as noted above, the windows are already missing. Thus, staff suggests that the guidance of *Evaluating Historic Windows for Repair or Replacement* (National Park Service, 2007) applies: “The number of windows being replaced is a consideration that may allow for window replacement that does not depend on deterioration. It may be possible that the replacement of a few windows may have only an inconsequential effect on the character of an elevation with many windows. Thus, where a need such as egress can be achieved with little change to the appearance of the building, a few windows may be replaced irrespective of their condition.

Windows 17 and 18 proposed to be replaced with a sliding door. Photos from application materials.

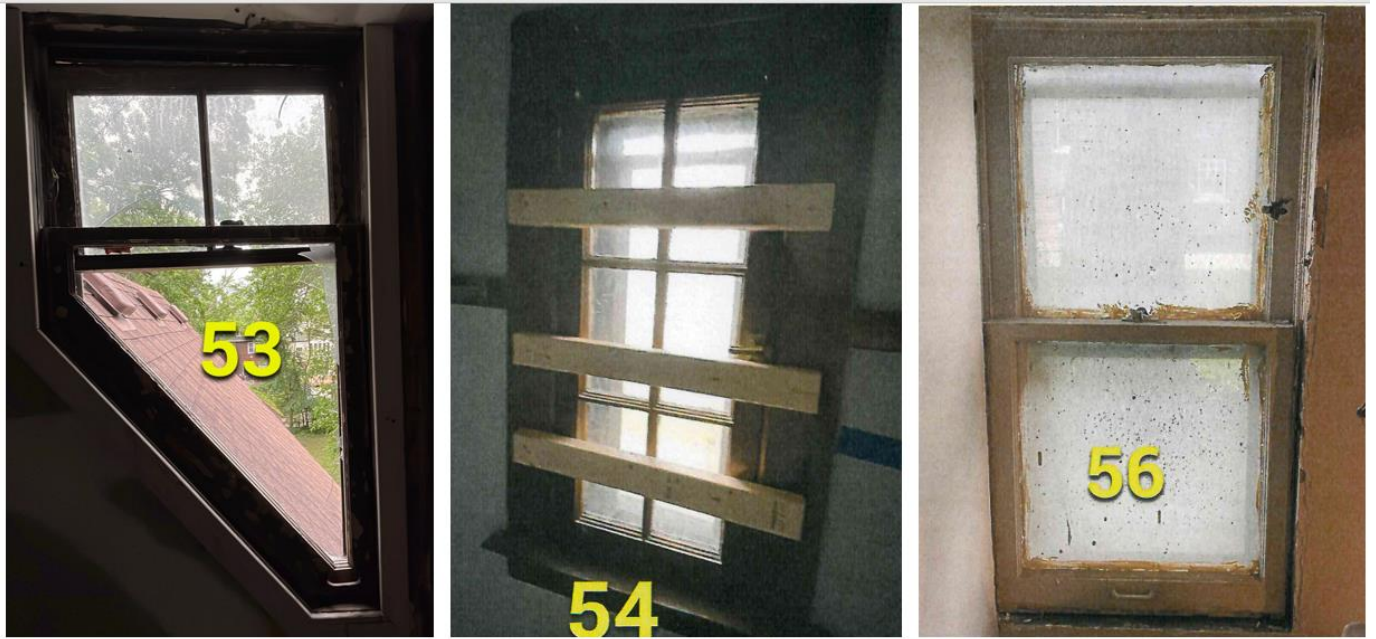
- Windows 1, 2, 53–56, and both garage windows appear to be original or historic windows. According to the submitted window schedule, their condition is listed as either “fair” or “missing parts.” Based on applicant photos, the windows seem to have missing glass, missing rope, or to be painted over, all conditions that are repairable. Standards #2 and #6 (quoted below) require that historic materials and features be retained unless they are deteriorated beyond repair.

Examples of historic windows proposed for replacement.

Staff concludes that the proposed replacement of windows 1, 2, 47, 53–56, and both garage windows does not meet the Secretary of the Interior’s Standards for the following reasons:

- The windows are historic materials that have not been shown to be deteriorated beyond repair.
- For windows 47 and 53, the proposed work replaces nonrectangular windows with rectangular windows.

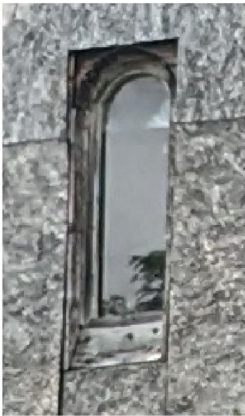
- Window 47 is a historic arched window, yet the proposed replacement is not. The proposed replacement of window 53 would also replace a distinctive irregular window with a rectangular window. This is contrary to Standard #2, which requires that “alteration of features, spaces and spatial relationships that characterize a property will be avoided.”

Window #47. Left: existing window, photo by staff. Right: proposed window from application materials.

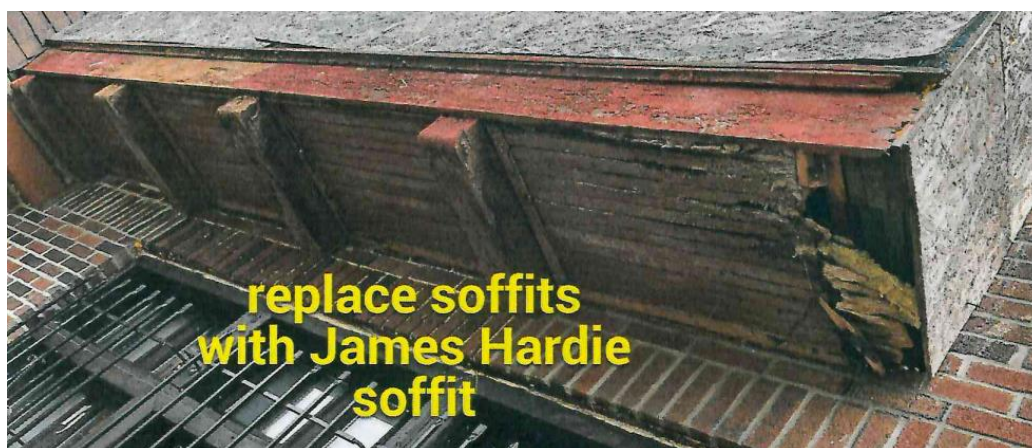
- The application includes a photo showing that one area of the soffit has deteriorated; however, there is not enough information to determine if the entirety of the soffits on the house and garage have deteriorated beyond repair. Standard #6 directs that the replacement of historic features shall be avoided unless they are deteriorated beyond repair.

- Further, Standard #6 states that a synthetic replacement would not be appropriate: “Where the severity of deterioration requires replacement of a distinctive feature, the new feature shall match the old in design, color, texture, other visual qualities, and where possible, materials.” Thus, a replacement should be wood, rather than the proposed James Hardie soffit and trim.

- Existing historic window trim will be retained. If it is deteriorated beyond repair, its replacement will be subject to approval by staff.
- The soffit panels may be replaced only to the extent that they have deteriorated beyond repair. The new soffit and trim panels will be wood rather than synthetic fiber-cement panels and will be painted a color selected from Color System D or another color approved by staff.
- The color of the proposed rear (south) doors will be a color selected from Color System D or another color approved by staff.
- The selection of garage doors will be subject to approval by staff.
- The color of gutters will be a color selected from Color System D or another color approved by staff.
