STAFF REPORT: 9/13/2023 REGULAR MEETING

APPLICATION NUMBER: #23-8515

ADDRESS: 3515 SHERBOURNE

SCOPE: DEMOLISH ADDITION, ERECT REAR DECK, REPLACE WINDOWS, REPAIR DRIVEWAY, PAINT TRIM (WORK COMPLETED WITHOUT APPROVAL)

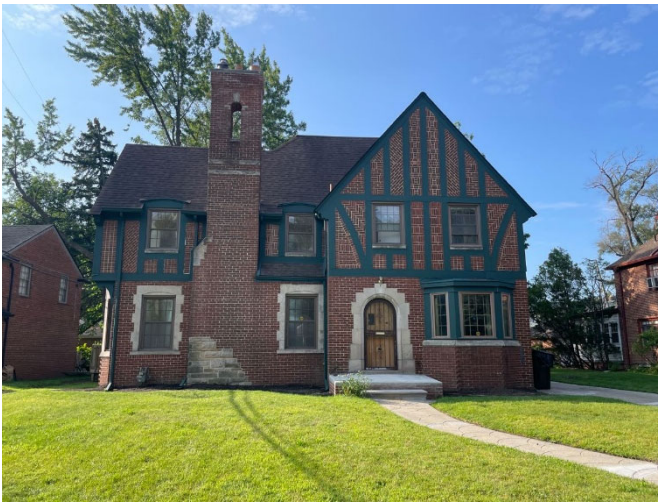
Site Photo 1, by Staff August 29, 2023: (North) front elevation of house, showing location of removed foundation plantings and painted trim, work completed without approval.

- From designation until April 2023, photos and documents show the presence of foundation plantings around the front and side elevation of the house. Staff observed that the removal of these foundation plantings without approval has exposed utilities, an air conditioning unit, and the deck at the rear. (See photos 1, 3, 7 and designation photo.)

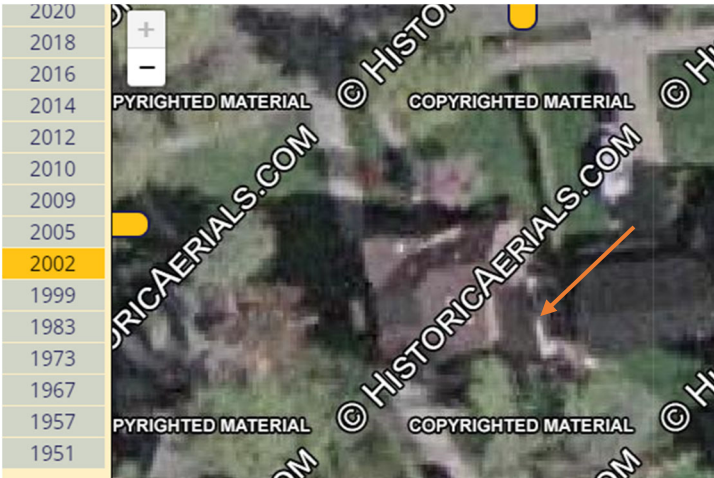
Aerial 1, by Historicaerials.com 2002: Blurred image showing presence of rear expanded room at time of historic designation.

- The Sherwood Historic District was established in 2002.
- No documentation on the construction of the rear expansion room and the surrounding wood deck was found, but evidence of their existence at the time of designation is found from historic aerial imagery. (*See aerial 1*)

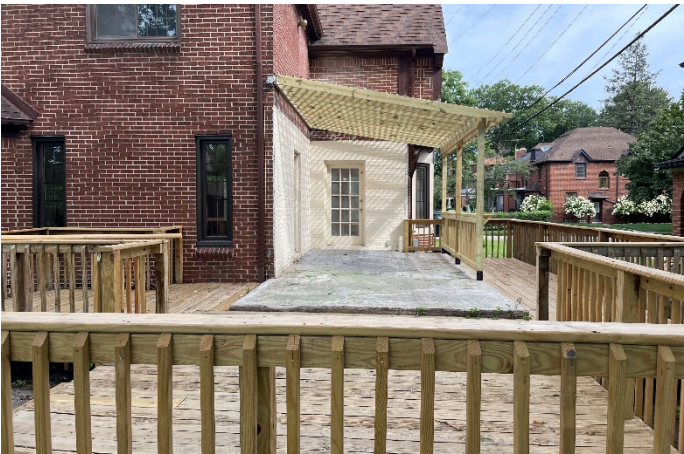
Site Photo 2, by Staff, August 14, 2023: South elevation of former room expansion by previous owner without approval and construction of the new pergola by current owner without approval. The surrounding deck and railing were repaired by current owner.

- The proposed construction of the pergola over the concrete pad of the former expansion, introduces, in staff's opinion, a new vertical element that conflicts with and is not compatible with historic features and proportions of the tudor, English Revival form of the property. Visible from the public street (*see site photos 2-3*), the pergola protrudes out from the dominant angles and line forms of the house, creating a disproportionate conflict of angles, scale, and line forms that pushes against and clashes with the stone, brick, and timbering of the house's architecture. Also, the proposed color, natural stain, rather than a color that is proposed to match the house trim, causes this element to stand out in front of the architecture, rather than recess into it and is not appropriate.

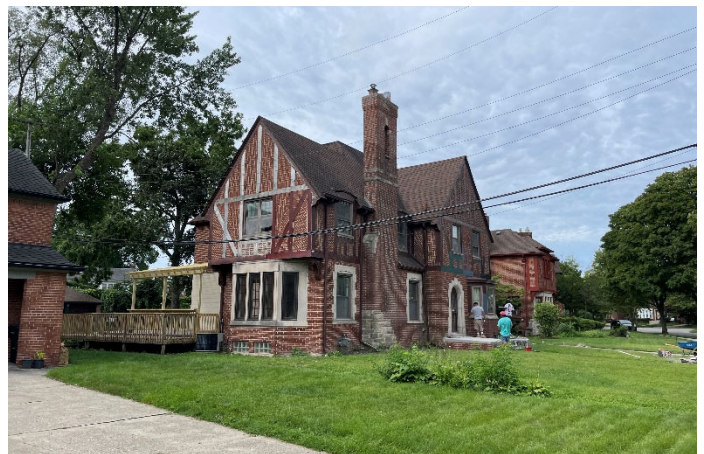
Site Photo 3, by Staff, August 14, 2023: East (side) and front elevation showing view of the deck, pergola and removed foundation plantings (without approval) from the public street.

- The repair of the deck and railing with like material is appropriate. However, staff recommends that a paint or solid stain be applied instead of the proposed natural stain. In the absence of a planting plan to replace the unapproved removal of foundation plantings that is in this proposal, the deck once recessed in the landscape and now is highly visible. (*See site photos 3 & 7*)

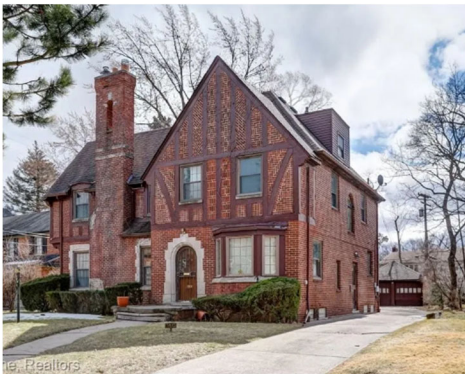
Site Photo 4, by realtor.com, April 2023: Front (north) elevation showing foundation plantings that have been removed and arched window on east elevation that was replaced by the current owner.

- Staff received confirmation from the applicant that the proposal for removal of these plantings does not include a plan at this time to replant any plantings at this time. The owner stated that the foundation plantings were "overgrown". However, staff sees from the April 2023 real estate listing photos that the foundation plantings appeared healthy and well maintained. (See site photos 4 & 7)

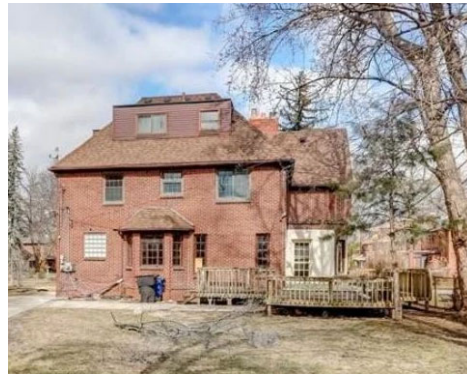
- The rear addition/expansion room was demolished. This condition left a concrete slab footing, painted exterior brick walls (once interior), and replaced doors leading to the outside.

- The rear deck and railing were present, although the conditions of the wood materials were aged and rotted at some locations. The pergola was not present and is a construct of the applicant prior to approval.

Site Photo 5, by realtor.com, April 2023: Rear (south) elevation showing extension room was removed, deck, and bay casement windows that were replaced by the current owner.

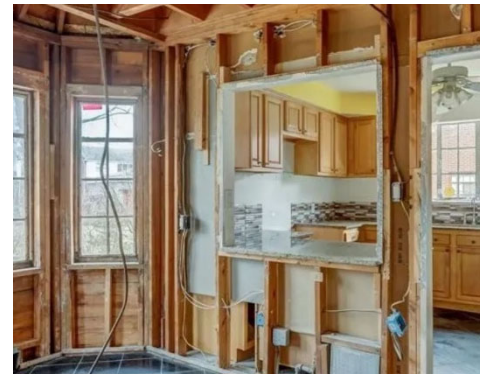
Site Photo 6, by realtor.com, April 2023: Dining room bay and kitchen interior showing steel casement windows that were replaced by the current owner.

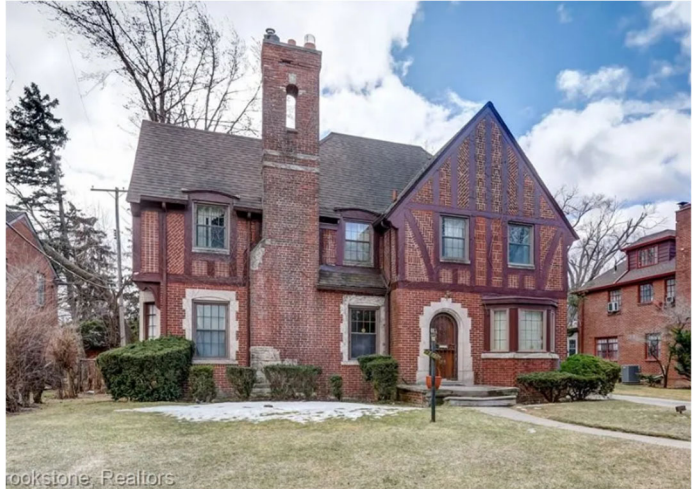
Site Photo 7, by realtor.com, April 2023: Front elevation (north) showing foundation plantings that screened the deck in the rear and casement windows at the east bay that were replaced by the owner.

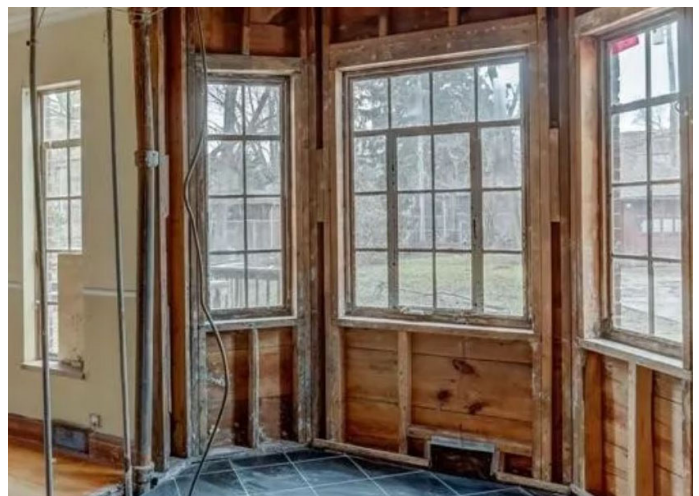
Site Photo 8, by realtor.com, April 2023: Dining room bay interior showing steel casement windows that were replaced by the current owner.

evidence or statement from an architect or window specialist. Staff did observe that the windows appeared to be in place and in fair condition from real estate images, but not able to view any particular details as stated by the owner, in these images. (See site photos 4-8 and floor plan 1)

- It is staff's opinion that these 13 remaining steel casement windows with true divided light are distinctive, character-defining features of the house that were remaining examples of the window expression for this English Revival home that were removed without approval.
- The proposed operation, configuration, vinyl material, between the glass grids and glass tint color have no resemblance to the original casement windows and are not appropriate.

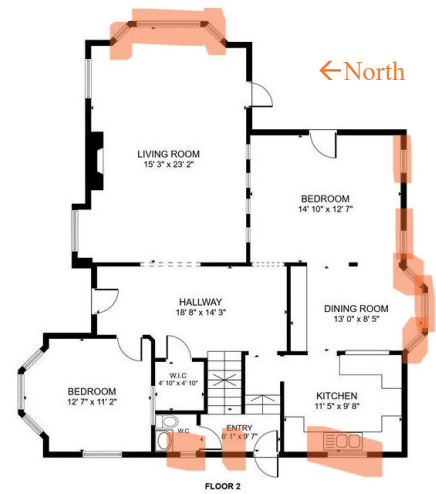
FLOOR 1: 1,385 sq.ft. FLOOR 2: 1,360 sq.ft. FLOOR 3: 1,171 sq.ft. FLOOR 4: 759 sq.ft. TOTAL: 4,675 sq.ft.
 Floor plan 1, by realtor.com, orange highlights by Staff showing former locations of 13 steel casements replaced by current owner at the rear (south) and side (east and west) elevations.

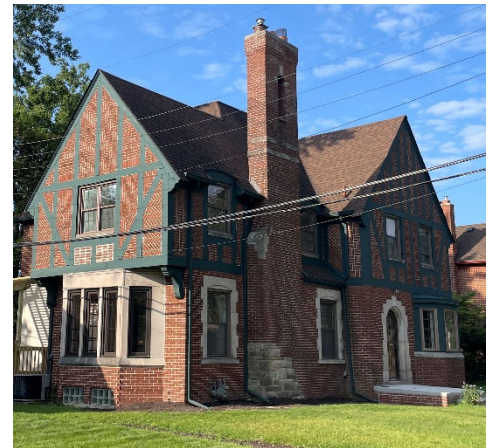
- Staff finds that the proposed repair of the fascia, soffits, concrete driveway and the proposed painting of exterior trim appropriate and follows the guidelines and standards.
- Staff observed that the tuckpointing at the porch and side elevation of the house was poorly executed and does not follow NPS guidelines. Staff found areas with mismatched pointing style and color to the existing mortar: the new mortar is bleached, nearly white and tuckpointing was left flush or even covering some of the brick units. It is staff's opinion that the proposed work for tuckpointing was not executed according to NPS Preservation Brief #2, "Repointing Mortar Joints in Historic Masonry Buildings", and therefore fails to preserve the historic craftsmanship that characterizes the distinctive character-defining features of the brick detailing of this property.

Site Photo 9, by Staff, August 29, 2023: East (side) and north (front) elevation showing tuckpointing below second floor window and front porch (completed without approval).

- The execution of the proposed tuckpointing was not executed in a manner that complies with NPS guidelines and has created scarring on the east elevation and front porch by introducing mortar that does not match existing mortar and applied in manner that covers existing brick.
