**STAFF REPORT: SEPTEMBER 13, 2023 MEETING**

**APPLICATION NUMBER: 21-7584**

**ADDRESS: 1315 BROADWAY**

**SCOPE: REVISION TO PREVIOUSLY APPROVED DESIGN**

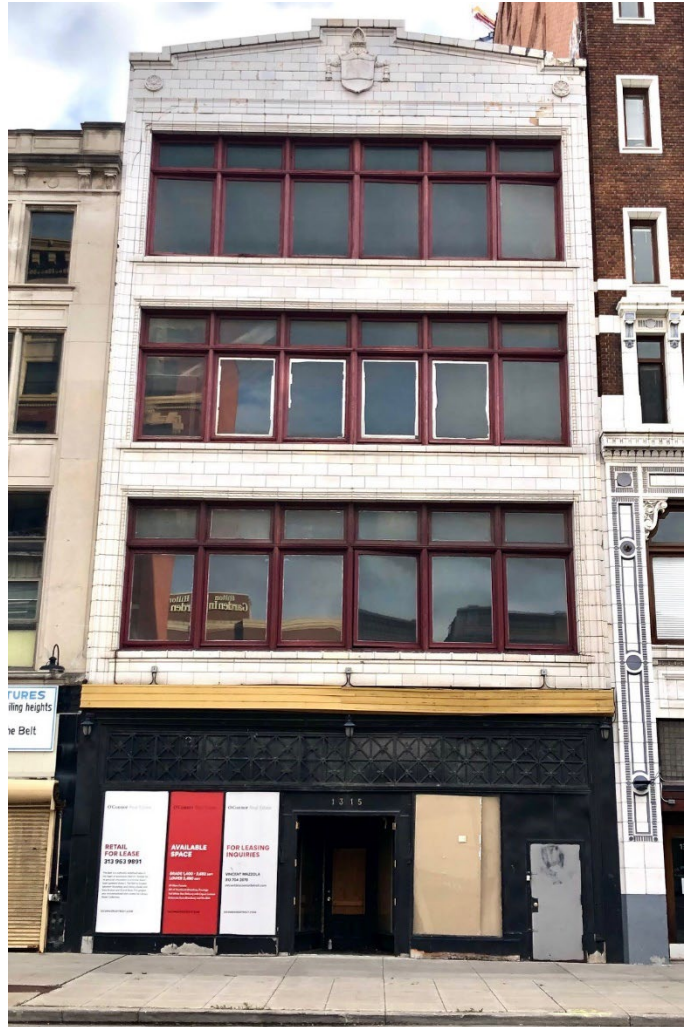
*Staff photo, September 7, 2023.*

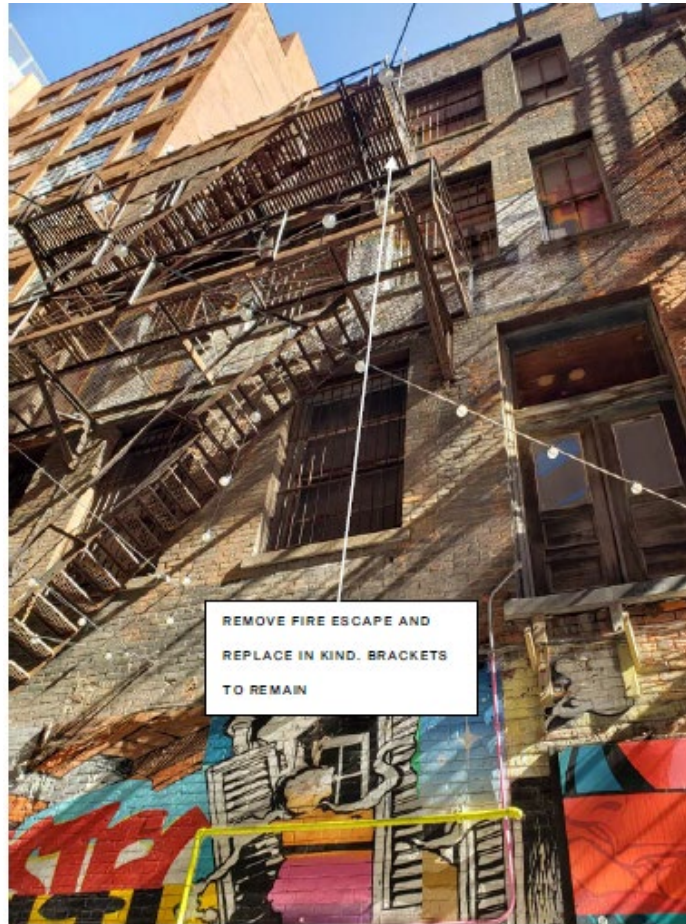
*Applicant photo from 2021 application.*

- It is staff's opinion the existing steel windows are character-defining features due to the operation, materiality, dimensionality, and pattern of window openings.

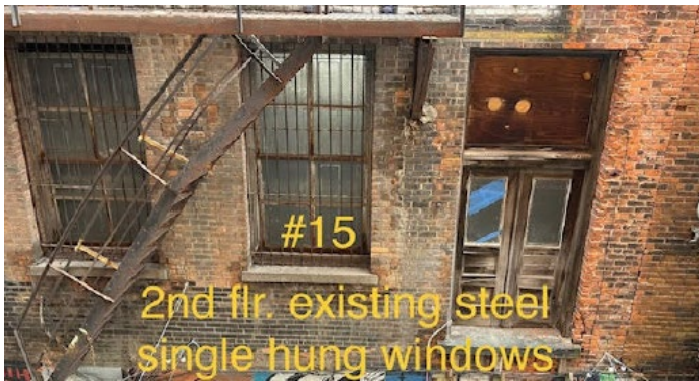
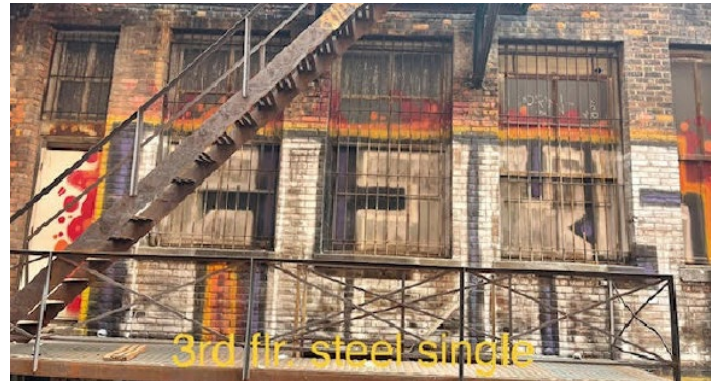
*Applicant photos from 2021 application.*

- In the 2021 application, Artisan Renovations concluded the steel frames and sash were in good condition and should be restored. In August 2023, Blackberry determined that the overall condition of the windows is poor. Only two exterior photos were submitted in Blackberry's report, so it is staff's opinion there is insufficient physical and visual documentation to substantiate the claim that the windows can't be adequately repaired.

Staff therefore recommends that the Commission issue a Denial for the work as proposed, as it does not meet the Secretary of the Interior's Standards for Rehabilitation, specifically Standards 1, 2, 5, and 6:

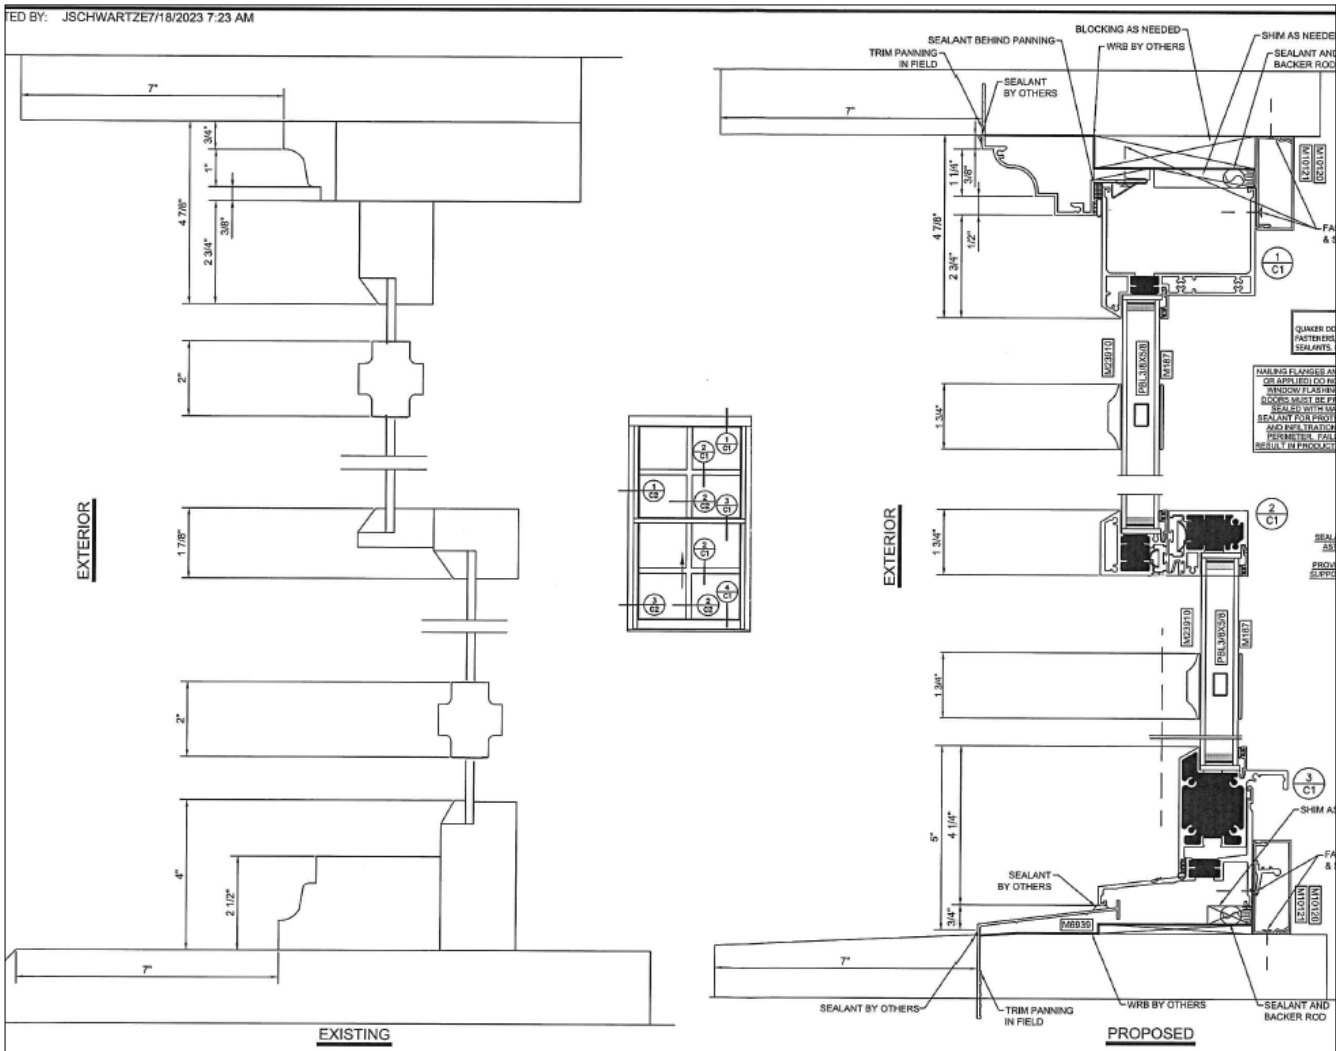
- TOP RAIL - The combined height of the top rail and trim of the new window is identical to the existing windows, and the profile for the new trim is very similar to the existing trim.

- MUNTIN BAR – Depth: The new muntin bars are about 1/2” shallower than the existing muntin bars (existing: 3/4” deep – new: 1/4” deep). Height: The new muntin bars are 1/4” shorter than the existing (existing: 2” high – new: 1-3/4” high).

- MEETING RAIL – The meeting rail height of the existing and proposed windows are similar with only 1/8” difference (existing: 1-7/8” high – new: 1-3/4” high).

- BOTTOM RAIL - The bottom rail of the new window is 1” taller than existing (existing: 4” high – new: 5” high), and the profile is drastically different.

- STAFF DETERMINATION – Based on the above analysis, it is staff’s opinion the proposed window is a close match to the existing windows.
