STAFF REPORT: SEPTEMBER 13, 2023 MEETING

APPLICATION NUMBER: 22-7665

ADDRESS: 715 VAN DYKE

SCOPE: ALTERATIONS TO PREVIOUSLY APPROVED PORCH DESIGN (WORK COMPLETED WITHOUT APPROVAL)

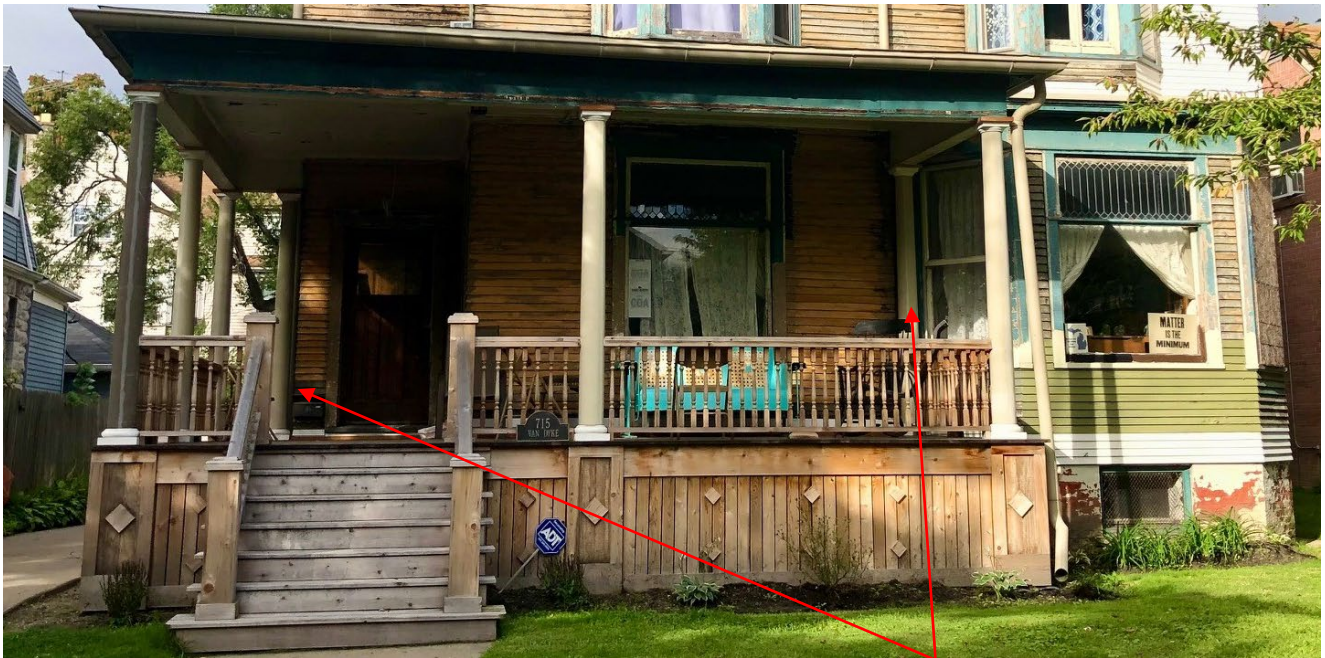
- The historic pilasters were replaced with round columns. Additionally, taller turned spindles were used for the porch railing, thick square newel posts were used at the stairs and a "solid" (i.e., no cut-outs) skirting with diamond medallions was installed.

HDC staff photo, August 30, 2023. Full columns were installed in place of reinstalling historic pilasters. Photos of pilasters in their original locations are on the following page.

- It is staff’s opinion the installed porch columns don’t meet the threshold of reasonable and feasible. The historic pilasters were the remaining distinctive, character-defining feature of the front porch and were to be reinstalled in their historic/original location. Composite Tuscan columns, similar in design and dimension to the historic pilasters as shown on the submitted cut sheet from the February 2022 application, are likely readily available. New Tuscan columns could have closely matched the historic pilasters and not offered a “piecing together of the porch appearance” as stated by the applicant. The current columns are much simpler in design and proportion and removed a level of architectural and historic detailing from the dwelling.

Recommendation One – Denial – Porch columns and medallions

Staff therefore recommends that the Commission issue a Denial for the work as proposed, as it does not meet the Secretary of the Interior’s Standards for Rehabilitation, specifically Standards 2, 5, and 6:

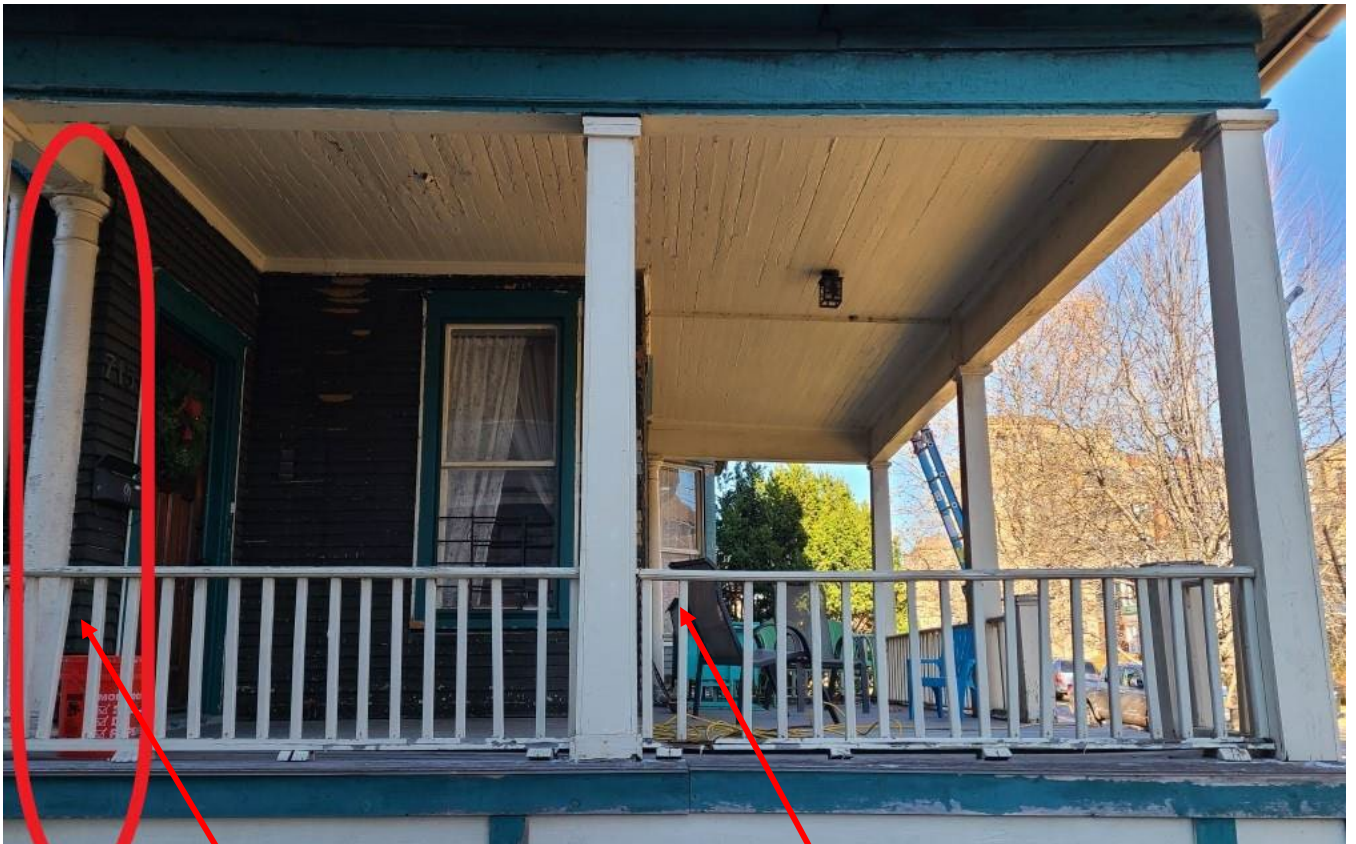
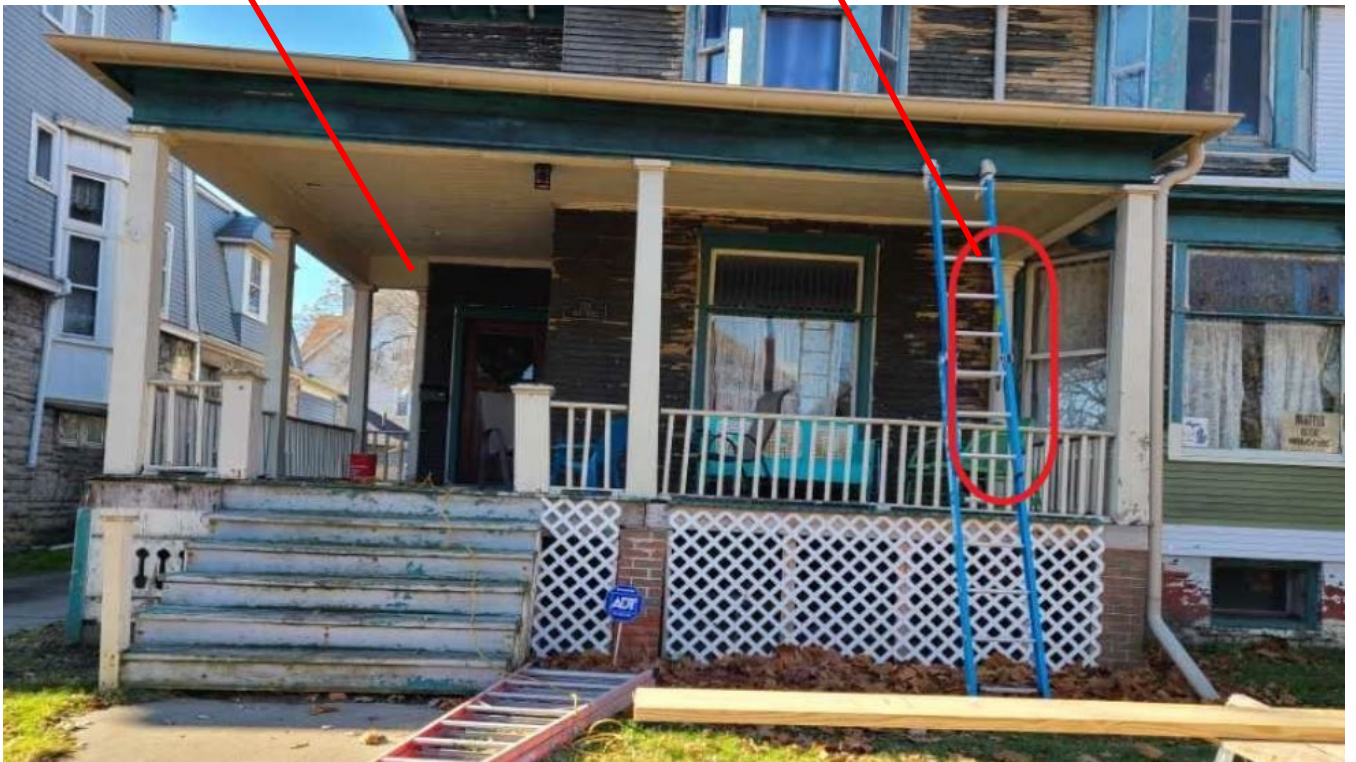
Applicant provided photos of the porch, pre-demolition, that show the location of the historic pilasters.

- Based on the photographs provided by the applicant within the February 2022 application, the wood pilasters remained on site and appeared to be solid and not deteriorated beyond repair.

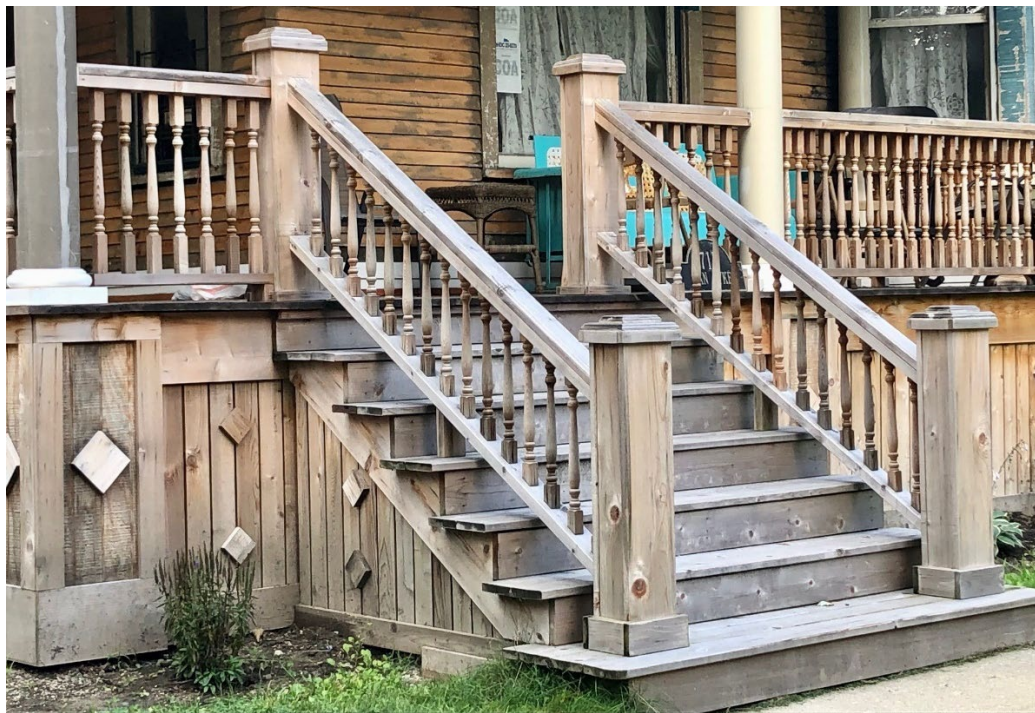
- Cut-outs within porch skirting are decorative ventilation openings for the area below the porch. The spacing between the vertical strips of wood used in this application may offer some level of air circulation.

- Applied medallions are not a traditional architectural component of historic porches. It is likely they could be removed without significant damage to the porch skirting.

- As mentioned earlier, turned spindles were used on Queen Anne houses, but often with more elaborate, finely detailed porch designs. It is staff's opinion however, due to the narrow spacing implemented between these spindles the more defined profile as installed is not demonstrably inappropriate.

HDC staff photo, August 30, 2023.

- All porch components will be painted Sherwin Williams SW2833, Roycroft Vellum, to match the trim on the remainder of the house.

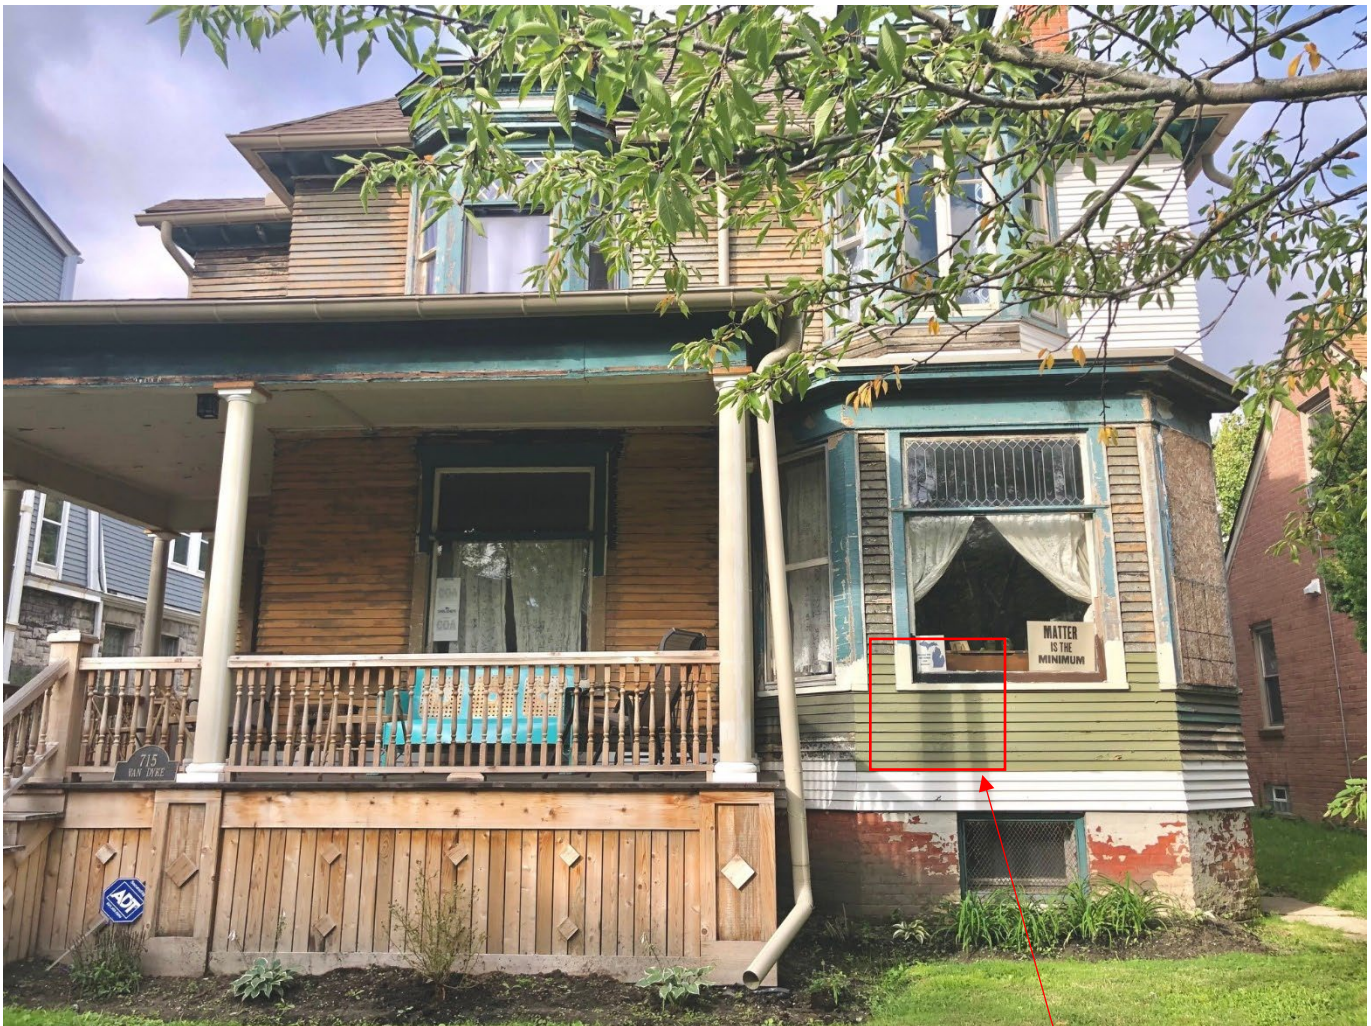
HDC staff photo, August 30, 2023.

- It appears that a mock-up of the intended exterior painting scheme was applied to a portion of the front façade. The exterior painting application didn't specify if the porch would be painted a uniform color to match the trim, or if a multiple-colored palette is planned for this area.

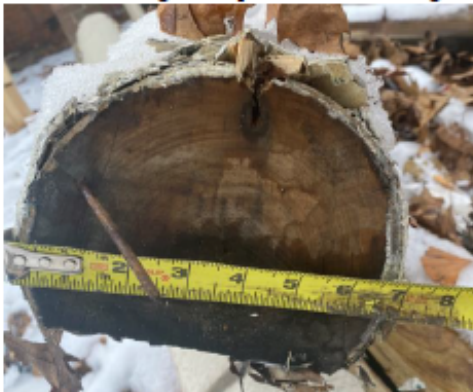
Diameter at the top of the pilaster – seven inches

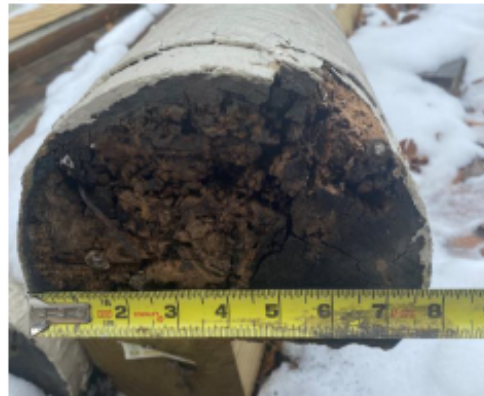
Bottom diameter of pilaster – eight inches
