STAFF REPORT: 11/8/2023 REGULAR MEETING

APPLICATION NUMBER: #HDC2023-00096

ADDRESS: 1465 CHICAGO

SCOPE: REPLACE ORIGINAL WINDOWS WITH ALUMINUM-CLAD WOOD WINDOWS, TUCKPOINTING, PAINT

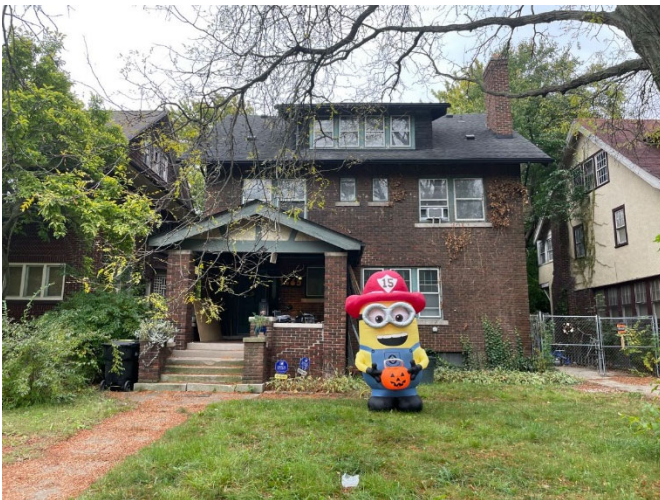
Site Photo 1, by Staff October 19, 2023: (North) front elevation of house, showing original wood windows behind storm windows.

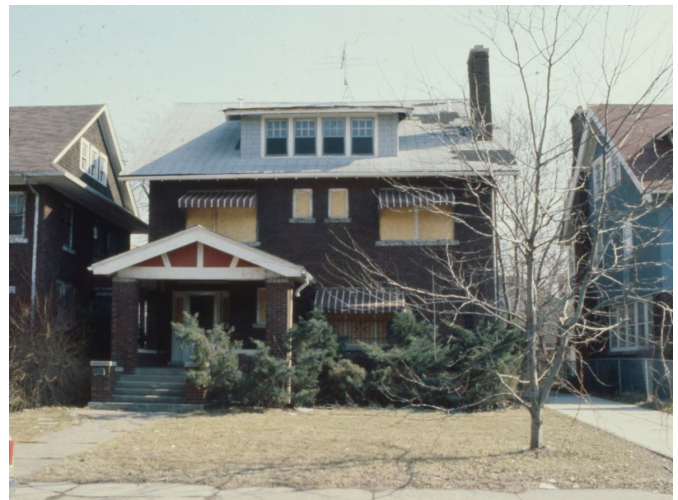
Designation photo 1980: (North) front elevation of the house showing 6/1 configuration in the dormer windows. Earlier designation photos are not available.

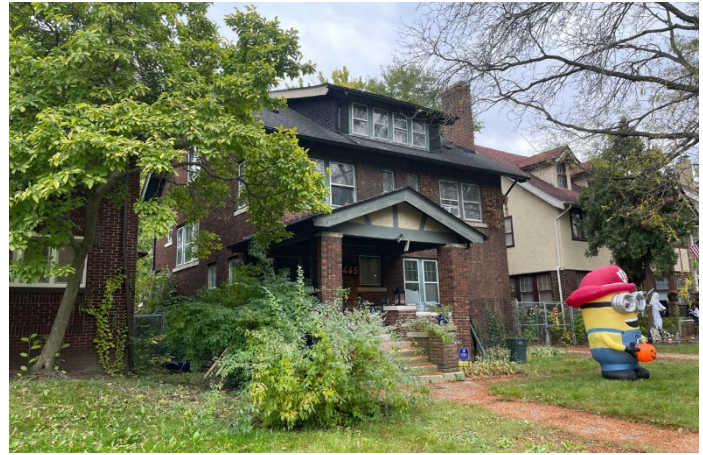
Site Photo2, by Staff, October 19, 2023: (East) side elevation of house, showing original wood windows behind storm windows.

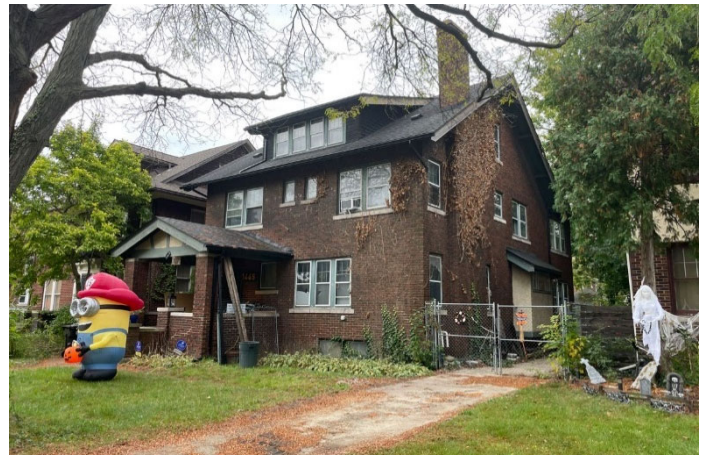
Site Photo 3, by Staff, October 19, 2023: (East) side elevation of house, showing original wood windows behind storm windows.

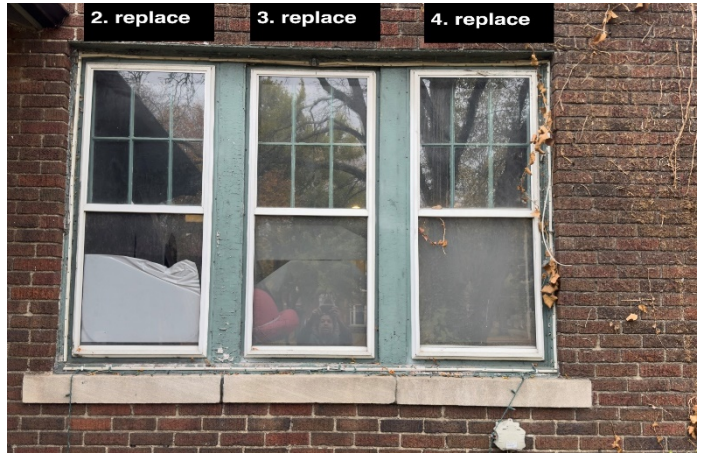
- Staff has not received a full assessment of all the windows and their conditions, nor did staff receive any photographic evidence or statement from an architect/historic window specialist stating that the windows are irreparable. The owner stated that the primary reason for replacement was the cost for repairing existing windows rather than replacement with new windows. Staff did observe that some wood wear on the lower sill area at some locations. However, after review of the images provided by the applicant and site visit with views to the external front and side elevations of the house, staff concluded that the current wood windows appear to be in place and in fair condition and are not in an irreparable condition.

Site Photo 4, by Applicant, October 2023: (North) front elevation, first floor, showing original wood 6/1 windows behind storm windows for replacement.

- It is staff's opinion that the original double-hung wood windows with true divided light are distinctive, character-defining features of the house. However, no documentation establishing that the condition of the original wood windows is beyond repair was submitted which does not meet Secretary of Interior Standards 2 or 6.

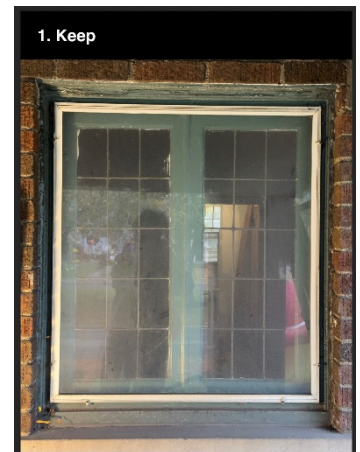
- The applicant confirmed that the wood mullions and brick mould would remain.
- The owner confirmed that the wood casement windows, located at the front and side elevations, will remain. However, the owner stated the intention to replace the second-floor original wood windows next year in a future application to match those that are in this application. (See site photo 5)

Site Photo 5, by Applicant, October 2023: (North) front elevation, first floor next to front door, showing original wood casement behind storm window to remain.
