STAFF REPORT: NOVEMBER 8, 2023 MEETING

APPLICATION NUMBER: HDC2023-00072

ADDRESS: 7908 – 7912 ST. PAUL

SCOPE: REMOVE WOOD SIDING (WORK COMPLETED WITHOUT APPROVAL), INSTALL WOOD SIDING, REPAIR/REPLACE WINDOWS

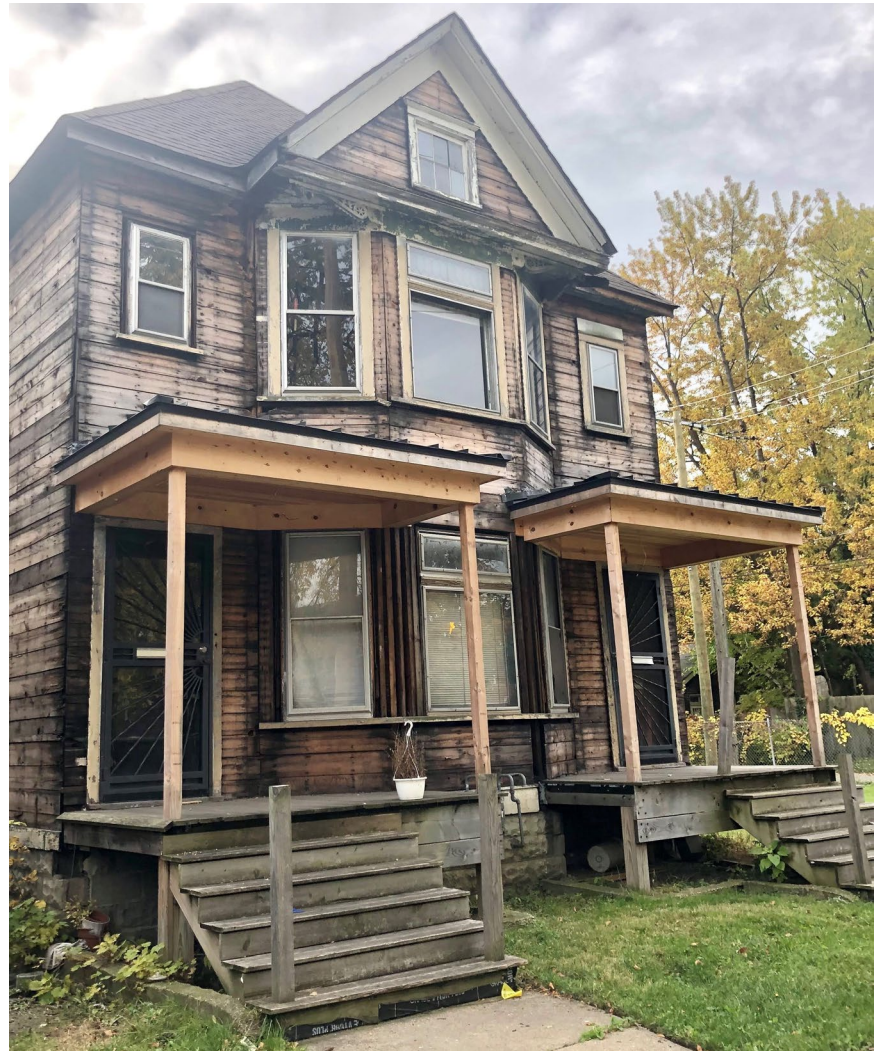
Staff photo, October 25, 2023

The historic wood siding and much of the wood trim was removed without HDC approval, so the underlying wood sheathing is the current exterior wall surface. Historic wood windows (some with leaded glass, some with wood muntins) are still in place in many openings, and the majority of visible window sash appear to be wood framed one-over-one double-hung units. Metal storm windows are in place on all non-boarded openings. Wood scrollwork applied trim remains at the underside corners of the front gable. The porches are in a state of reconstruction; the rebuilding of the porches were previously approved by the Commission.

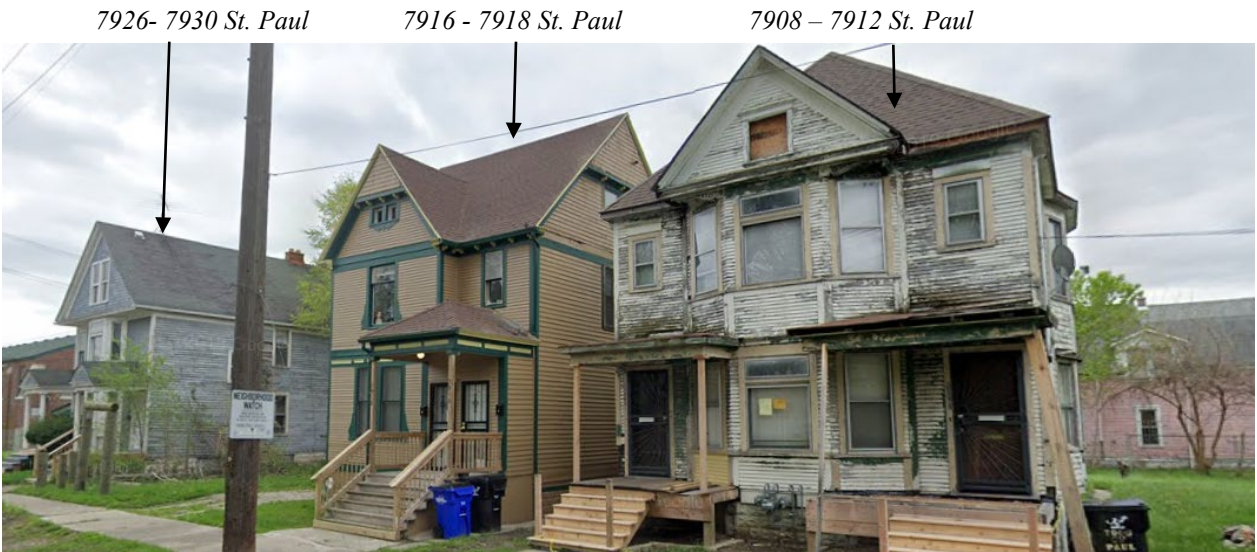
Staff photo, January 24, 2023.

- One highly visible detail that was present on all three buildings is the dual-sized wood siding - narrow boards on the front elevation with wider, more standard-sized boards on the side and rear walls. This combination is seen throughout West Village and is a defining feature of many clapboard homes in Detroit. Narrow siding, like narrow flooring, is more expensive to install, and intended to imbue the front elevation with a richer character (quite literally).
- The Commission reviewed an application for 7980-7912 St. Paul at its February 2023 meeting.

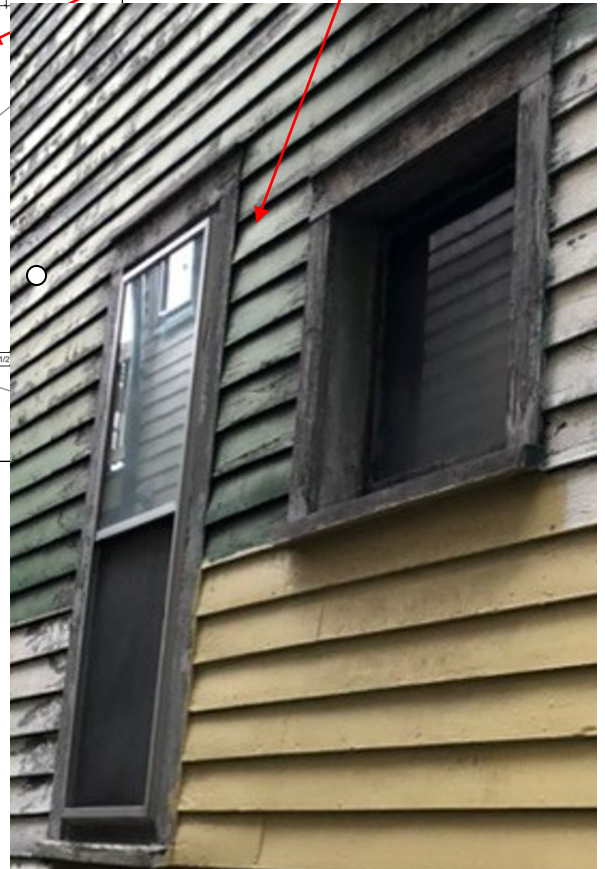
Applicant photo. East elevation. This close-up view shows the window casings for typical vertical window openings; the protruding trim at the headers and sills is also visible.

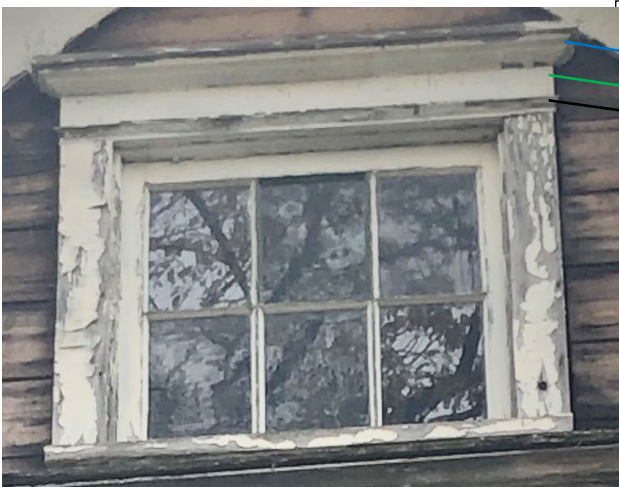
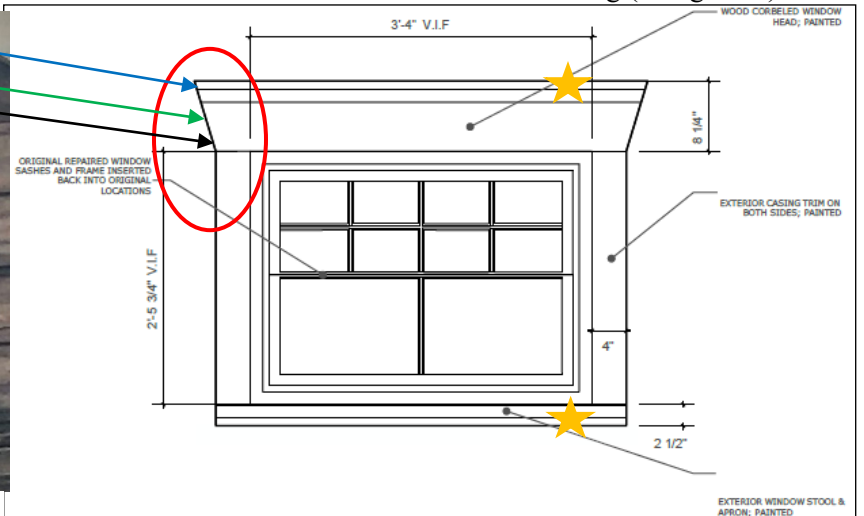
Above: Staff photo. Right: Applicant drawing.

- The drawing for the window casing for the small windows is not drawn accurately: it doesn't show the trim directly above the window opening (black arrow), the flat trim is shown to angle outward (green arrow) rather than only the decorative trim above the casing extending outward on an angle (blue arrow). Additionally, the protruding dimension for the sill and the header's decorative trim isn't noted on either drawing (orange star).

- Elevation drawings for the east and south elevations will be created and will document all related scope of work (including trim, wall, and porch details).
- The window casing drawings will be corrected to accurately reflect the existing conditions and dimensions.
- The front elevation drawing will be revised to include notations of the retention of trim within and below the gable.
- A site plan will be submitted to confirm placement and dimensions of rear stairwell (if one is being erected).
- Manufacturer’s or fabricator’s information, including sash dimensions, for the new wood windows will be submitted. The elevation drawings will note the window openings that will receive new window sash.
- Revised plans noting all the above conditions will be submitted for staff review prior to pulling a permit.

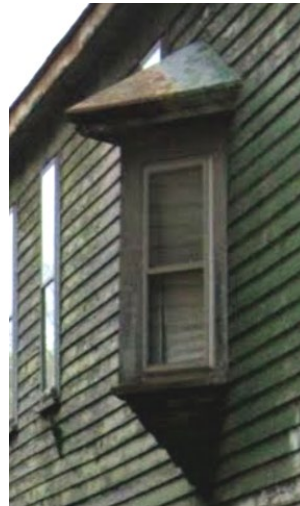
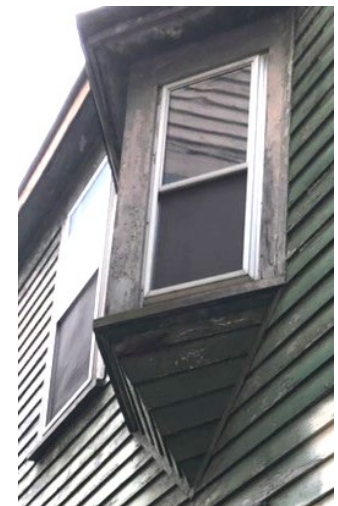
- Elevation drawings were not submitted for the east (side) and south (rear) elevations. The dwelling has four unique elevations so a drawing for each side of the house must be submitted to confirm the new siding, trim, and other details (if present) will match the previous existing conditions.

The roof was flat and clapboard siding covered the walls below the windows.

The applicant hasn't explained nor shown how the rear elevation will look. Specifically: will the built-out walls at both decks be retained or will they be removed, what type of railing will be installed, and will a two-story stair be erected. If stairs are to be erected, the placement, design, and finish of the stairway will need to be shown on a site plan in addition to the elevation drawing.
