STAFF REPORT: NOVEMBER 8, 2023 REGULAR MEETING PREPARED BY: T. BOSCARINO
Revised November 8, 2023 to include additional information on the appearance of the porch.

APPLICATION NUMBER: 23-00080

ADDRESS: 19170 WARRINGTON

SCOPE: REMOVE BALCONY, ALTER EAVES, CHANGE PAINT COLOR

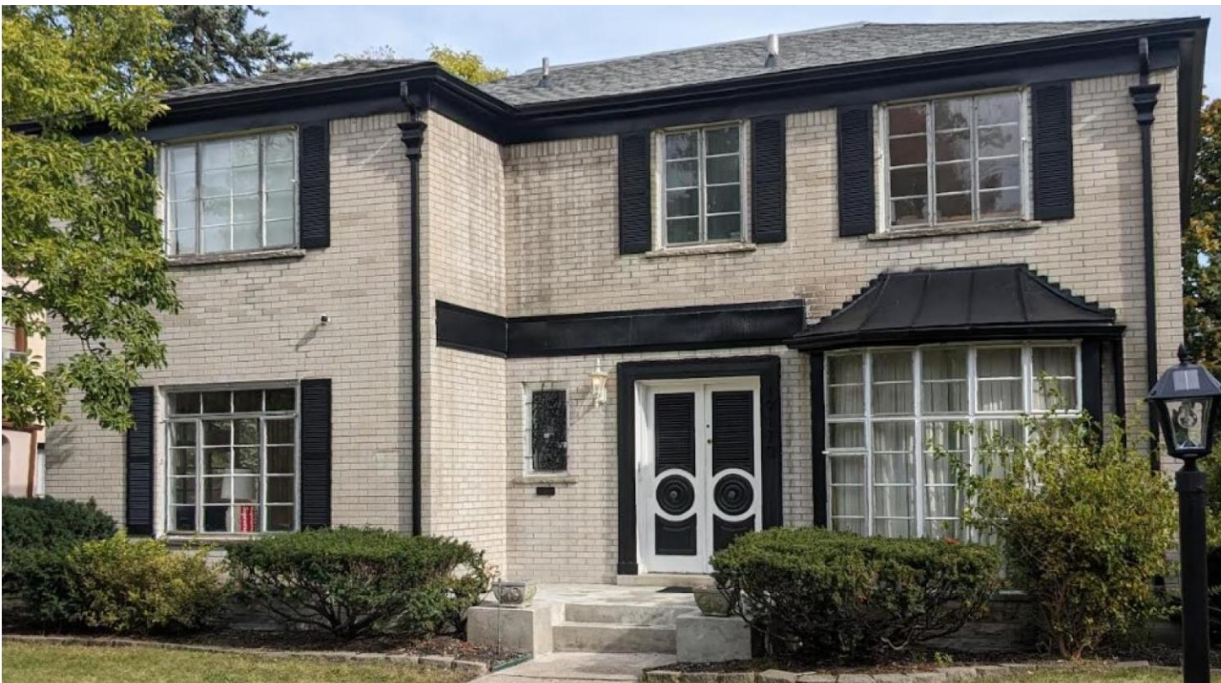
Front (viewed from Warrington Avenue facing east) view of subject property, October 2023 photo by staff.

The applicant proposes several work items, already completed and visible on the building. Most noticeably, a proposed removal of the balcony has already been completed. Also proposed (and completed) are new gutters and downspouts, new fascia boards, repairs to the poured concrete porch, and a change in paint color from blue and white to black.

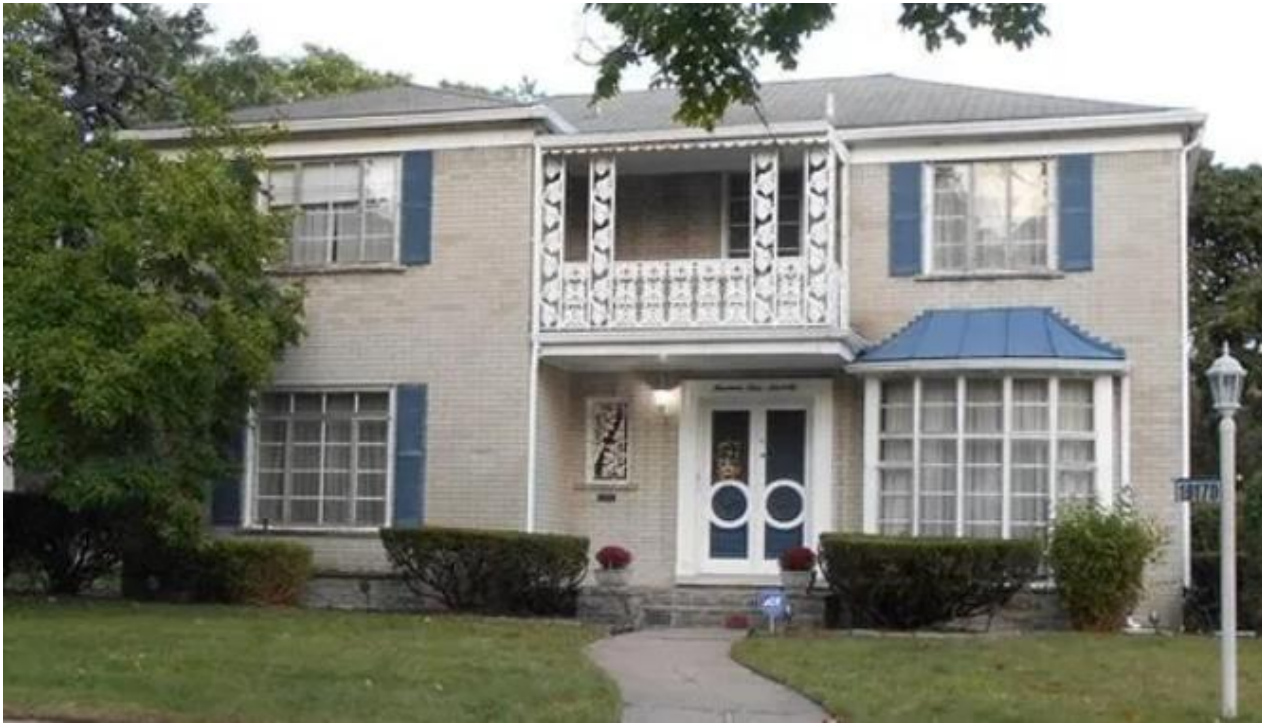
The subject property in 2022 2020 or 2021. Image: Google Maps <https://www.realtor.com/realestateandhomes-detail/M4321465246>

- The balcony proposed for removal (already removed without approval) is unambiguously a distinctive and character-defining feature of the building, as mentioned in the Elements of Design. Its metal (likely iron) details added a Colonial Revival character to the façade, while its cantilevered composition was a Modern

element. It appears to have been original to the building. The Secretary of the Interior's Standards for Rehabilitation, namely Standard #2, require that "the removal of historic materials or alteration of features and spaces that characterize a property shall be avoided."

Recommendation One: Denial of porch removal

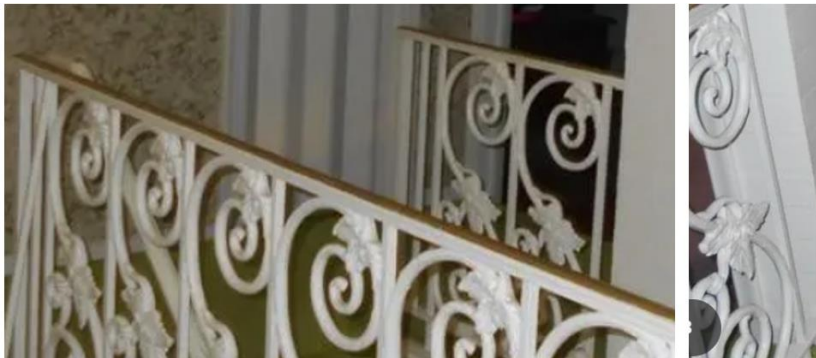
Interior views from realtor.com 2020 or 2021.

- **The removed porch appears to have had a leaf-and-vine motif sometimes found on mid-twentieth-century houses and is certainly an important and characteristic feature of its era.¹ Staff checked photos from Google Maps (2022) and the Historic Designation Advisory Board (2002) but these are of too low a resolution to view the details of the porch. However, a real estate listing (cited above) shows that a similar motif exists on the interior; this could be used as a model for reconstruction.**

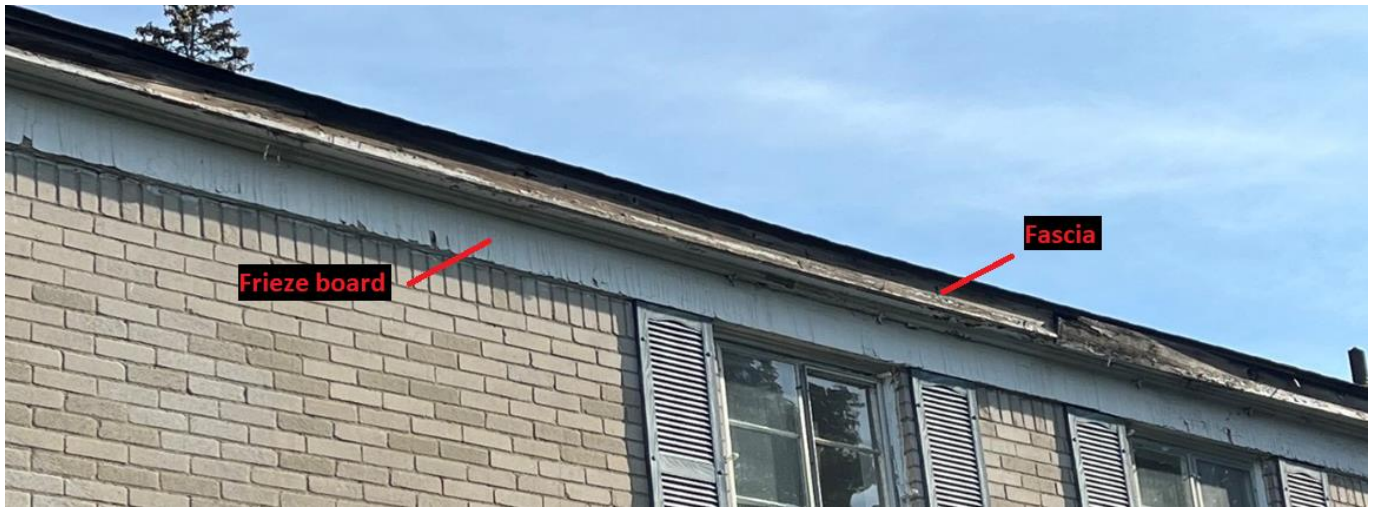
- The applicant included a photo of a portion of the eaves prior to replacement. The area shown depicts visible deterioration of the fascia boards and it is possible, though not certain, that the fascia boards on the entire house were deteriorated beyond repair. The new work matches the materials and dimensions of the historic material. The soffits and frieze boards appear to have been repaired rather than replaced. The work appears to satisfy the Secretary of the Interior’s Standards for Rehabilitation, namely Standard #6: “Where the severity of deterioration requires replacement of a distinctive feature, the new feature shall match the old in design, color, texture, and other visual qualities, and where possible, materials.”

Image from application materials, cropped and labeled by staff.
