STAFF REPORT: 11/8/2023 MEETING
APPLICATION NUMBER: HDC2023-00049
ADDRESS: 8066 KERCHEVAL
HISTORIC DISTRICT: WEST VILLAGE
APPLICANT: TADD HEIDGERKEN/ET AL COLLABORATIVE
DATE OF PROVISIONALLY COMPLETE APPLICATION: 10/16/2023
DATE OF STAFF VISIT: 10/26/2023

SCOPE OF WORK: RECONSTRUCT STOREFRONTS, ADD ENTRYWAYS

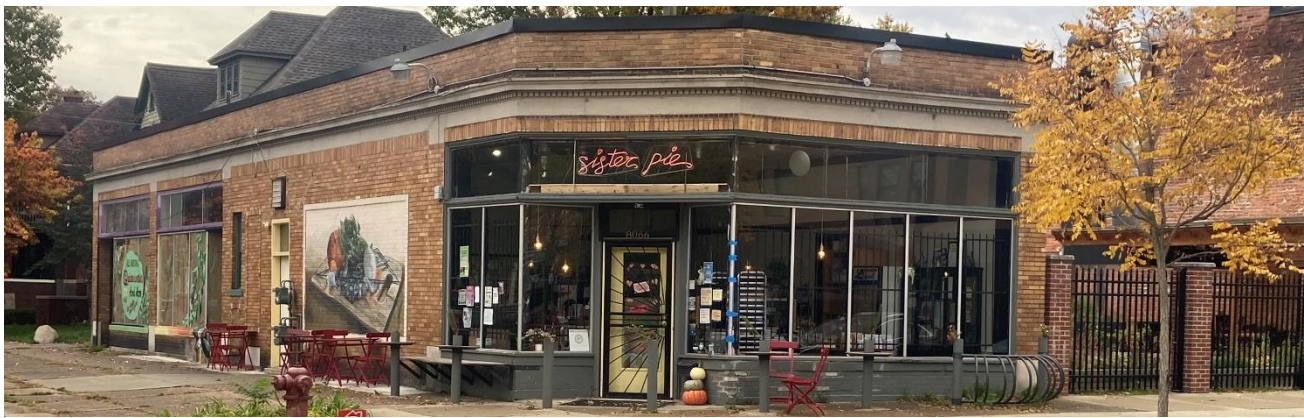
8066 Kercheval, staff photo taken on 10/26/2023

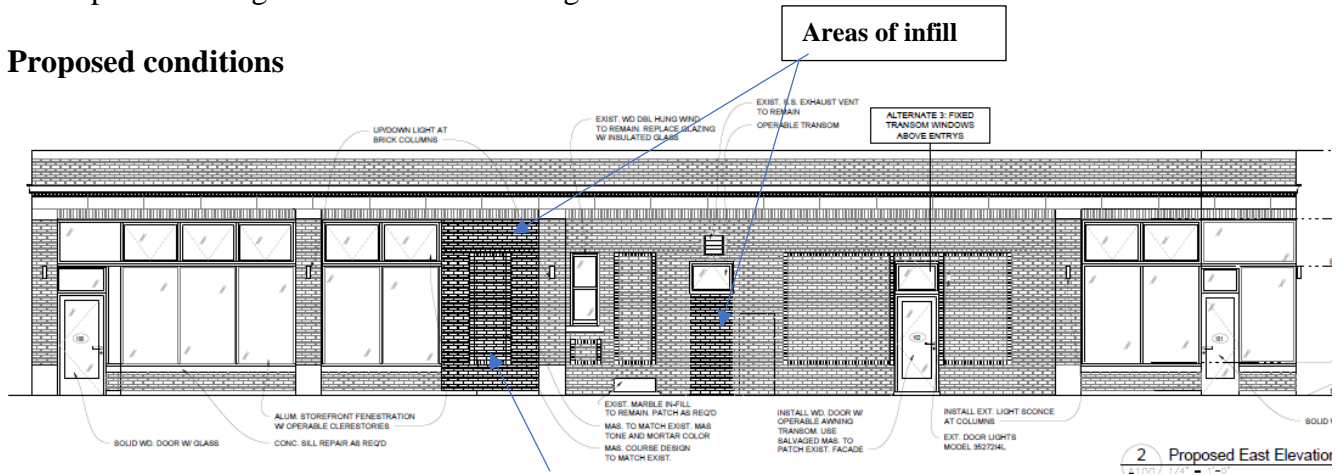
Proposed east elevation

This storefront currently includes three glazed panels and an inset doorway. The project proposes to decrease the width of this storefront opening by removing the current inset doorway, installing a new aluminum storefront which includes two glazed panels, and infilling the remaining opening with brick

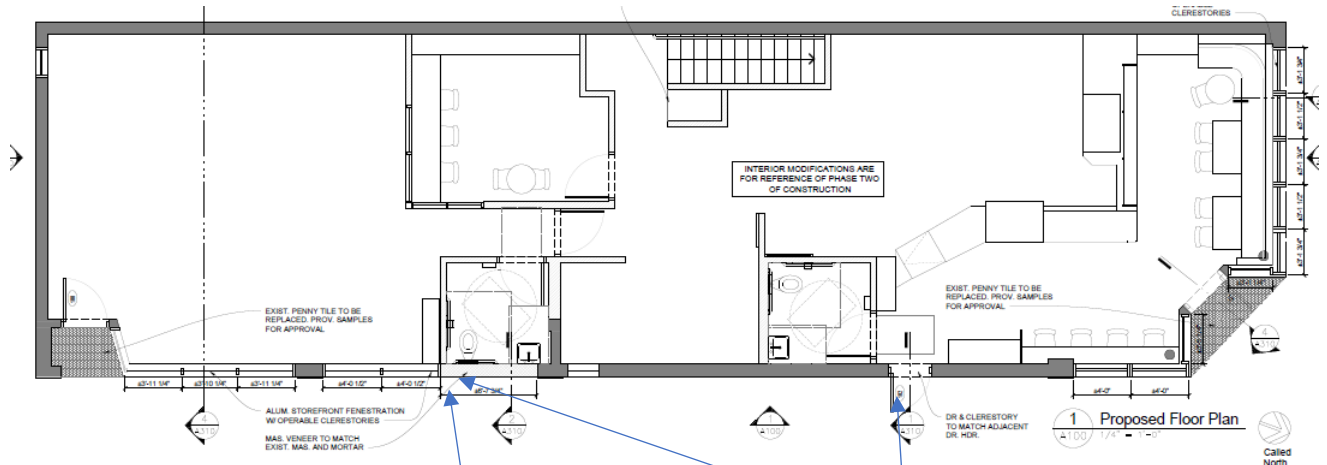
Proposed floor plan

This formerly inset entrance will be bricked in, reducing the width of the storefront

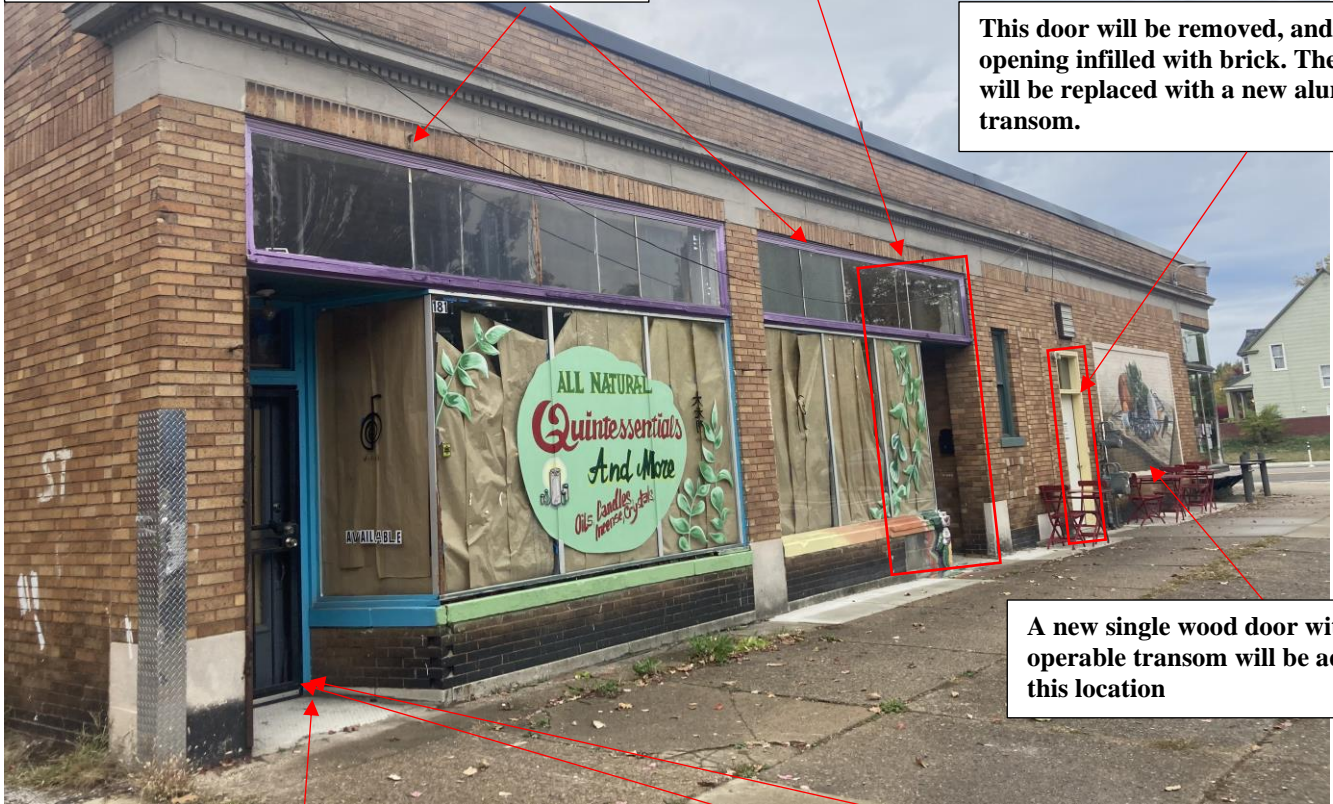
Current conditions

These storefronts, to include wood transoms and trim, wood doors and associated trim/casing, and aluminum windows with wood trim will be replaced with new aluminum storefronts. The existing wood beadboard ceilings will also be removed.

This window, door, and brick below will be removed and the opening infilled with new brick, thus reducing the width of the current storefront opening and the inset opening

This door will be removed, and the opening infilled with brick. The transom will be replaced with a new aluminum transom.

A new single wood door with operable transom will be added at this location

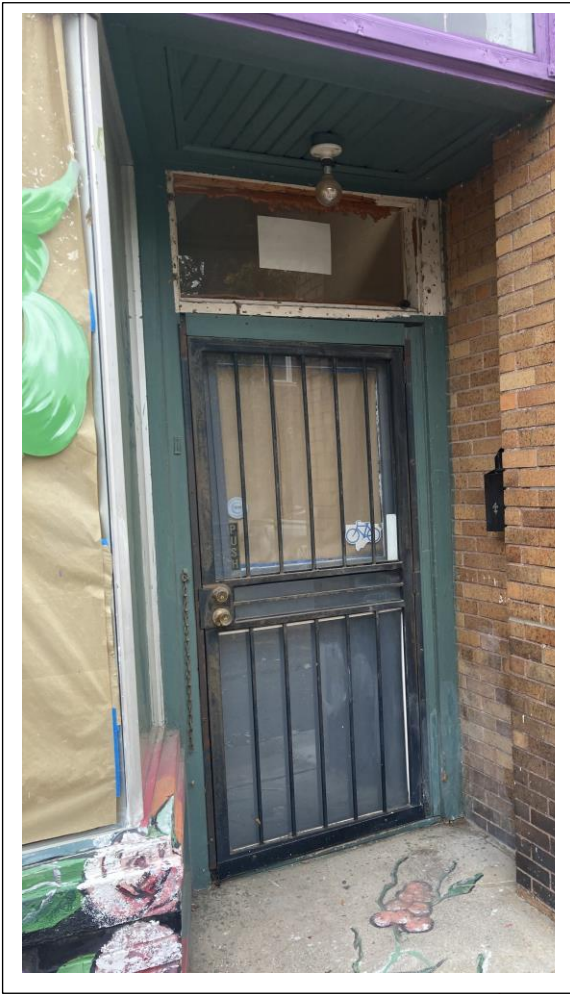
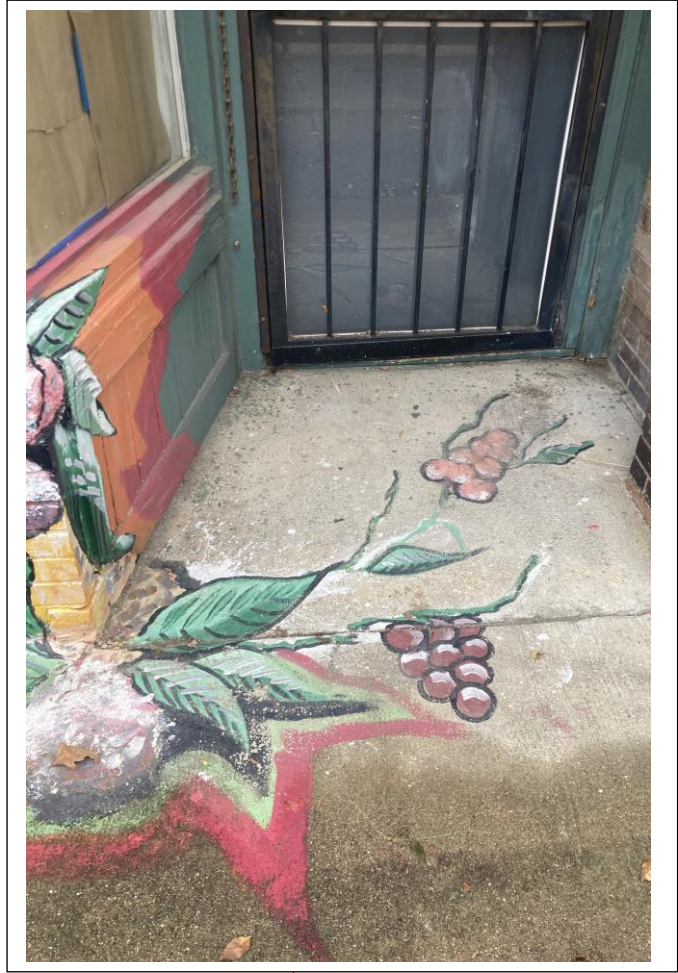
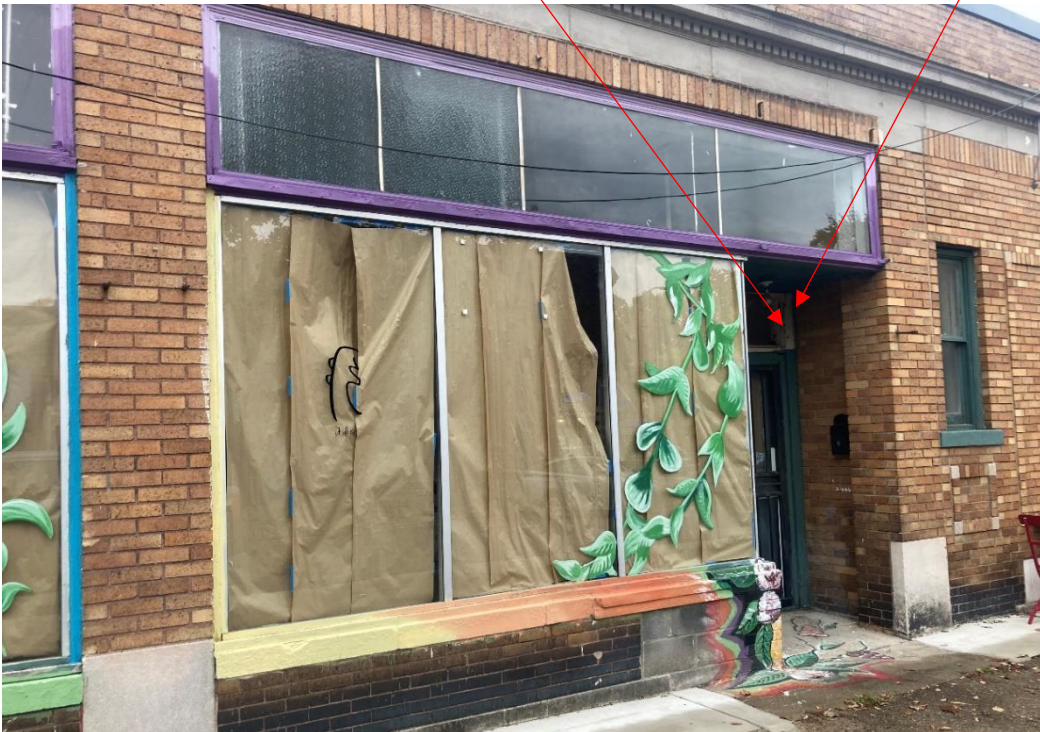
Door at side/east elevation, north storefront that will be removed and opening infilled with brick

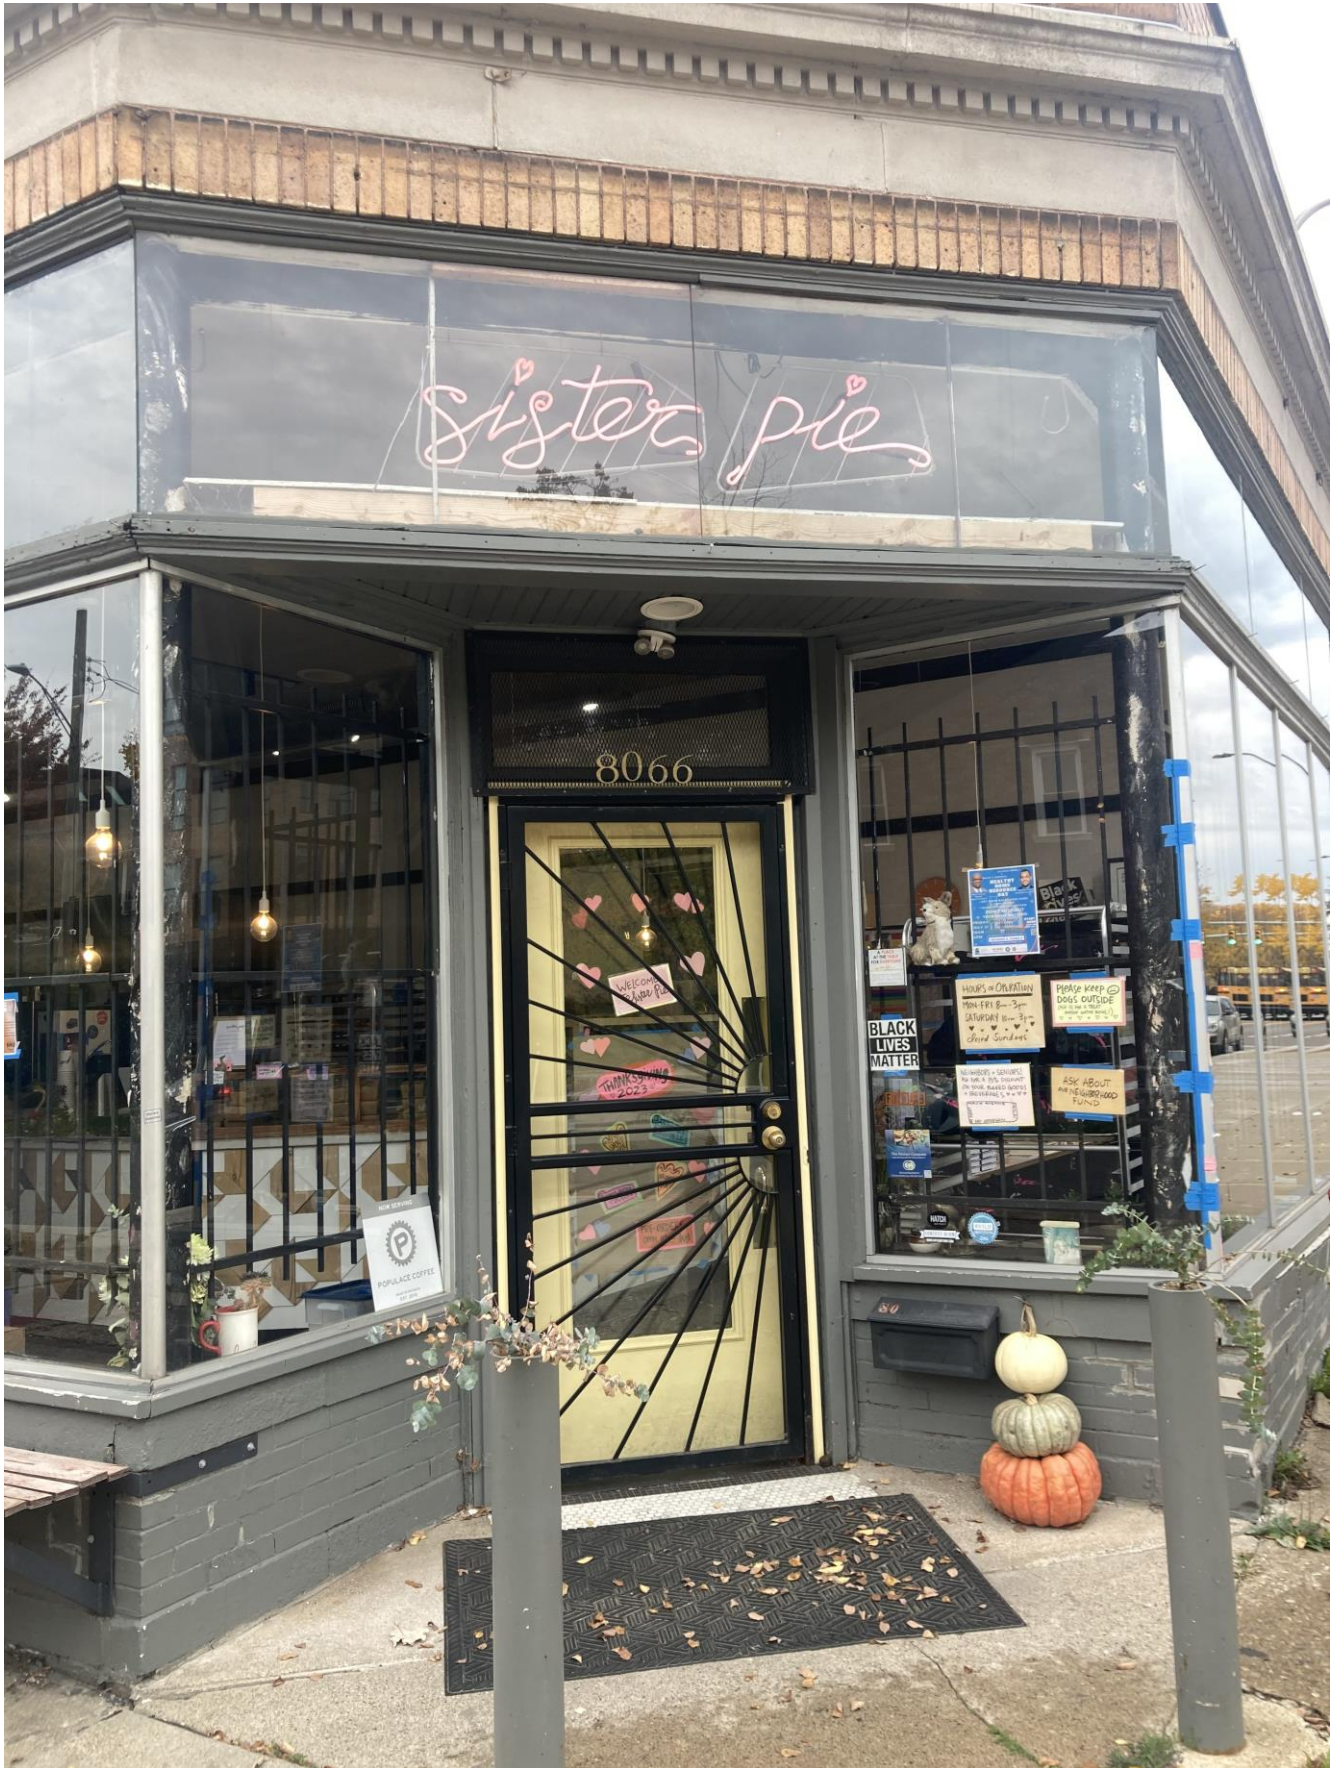
Main entrance at primary storefront, facing southwest. Staff photo taken 10/28/2023

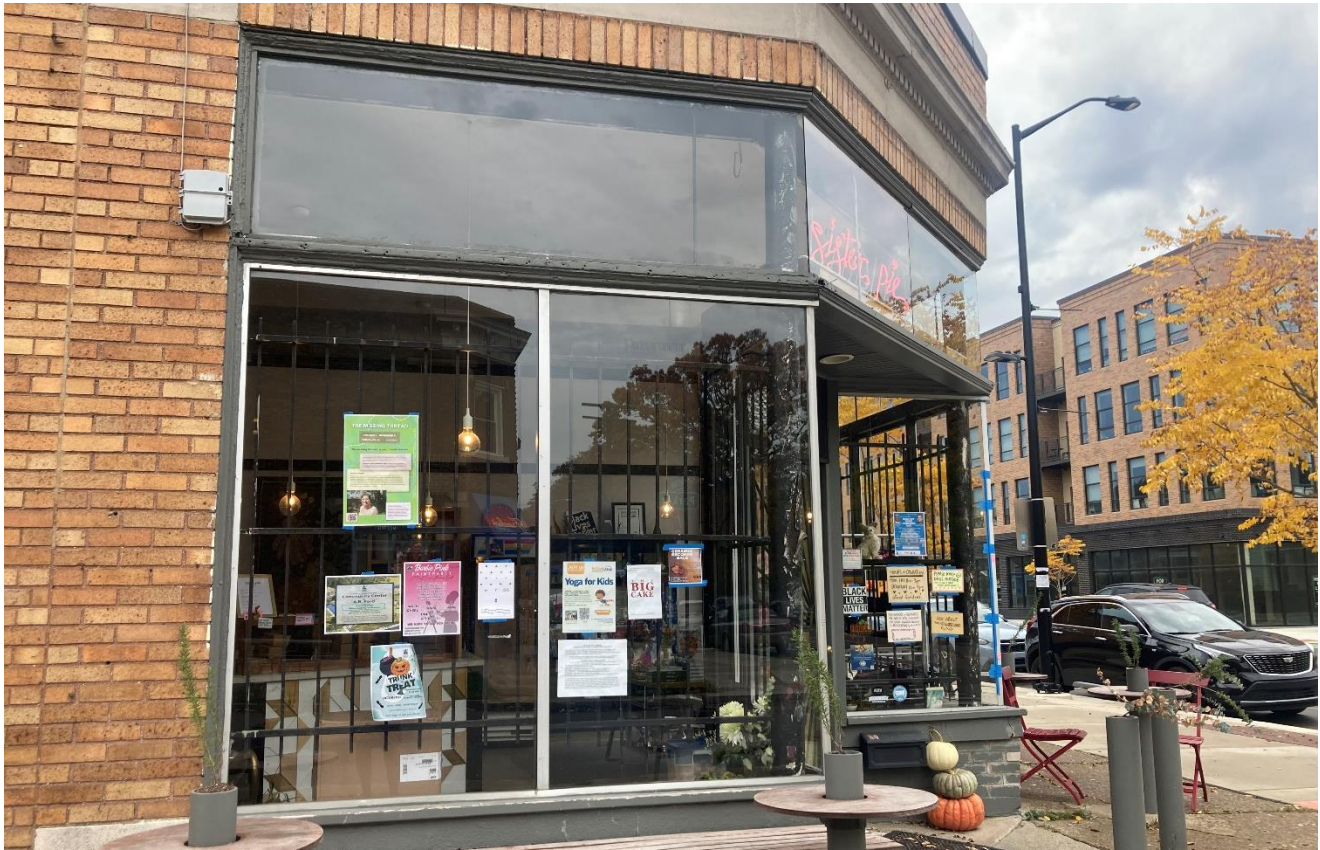
Wrap around storefront at primary entrance, facing northwest. Staff photo taken 10/28/2023

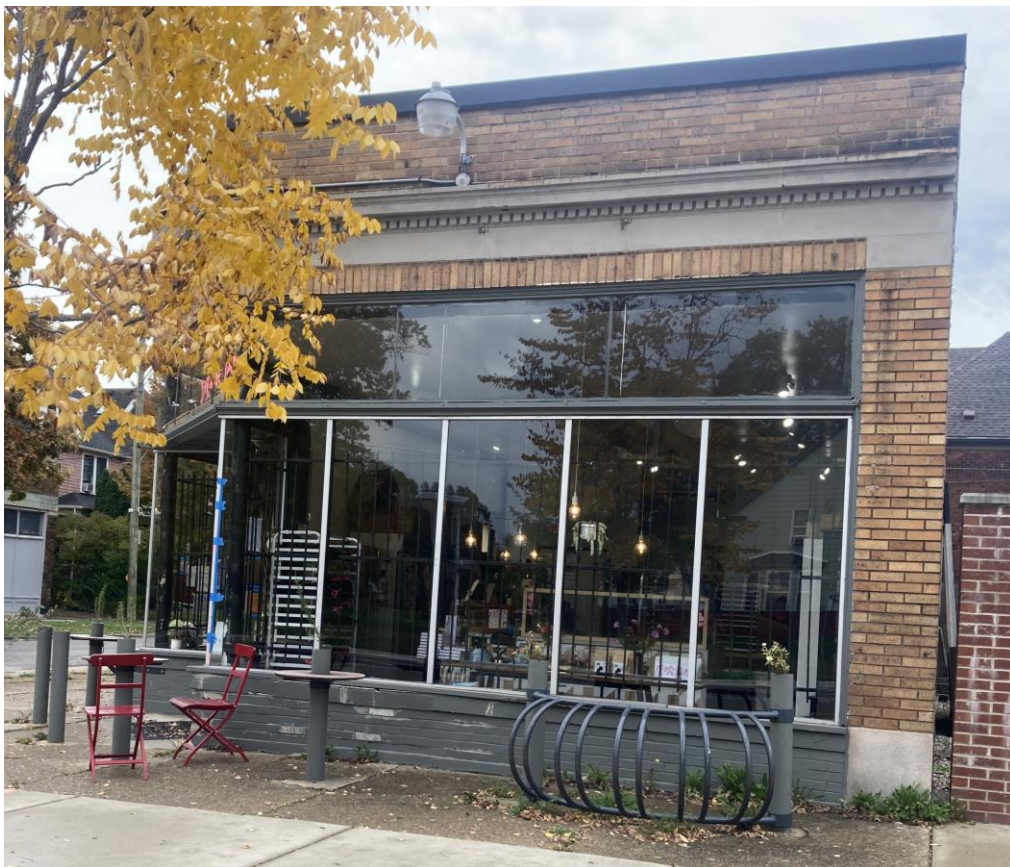
Primary storefront proposed for replacement with new aluminum storefront. Wood doors, aluminum windows, wood trim, wood transom, and penny tile will be removed.

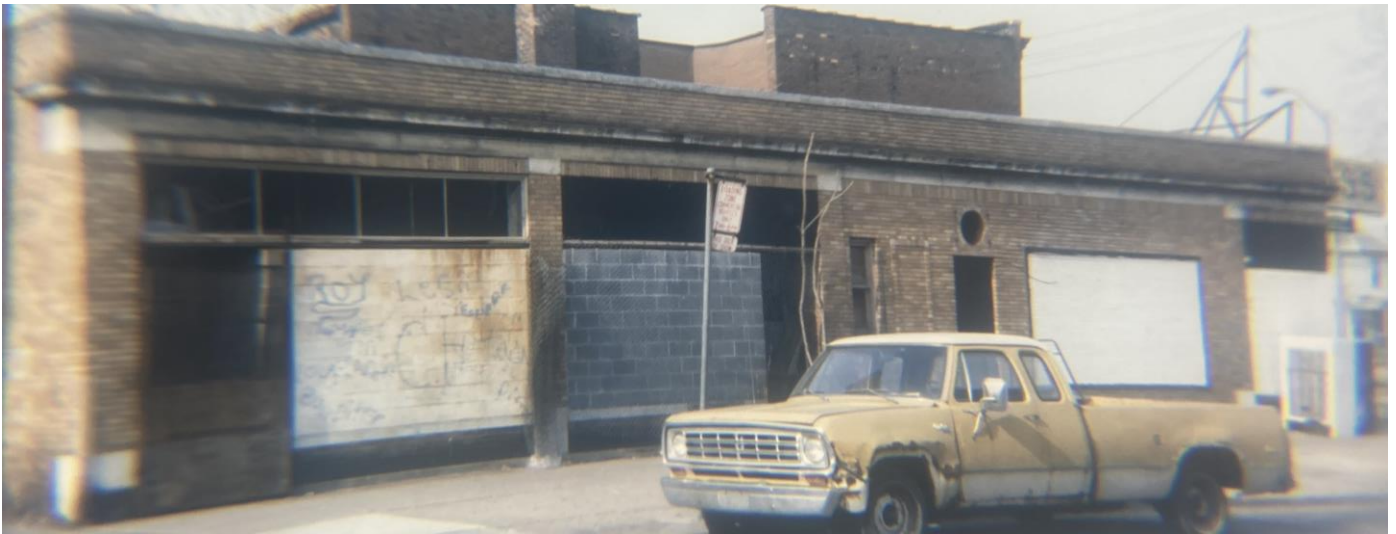
Designation slide, facing northwest. Photo taken in 1983

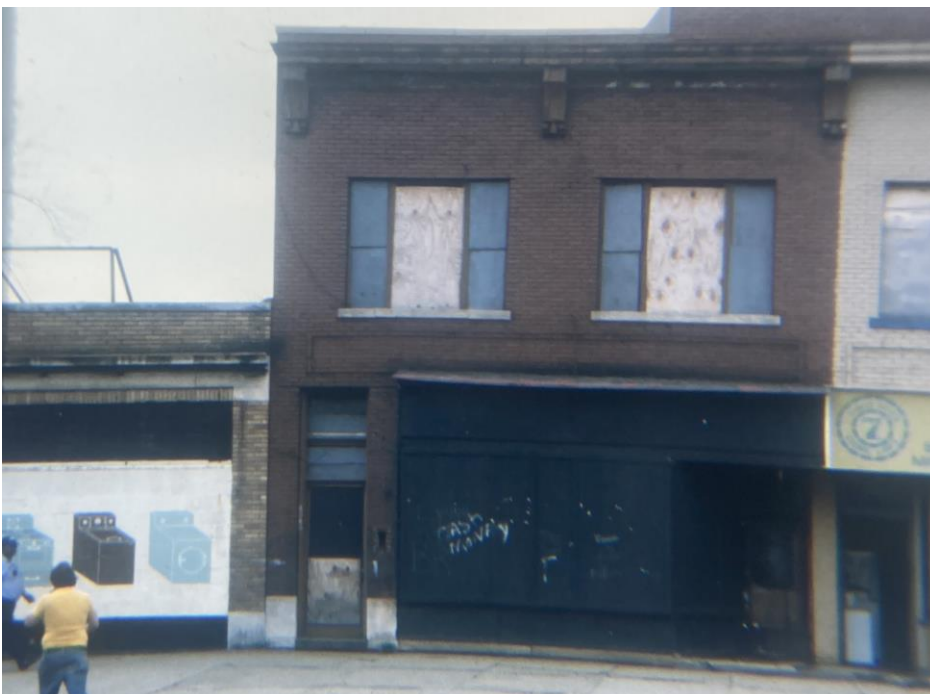
Designation slide facing south. Photo taken in 1983

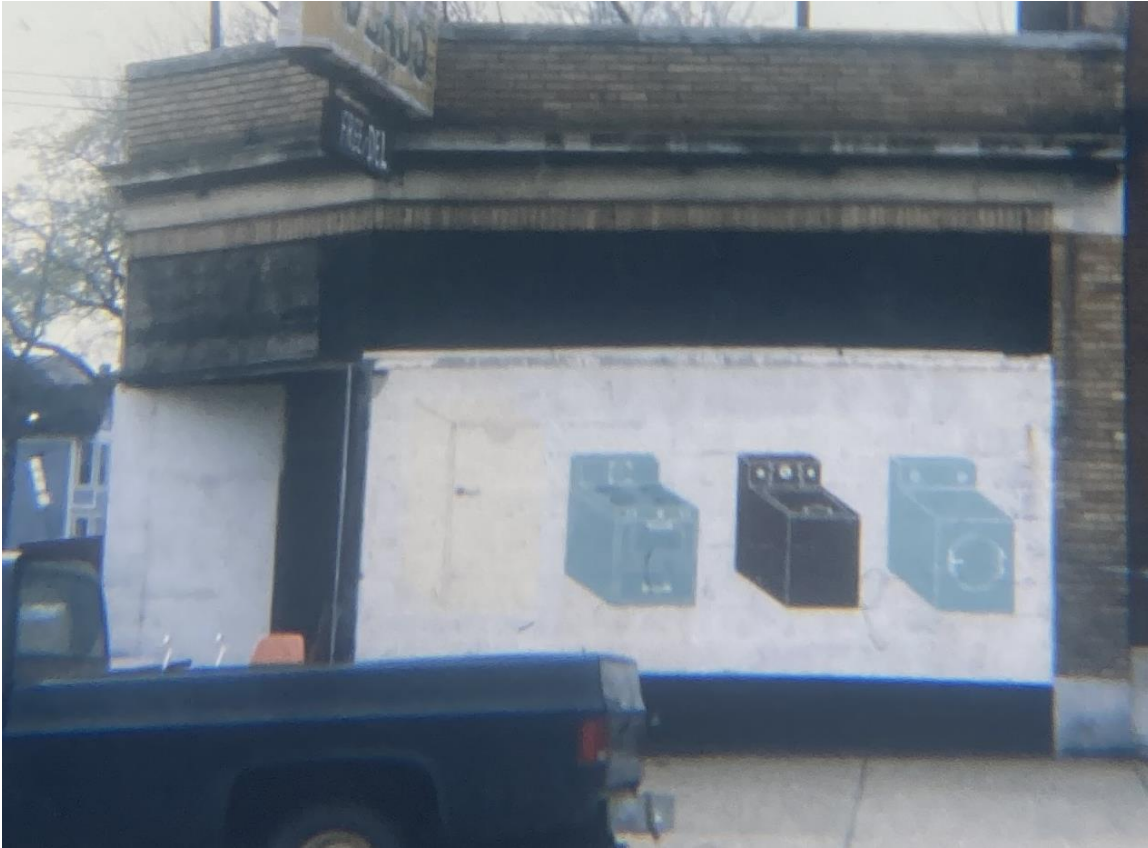
Designation slide facing south. Photo taken in 1983

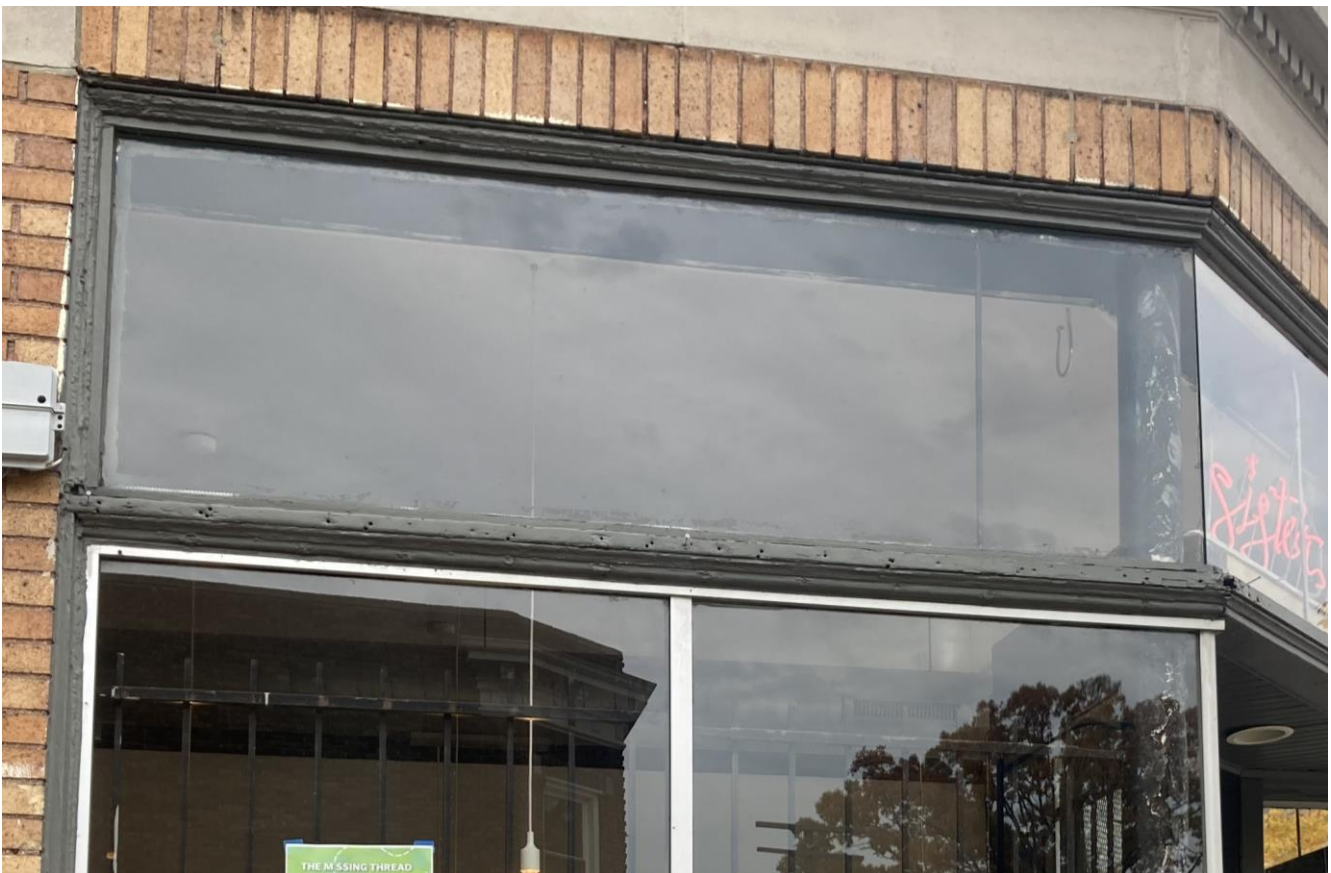
Transom at main entrance/primary storefront., facing west. Note trim profile. Staff photo taken 10/28/2023

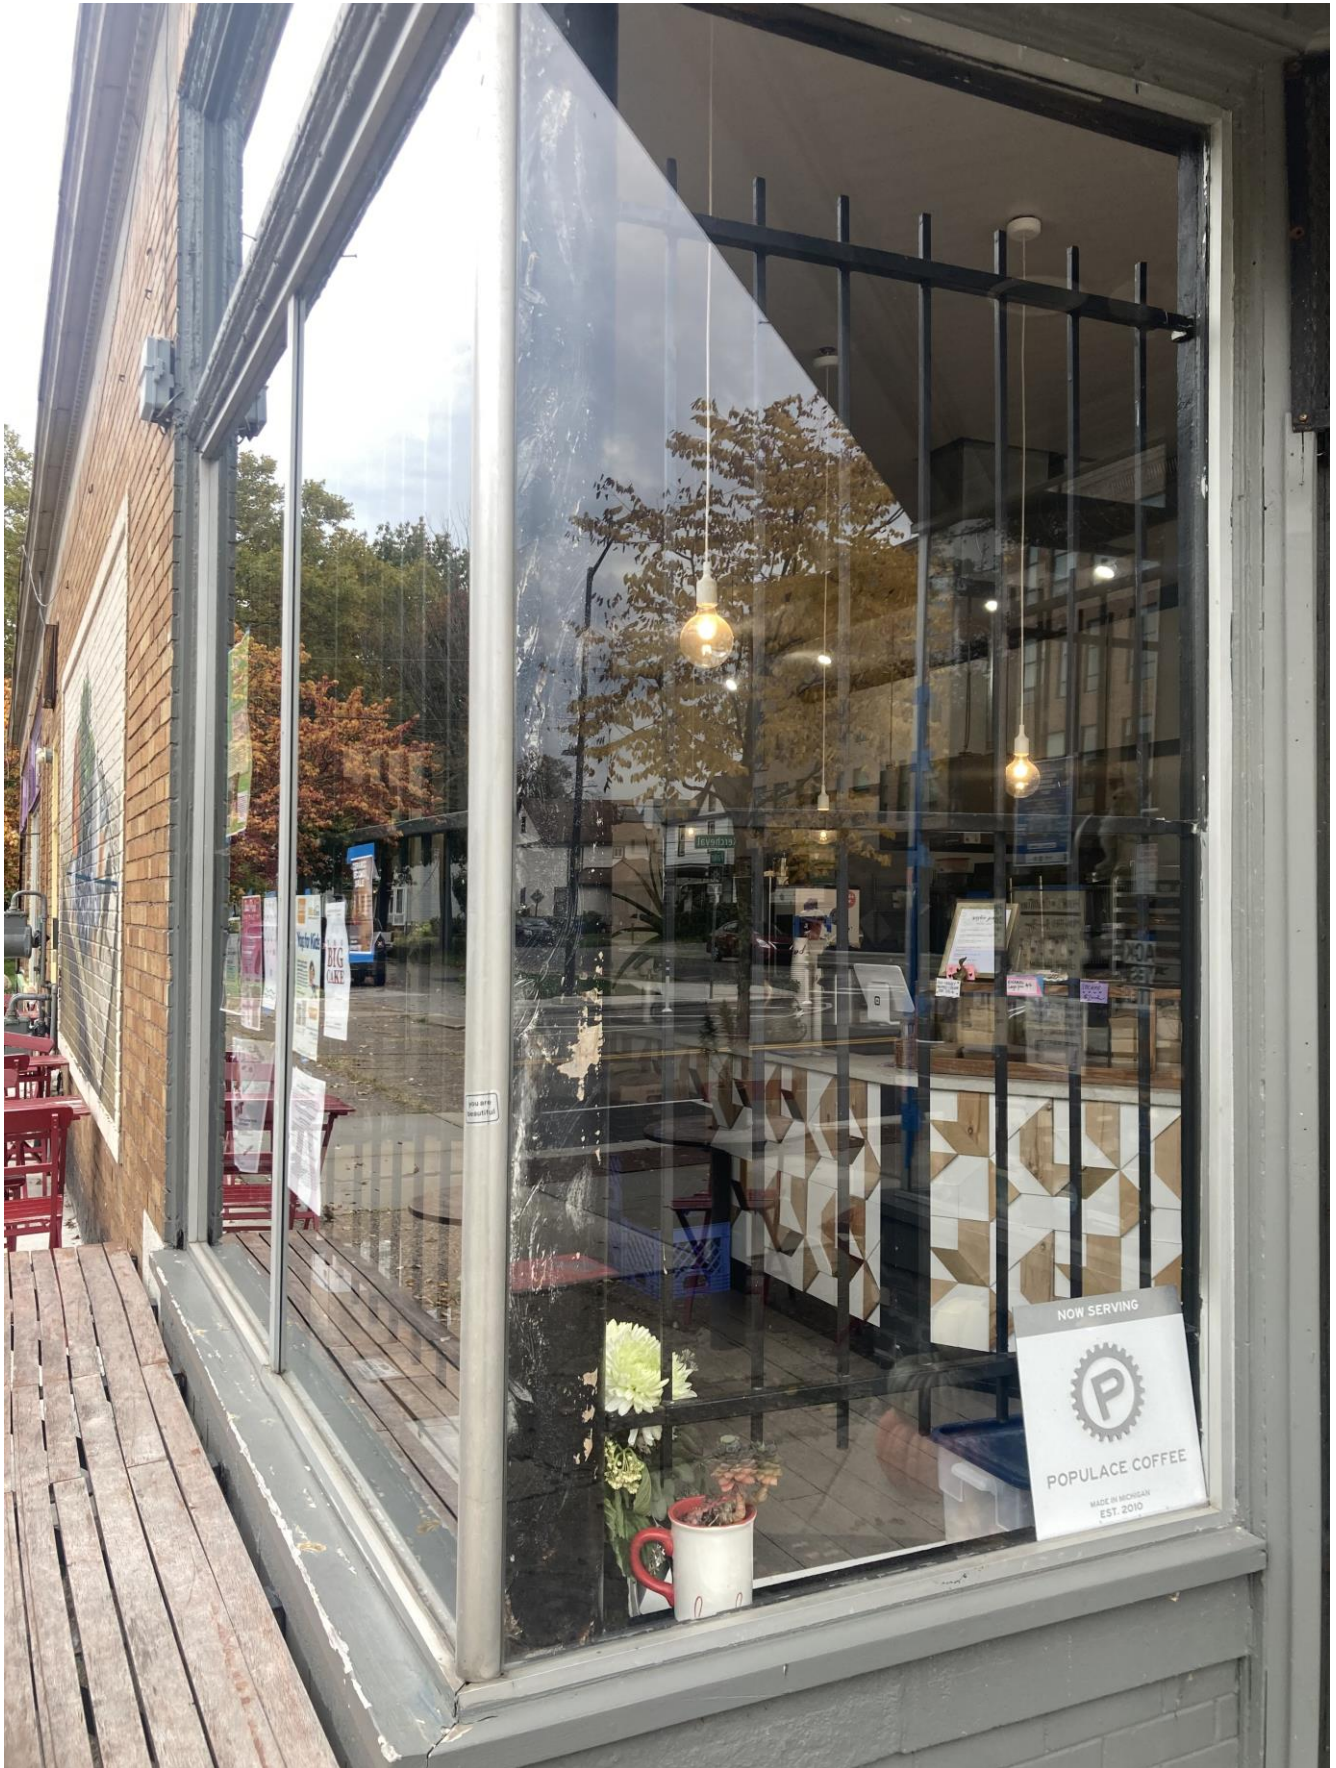
Storefront window at main entrance. The wood sill directly below the aluminum windows do not appear to be present in the 1983 designation slides. Staff photos taken on 10/28/2023

- Note the details/profile of the cornice trim at the transom
- The applicant has submitted a report from a licensed structural engineer which states the following re: the condition of the storefronts proposed for replacement:
 - “The windowsill is wood that has deteriorated from moisture and no longer properly supports the single-pane windows. The brick below the wood sill is bowing out towards Kercheval Street.”
 - “The north wall windowsill and brick deterioration and movement must be corrected to prevent the front window glass from falling.”

Staff does note the presence of tape at the front/north façade storefront window assembly, which does indicate that the current non-historic aluminum window system is failing at this location. The applicant has also supplied photos of the storefronts, taken from the interior and exterior, to document the existing conditions. The wood sills/trim which sit directly below the aluminum windows do not appear to be present at the time of the district's designation. They are therefore not distinctive character-defining features of the building and, per the submitted condition assessment, merit replacement due to their poor condition.

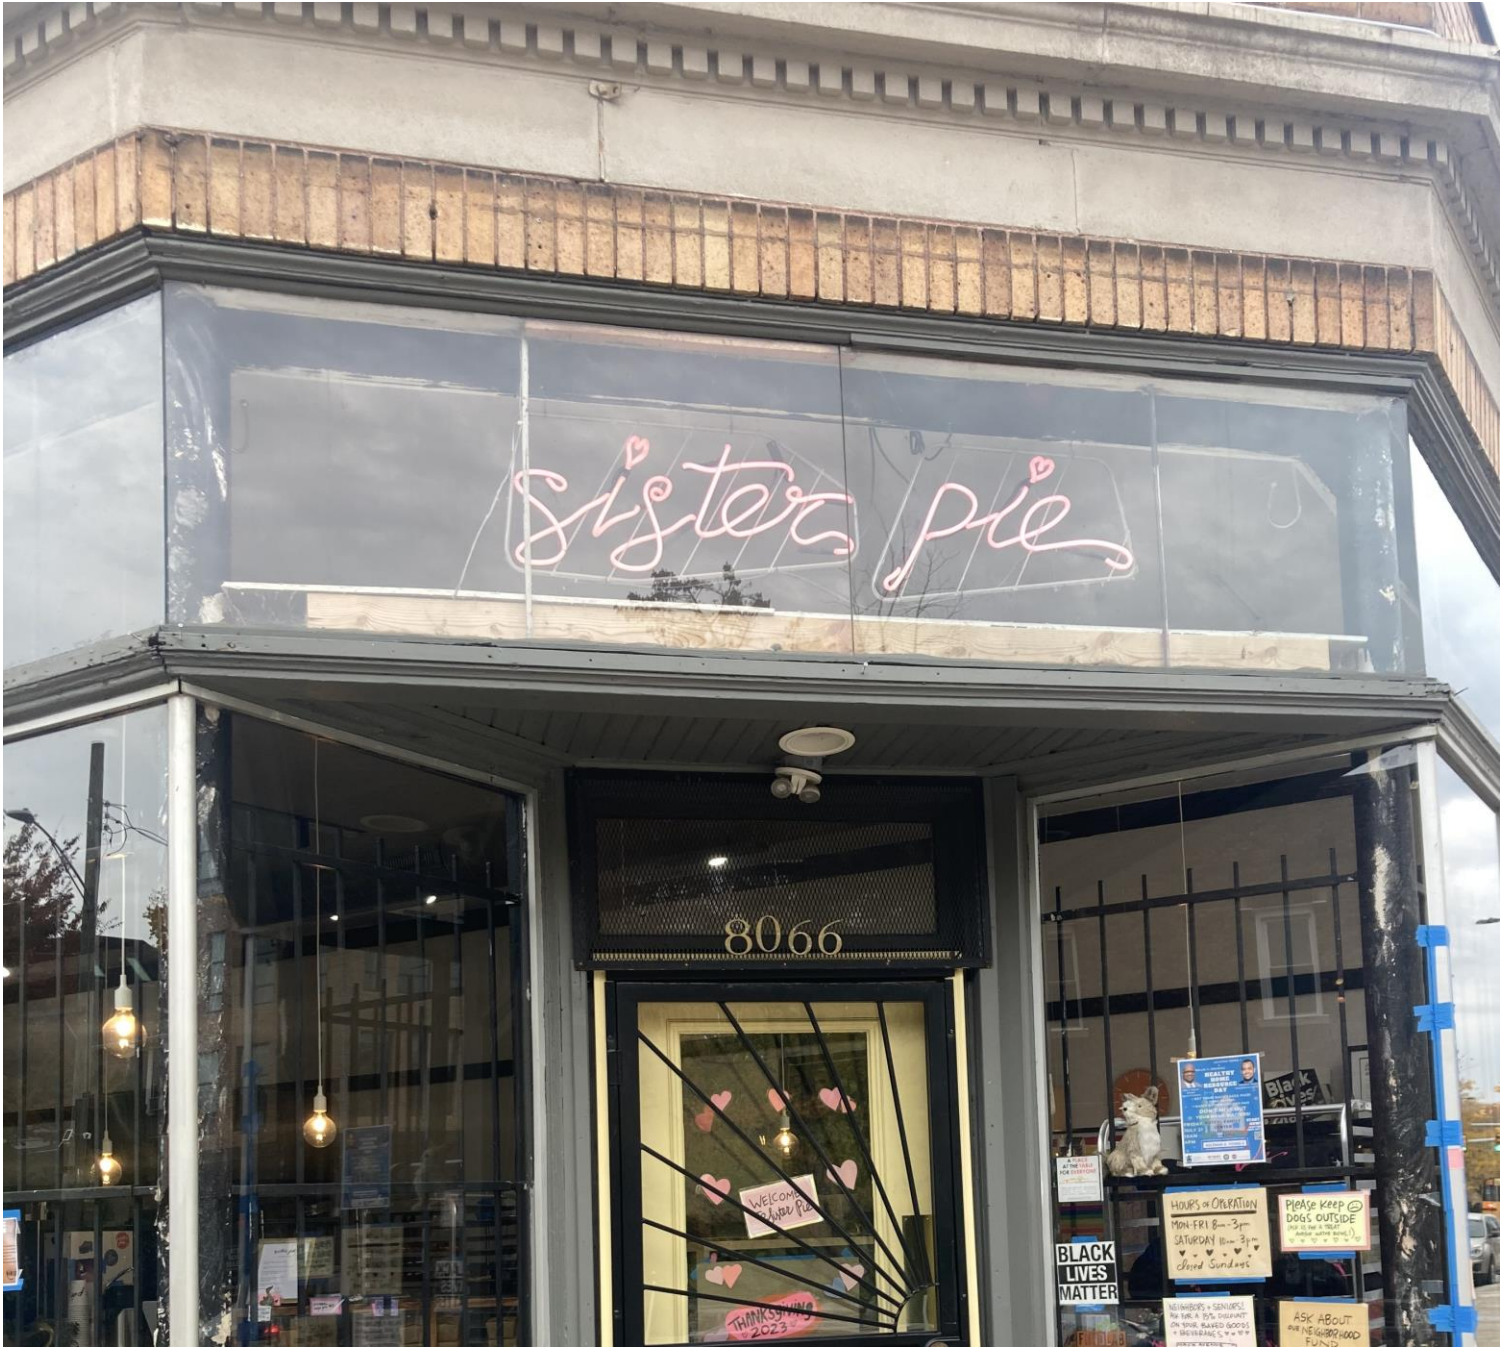
Transom at main entrance/primary storefront. Note trim profile. Staff photo taken 10/28/2023
