**STAFF REPORT:** 12/13/2023 REGULAR MEETING

**APPLICATION NUMBER:** HDC2023-00144

**ADDRESS:** 2485 BURNS

**SCOPE:** REPAIR AND ENLARGE FRONT PORCH AND WALKWAY

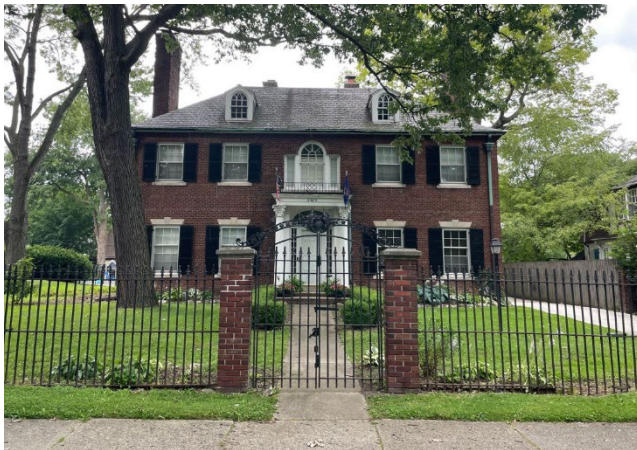
*Site Photo 1, by Staff July 20, 2023: (East) front elevation, showing the existing front porch.*

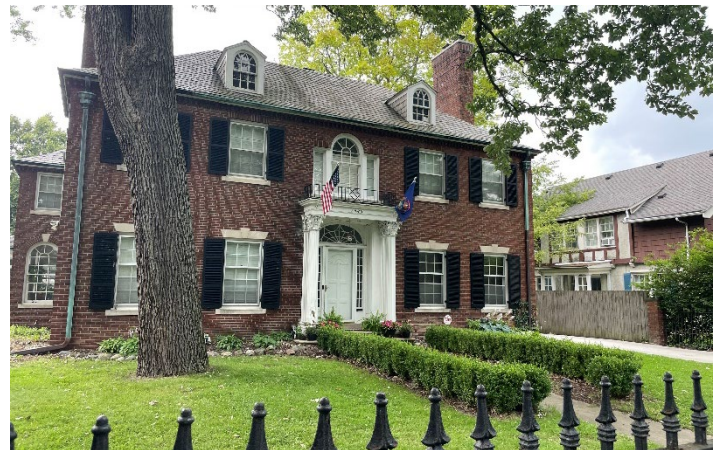
*Site Photo 2, by Staff July 20, 2023: (East) front elevation, showing the existing front porch.*

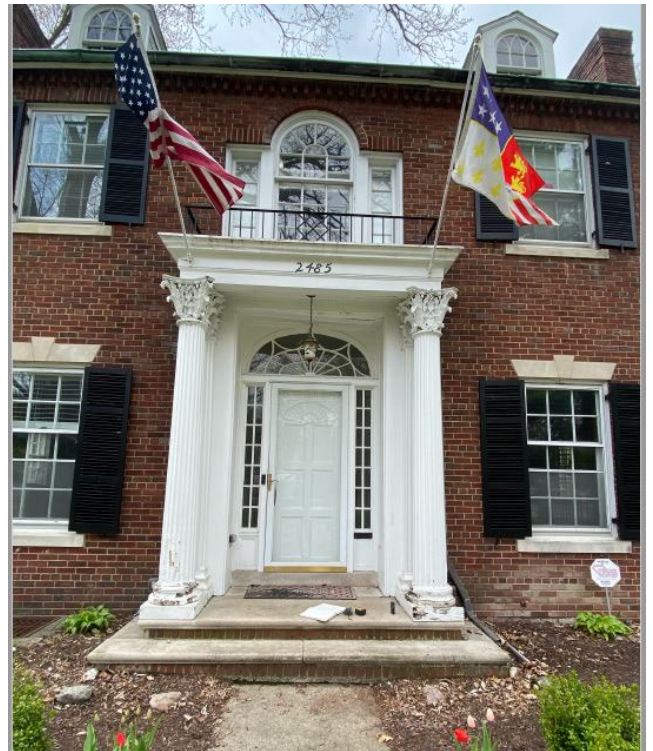
Site Photo 3, by Applicant: (East) front porch existing conditions, showing the original dimensions of the threshold, upper landing, and the lower step.

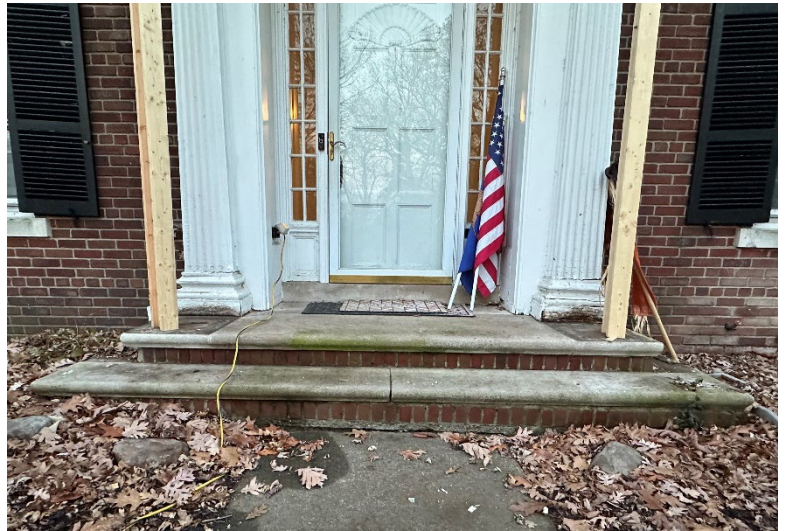
- The existing front porch features cast stone capping and matching brick underlay detailing that matches the material, scale and color of the house (See photos 1-3). Staff offers the opinion that the rectangular shape and material of the porch, especially the top step that supports the columns, is a character defining feature that supports the symmetry and geometry of this Georgian Revival architecture.

*Site Photo 4, by Applicant: (East) front porch existing conditions, showing the original dimensions of the threshold, upper landing, and the lower step.*

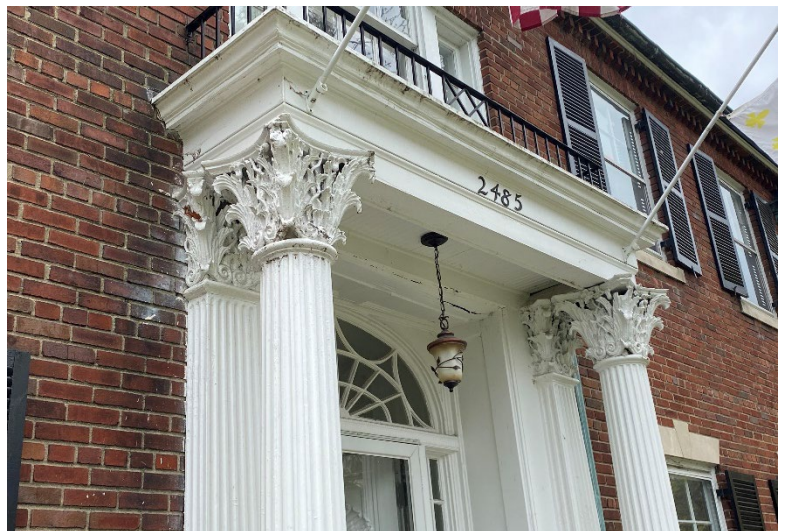
- Staff reviewed the repair work and noticed how the porch roof/balcony has slightly separated from the house due to wear from the columns resulting in water damage to the porch ceiling and doorway. The proposed repair work is in alignment with the Secretary of Interior Standards and is appropriate. (See Site Photo 5.)

*Site Photo 5, by Applicant: (East) front porch existing conditions, showing the original capitals and water damage over the doorway.*

- Repair 2 columns
  - Remove, prop balcony, strip all paint layers, repair surface, repair columns, prime and paint color white, reinstall.
- Repair 2 pilasters
  - Strip all paint layers, repair surface in kind, prime and paint color white.
- Repair 4 capitals and repair 4 bases
  - Remove, strip, rebuild/ repair in kinds as needed, prime, paint color white, reinstall.
- Repair Porch Roof/Ceiling/Balcony
  - Position balcony into proper position after columns have been removed.
  - Remove bead board ceiling, remove rotten structure, rebuild all, reset roof structure back into original position in the wall, install new bead board ceiling, prime and paint color white.
  - Remove inset ceiling panels, remove/replace rotten structural wood, replace wood panels with matching wood panels, prime and paint color white.

- Remove existing roof and decking, replace wooden decking and install new copper roof (fabricated by 3rd party), insert into cut brick line, mortar in, ensure proper slope and draining to downspout, solder outlet. No changes in the original design.
- Repair Front Door and Surrounding Sidelights
  - Repair-in-kind any rotten wood for the lower panels on sidelights and frame returns
  - Seal prime and paint all remaining parts of the front porch, color white.

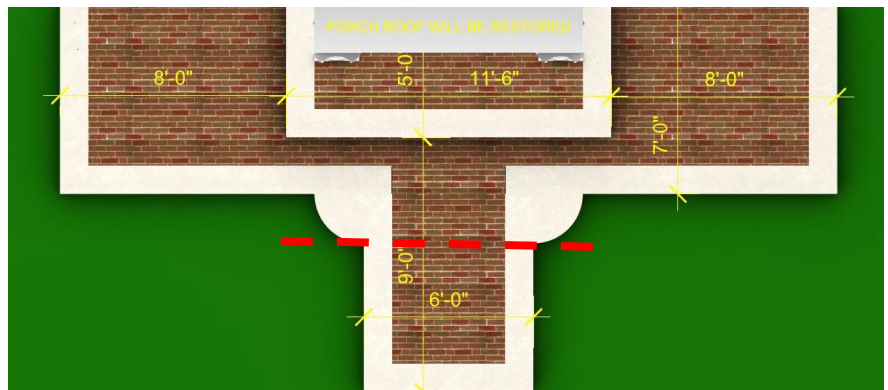
- The introduction of brick pavers on the top level of the porch, which greatly alters the simplicity and uniformity of the upper threshold of the porch that supports the columns both physically and visually as one architectural unit. Staff does not have an issue with the expansion of its dimension as proposed if it maintains the limestone surface at this location.
- While the expansion of the lower area of the porch with a brick interior and limestone exterior is appropriate in staff's opinion, the introduction of a "tongue" that extends out into the walkway, alters the character defining feature of the front elevation critical to an understanding of the building's style by introducing a new design element that is historically not appropriate. Staff offers the opinion that the porch expansion maintain a simple rectangular form or, if the

Figure 3, by Applicant: proposed front porch, showing the expansion of the threshold, the top step landing, the porch, and the width of the sidewalk. Note staff's red dashed line, which is the recommendation for the limits of the lower porch expansion.

Commission consents to the introduction of the two quarter-round limestone blocks, that this point is the terminus of the porch extension. (See staff's drawn red line in Figure 2).

- The upper step consists only limestone capping, as historically shown.
- The applicant provides HDC staff with an updated site plan that shows the front porch lower deck has a rectangular shape or projects no further than the outer edge of the proposed quarter-round limestone blocks, not protruded out into the sidewalk.
- The applicant provides HDC staff with an updated site plan that shows the walkway is expanded no more than 5' and consists of one material, such as clay-fired brick or concrete.
