STAFF REPORT: 12/13/2023 MEETING
APPLICATION NUMBER: HDC2023-00145

ADDRESS: 4138 LINCOLN

HISTORIC DISTRICT: WOODBRIDGE FARM

SCOPE OF WORK: REPLACE WINDOWS; CONSTRUCT PORCH

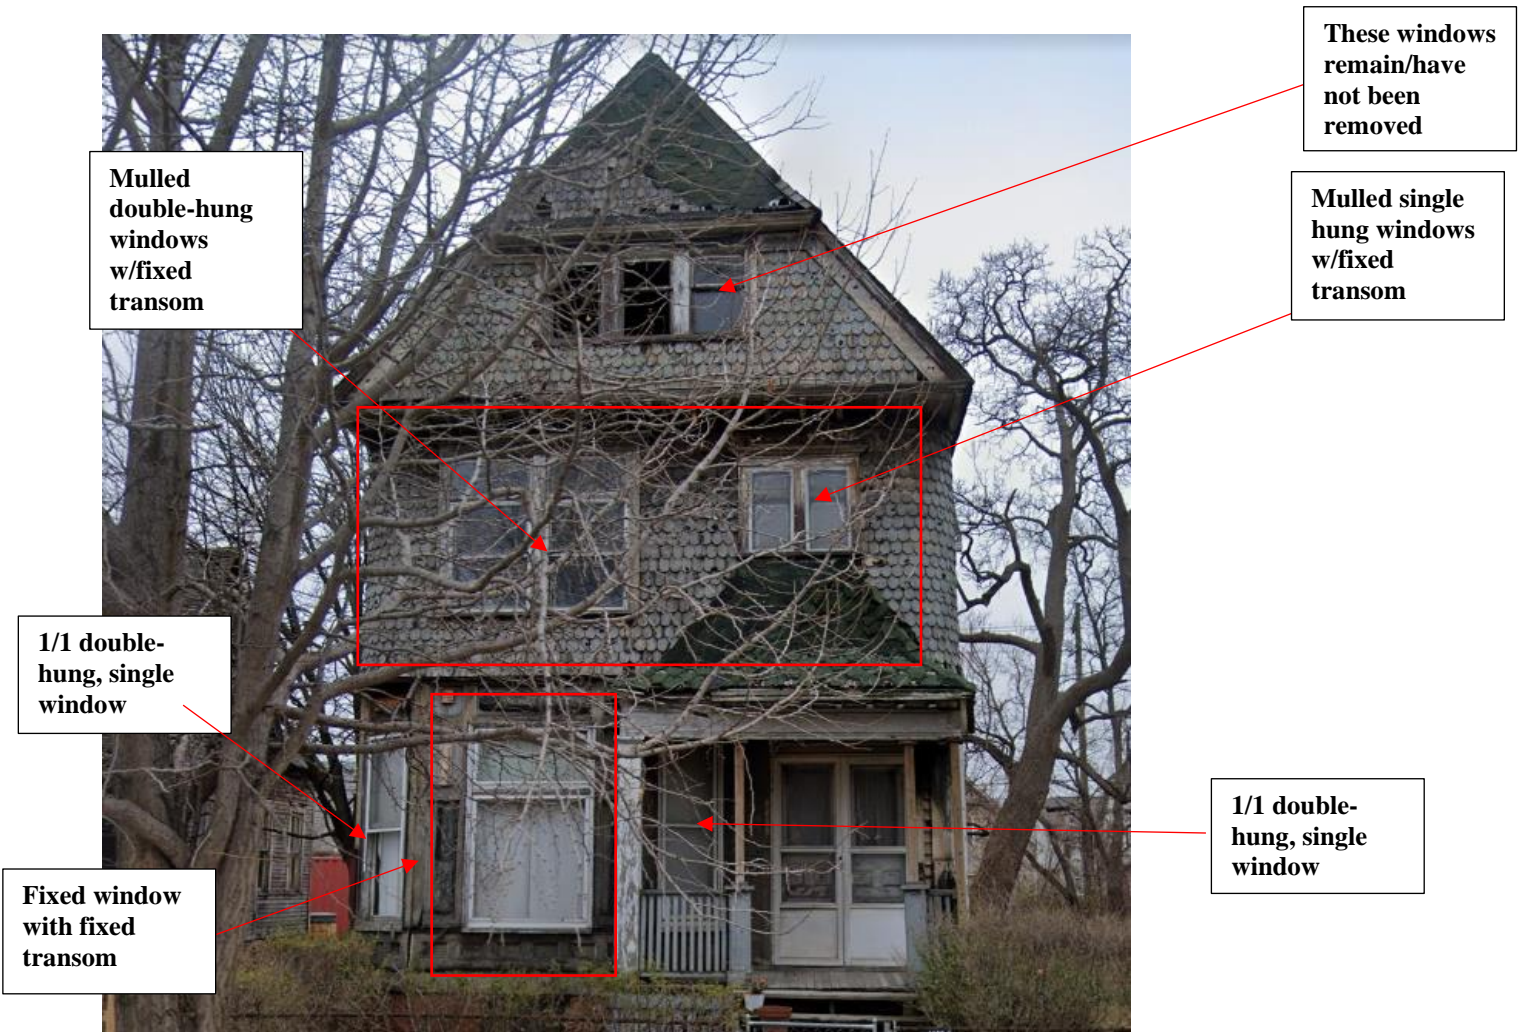
Google Streetview, prior to unapproved window removal. This picture indicates the location of the five windows at the front façade (outlined in red) which were all topped with a transom. The second story windows which included a transom were also mullied, paired units. See below images for the condition of these windows before their removal in 2021 and after/2023. The other two windows at the front elevation, first story, and those at the side walls were more standard, 1/1, double-hung units. As noted above, the 2021 application only provided typical details for the former/historic 1/1 wood windows. However, the dimensions of the five windows which included transoms were not documented prior to their unapproved removal.

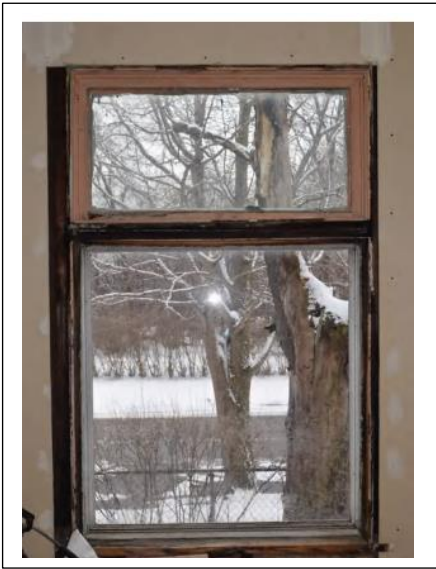
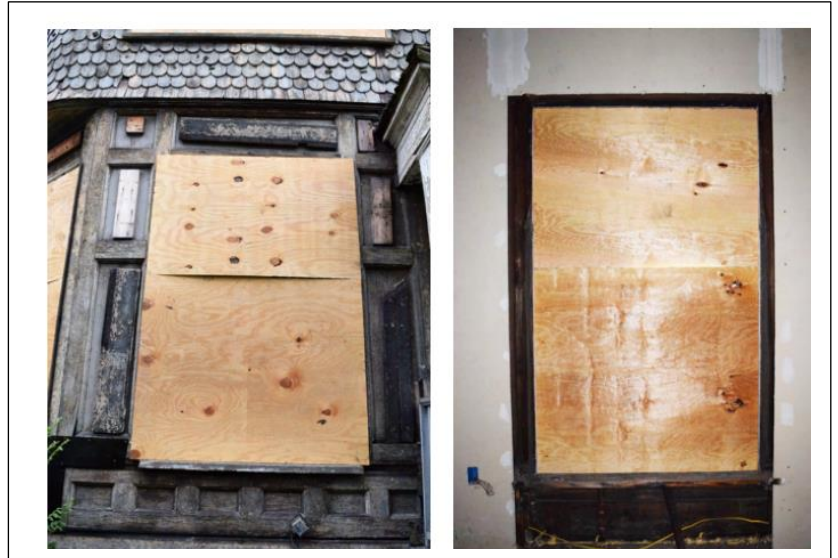
Fixed window with fixed transom at first story, 2021 condition (left) and 2023 condition after unapproved removal (right). The entire window and transom have been removed. The exterior woodwork remains

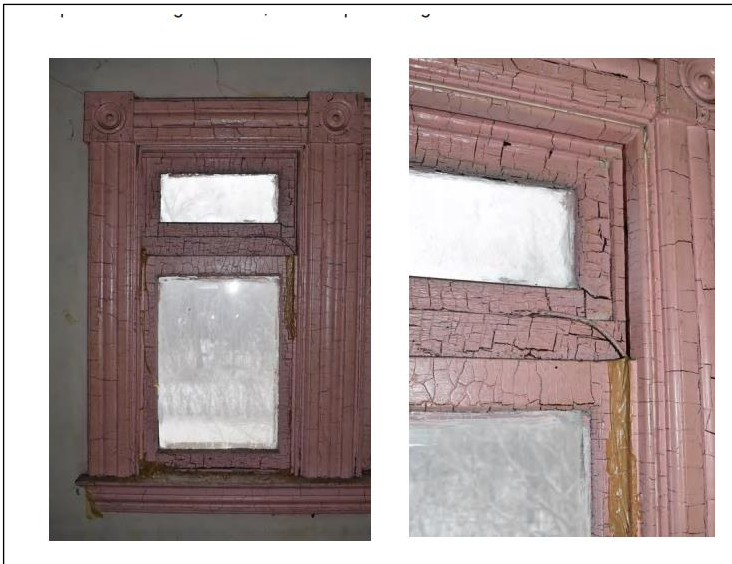
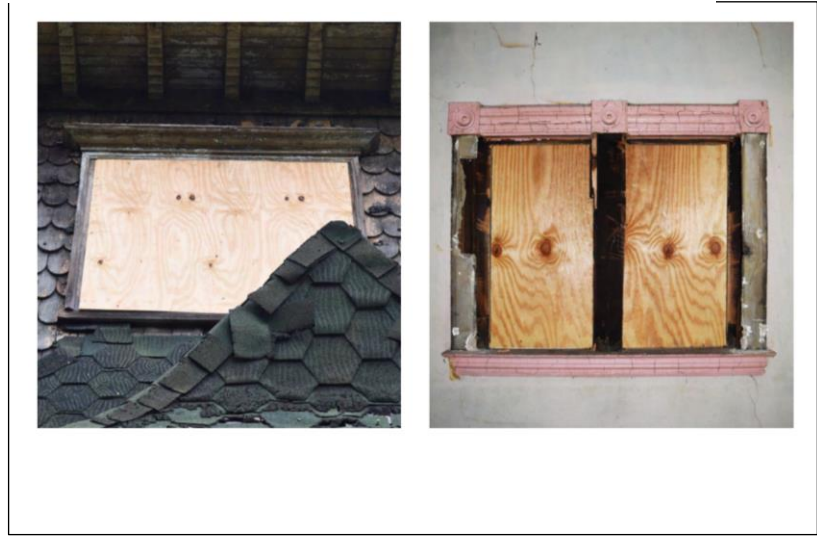
Paired mullioned single hung windows with fixed transom at second story, 2021 condition (left) and 2023 condition after unapproved removal (right). The sash has been removed, but the mullion and exterior casing and crown mould remains

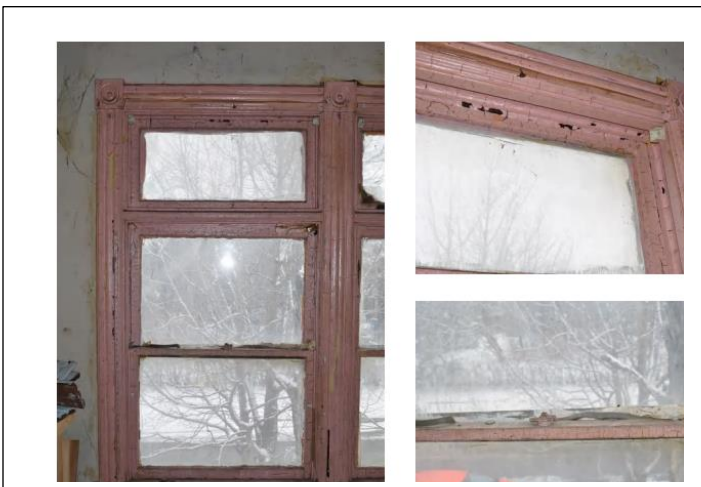
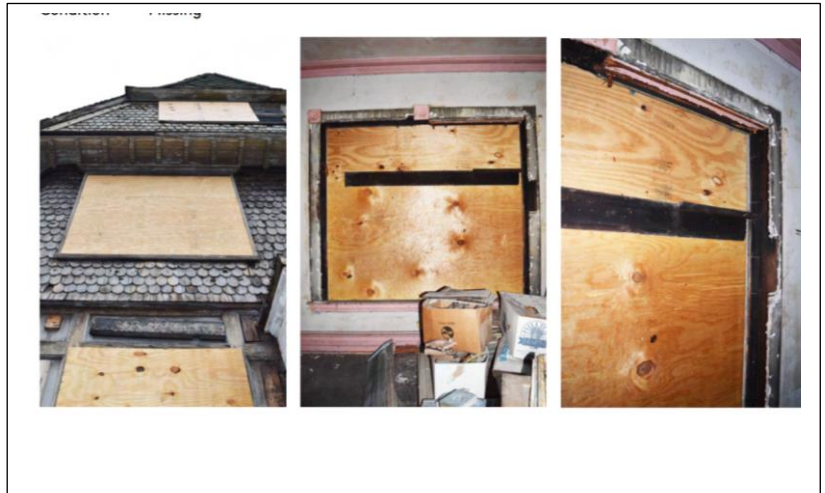
Paired mullioned double-hung windows with fixed transom at second story, 2021 condition (left) and 2023 condition after unapproved removal (right). The entire windows and to include horizontal and vertical mullions have been removed while the exterior casing and crown mould remains

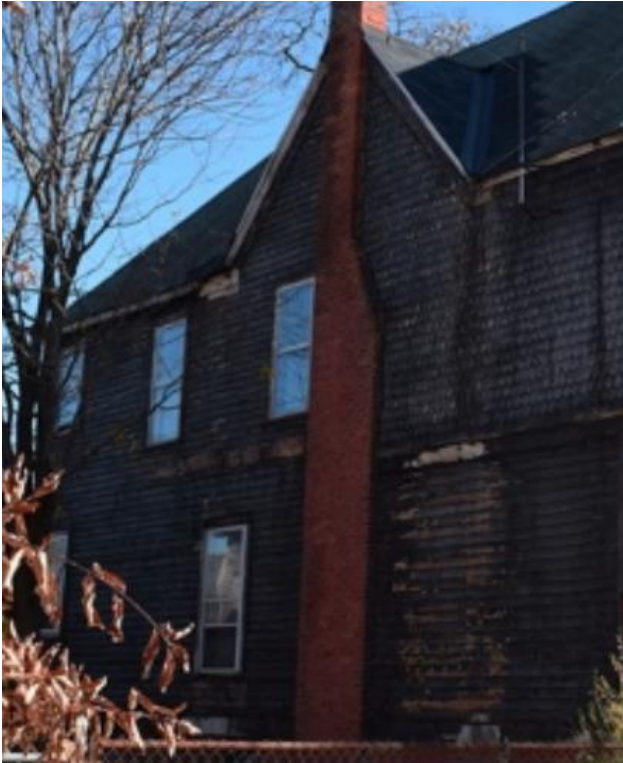
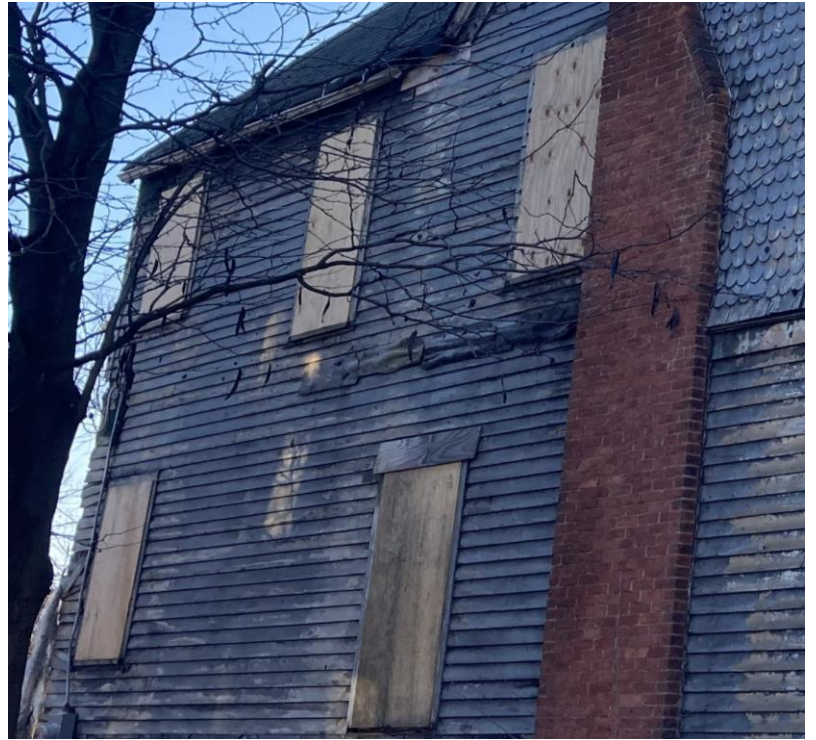
North wall. Appearance in 2021 (left) and 2023 (right). Note that these windows were single, 1/1 wood windows (with aluminum exterior storms). The 2021 application proposed to retain and restore these windows. The window sash at this wall has been removed while the exterior trim/casing remains.

- The original wood windows at the north/side wall and front/west façade were distinctive, character-defining features of the home and were in repairable condition in 2021. As no documentation exists to demonstrate that these windows were deteriorated beyond repair at the time of their removal, an exact replication of these units is the appropriate treatment.

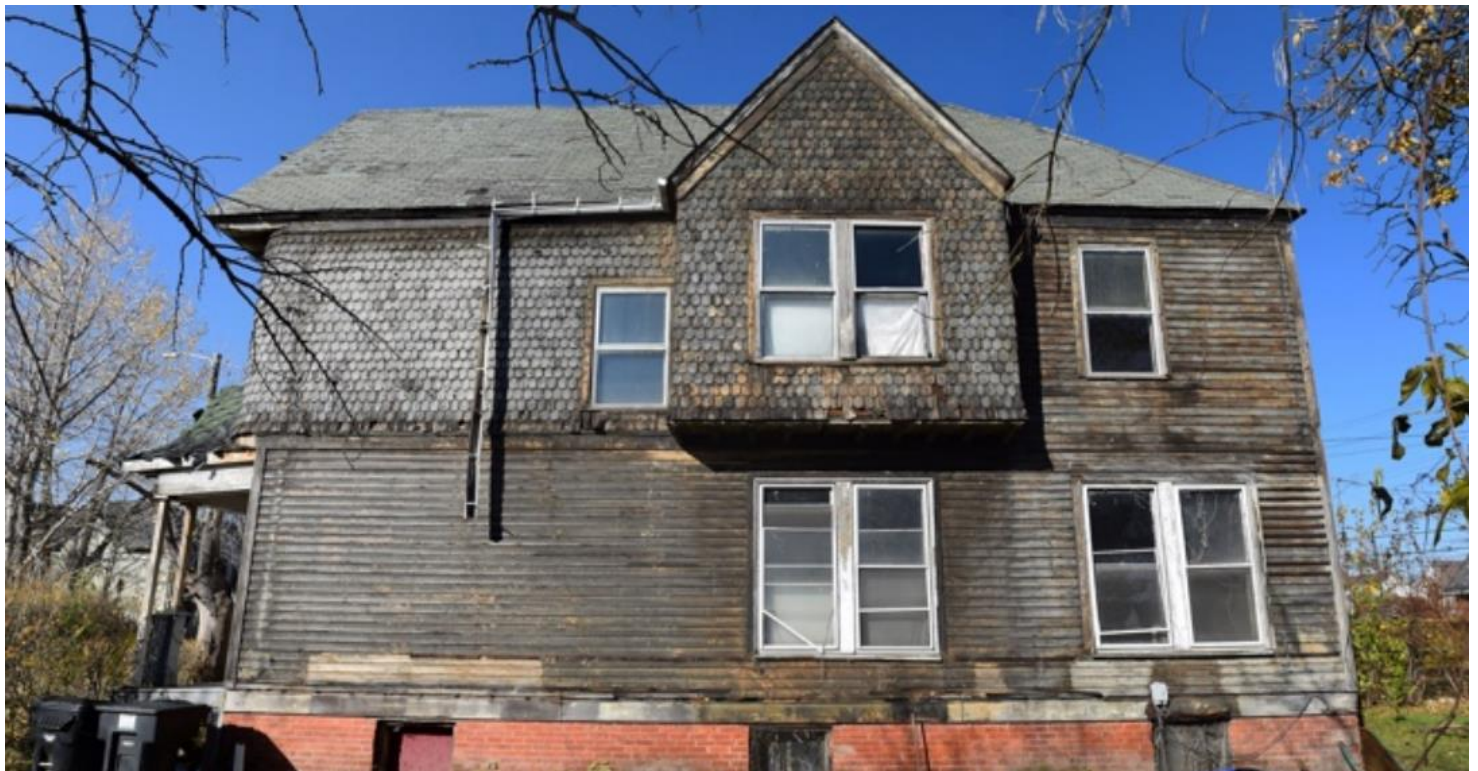
South wall, 2021. Note that this wall includes 1/1 wood windows (with aluminum exterior storm windows), both single and mullied, paired units. The 2021 application proposed to replace the window sash and exterior wood casing *while retaining the mullions*. The Commission approved this work item.

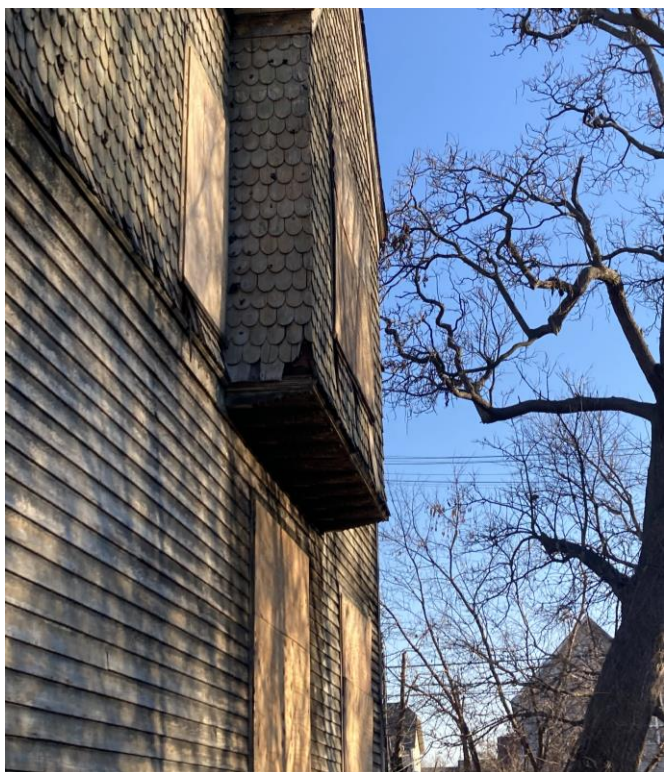
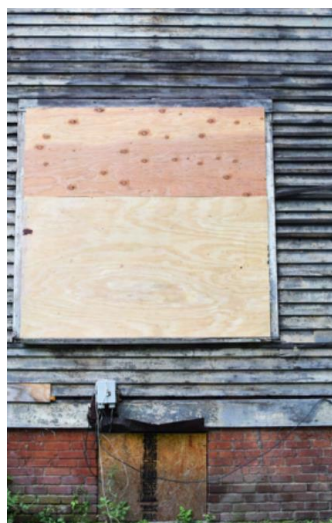
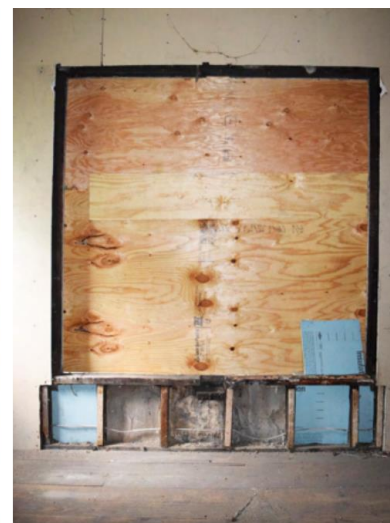
South wall, 2023. Exterior (left photo) and interior of first story eastern mullied paired windows (right). Note that all windows and mullion have been removed while the exterior casing remains.

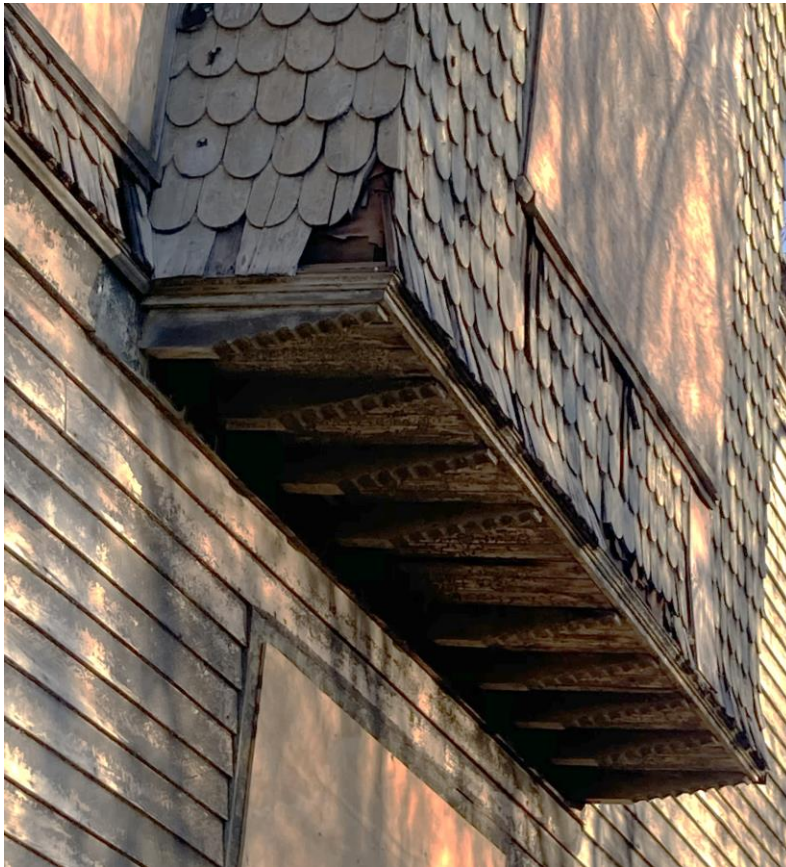
- Generally speaking, the proposed new porch will not obscure, damage, or destroy character-defining features at the property. However, note that the applicant proposes to remove the historic wood brackets which are currently located at the underside of the second story bay and install them at the new porch soffit (see below). Although these brackets are currently not easily visible from public right of way, staff does recommend against this aspect of the proposal as it will destroy the historic relationship between the bay and its original decorative detailing. The brackets should be preserved and rehabilitated in their historic position, allowing the original architecture of the building to be readable in the context of the new porch.

The current application proposes to remove these brackets and install them at the soffit of the new porch roof. HDC staff recommends against this aspect of the application. Staff photo taken 12/8/2023

- The pitch/hip height of side porch's roof shall be raised so that that it more closely resembles the appearance of the front porch roof.
- The existing brackets at the underside of the south elevation's second story bay shall be repaired and remain in place/shall not be installed at the new porch roof.
- The applicant shall submit revised dimensional design drawings of the new south side porch at a 5/8" scale or better to HDC staff reflecting these conditions for review and approval prior to the issuance of the project permit.
